# Site Accessibility Evaluation

### Centennial Park

**Accessibility Evaluation**

***Inspection Date: 09/20/2021  
Inspector: Michael Killebrew/Jason  
Crowe***

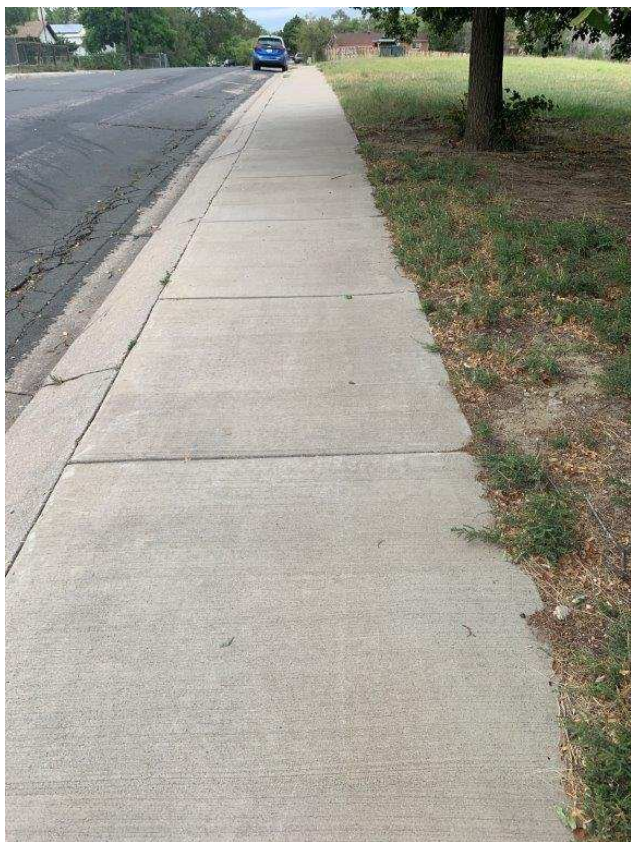
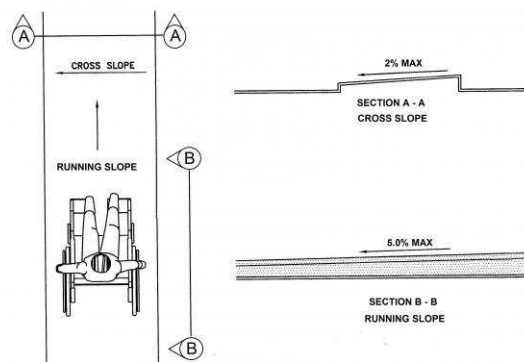
### Finding #1 Continued

The accessible path of travel has cross slopes greater than 2%.

There are 36 pads of concrete on the route that runs along El Morro with excessive cross-slope measuring as high as 3.7%. 13 were measured at 3% or more.

Remove and replace pads of concrete to compliance.

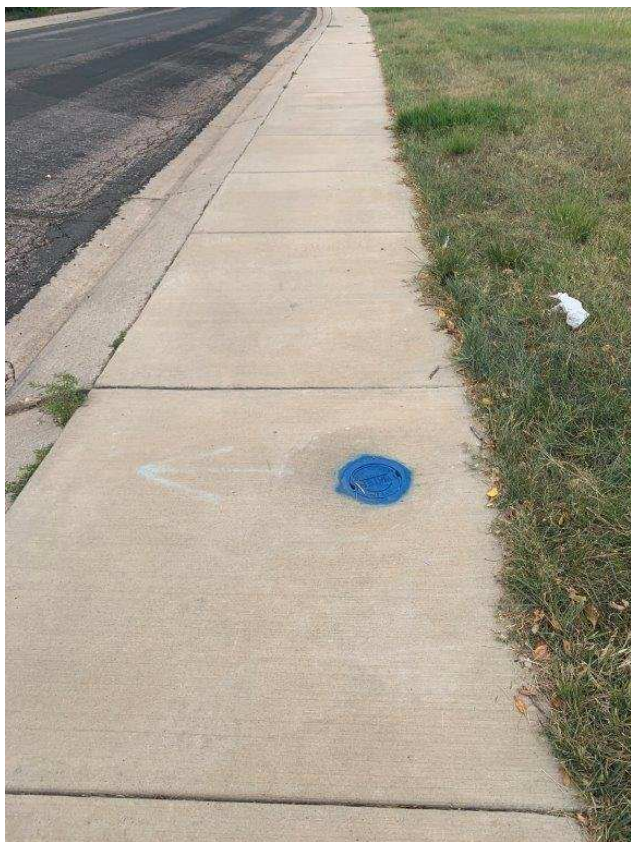
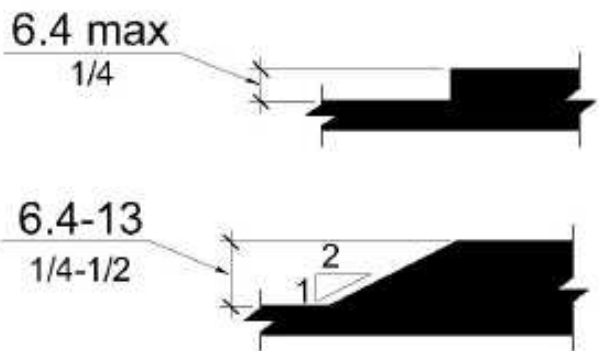
Finding 188516 Main Photo

The water main is recessed on the sidewalk. The recess is 20x20x2" deep and has cross slopes in the 9-10% range.

The surface of the pedestrian access route has vertical discontinuities greater than 1/2 inch or between 1/4 inch and 1/2 inch that are not beveled.

At this water main in the sidewalk, the sidewalk reduces to 33" wide.

Remove and replace the sidewalk panel, and increase the height of the water main access.

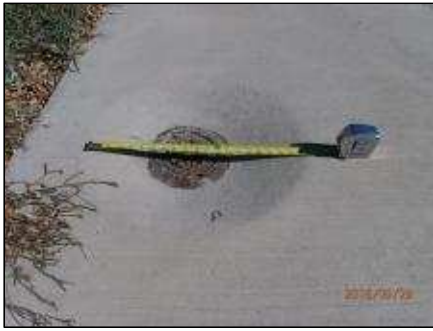
Watermain access recessed in the sidewalk

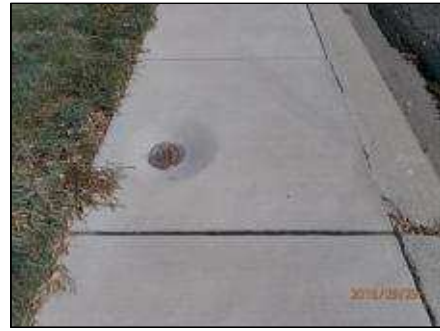
Water main access is recessed in the sidewalk

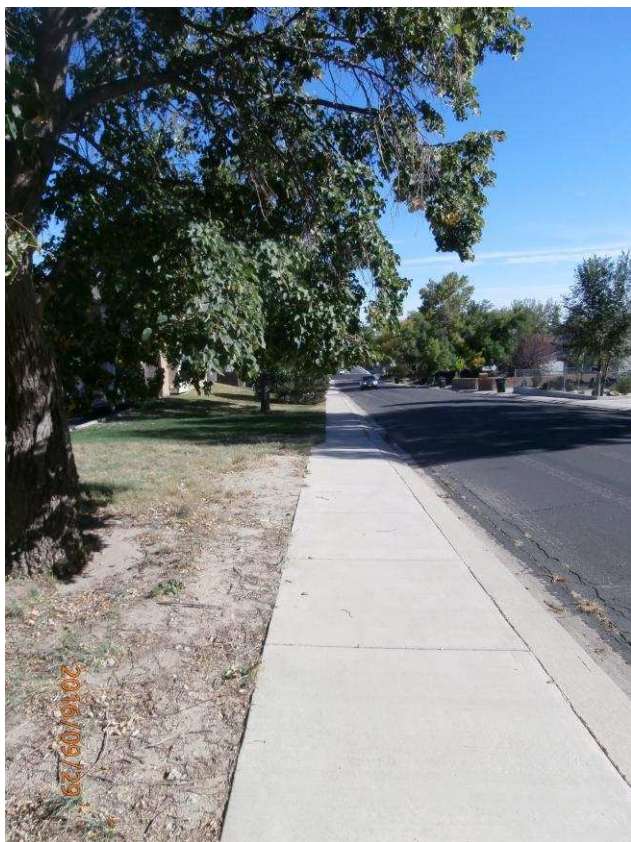
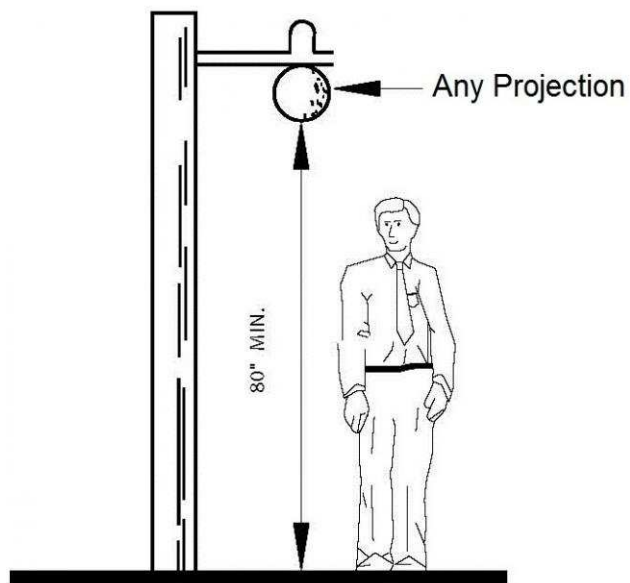
Finding #3 Continued

The tree branches extend down too close to the route of travel.

There is only 64" of headroom at the sidewalk.

Tree branches hang within 80" of the sidewalk

Keep vegetation trimmed within 80" of the sidewalk.
