Restoration Specific Asbestos and Lead Based Paint Survey Report

**2605 Robin Dr
Colorado Springs, CO 80909**

**Anderson Property Inspections
Colorado Springs, CO**

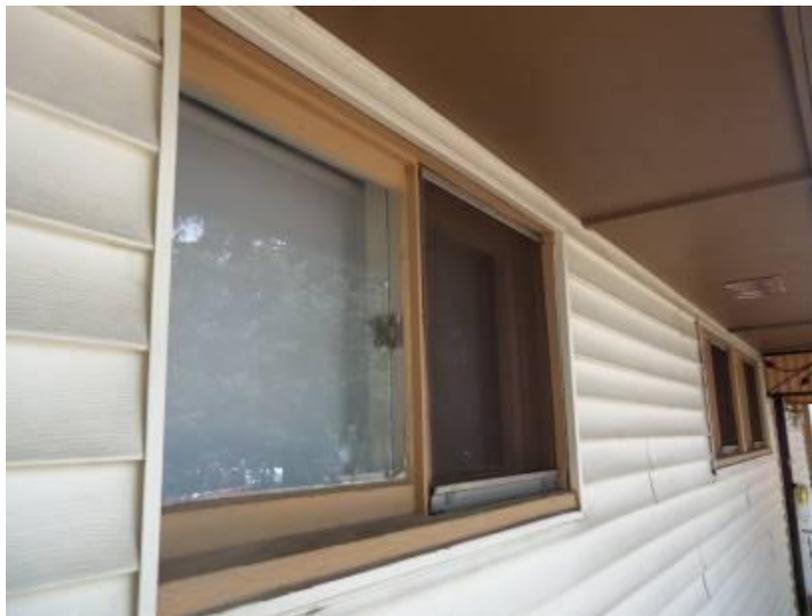
Western elevation windows tested positive for lead-based paint, soffit and fascia tested negative

- **All window components, even though the sills may be non-detect for lead-based paint all framework tested positive and therefore RRP protocols should be followed when removing and replacing the window units**
- **In addition, there was significant paint deterioration noted on some of the windows but no physical paint chips observed around the associated perimeter of the dwelling**

The lead-based paint inspection did identify components with lead above the regulatory definition on building material slated for demolition as a result of this loss. The components which were inventoried above that do contain lead based paint must be removed using proper protocols as defined by the [EPA's Regulations on Residential Property Renovation at 40 CFR 745.80, Subpart E](#)

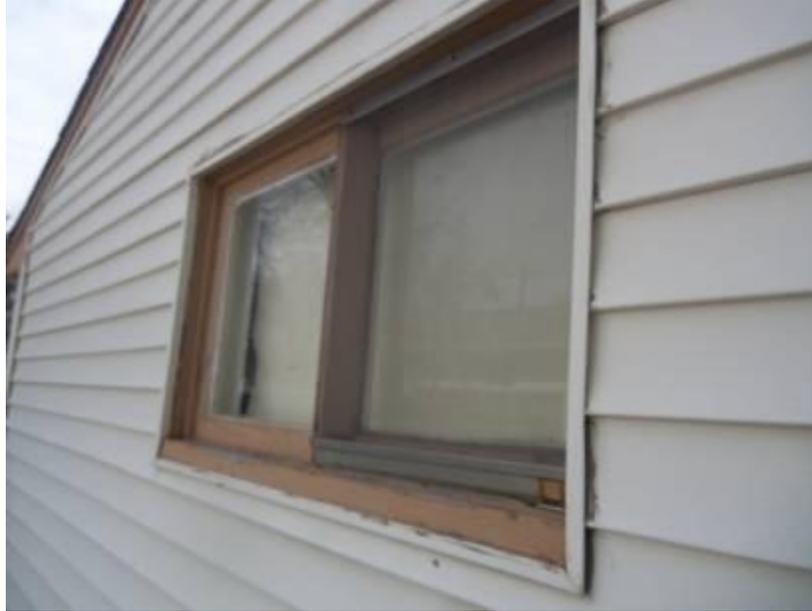
Northern exterior elevation window framing tested positive for lead-based paint

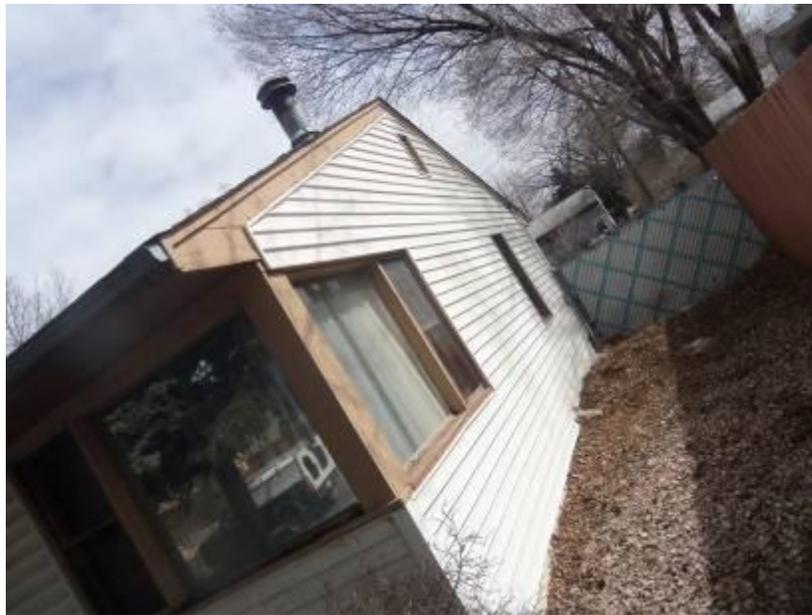
Southern exterior elevation window framing components tested positive for lead-based paint

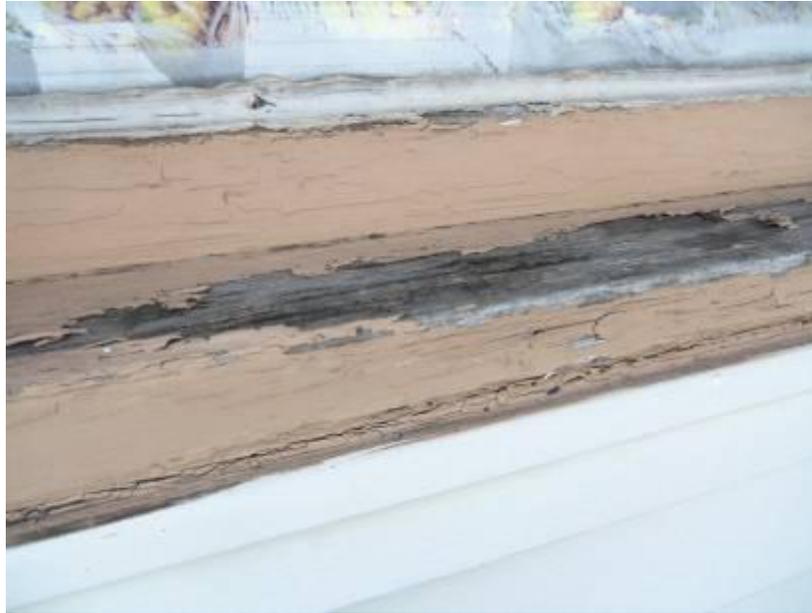
Sills and adjoining frame work paint is in deteriorated condition, although no visible paint debris noted in the associated drip line

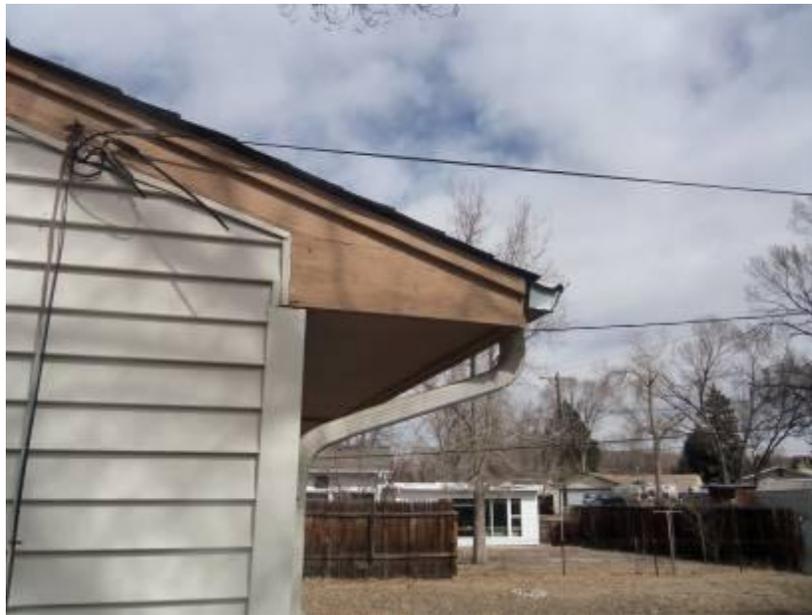
Soffit and fascia boards around entire dwelling tested negative for lead-based paint
