# **Restoration Specific Asbestos and Lead Based Paint Survey Report**

**2518 Ember Dr  
Colorado Springs, CO 80910**

**Anderson Property Inspections  
Colorado Springs, CO**

**Site Visit(s): 4/24/14  
Report Date: 5/1/14**

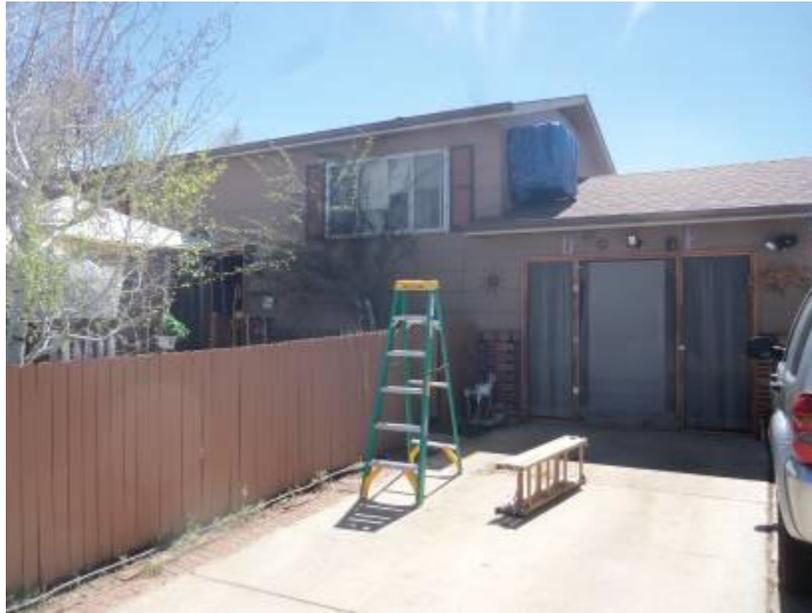
**Front of dwelling no lead-based paint found on any components**

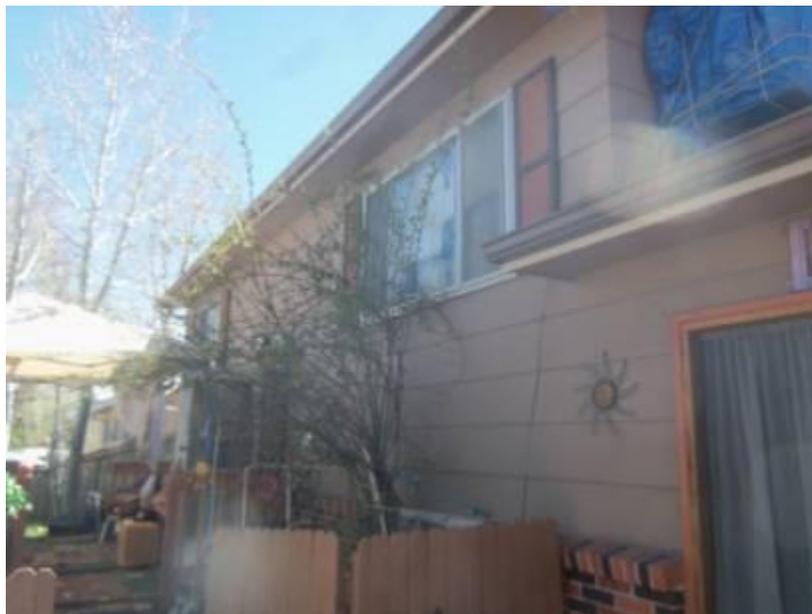
**Additional angle of front of dwelling wood shutters, door trim, siding, fascia and soffit boards are tested negative for lead-based paint**

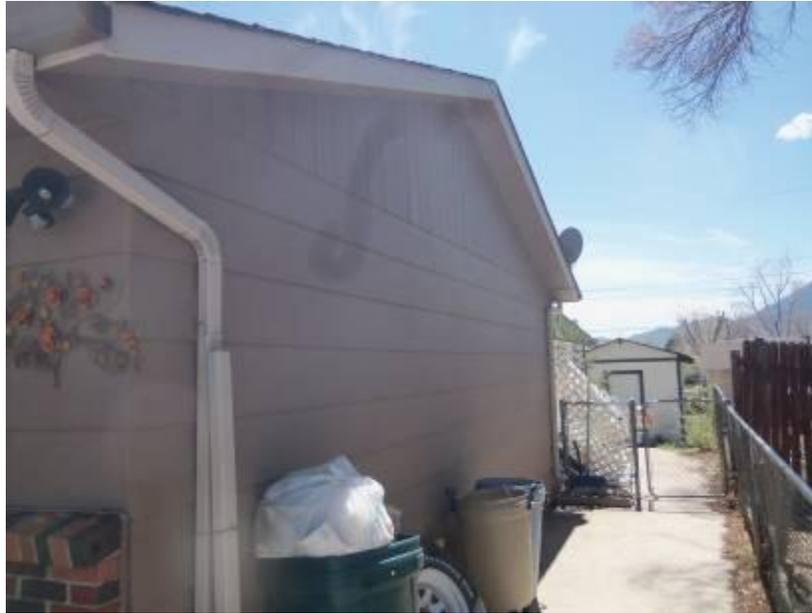
**Western exterior elevations tested negative for lead-based paint**

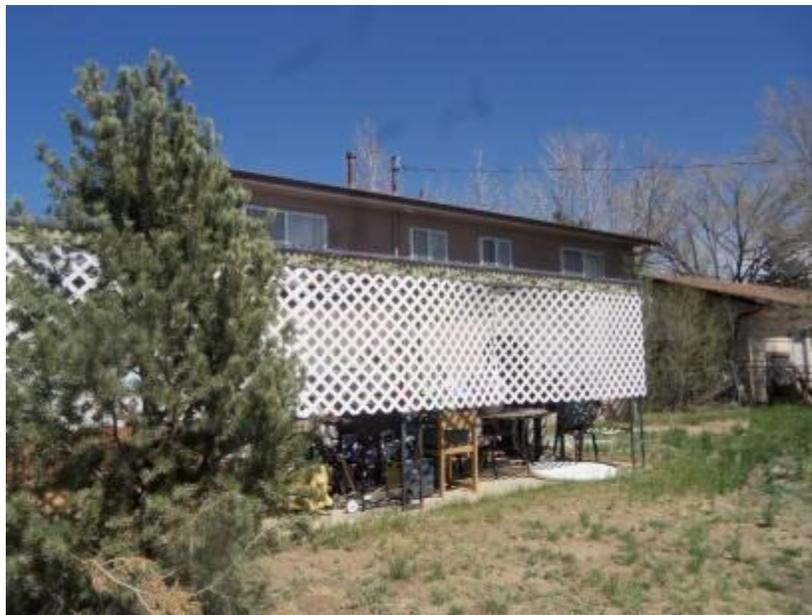
**Rear of dwelling tested negative for lead-based paint**

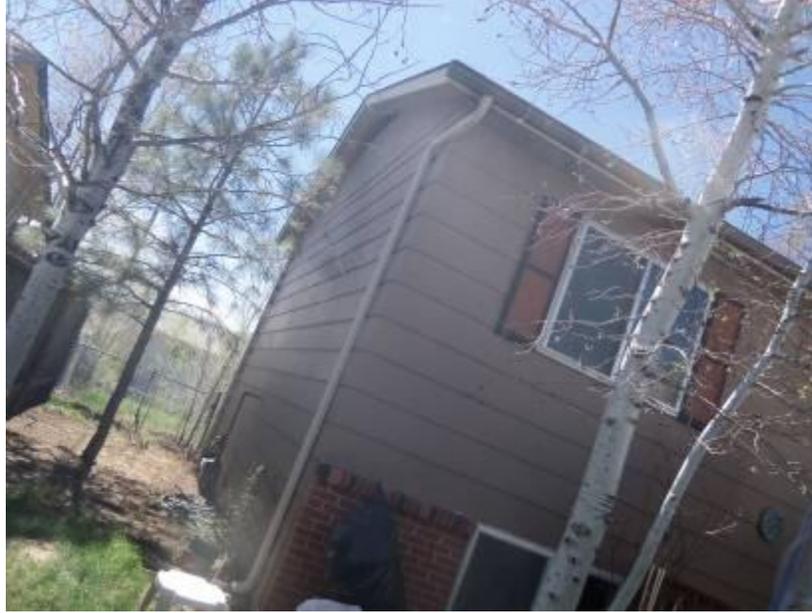
**Eastern exterior elevation tested negative for lead-based paint**

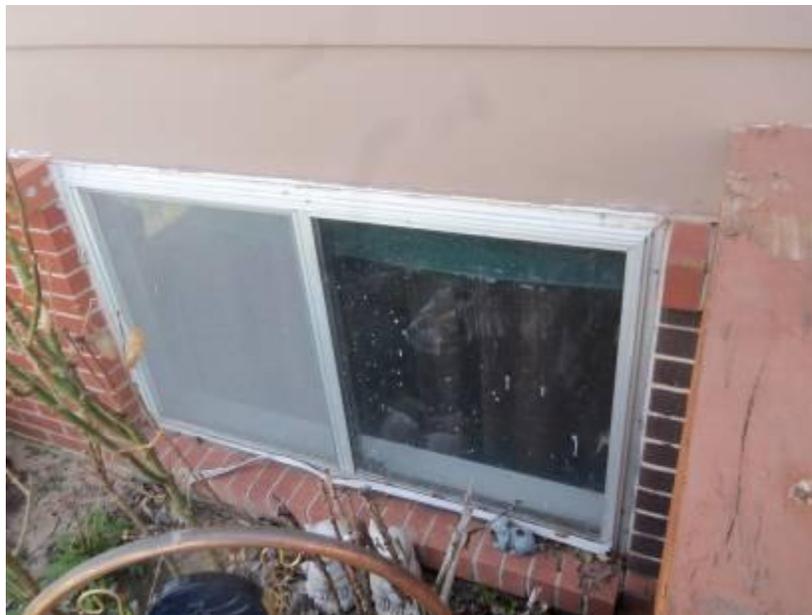
**Windows are newer vinyl windows with minimal painted components which tested negative for lead-based paint**

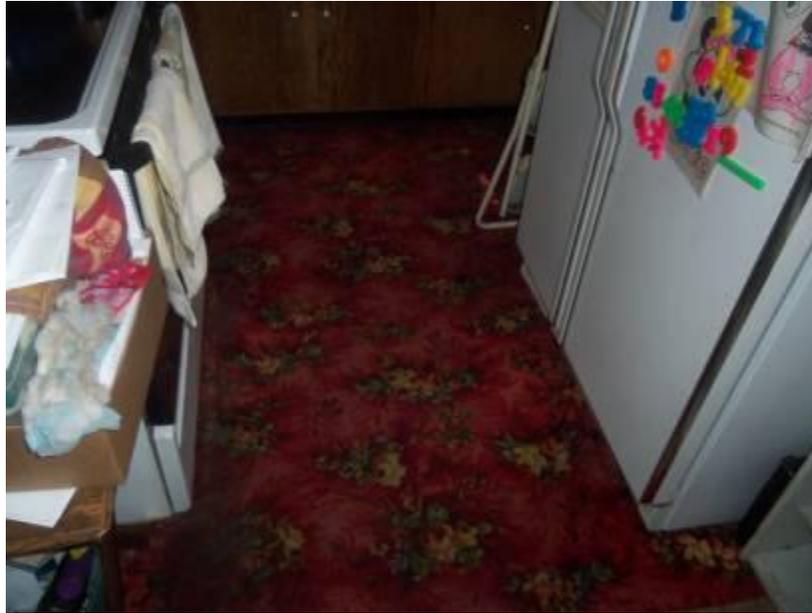
**Asbestos-containing materials, which will be affected by the scope of demolition as a result of this loss, have been positively identified in the white texture and associated overspray (4% Chrysotile) applied to the drywall substrate walls in the main and basement level bathrooms including under the ceramic tile, fiberglass and plastic bathtub surrounds as well as in the yellow mastic (Trace Chrysotile) associated with the kitchen vinyl tile flooring material.**

**Overview of kitchen flooring with white vinyl tile with Trace Chrysotile mastic under (see conclusion)**

**As the identified asbestos containing material is to be disturbed by the proposed demolition/renovation work, proper asbestos abatement procedures shall be implemented prior to the commencement of such work. All required asbestos abatement work shall be performed in accordance with all applicable Federal, State and Local rules and regulations. The abatement project shall be filed with all agencies having jurisdiction over this project such as the Colorado Department of Health and Environment.**

**A licensed abatement contractor must perform the removal of all friable and non-friable ACM. API believes that the implementation of these recommendations will serve to best comply with Air Quality Control Commission Regulation No. 8, Part B "Emission Standards for Asbestos."**

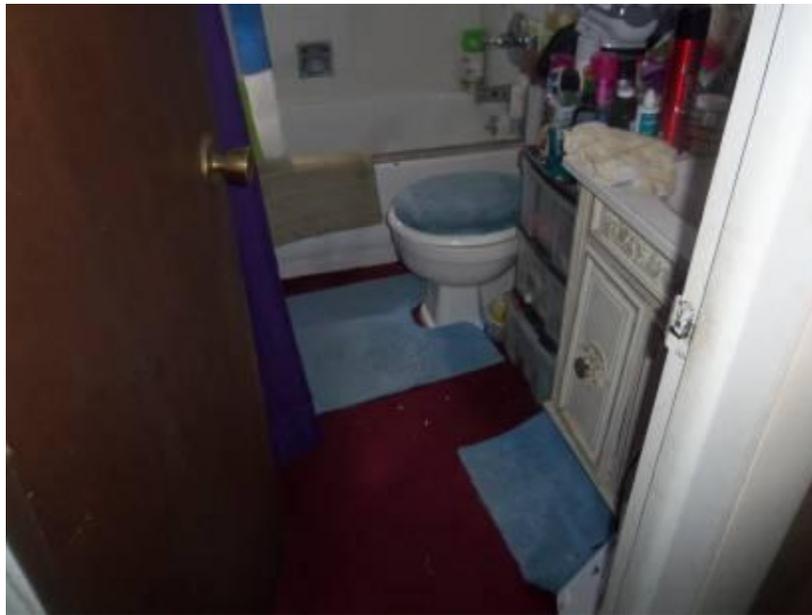
**Overview of main level bathroom walls tested positive for asbestos texture includes behind the fiberglass and ceramic tile surrounds**

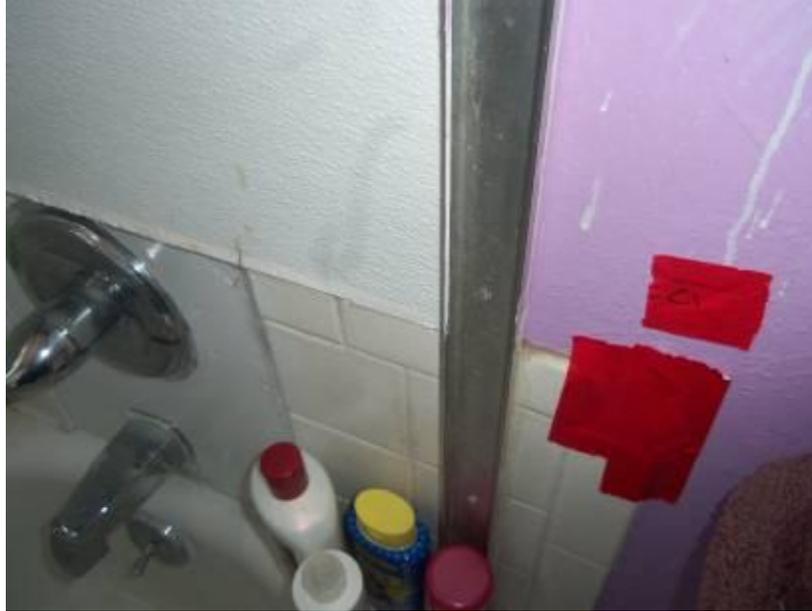
**Fiberglass and ceramic tile surrounds have asbestos containing texture associated with the wall system in the main level bathroom**

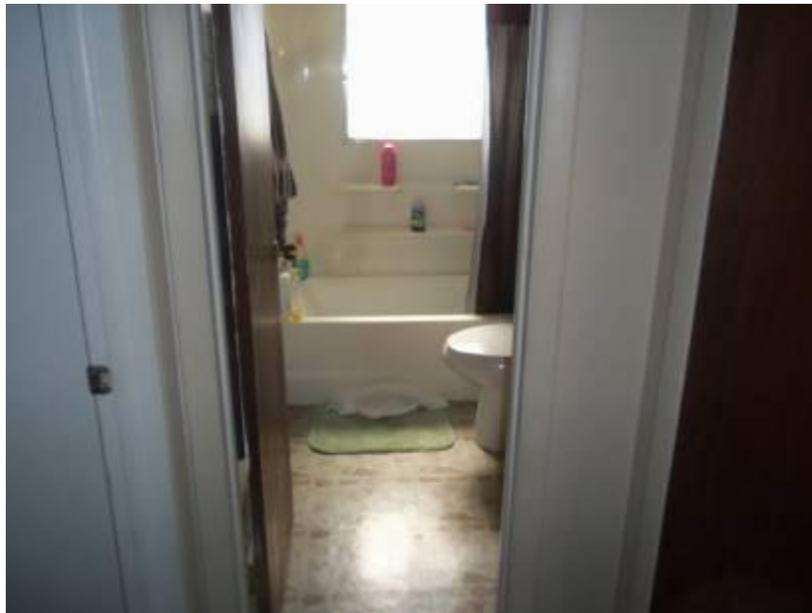
**Overview of basement level bathroom walls tested positive for asbestos in the texture**

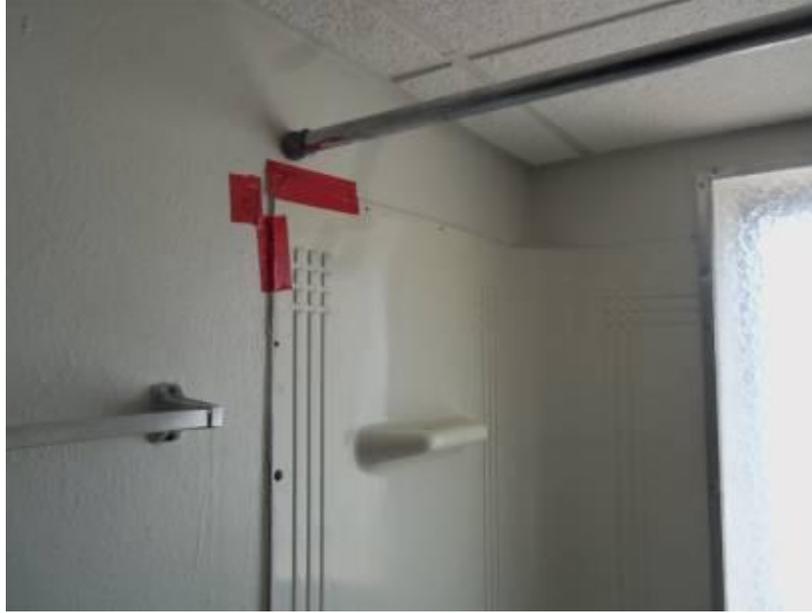
**Plastic surround in basement bathroom tested positive in the texture of the drywall behind**
