# **Restoration Specific Asbestos and Lead Based Paint Survey Report**

**2636 Maroon Bells Ave  
Colorado Springs, CO 80918**

**Anderson Property Inspections  
Colorado Springs, CO**

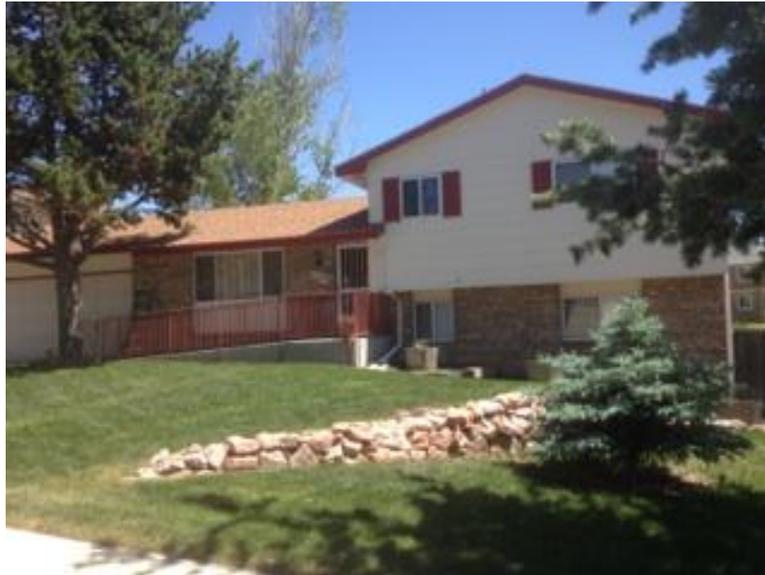
**Front of dwelling all painted components tested negative for lead-based paint**

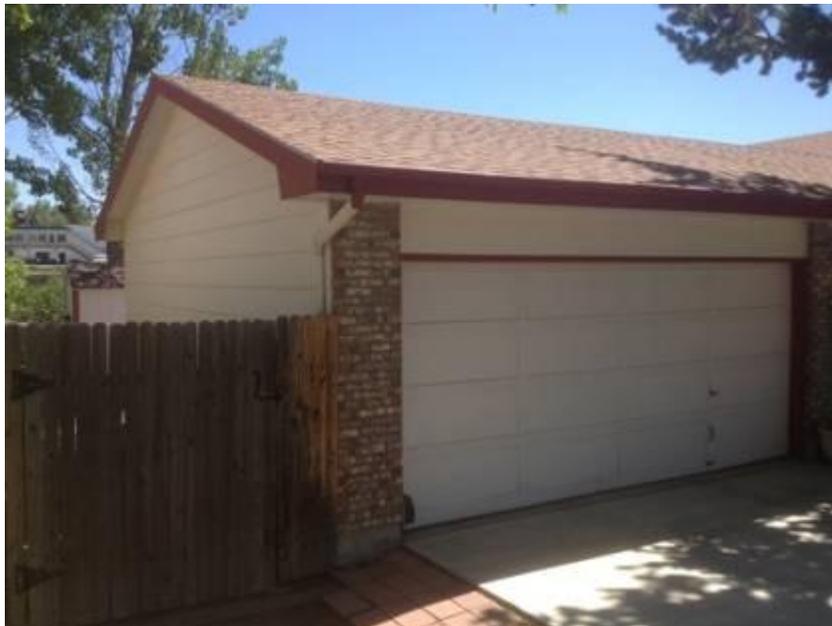
**Garage door components, fascia and soffits tested negative for lead-based paint around entire dwelling**

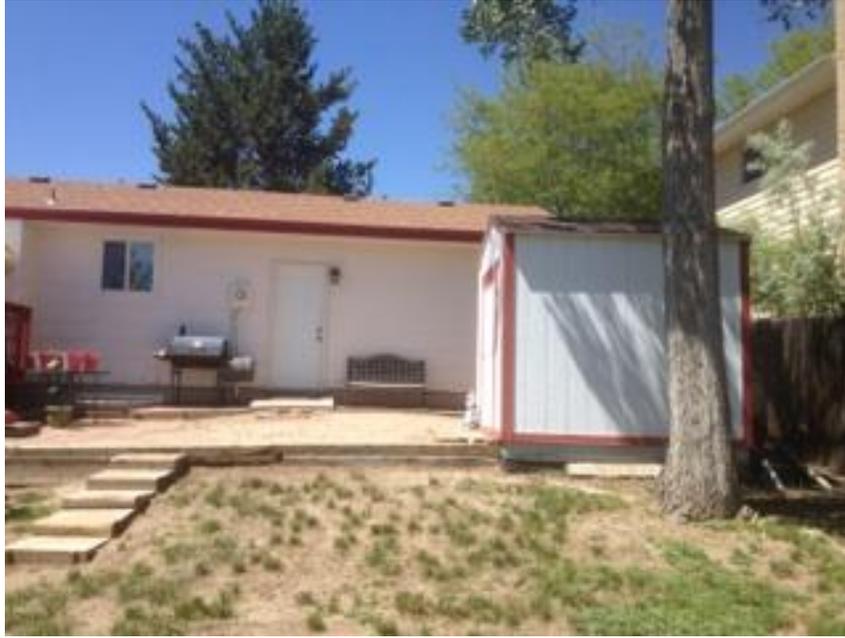
**Back of dwelling door components, painted siding and wood trim all tested negative for lead-based paint**

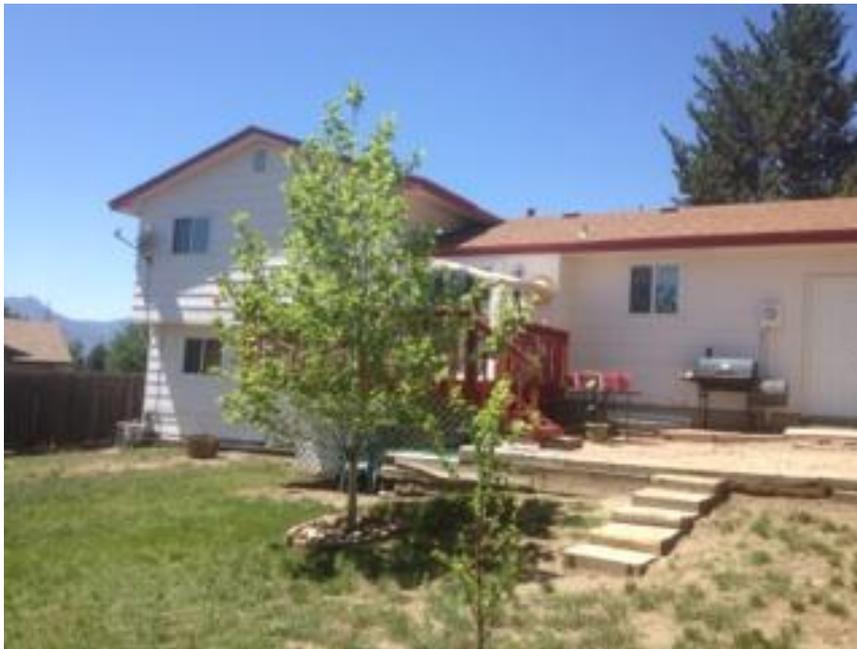
**2<sup>nd</sup> angle of rear of home all components tested negative for lead-based paint**

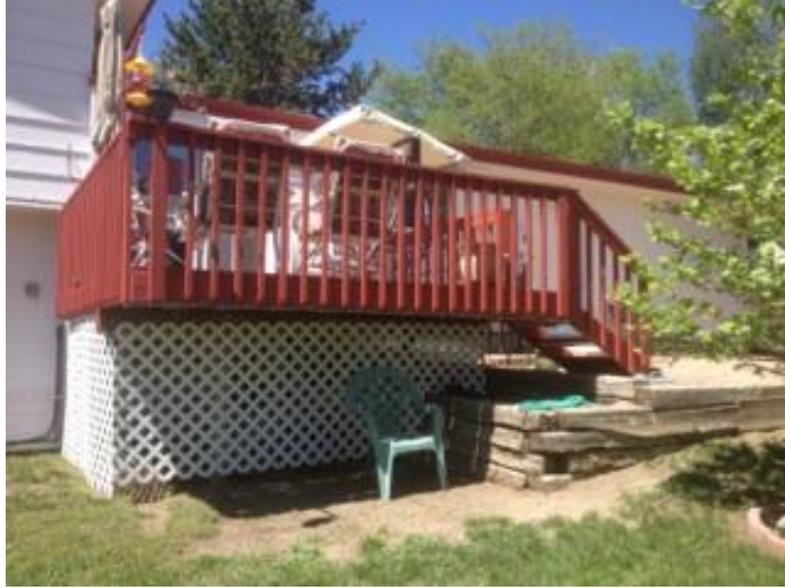
**Painted deck components tested negative for lead-based paint**

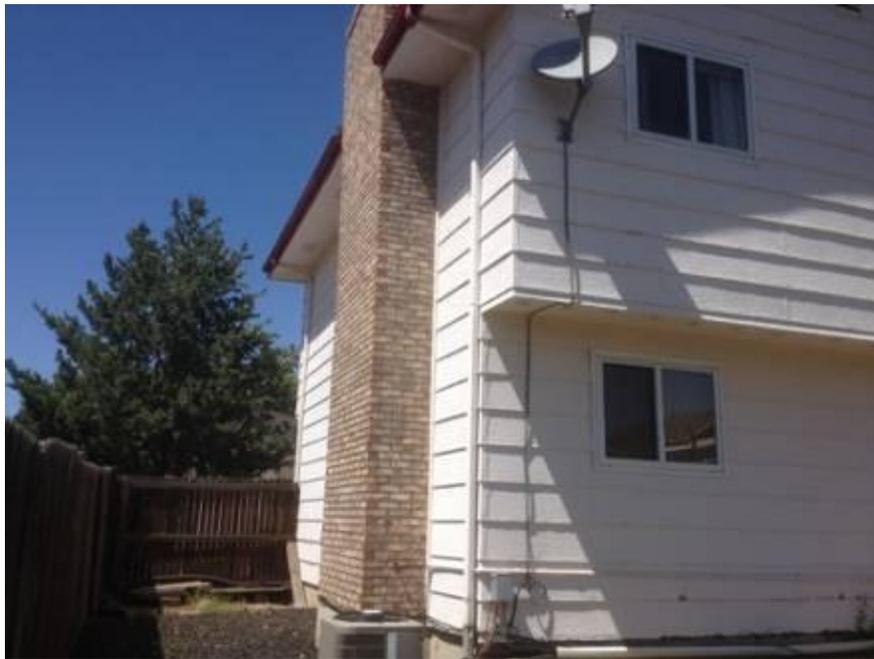
**Western elevation painted components tested negative for lead-based paint**

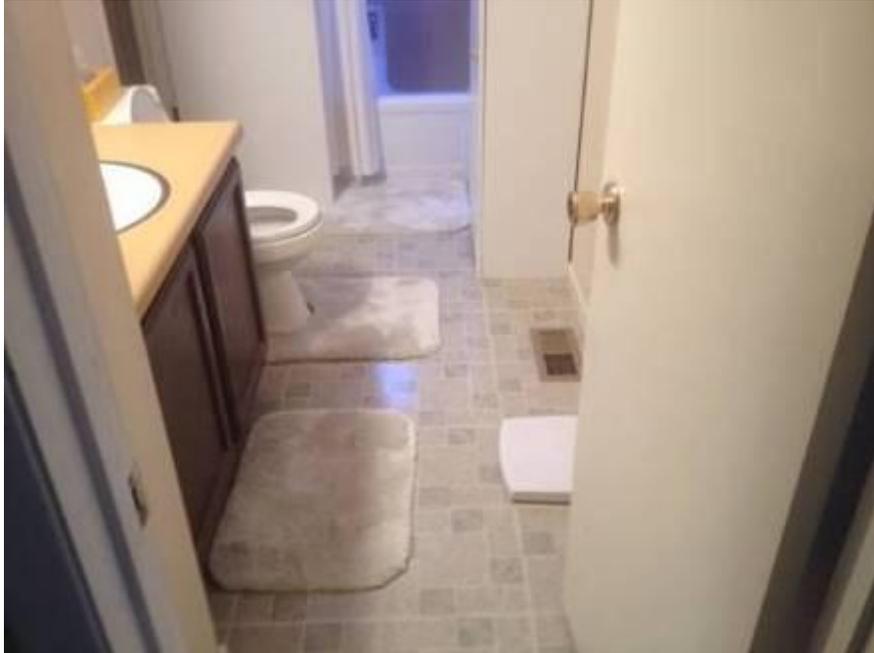
**Asbestos-containing materials, which will be affected by the scope of demolition as a result of this loss, have been positively identified in the white texture and associated overspray (2% Chrysotile) applied to the drywall substrate walls in the upper level bathroom and main level kitchen to be impacted by the renovation as well as the bottom layers of sheet vinyl present in both the upper level bathroom and lower level bathroom/laundry closet (25% Chrysotile in both) slated for removal.**

**Overview of upper level bathroom to be affected texture applied to walls and bottom layer of vinyl flooring both tested positive for asbestos**

**As the identified asbestos containing material is to be disturbed by the proposed demolition/renovation work, proper asbestos abatement procedures shall be implemented prior to the commencement of such work. All required asbestos abatement work shall be performed in accordance with all applicable Federal, State and Local rules and regulations. The abatement project shall be filed with all agencies having jurisdiction over this project such as the Colorado Department of Health and Environment.**

**A licensed abatement contractor must perform the removal of all friable and non-friable ACM. API believes that the implementation of these recommendations will serve to best comply with Air Quality Control Commission Regulation No. 8, Part B “Emission Standards for Asbestos.”**

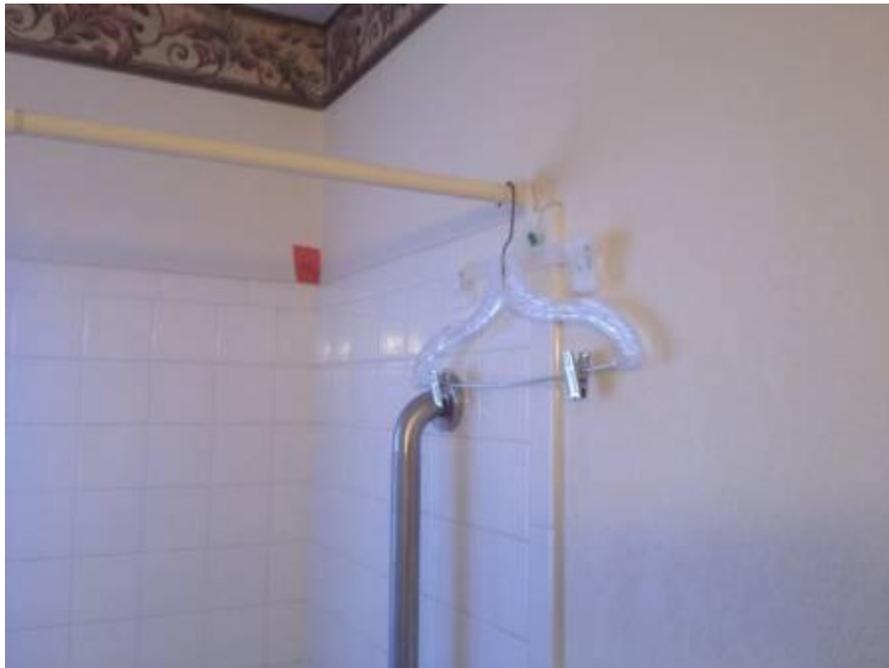
**Shower surround to be replaced in the upper level bathroom which tested positive for asbestos in the wall texture**

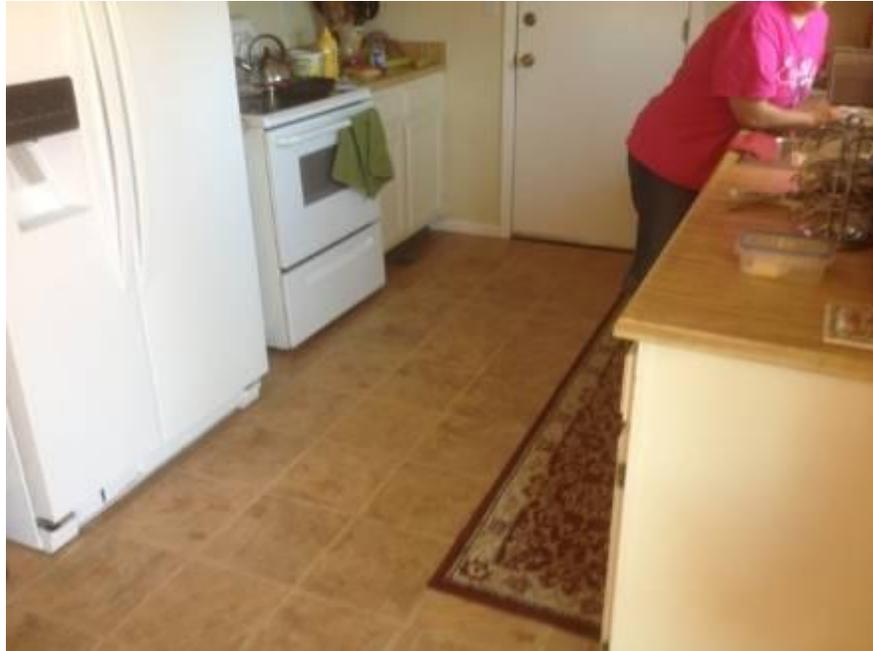
**Overview of kitchen cabinets to be impacted wall texture tested positive for asbestos**

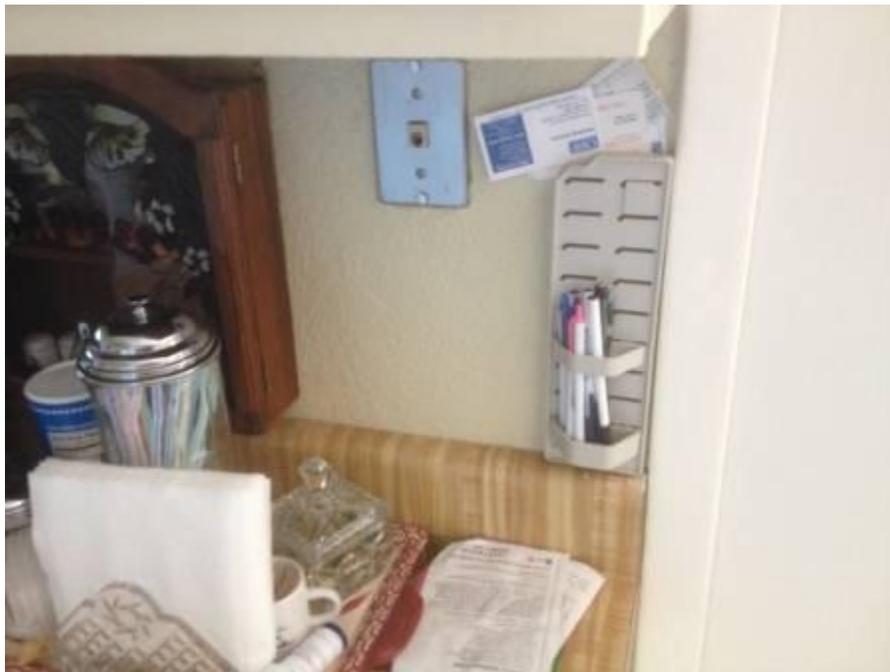
**Wall texture applied to drywall in kitchen tested positive for asbestos**

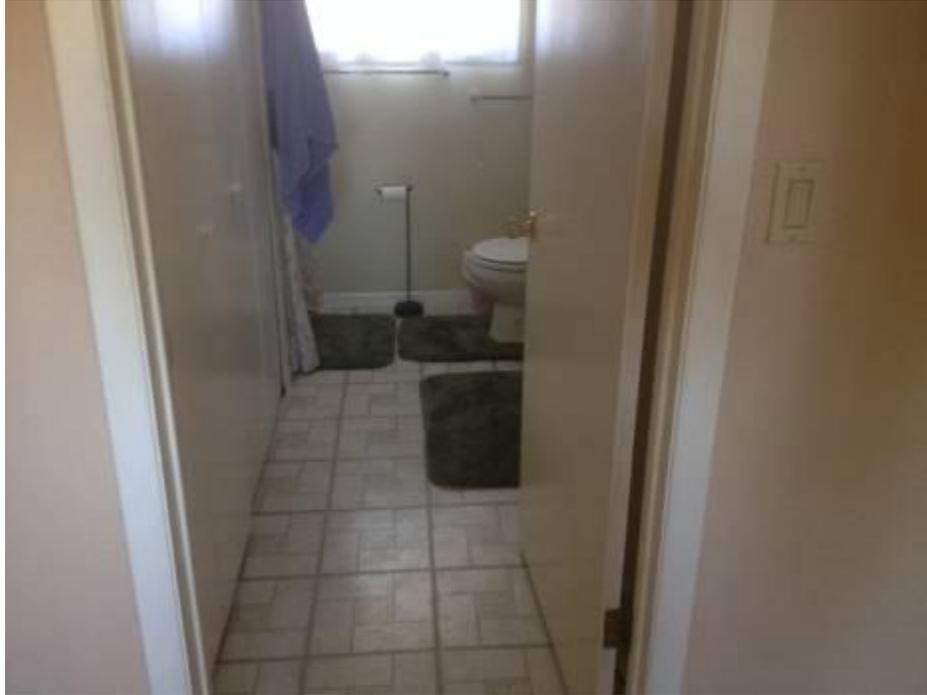
**Overview of basement bathroom with laundry closet to have flooring replaced bottom layer of vinyl flooring tested positive for asbestos**

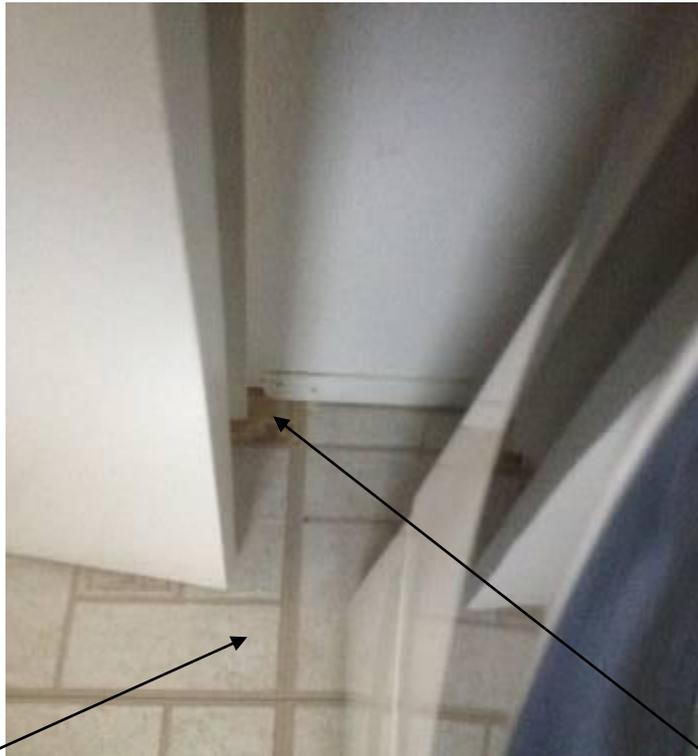
**Two layers of vinyl flooring in the lower level bathroom bottom layer tested positive for asbestos**
