Restoration Specific Asbestos and Lead Based Paint Survey Report

**841 E Monument St
Colorado Springs, CO 80903**

**Site Visit(s): 8/27/14
Report Date: 9/2/14**

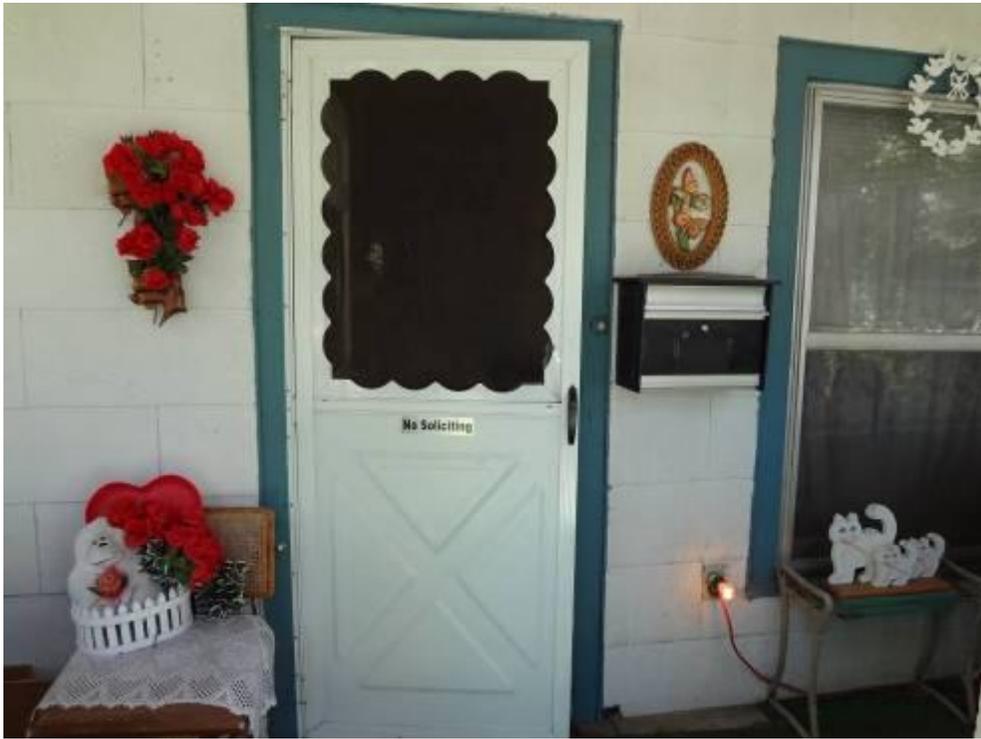
View of front entrance, wood door, blue trim and casing tested **POSITIVE** for lead based paint above the regulated trigger level of $(1.0\text{mg}/\text{cm}^2)$

The lead-based paint inspection did identify components with lead above the regulatory definition on building material slated for demolition as a result of this planned renovation. The components which were inventoried above that do contain lead based paint must be removed using proper protocols as defined by the [EPA's Regulations on Residential Property Renovation at 40 CFR 745.80, Subpart E](#)

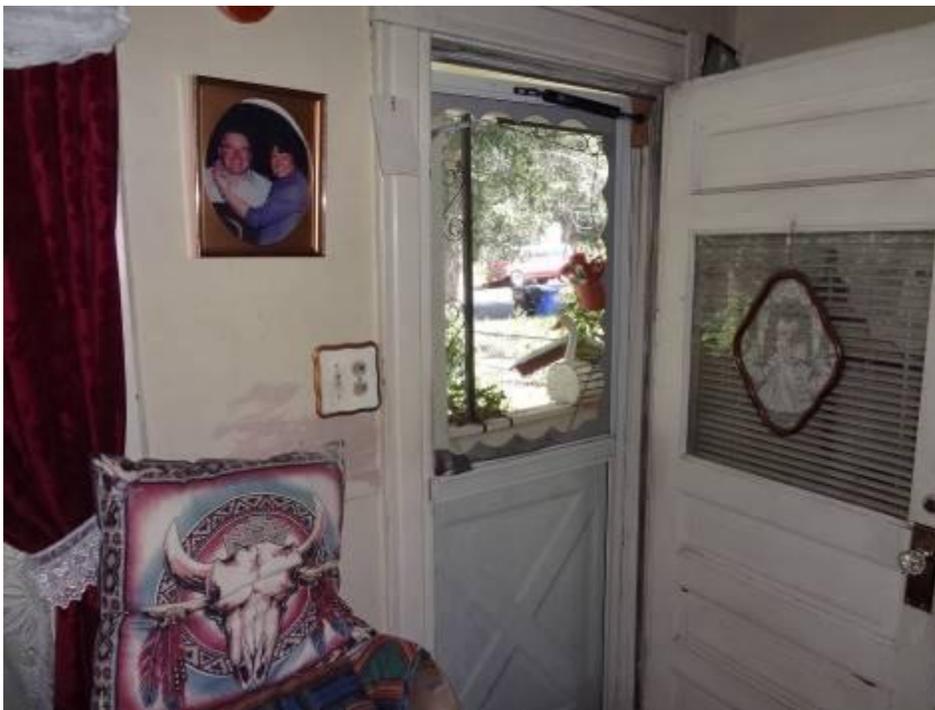
White front door, jamb and casing tested **POSITIVE** for lead based paint above the regulated trigger level of $(1.0\text{mg}/\text{cm}^2)$

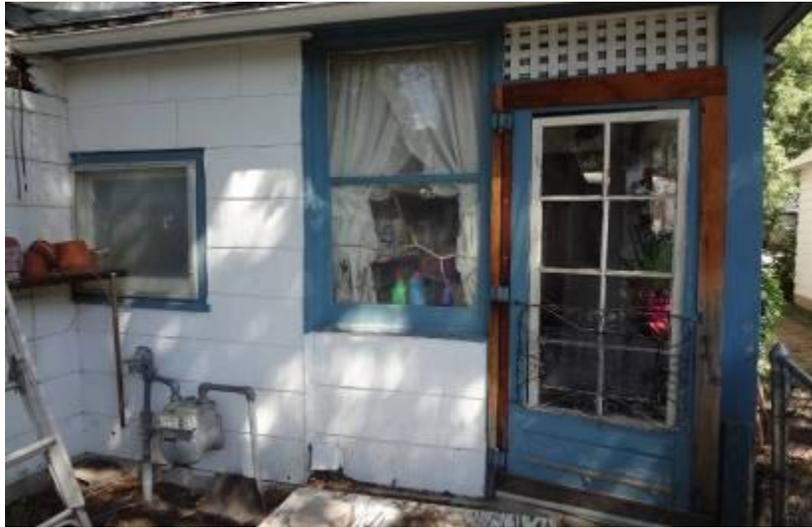
Rear entrance blue door, jamb, trim work and windows with components painted blue tested POSITIVE for lead based paint above the regulated trigger level of (1.0mg/cm²)

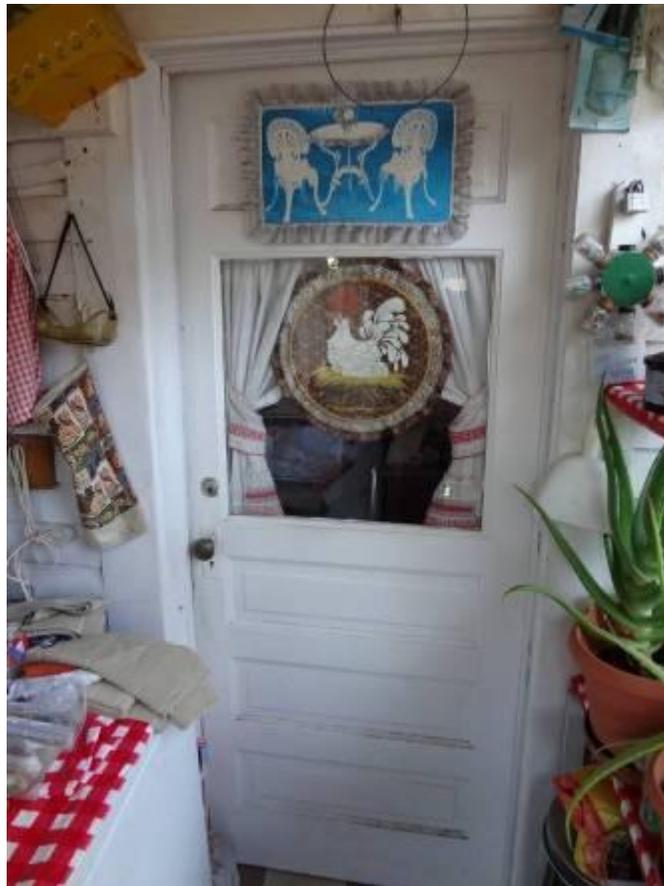
Rear entrance to the home from the enclosed patio, white door, casing and jamb tested POSITIVE for lead based paint above the regulated trigger level of (1.0mg/cm²)

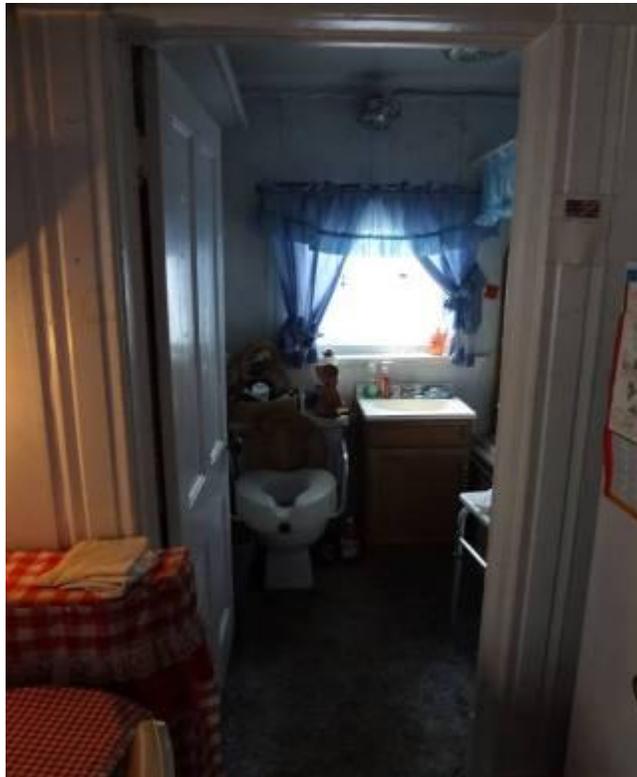
View of rear bathroom where renovations are planned no asbestos found in the wall material and surround planned to be removed

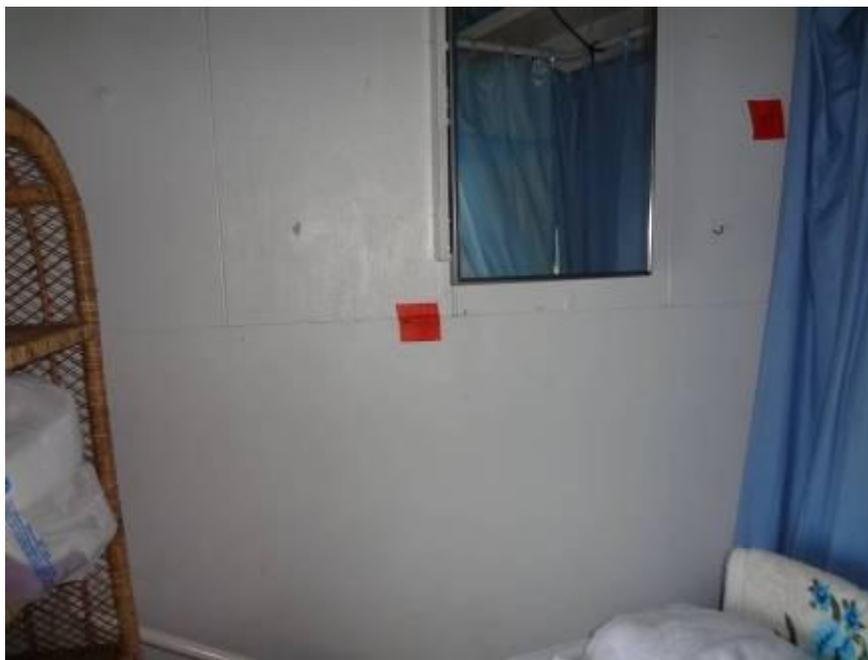
Location of upper textured wall panels and lower tub surround fiber board with mastic tested non-detect for asbestos

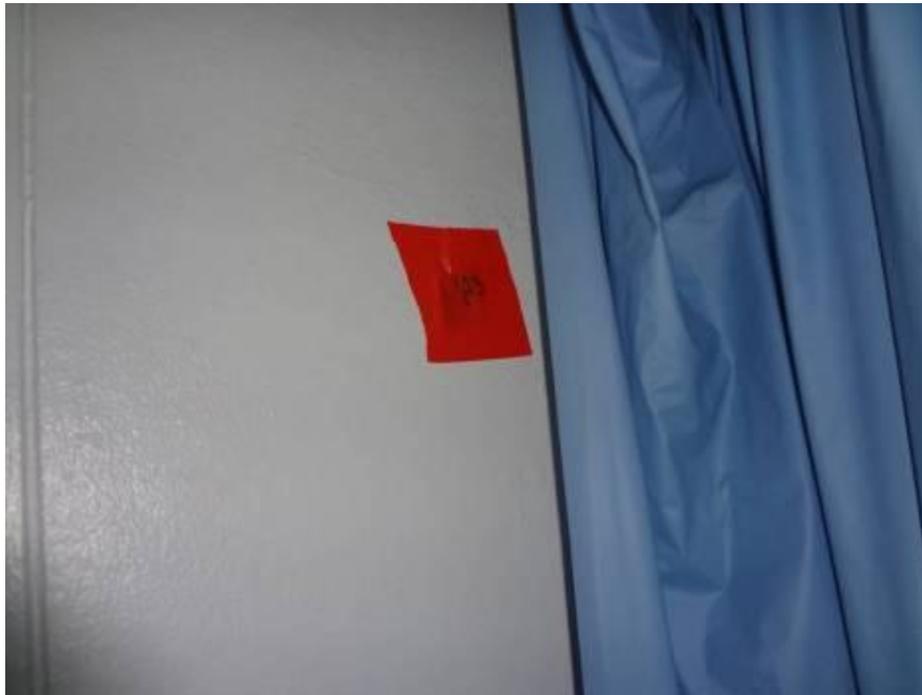
Sample A841 3 of the textured wall panels located in the bathroom are negative for asbestos

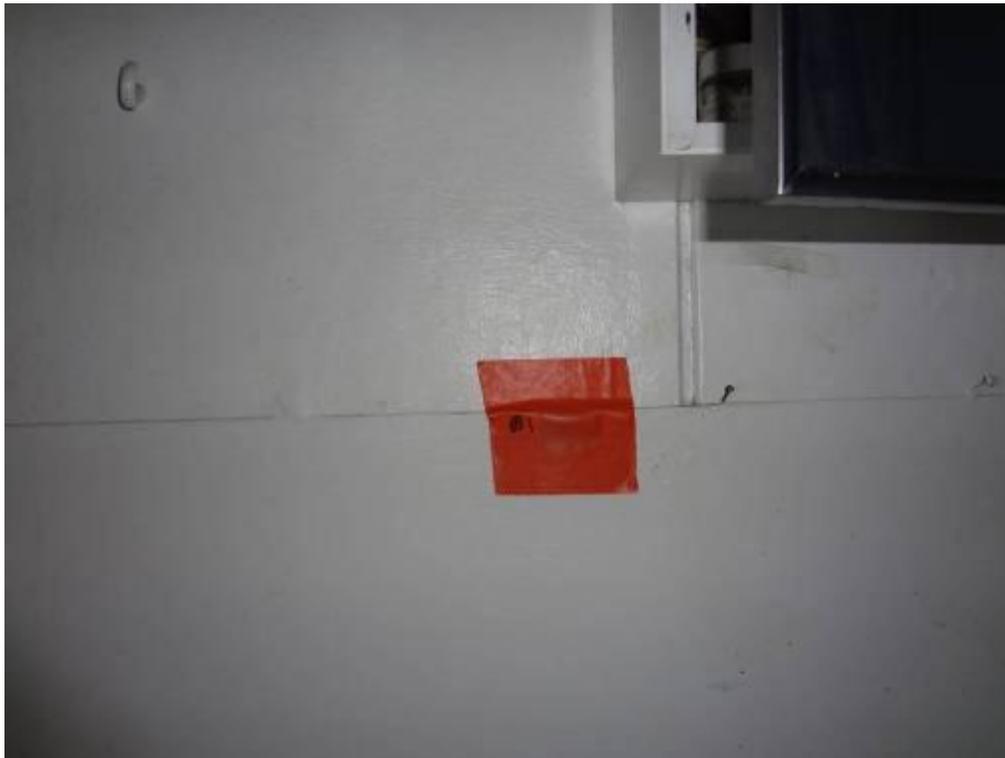
Sample B841 1 of the white painted fiber board used as a tub surround is negative for asbestos

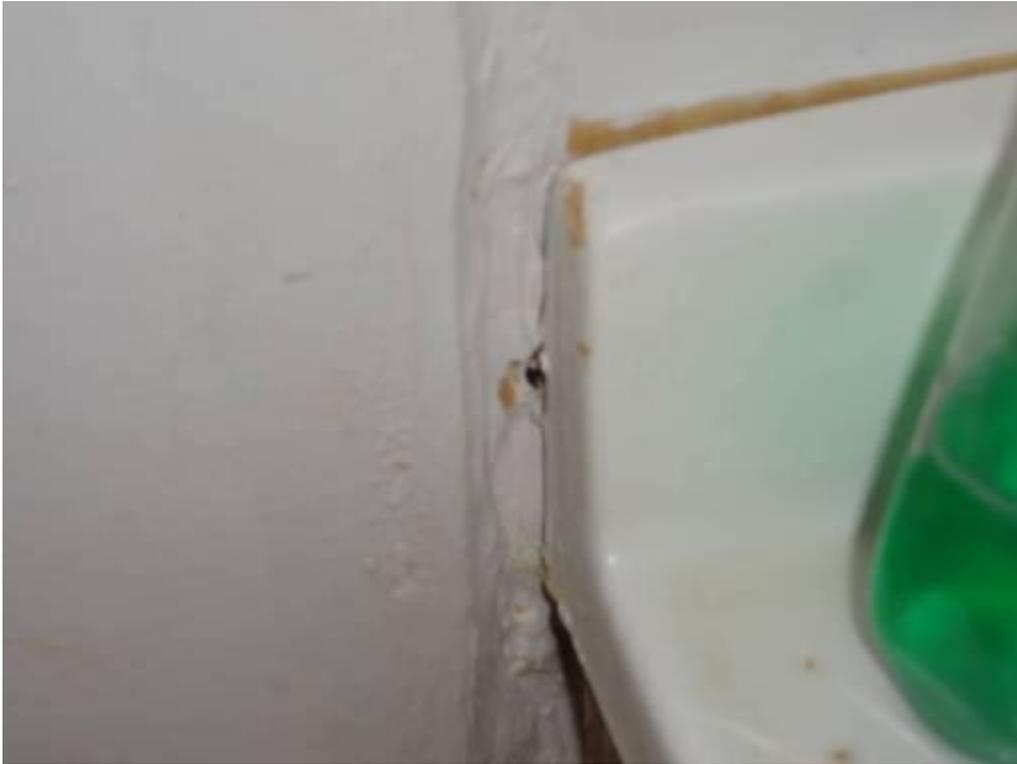
Sample C841 1 of the sealant found around the bathroom sink is negative for asbestos

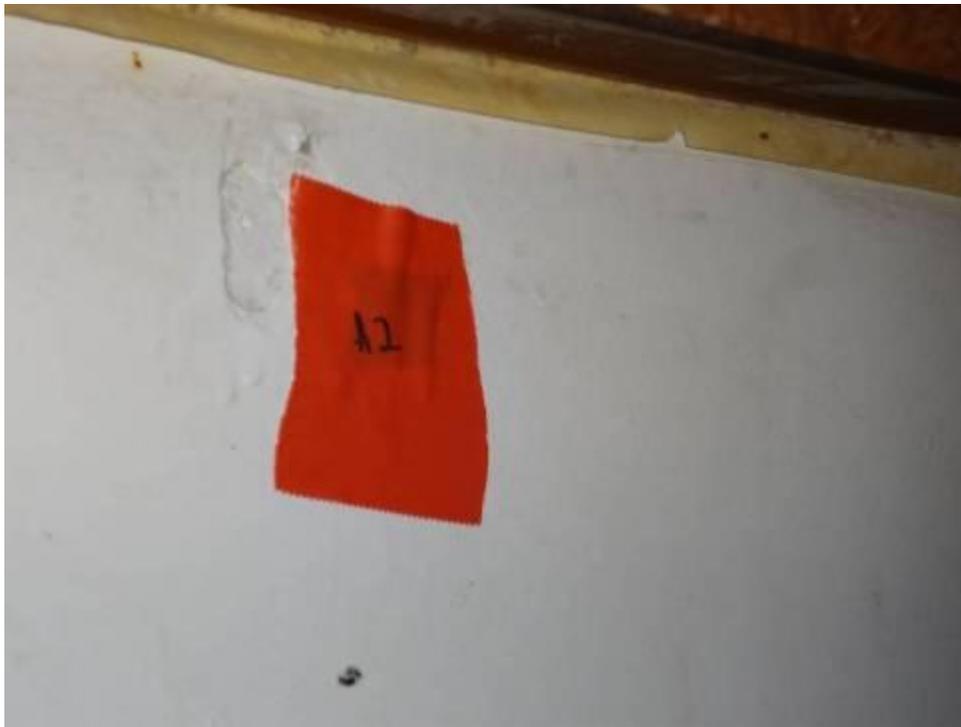
Sample A841 2 of textured fiberboard found on wall of the bathroom are negative for asbestos

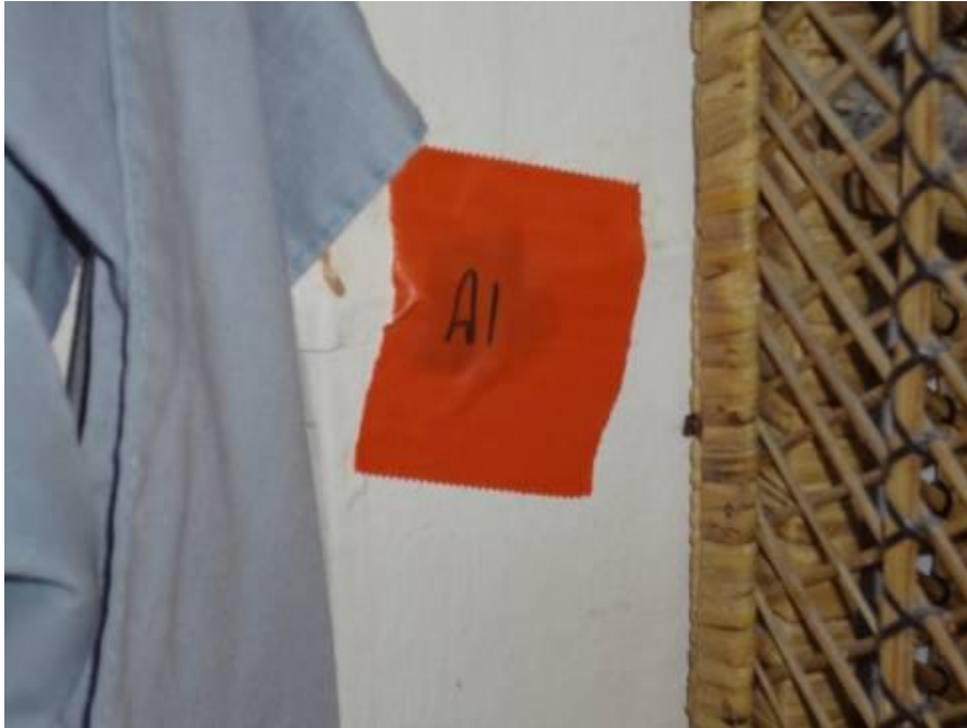
Sample A841 1 of textured fiberboard in the bathroom is negative for asbestos
