Restoration Specific Asbestos Survey Report

**5040 Sunsuite Trail N
Colorado Springs, CO 80917**

**Anderson Property Inspections
Colorado Springs, CO**

Report Date: 10/30/14

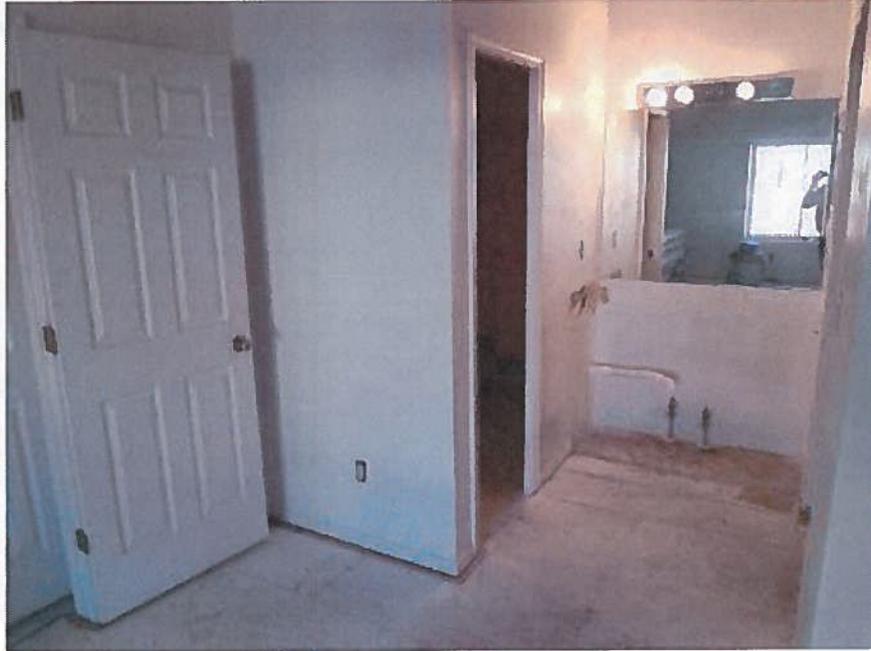
View of west bedroom bathroom area scheduled for renovation

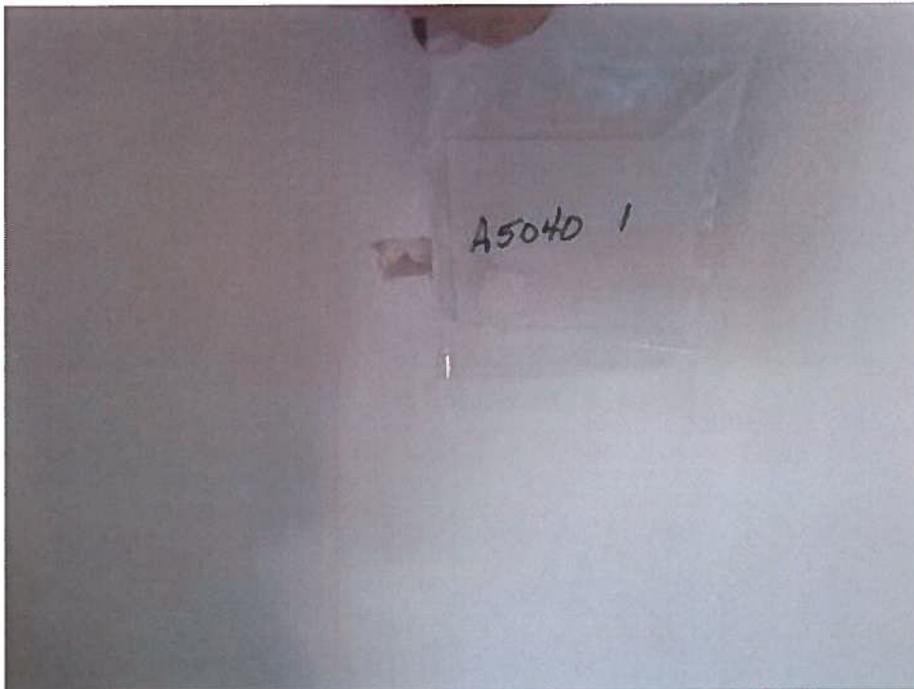
**Sample A50401 of orange peel style textured found to be non-detect for asbestos,
taken from the bedroom wall shared with the bathroom**

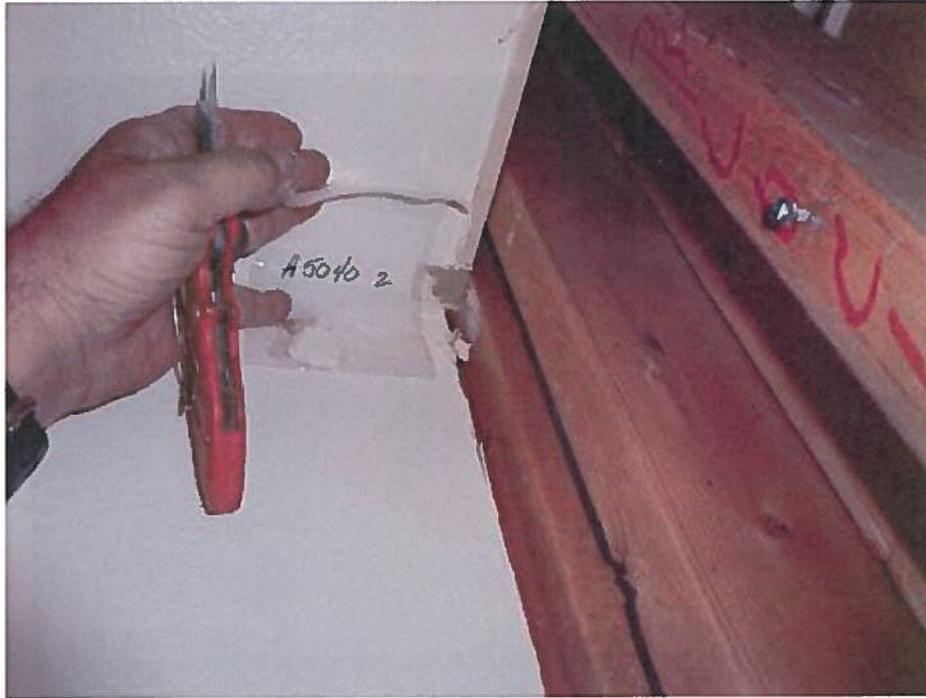
Sample A50402 of the orange peel style textured drywall substrate wall system taken from the seam of the wall and vaulted ceiling in the bathroom is non-detect for asbestos

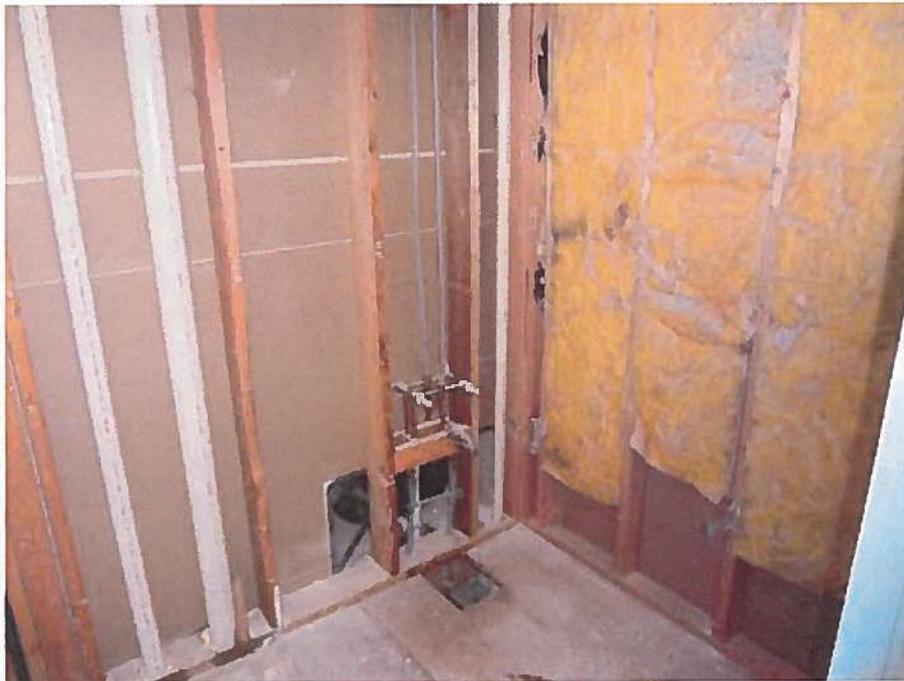
Wall finishes and tub previously removed by the homeowner

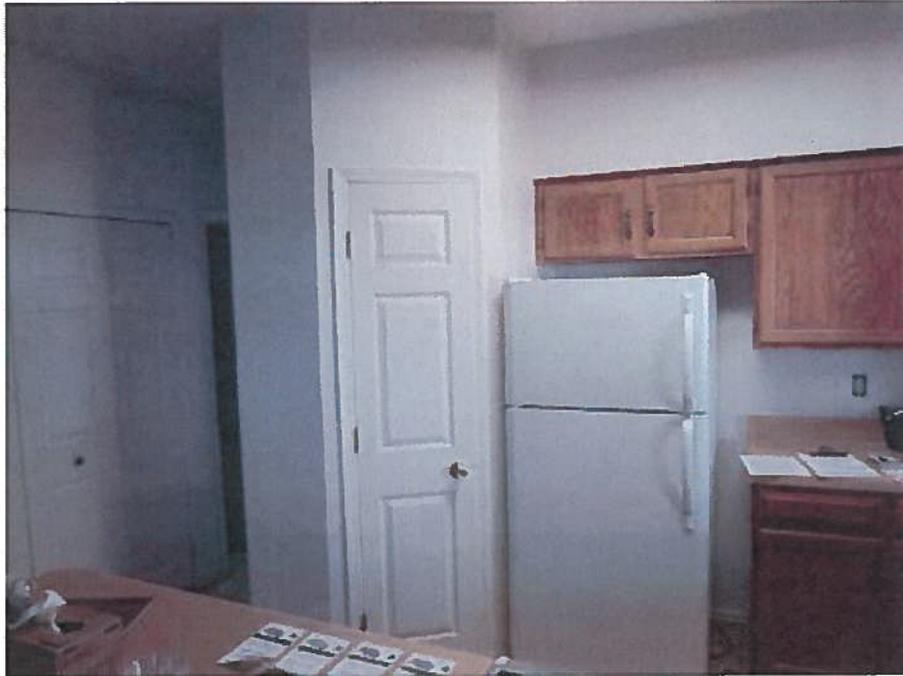
View of pantry closet in the kitchen scheduled to be removed

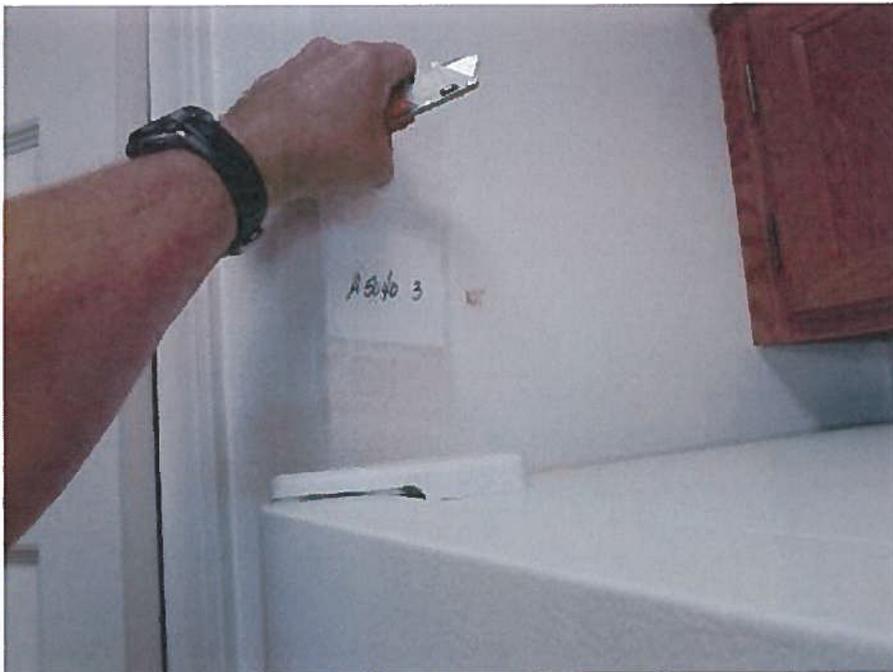
Sample A50403 of the orange peel style texture material on the kitchen pantry wall is non-detect for asbestos

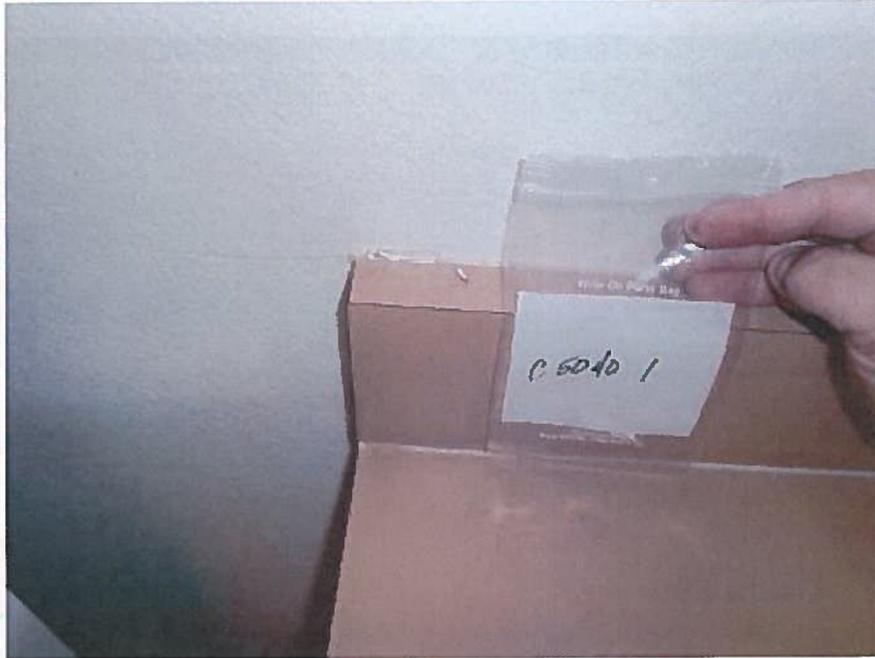
Sample C50401 of the white sealant used on the counter top scheduled to be replaced in the kitchen is non-detect for asbestos

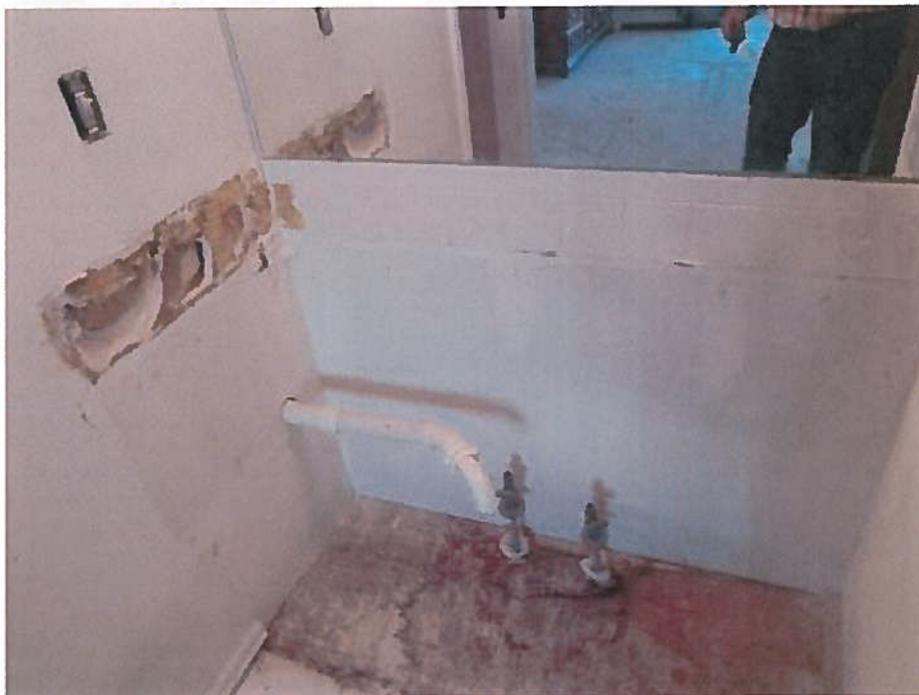
View of the bathroom sink area to be renovated, vanity was previously removed by the homeowner

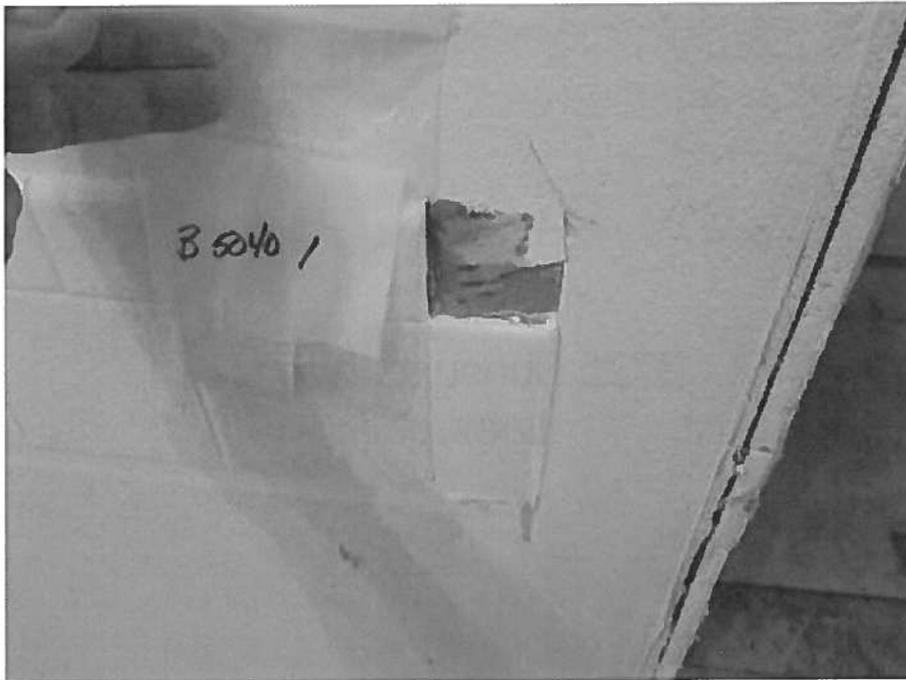
White ceramic tile bathroom sink surround B50401 is non-detect for asbestos
