Restoration Specific Asbestos and Lead Based Paint Survey Report

**1023 E Vermijo Ave
Colorado Springs, CO 80903**

**Anderson Property Inspections
Colorado Springs, CO**

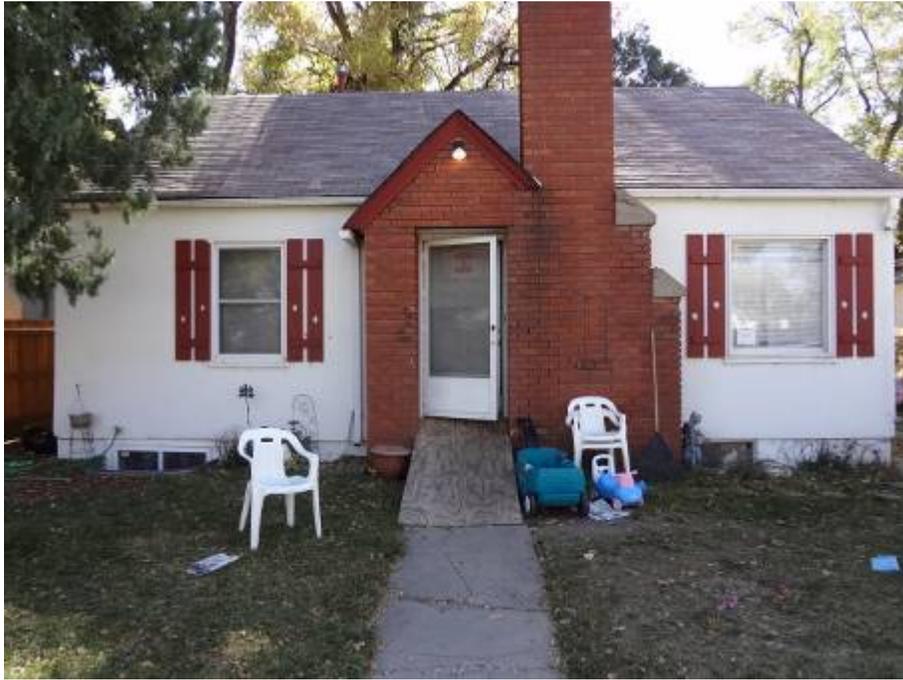
Front of dwelling note nearly all wood painted window components as well as front door wood trim and jamb tested positive for lead-based paint

The lead-based paint inspection did identify components with lead above the regulatory definition on building material slated for demolition as a result of this loss. The components which were inventoried above that do contain lead based paint must be removed using proper protocols as defined by the [EPA's Regulations on Residential Property Renovation at 40 CFR 745.80, Subpart E](#)

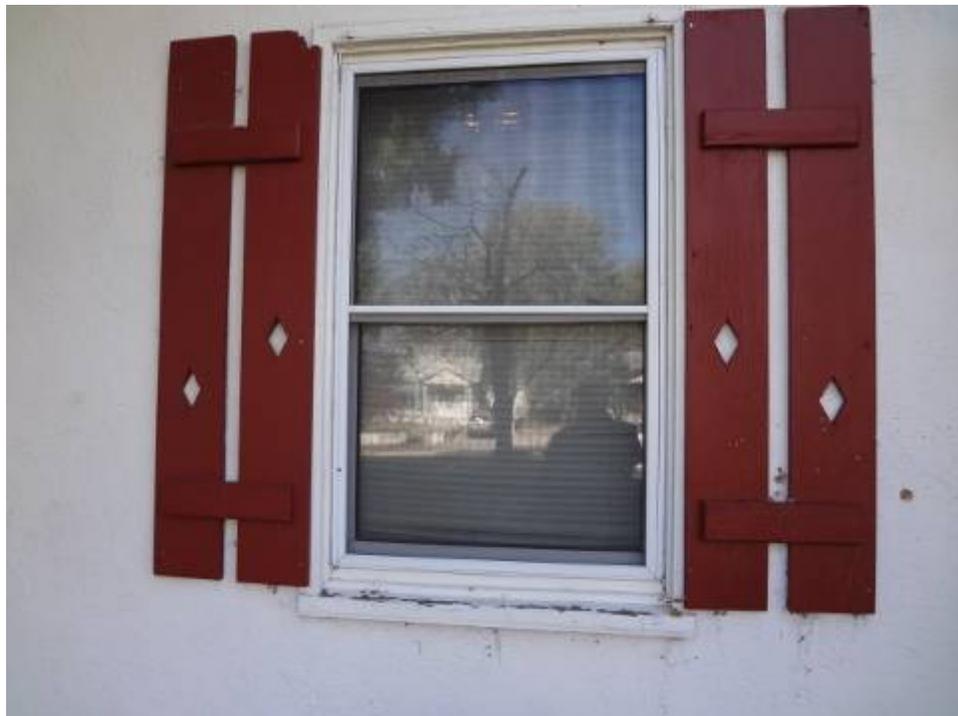
Sill, casement, framework and sash tested positive for lead-based paint on majority of windows

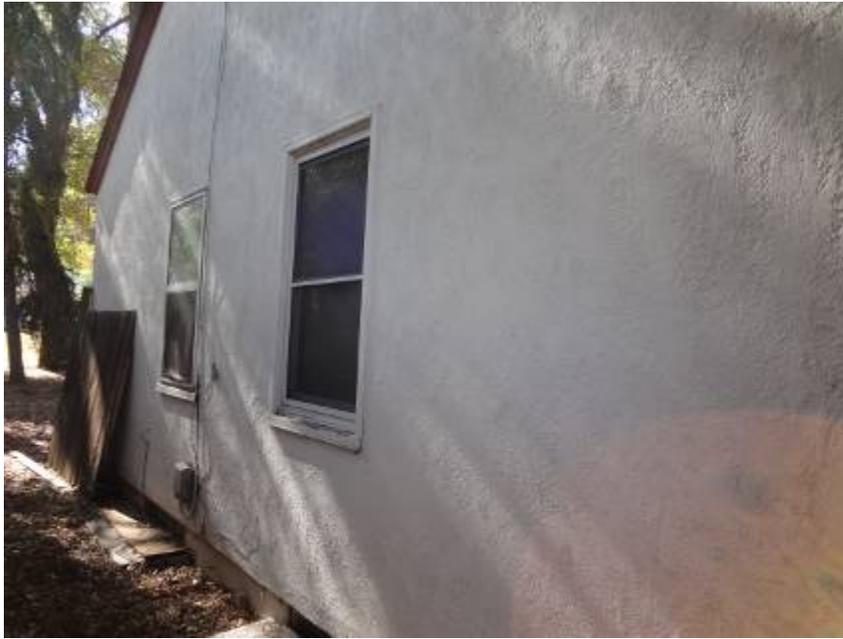
Overview of eastern elevation window components tested positive for lead-based paint

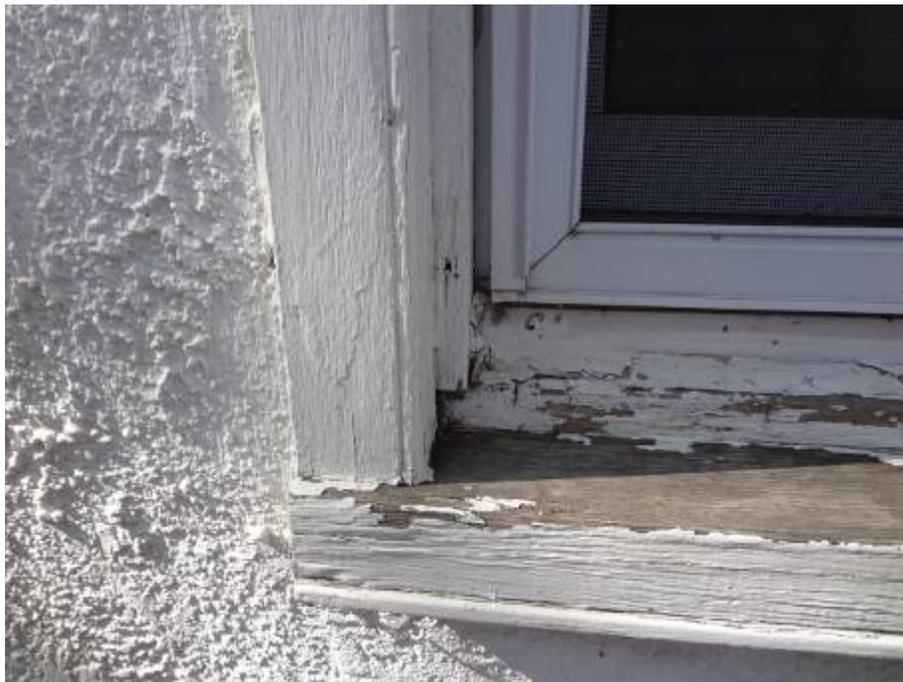
Some deterioration on sills and casement which tested positive for lead-based paint

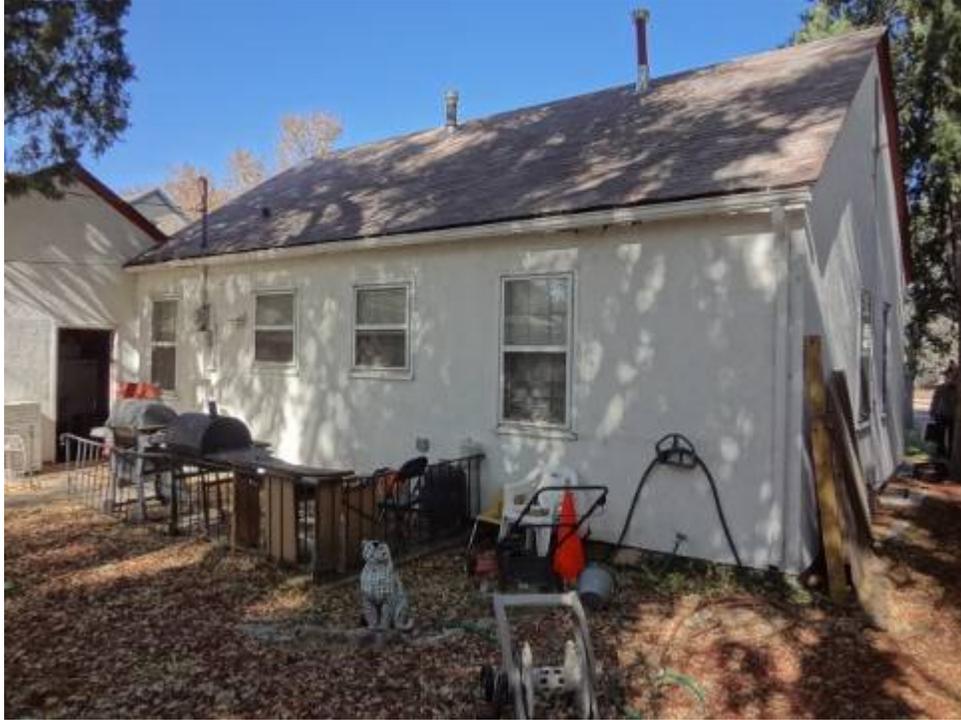
Southern elevation windows tested positive for lead-based paint on the wood components

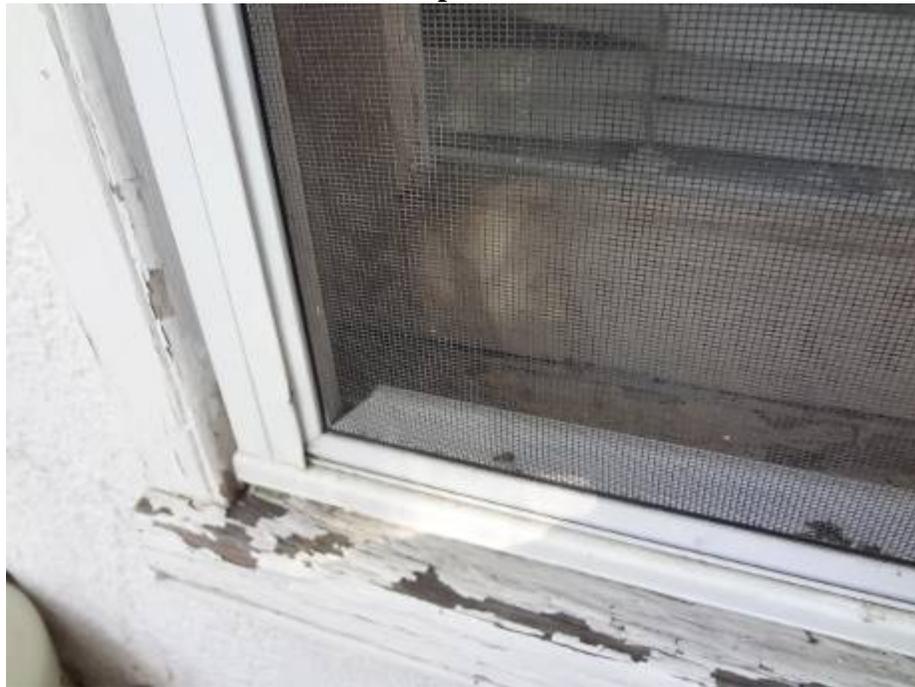
Again sills and casement along with window framework tested positive for lead-based paint

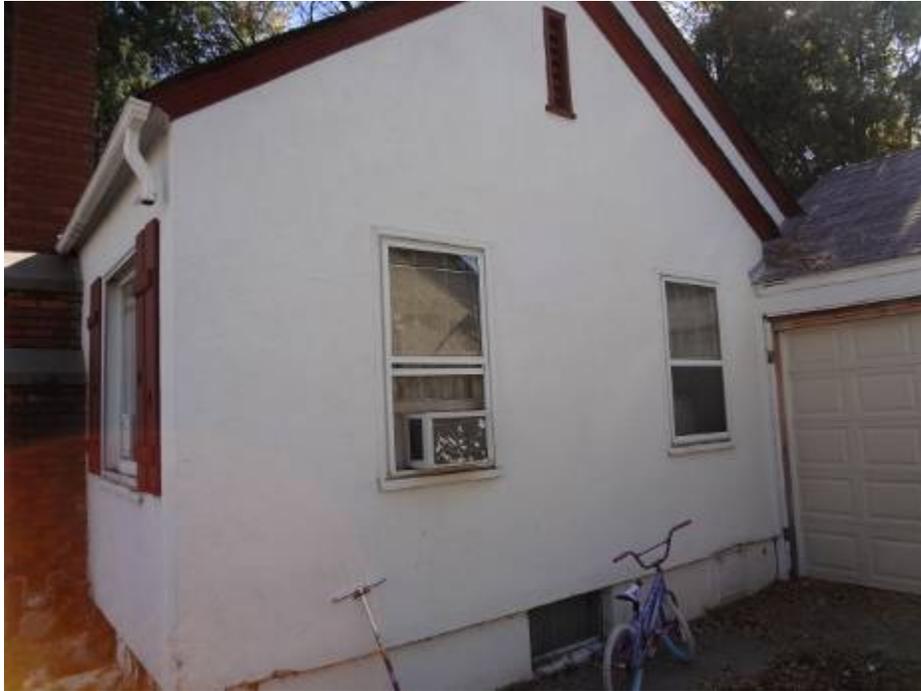
Western elevation both windows tested positive on painted wood components for lead-based paint

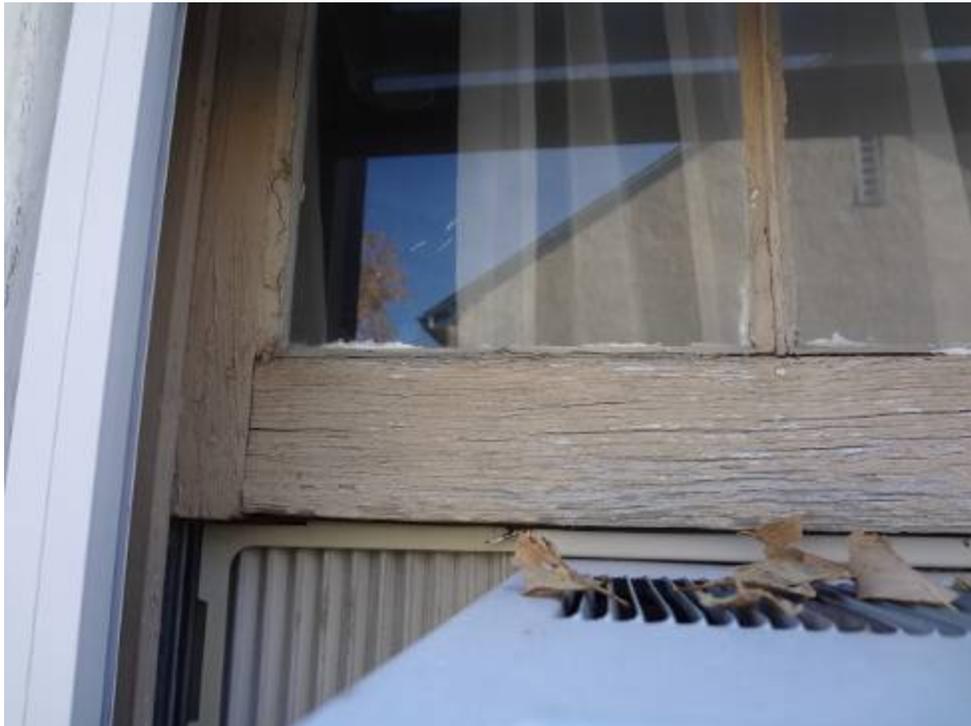
Sill and framework tested positive for lead-based paint
