# **Restoration Specific Asbestos and Lead Based Paint Survey Report**

**2411 W Uintah St  
Colorado Springs, CO 80904**

**Anderson Property Inspections  
Colorado Springs, CO**

**Site Visit(s): 12/2/14  
Report Date: 12/8/14**

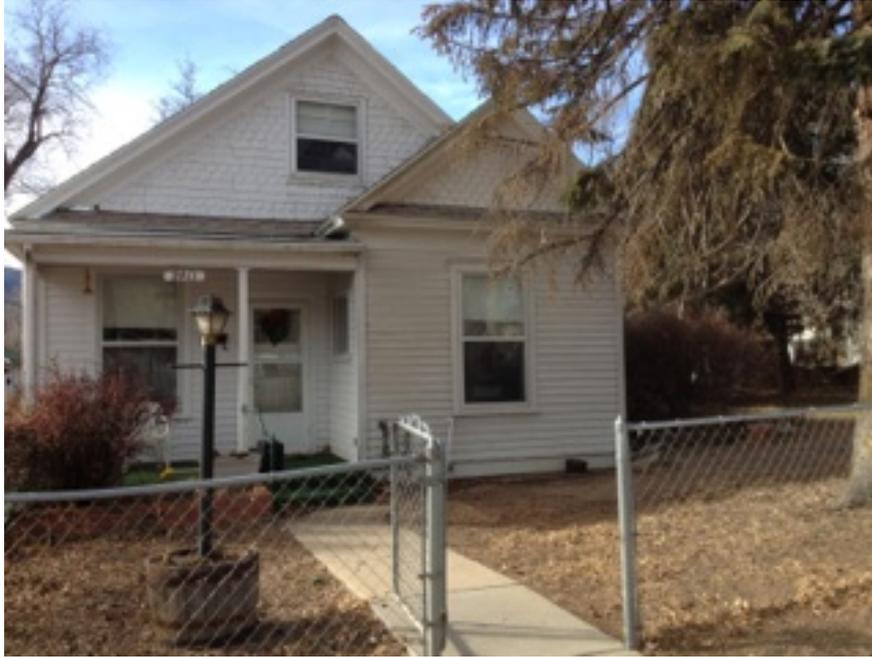
**Front of dwelling (north) note all siding, windows and wood trim came back positive for lead-based paint on this elevation**

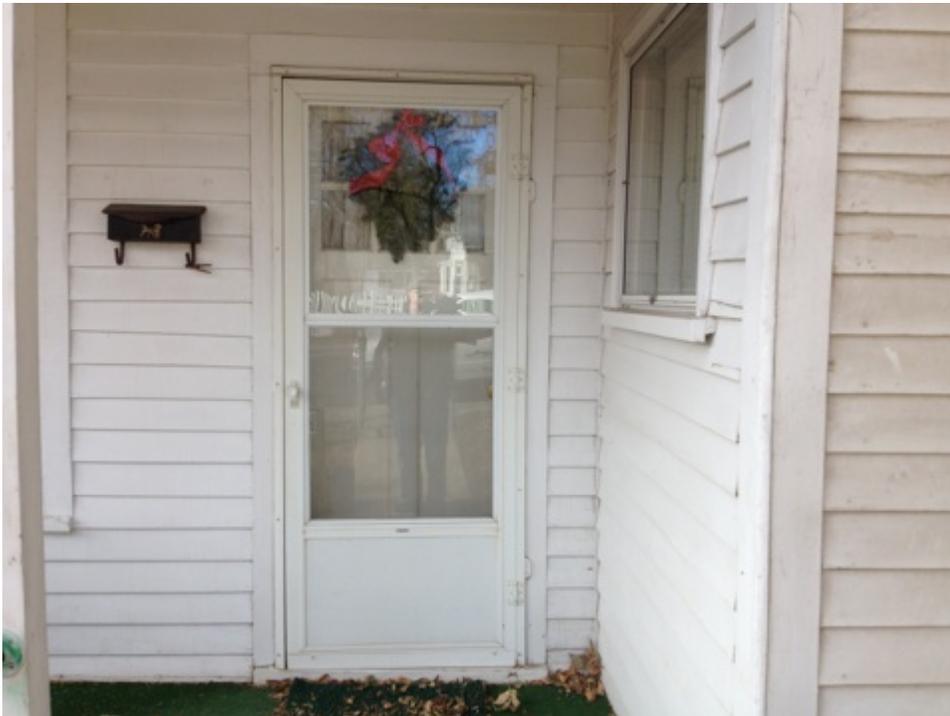
**Door trim, windows and siding all tested positive on the north exterior elevation for lead-based paint**

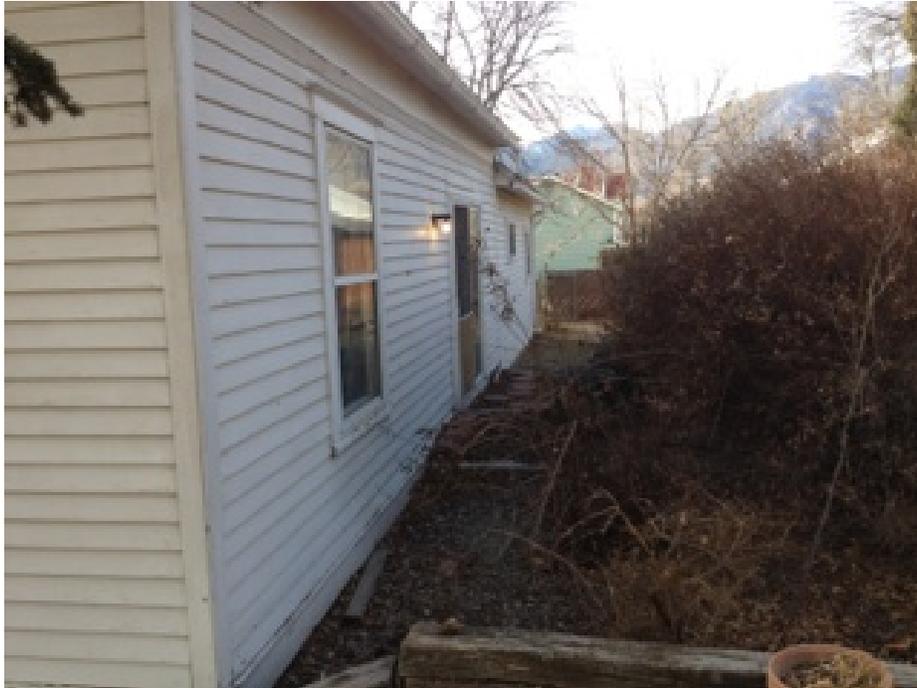
**Western elevation soffit, fascia, siding and window trim all tested positive for lead-based paint**

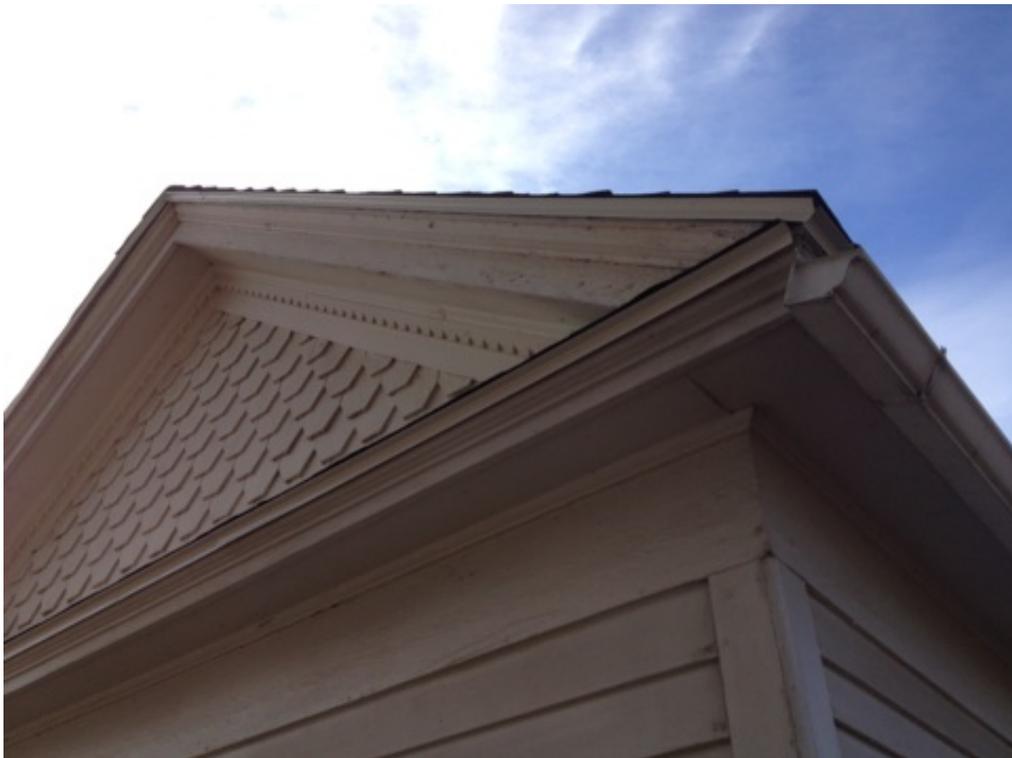
**Soffit, fascia and accent trim around north, east and western elevations all tested positive for lead-based paint**

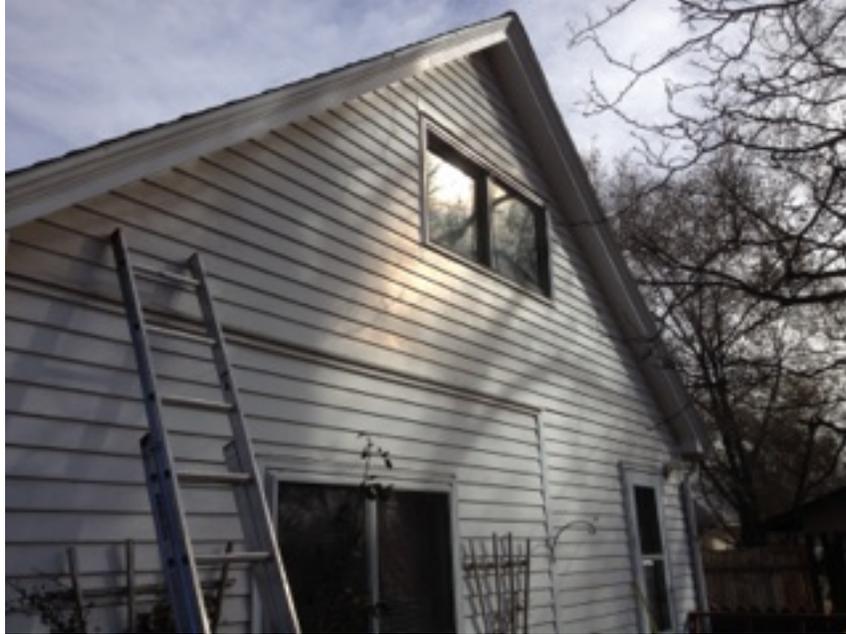
**Southern elevation (clearly renovated recently) all tested negative for lead-based paint**

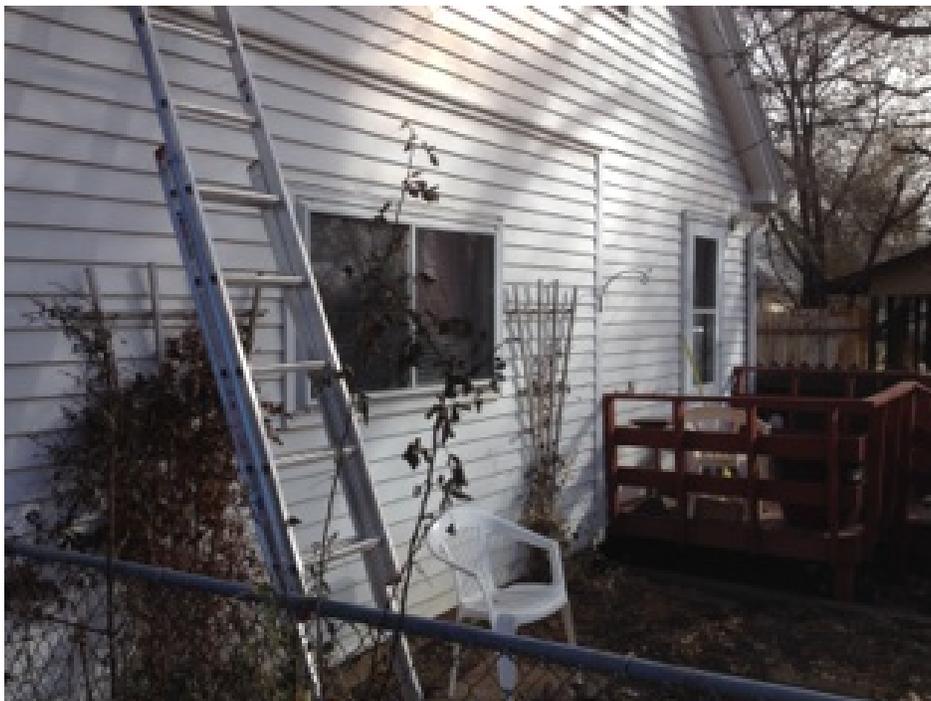
**Decking off southern elevation tested negative for lead-based paint**

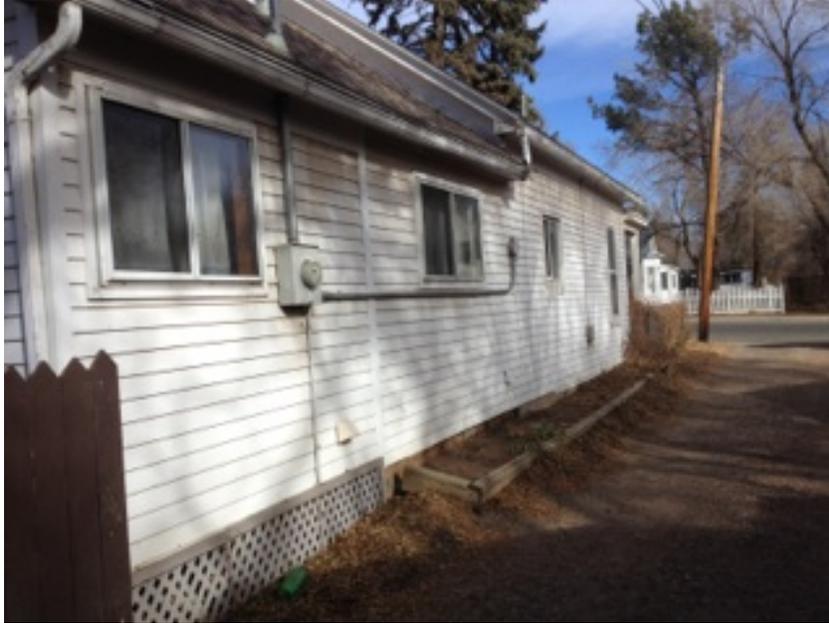
**Eastern elevation fascia, soffit and window trim all tested positive for lead-based paint**

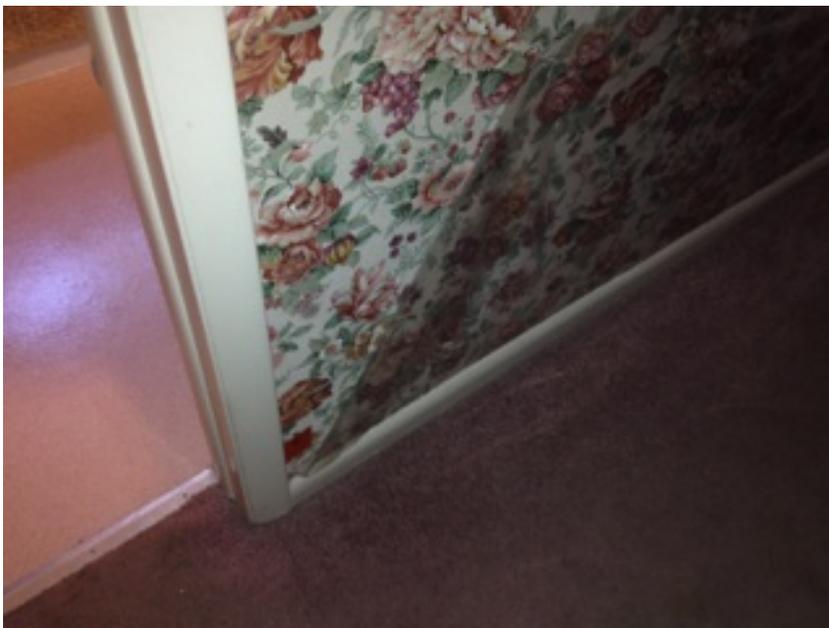
**Interior wall paper over drywall in hallway tested non-detect for asbestos, wood trim is negative for lead-based paint**

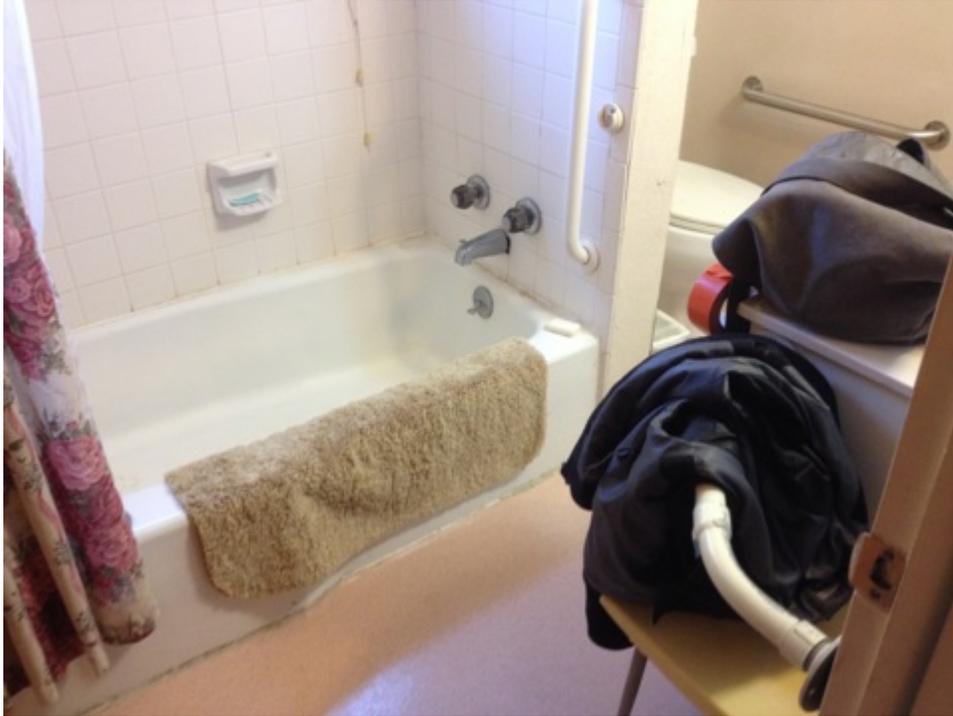
**Asbestos-containing materials, which will be affected by the scope of demolition as a result of this loss, have been positively identified in the tan texture and associated overspray (2% Chrysotile) applied to the drywall substrate walls present in the main level full bathroom slated for impact during the renovation process.**

**Overview of full main level bathroom to be renovated (walls tested positive for asbestos in the texture)**

**As the identified asbestos containing material is to be disturbed by the proposed demolition/renovation work, proper asbestos abatement procedures shall be implemented prior to the commencement of such work. All required asbestos abatement work shall be performed in accordance with all applicable Federal, State and Local rules and regulations. The abatement project shall be filed with all agencies having jurisdiction over this project such as the Colorado Department of Health and Environment.**

**A licensed abatement contractor must perform the removal of all friable and non-friable ACM. API believes that the implementation of these recommendations will serve to best comply with Air Quality Control Commission Regulation No. 8, Part B “Emission Standards for Asbestos.”**

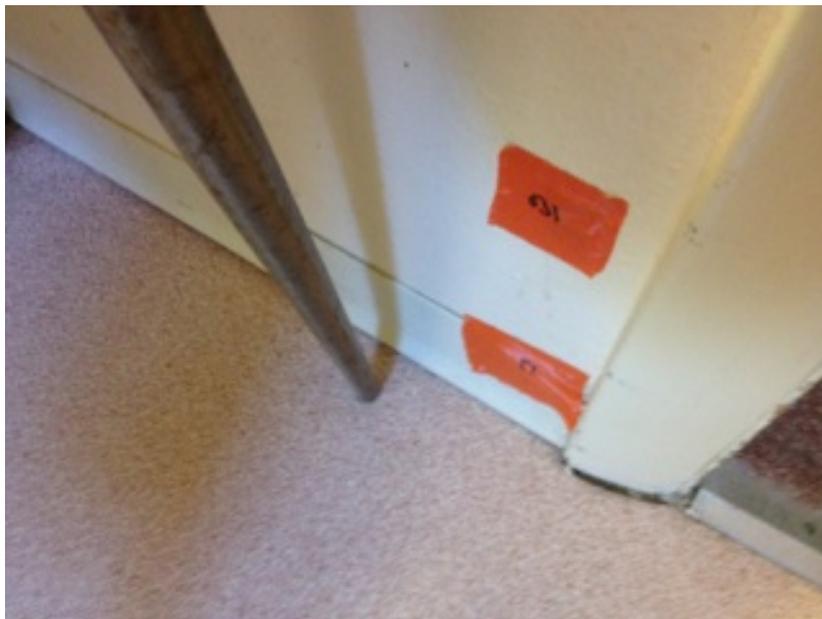
**Wall texture tested positive for asbestos in the bathroom while the base cove mastic tested non-detect**

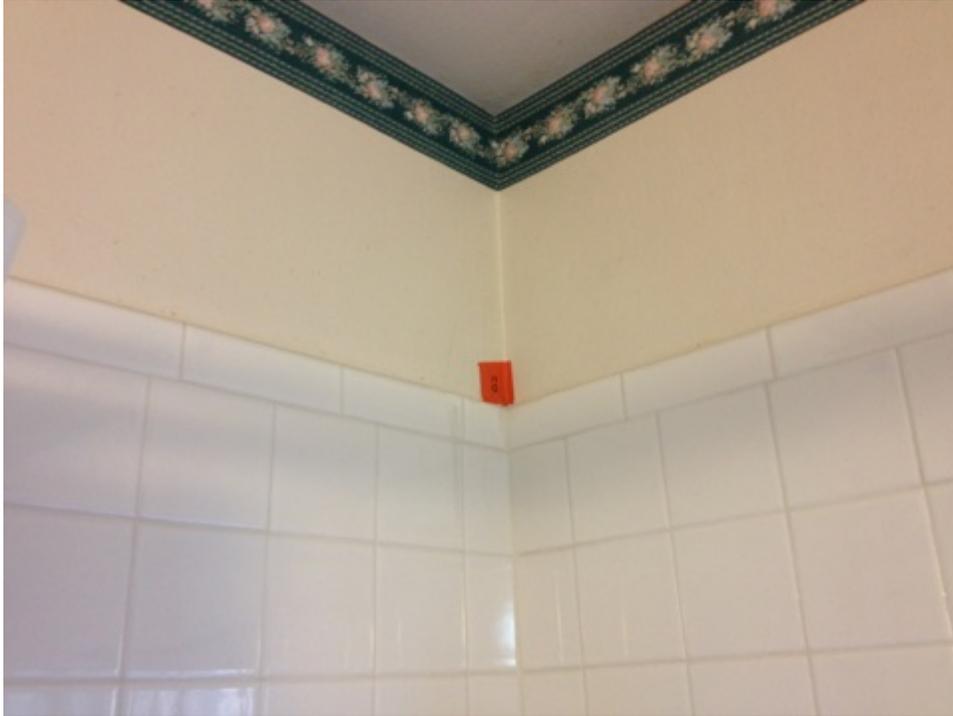
**Wall texture in the bathroom tested positive for asbestos painted walls in the bathroom tested negative for lead-based paint**

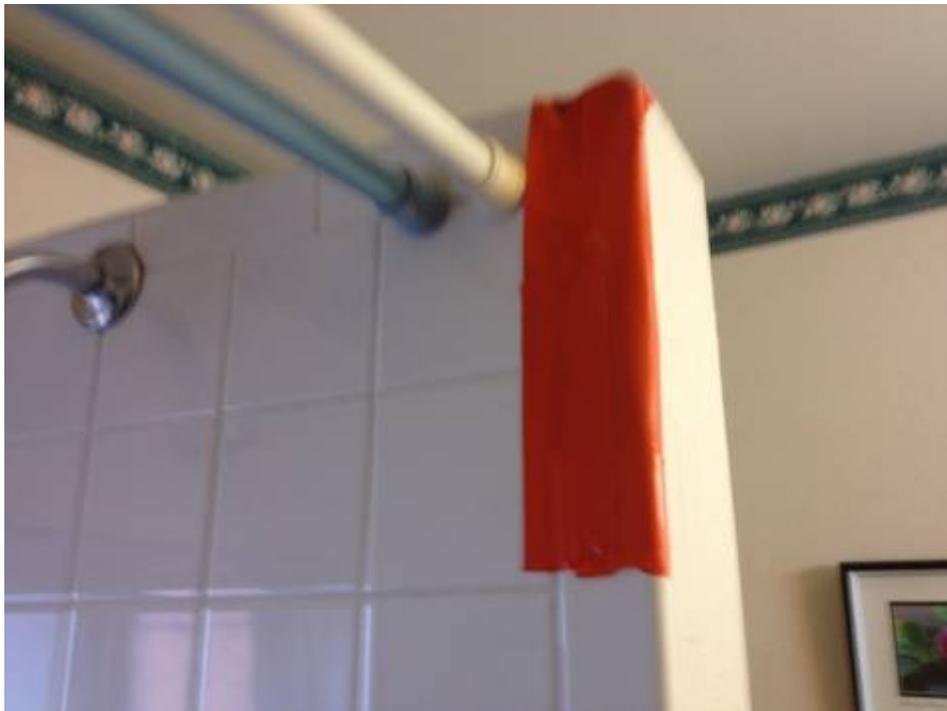
**Ceramic tile surround elements tested non-detect (note wall texture tested positive)**

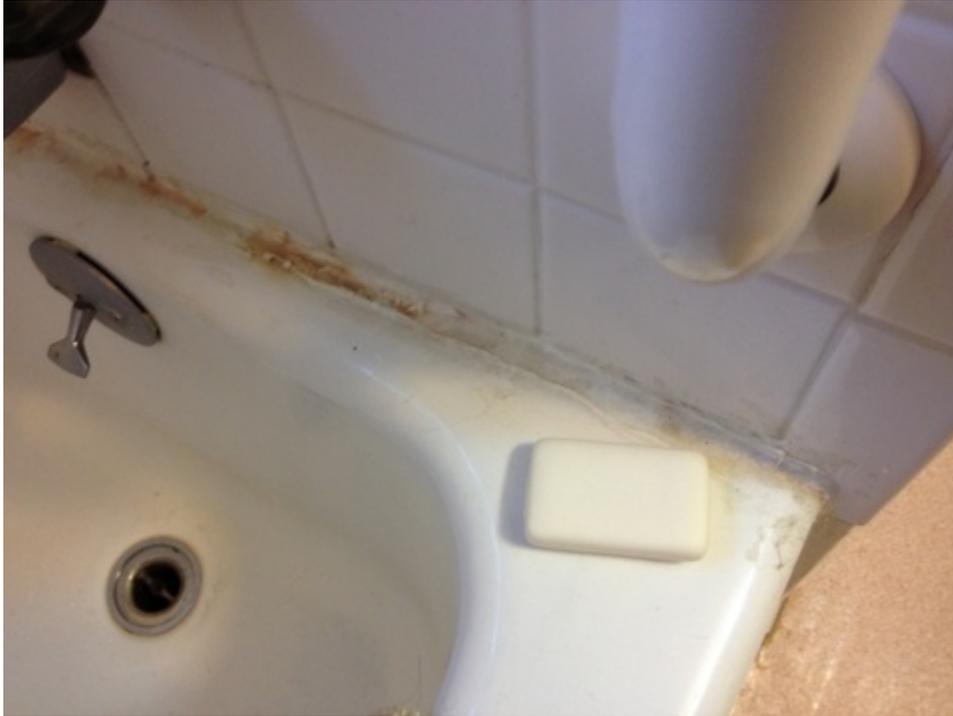
**White sealant used on surround tested non-detect for asbestos**
