January 22, 2015

Housing and Community Initiative
Attention: Deane Robertson
30 S Nevada Ave, Suite 604
Mail Code 640
Colorado Springs, CO 80903

RE: 1134 Pando Avenue
STE JOB: 150111

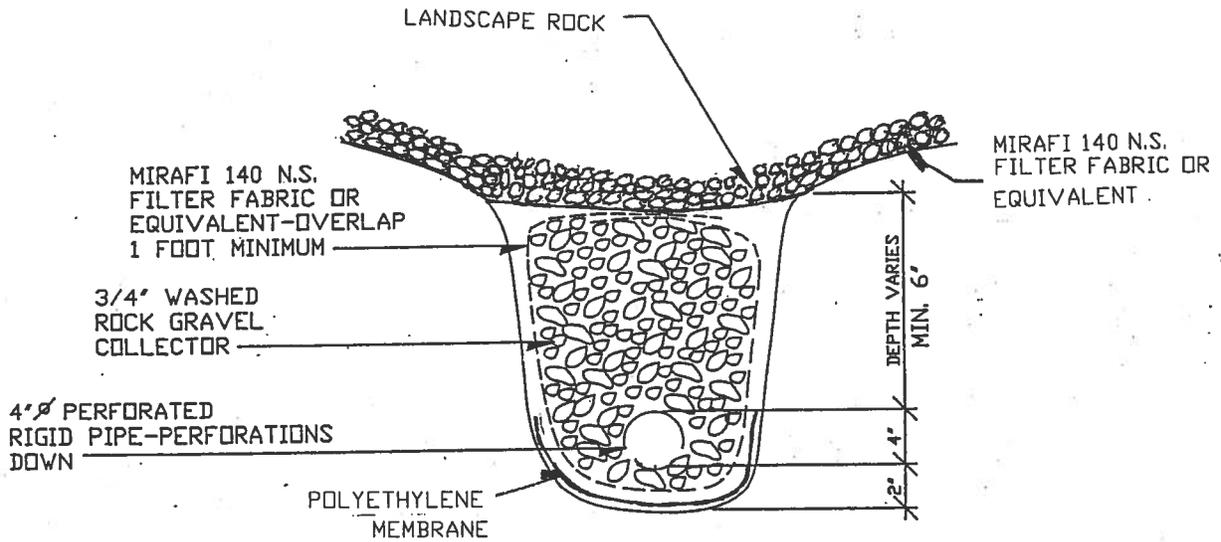
**SURFACE INTERCEPTOR TRENCH
DRAIN DETAIL**

Water intrusion into the crawlspace appears to be associated with poor grading, lack of a gutter system along portions of the roof, downspout discharges, inappropriate backfill, etc. Surface water infiltrated the backfill adjacent to the foundation and enters through cracks and beneath the footing. Ponded water also appears to enter through the vent at the northwest corner.

- A shallow surface interceptor drain can be installed in the swale located on the west side of the home.
- Decorative edging, sidewalks and other flatwork should be planned and constructed so that they do not restrict rapid surface flows away from the foundation region.
- Roof downspouts should be extended across all backfill zones and discharged into an area of positive drainage away from the structure.
- No sod, grass, shrubs, flowers, trees, or other vegetation requiring water should be placed within five feet of the foundation or within any backfill zone. Sprinklers must not discharge water within five feet of the foundation or within any backfill zone.

Attached to this letter is a detail showing the suggested Surface Intraceptor Drain. The drain must have a gravity daylight discharge at the surface. It must be understood the interceptor drain will be located near the surface and is susceptible to freezing.
