## **Restoration Specific Asbestos Survey Report**

**21 South Murray Blvd  
Colorado Springs, CO 80916**

**Anderson Property Inspections  
Colorado Springs, CO**

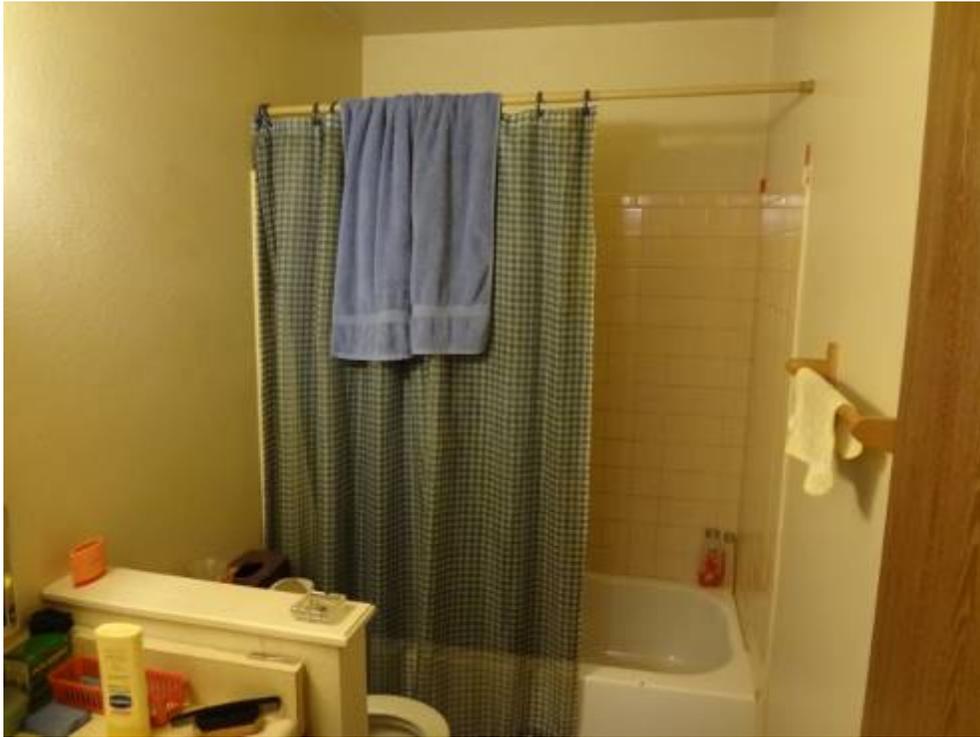
**View of upper level bathroom scheduled for replacement of tub surround**

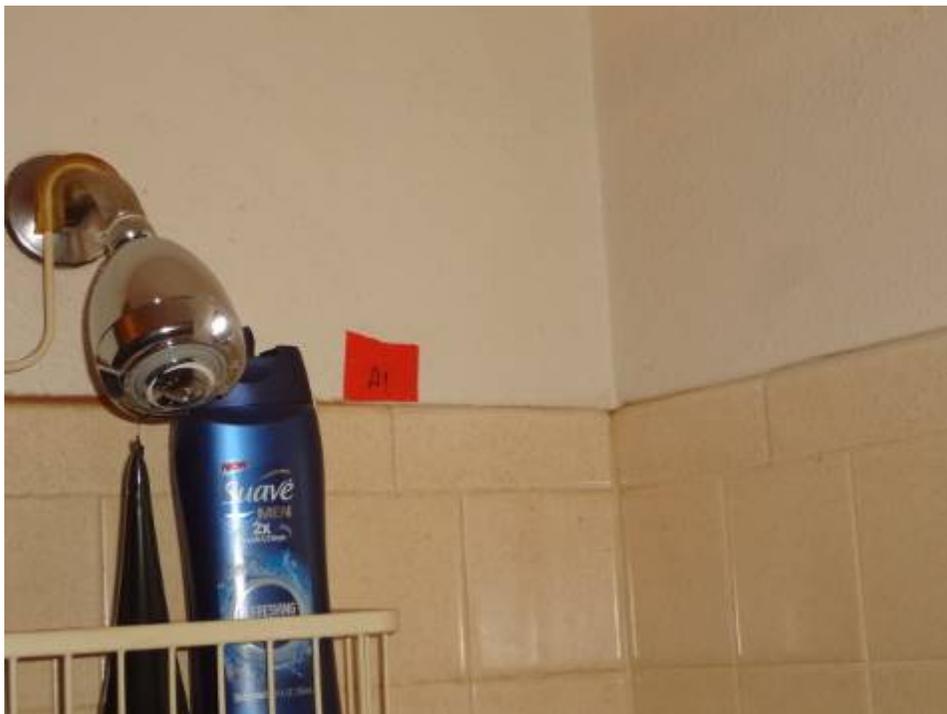
**Sample A211 of the orange peel texture material applied to the drywall substrate wall system in the bathroom and homogeneous to textured east wall of the kitchen is non-detect for asbestos**

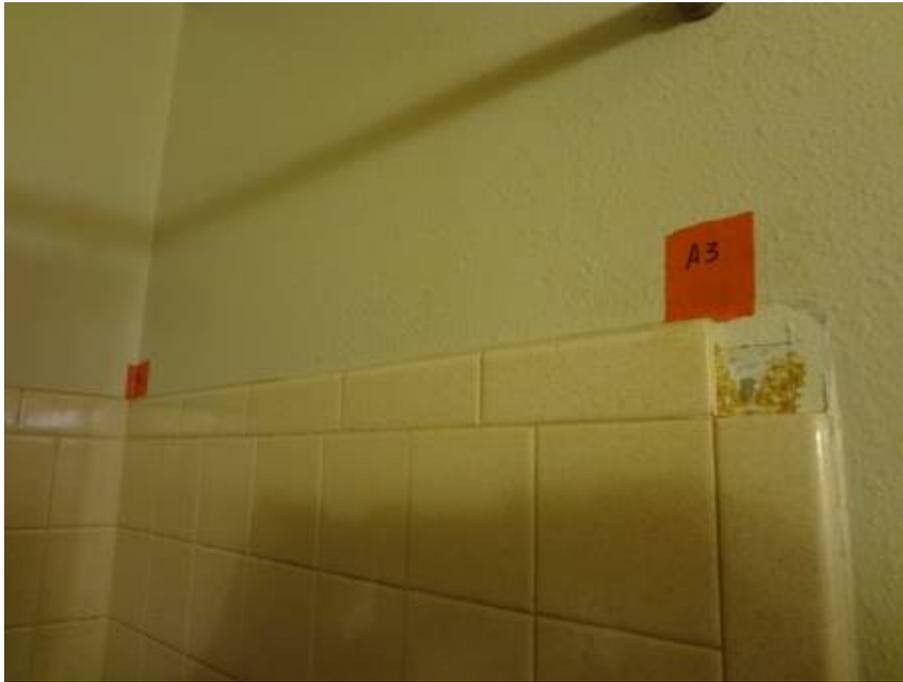
**Sample locations of the orange peel texture material, tub surround ceramic tile with tan grout and gold adhesive is non-detect for asbestos**

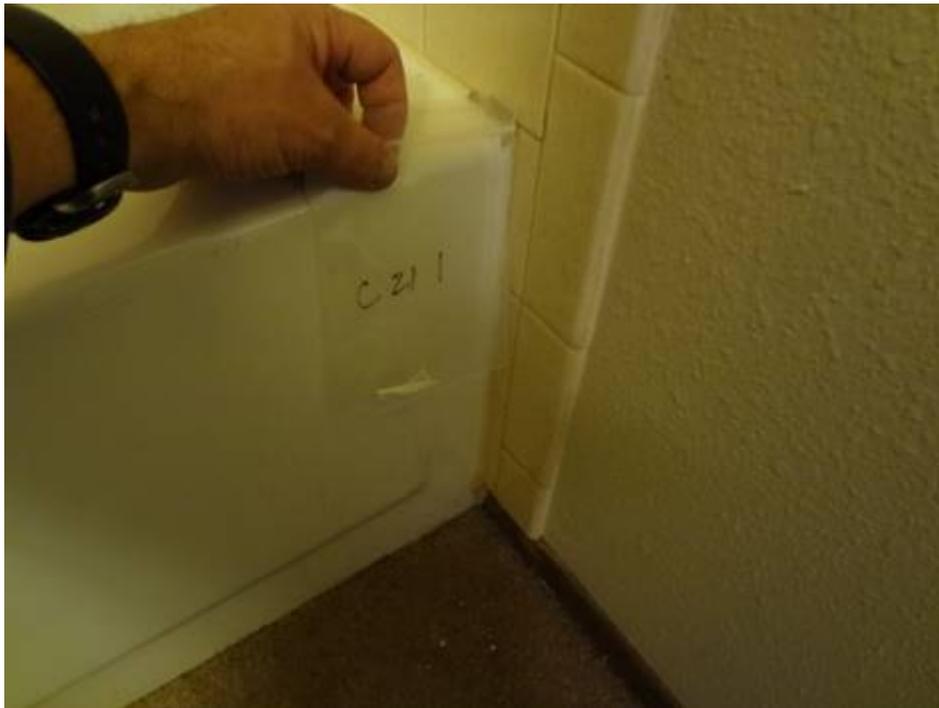
**Sample C211 of the white sealant found around the edge of the tub is non-detect for asbestos**

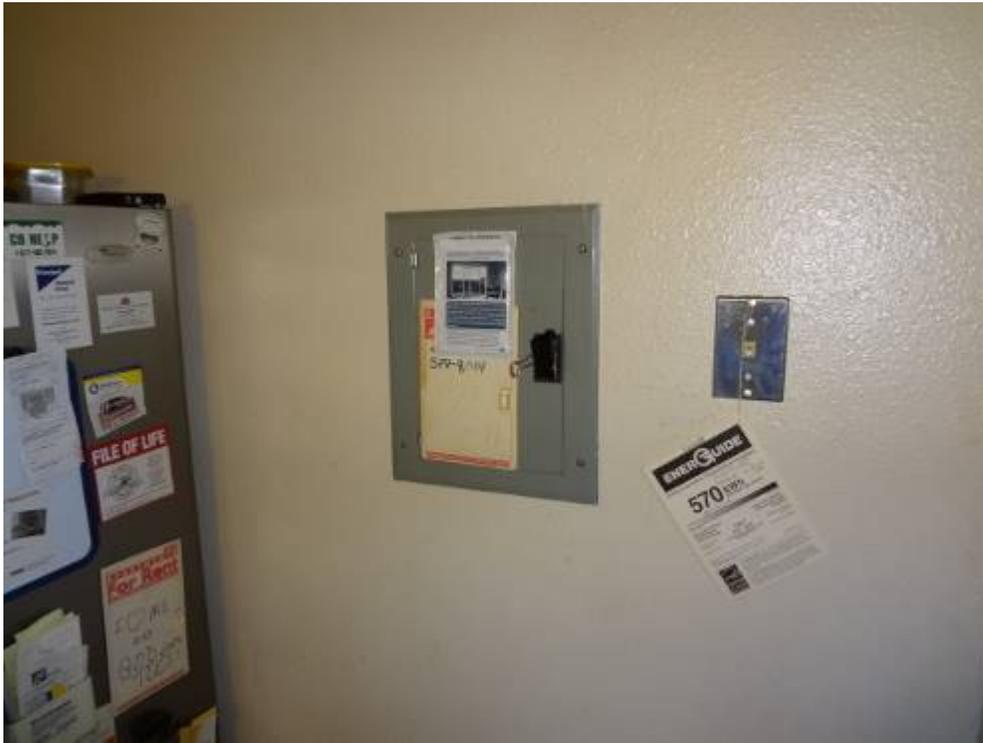
**View of the power panel located in the kitchen, replacement of the panel may impact the orange peel type textured drywall which is homogeneous with the texture material found in the bathroom, the texture material is non-detect for asbestos.**
