# **Restoration Specific Asbestos and Lead Based Paint Survey Report**

**922 Boggs Pl  
Colorado Springs, CO 80910**

**Anderson Property Inspections  
Colorado Springs, CO**

**Site Visit(s): 12/23/14  
Report Date: 12/30/14**

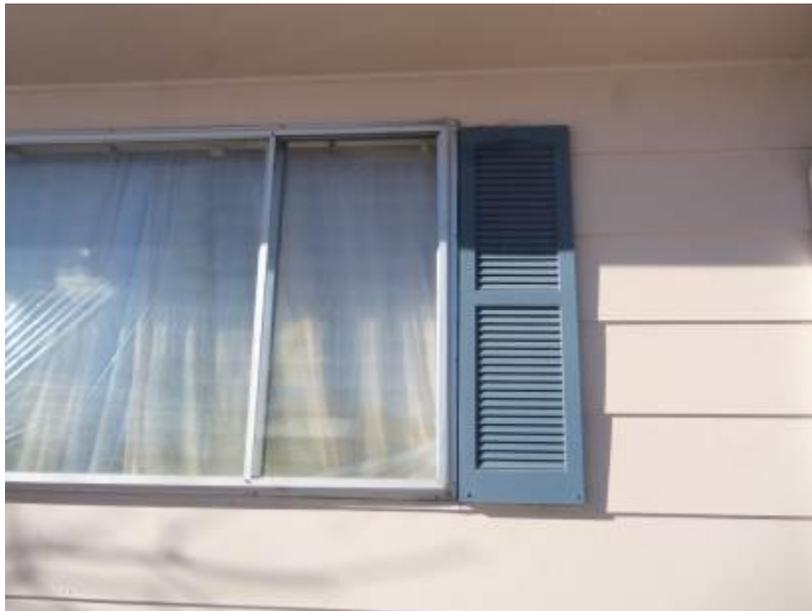
**Window shutters, trim and siding all tested negative for lead-based paint around the dwelling**

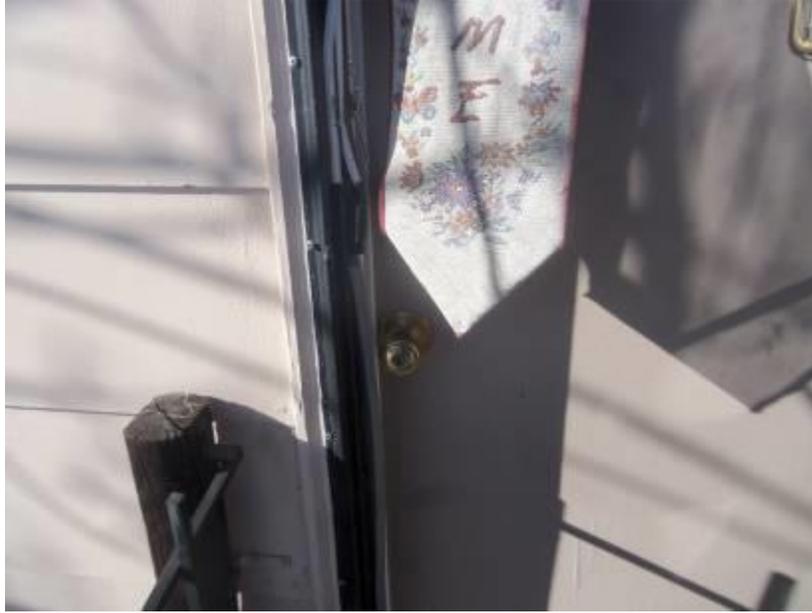
**Door slabs, trim and jambs both front and back tested negative for lead-based paint**

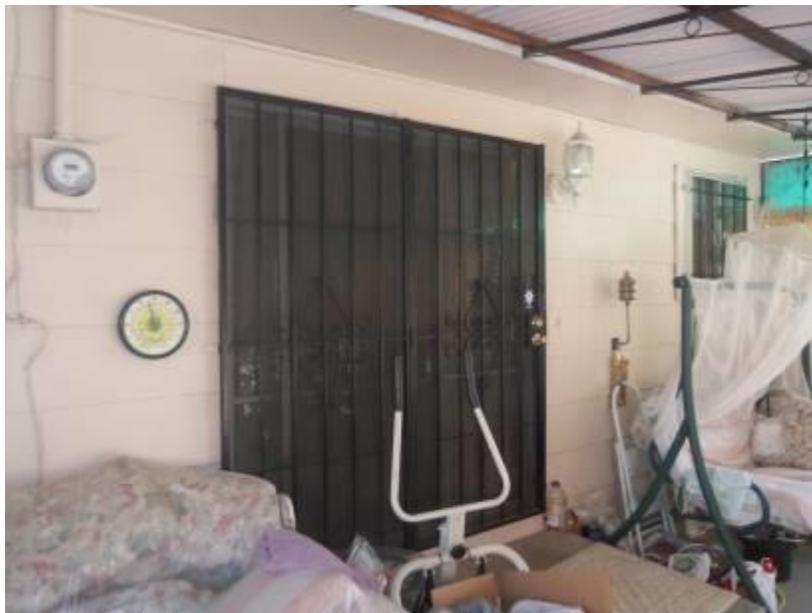
**Back slider door components and siding tested negative for lead-based paint**

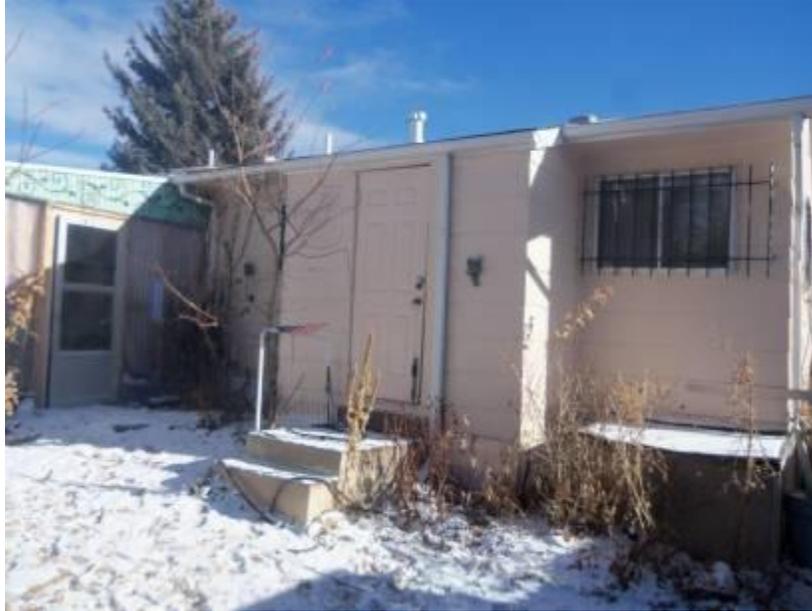
**Back door components, siding and window components for back window slated for enlargement all tested negative for lead-based paint**

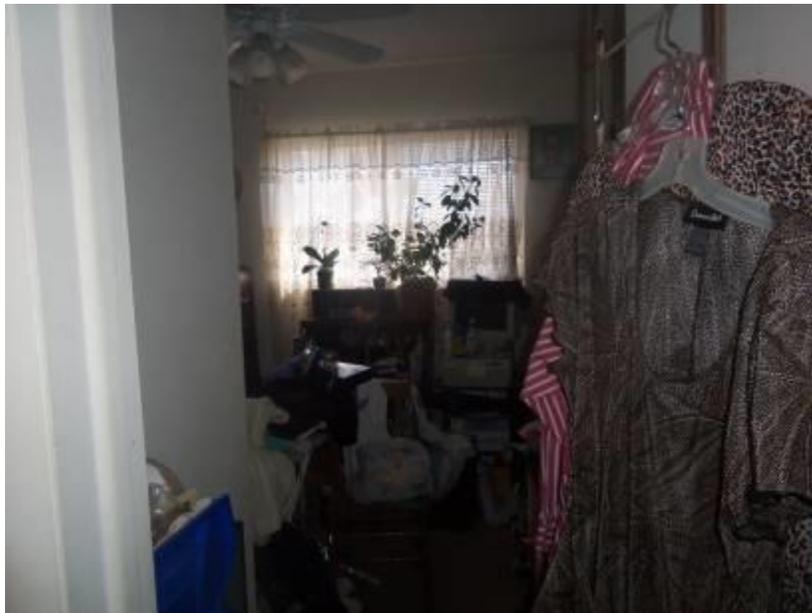
**Asbestos-containing materials, which will be affected by the scope of demolition as a result of this loss, have been positively identified in the tan texture/compound, joint compound and associated overspray (3% Chrysotile) applied to the drywall substrate wall material slated for impact in the main level laundry closet off the kitchen, all three bedrooms with windows slated for enlargement as well as the main level bathroom slated for renovation. It appears that the bathroom has two layers of texture applied which denotes a potential partial renovation in the past, however with three of the wall samples coming back positive for an asbestos compound it is apparent that the original applied texture and joint compound were asbestos containing.**

**Middle front bedroom where window is slated for enlargement walls and trim tested negative for lead-based paint but drywall has asbestos containing texture applied**

**As the identified asbestos containing material is to be disturbed by the proposed demolition/renovation work, proper asbestos abatement procedures shall be implemented prior to the commencement of such work. All required asbestos abatement work shall be performed in accordance with all applicable Federal, State and Local rules and regulations. The abatement project shall be filed with all agencies having jurisdiction over this project such as the Colorado Department of Health and Environment.**

**A licensed abatement contractor must perform the removal of all friable and non-friable ACM. API believes that the implementation of these recommendations will serve to best comply with Air Quality Control Commission Regulation No. 8, Part B "Emission Standards for Asbestos."**

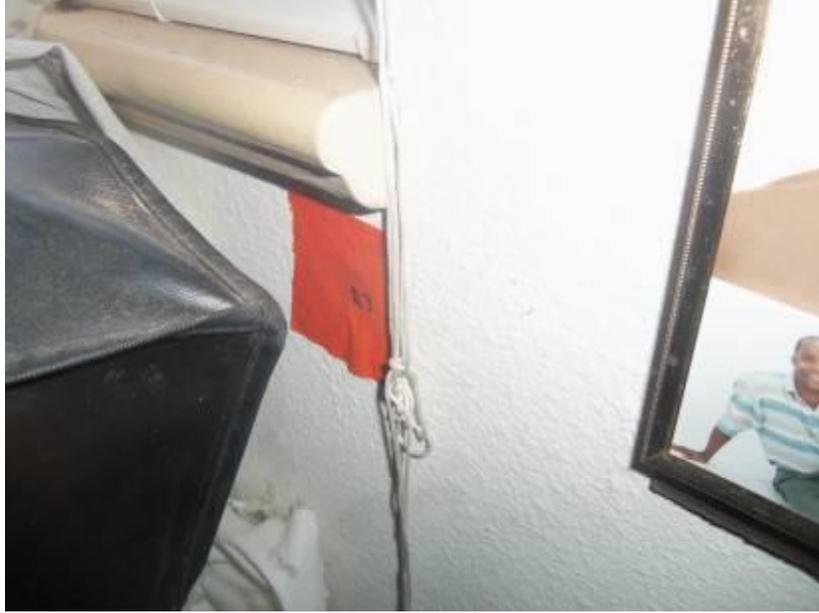
**Positive wall sample in bedroom**

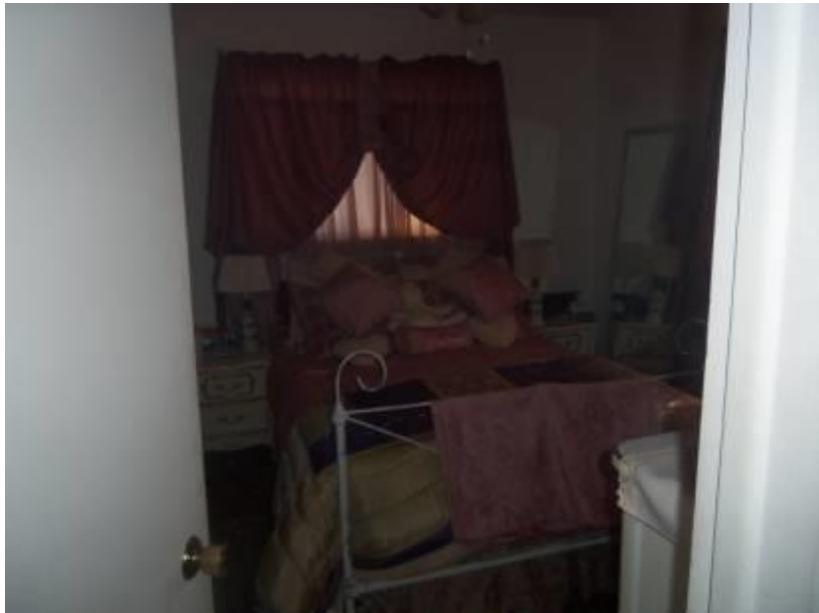
**Front corner bedroom window is slated for enlargement walls and trim tested negative for lead-based paint but drywall has asbestos containing texture applied**

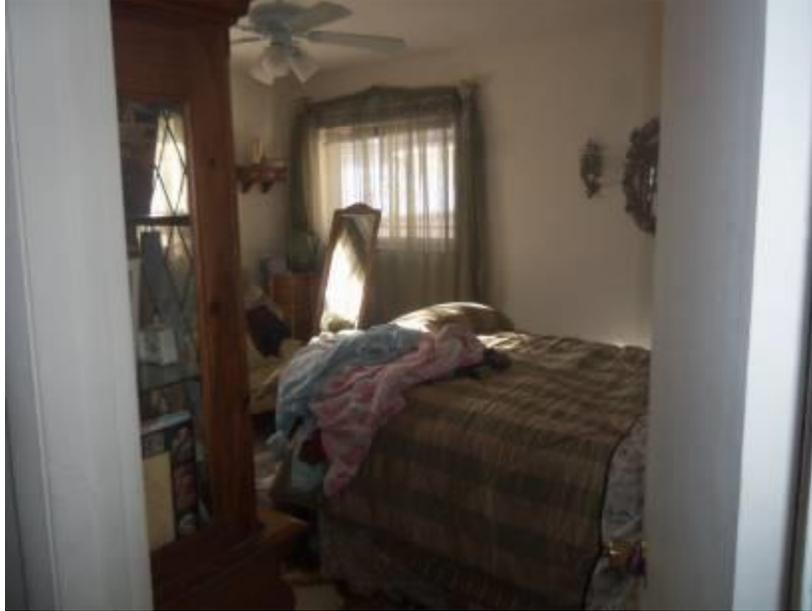
**Back corner bedroom where window is slated for enlargement walls and trim tested negative for lead-based paint but drywall has asbestos containing texture applied**

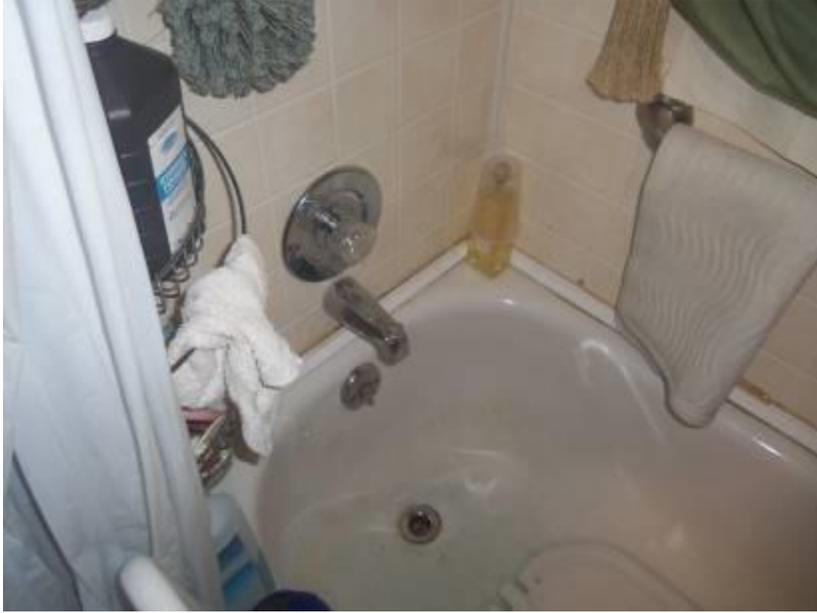
**White sealant and fiberboard surround tested non-detect for asbestos**

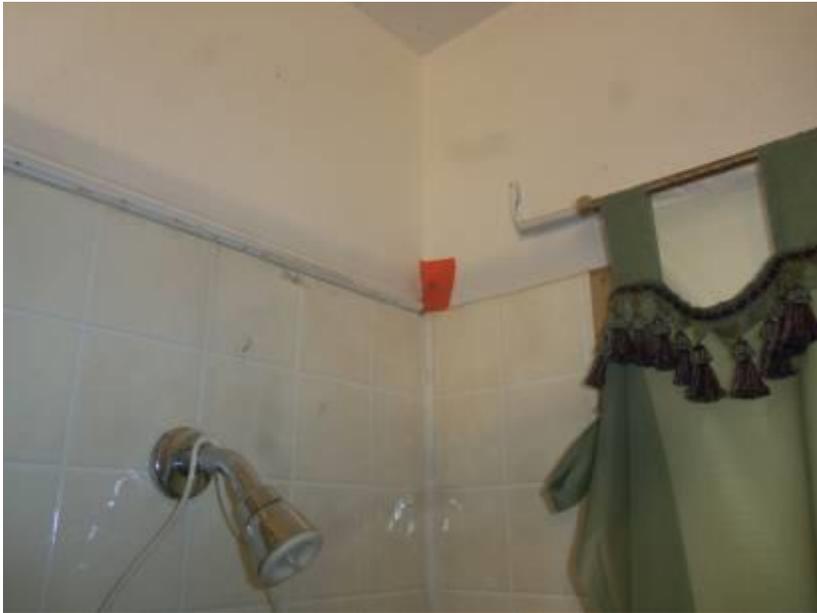
**Positive wall sample location in bathroom**

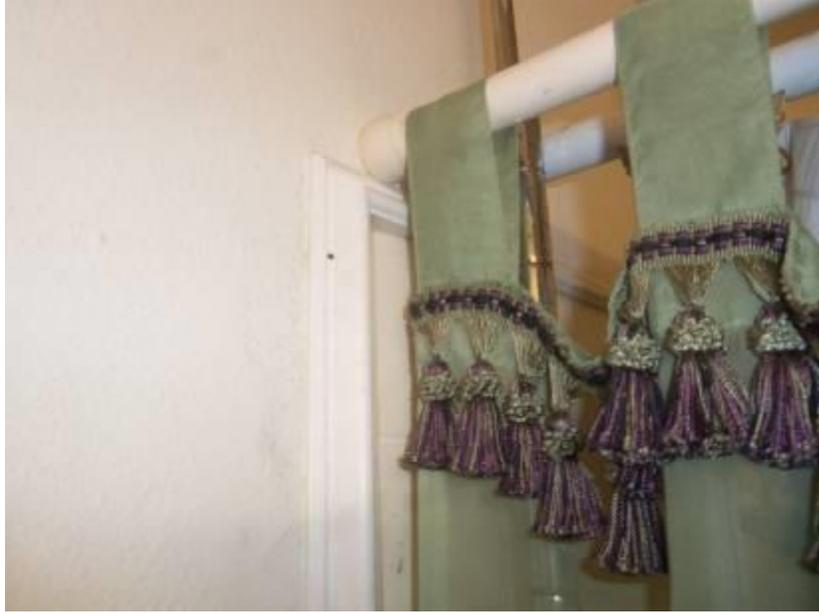
**Textured walls in bathroom and under bath surround tested positive for an asbestos containing texture**

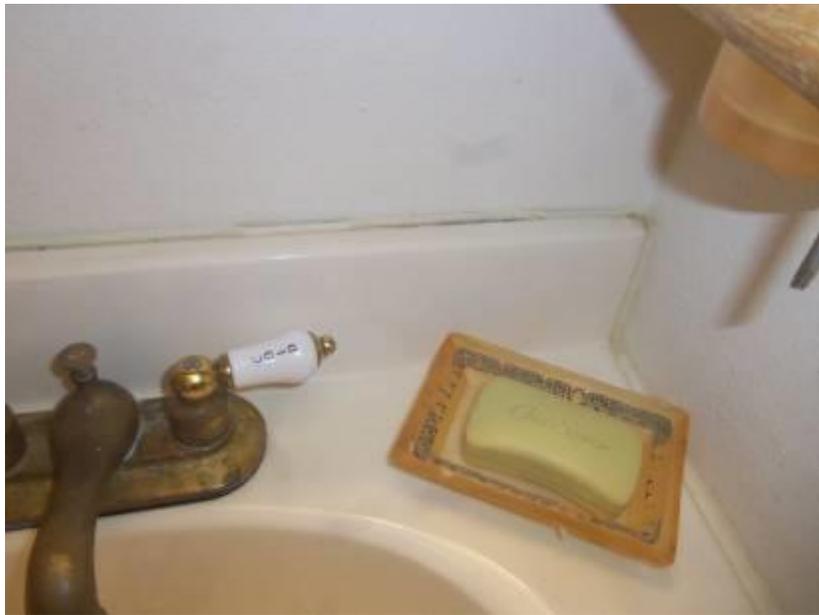
**White sealant also present on vanity top which tested non-detect for asbestos**

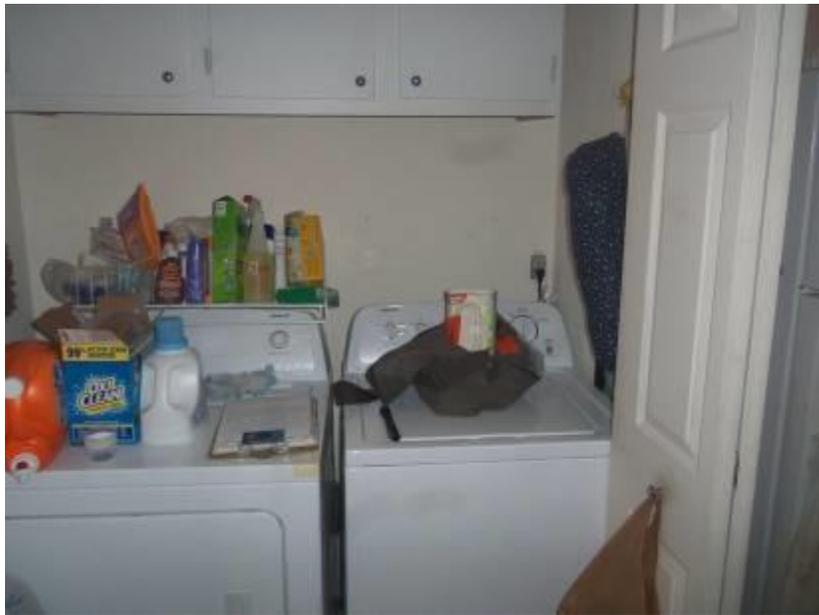
**Walls on interior of laundry closet tested positive for asbestos in the texture**

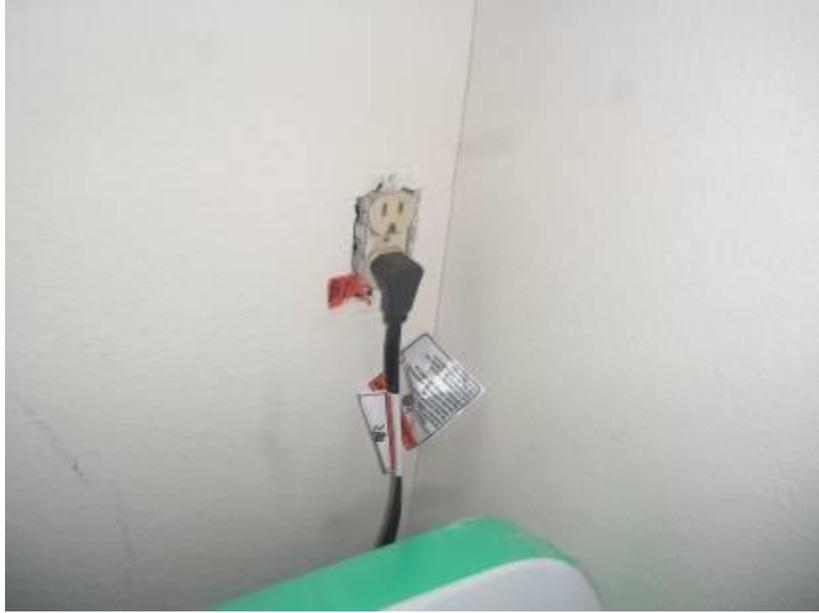
**Positive wall sample in laundry closet**
