Restoration Specific Asbestos and Lead Based Paint Survey Report

**634 N Royer St
Colorado Springs, CO 80903**

**Anderson Property Inspections
Colorado Springs, CO**

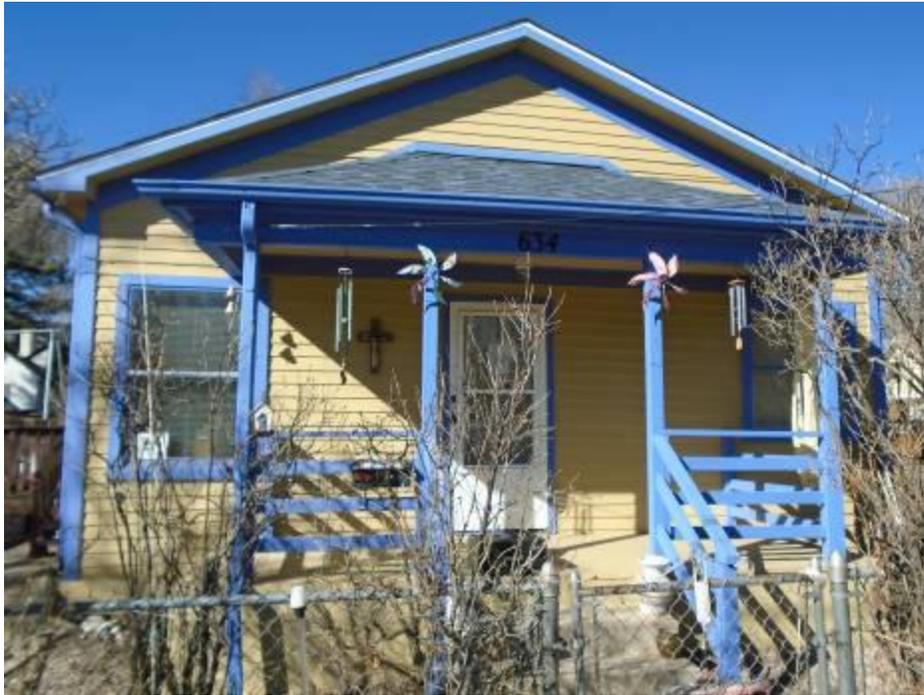
Front view of dwelling faces east

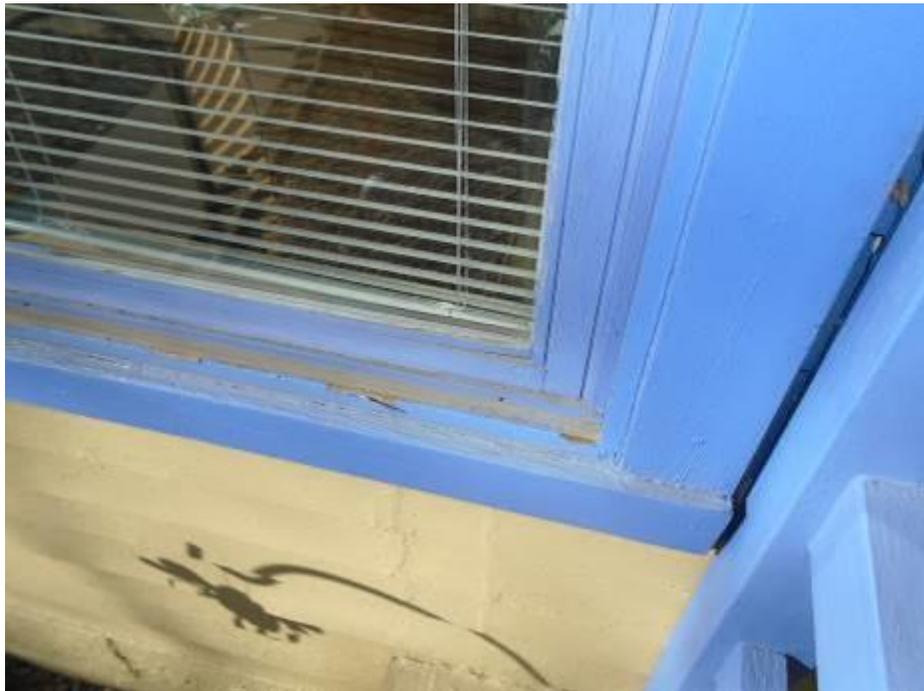
Front elevation window components are below regulated lead based paint regulated trigger level of ($1.0\text{mg}/\text{cm}^2$). However, adjoining the beige colored siding boards did test above the trigger level, the siding boards should be handled appropriately if their removal is required for installation of new windows

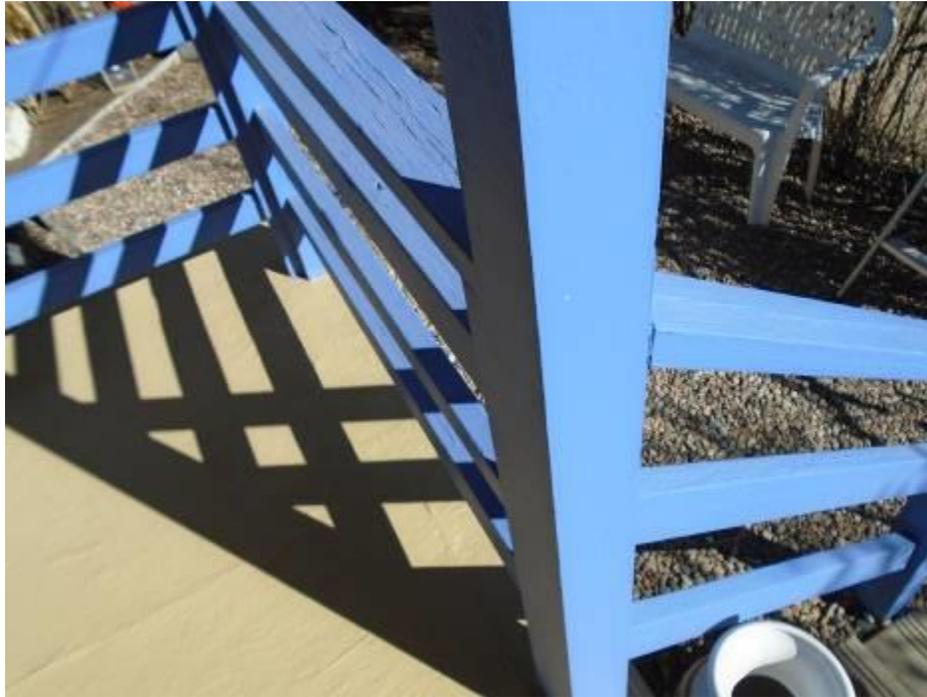
Front railing test for lead based paint was below the regulated trigger level of (1.0mg/cm²)

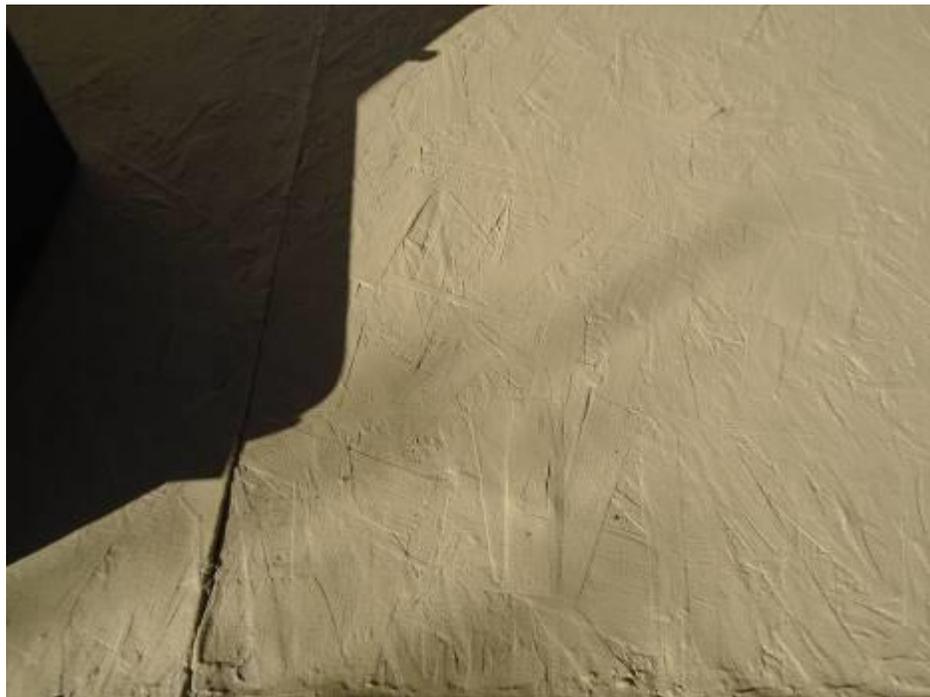
Front porch decking for lead based paint was below the regulated trigger level of (1.0mg/cm²)

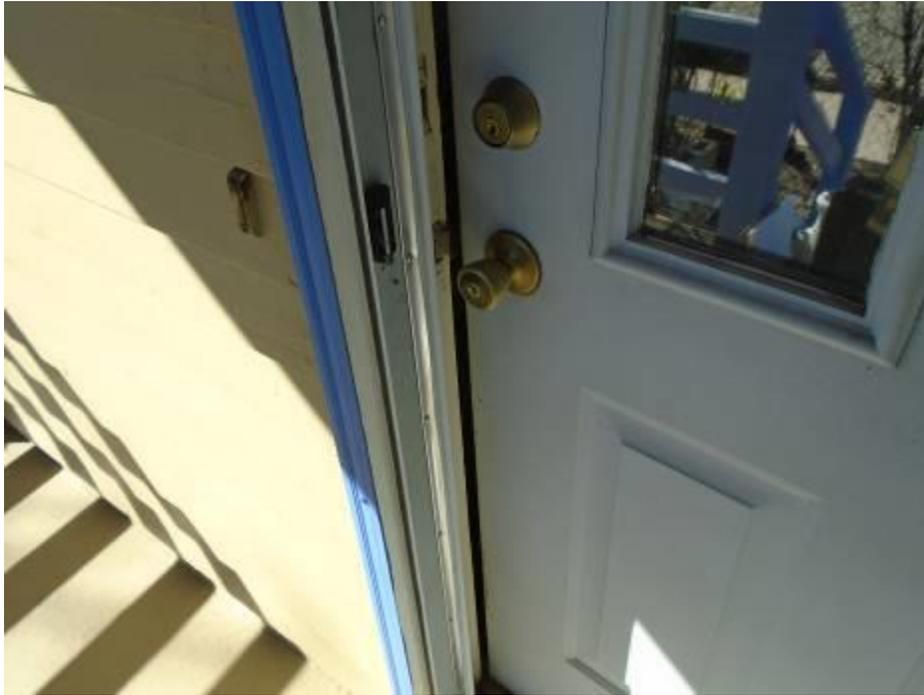
Front door components tested for lead based paint was below the regulated trigger level of (1.0mg/cm²)

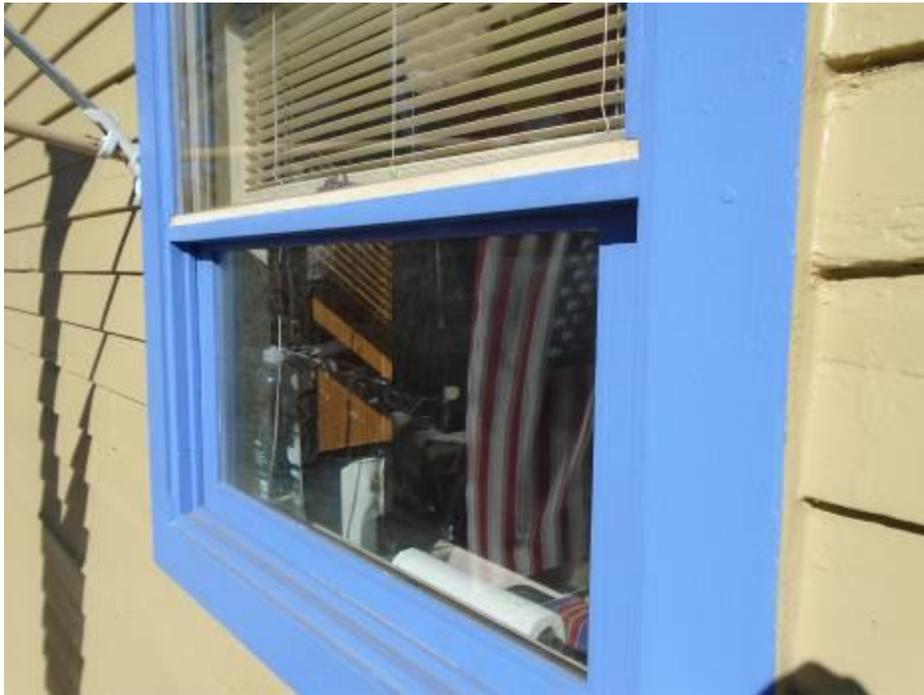
South elevation window components tested for lead based paint was below the regulated trigger level of (1.0mg/cm²)

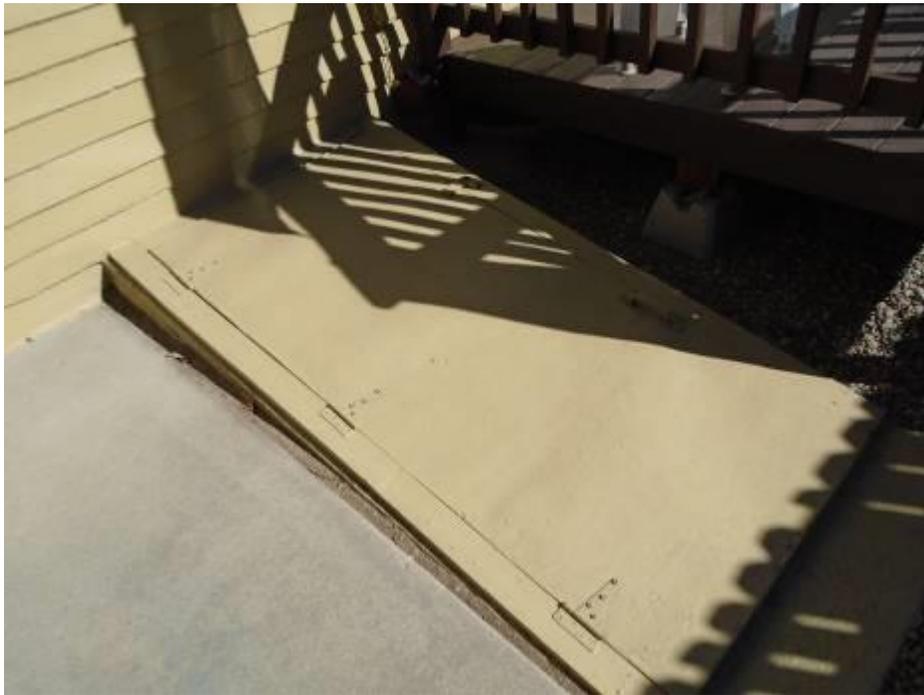
South elevation cellar/crawlspace egress hatch tested for lead based paint was below the regulated trigger level of (1.0mg/cm²)

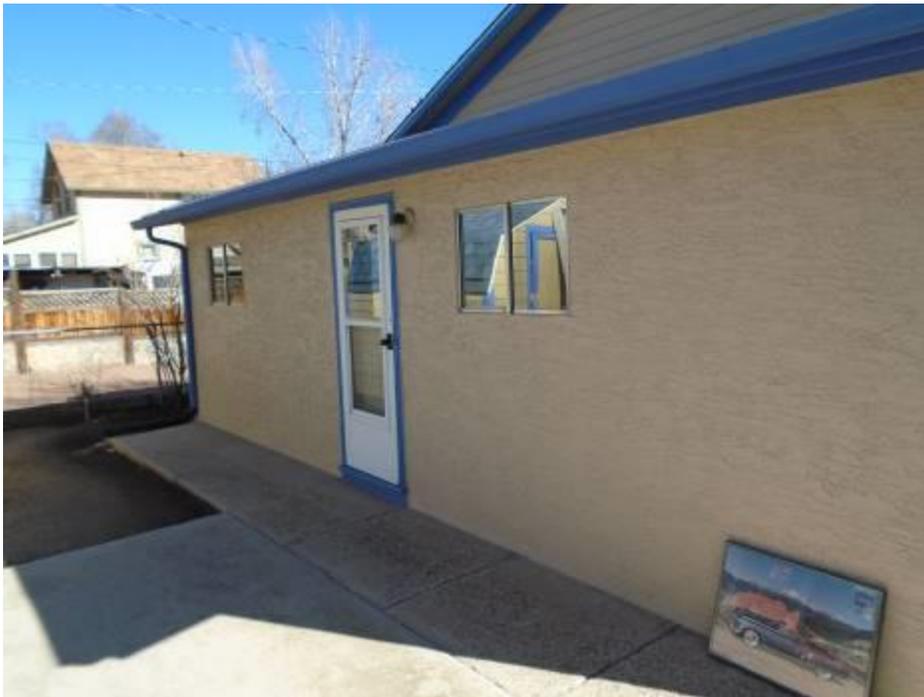
West elevation tested for lead based paint was below the regulated trigger level of (1.0mg/cm²)

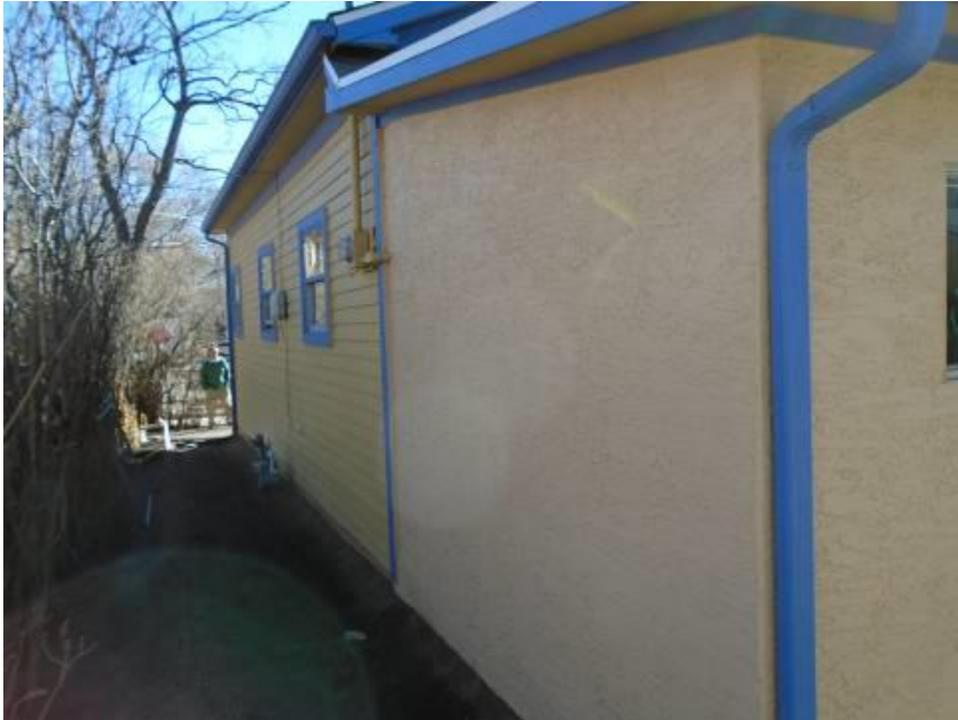
North elevation window components are below regulated lead based paint regulated trigger level of (1.0mg/cm²), however, the beige colored siding boards did test above the trigger level, the siding boards should be handled appropriately if their removal is required for installation of new windows

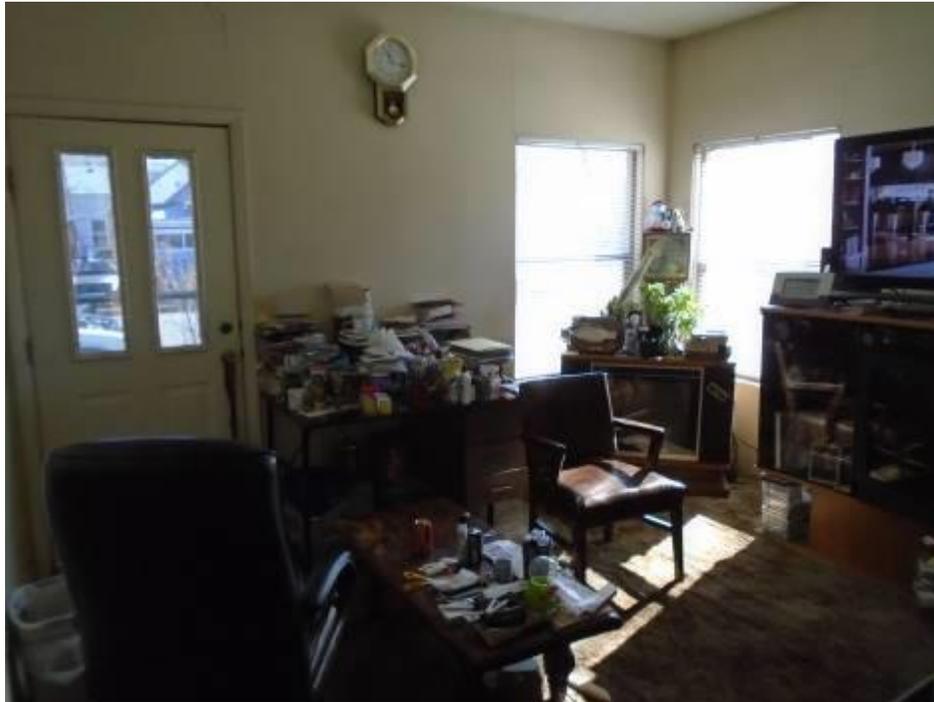
View of the living room walls/ceilings have asbestos surfacing applications

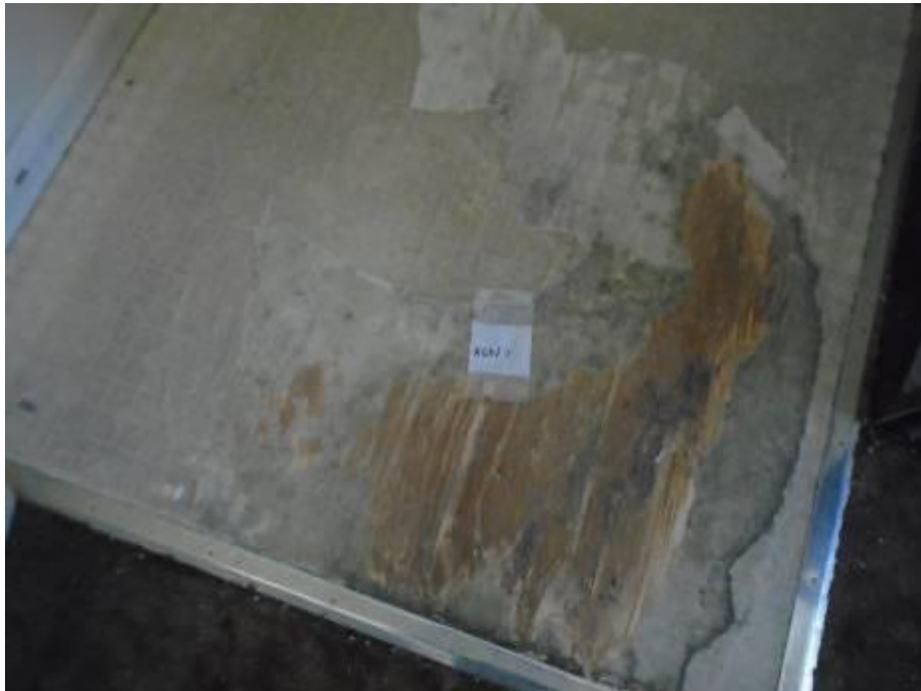
Sample A6341 of the gray sheet vinyl with mastic found adhered to a plywood substrate located at the main entry way is non-detect for asbestos

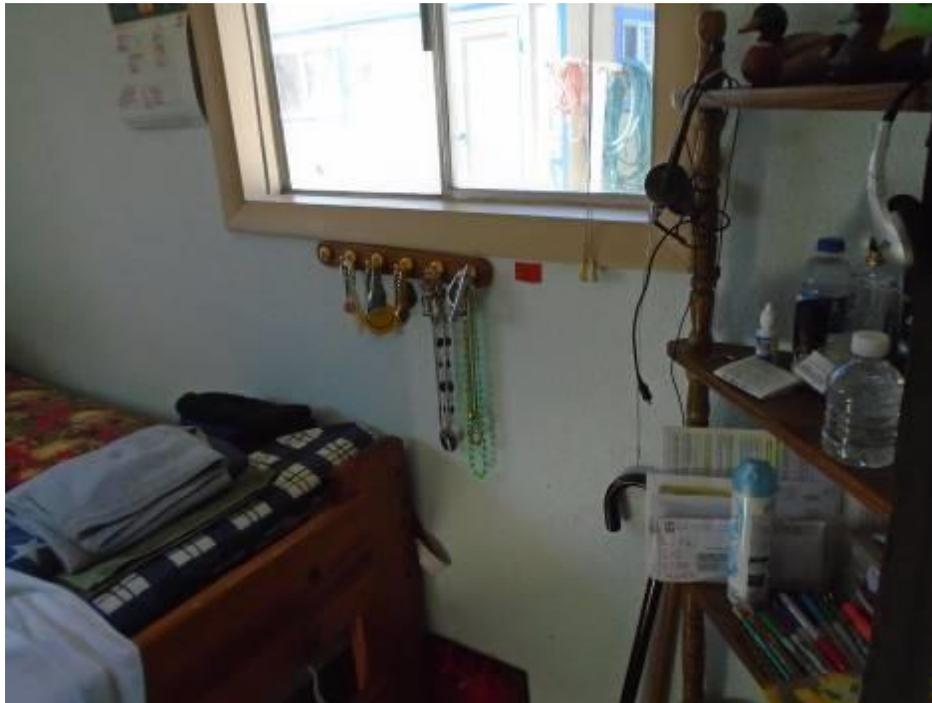
Sample C6341 of the orange peel style texture material taken from bedroom #2 (southwest corner) contains 2% Chrysotile asbestos

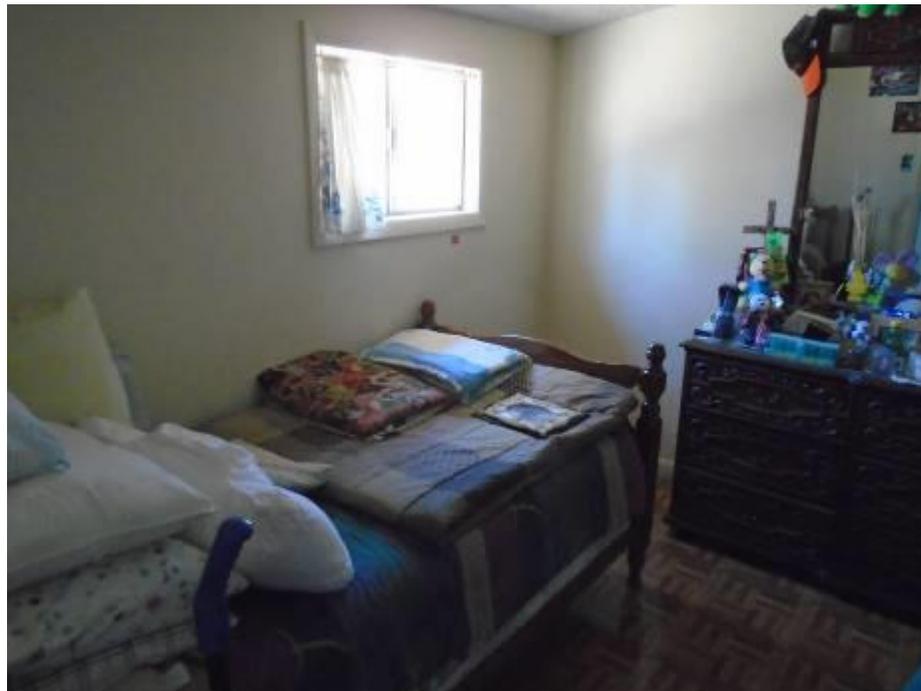
Sample C6343 of the orange peel style texture material taken from the window in bedroom #3 (northwest corner) is homogeneous with the texture material found in bedroom #2 and the bathroom and considered asbestos containing

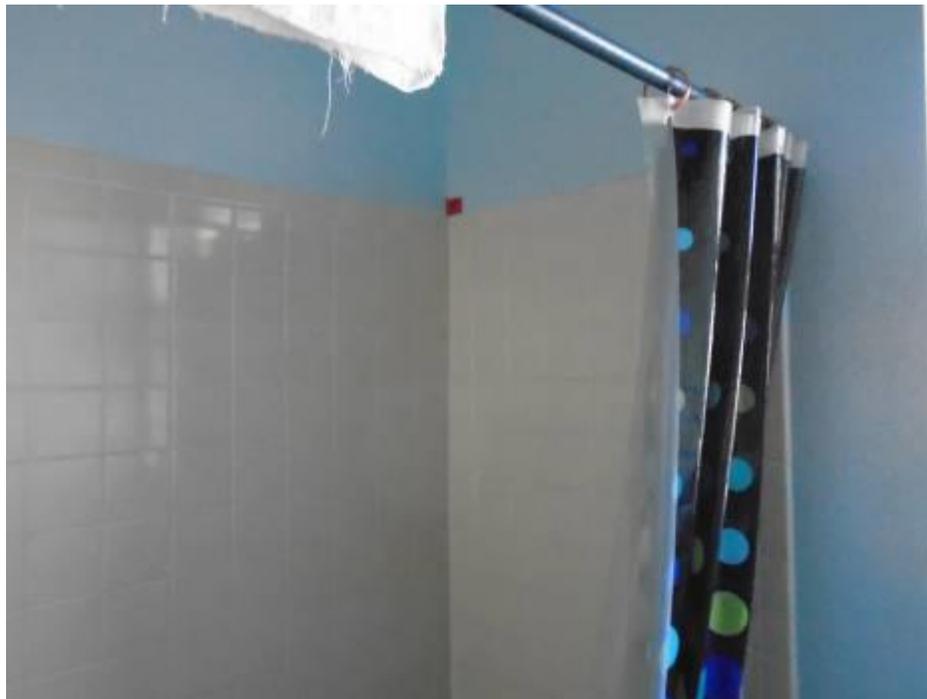
View of the tiled tub surround scheduled for replacement. Sample C6342 of the orange peel texture material including joint compound contains 6% Chrysotile asbestos

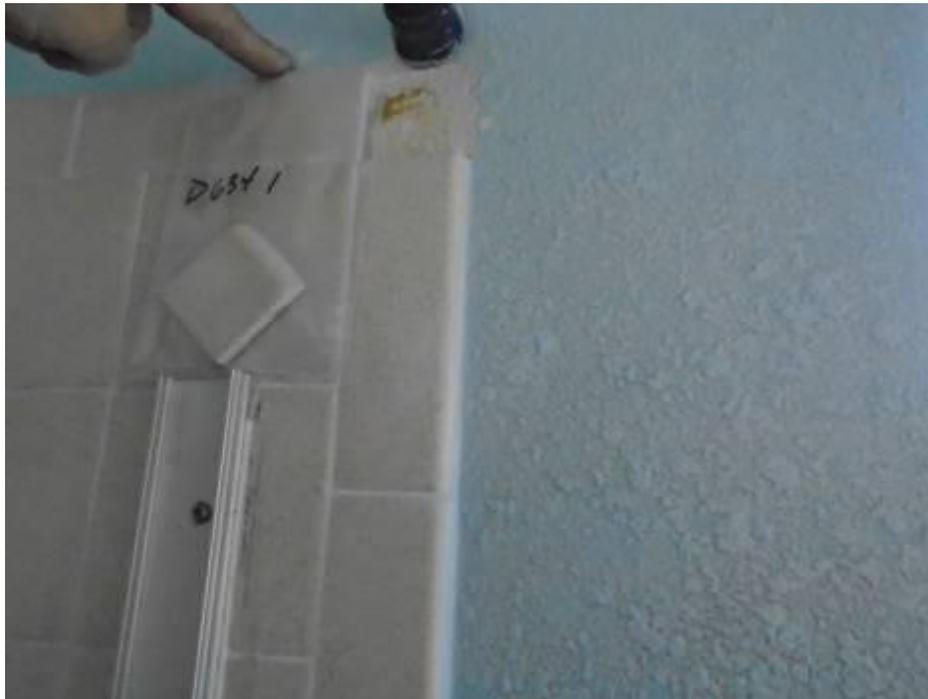
Sample D6341 of the beige ceramic tile with yellow mastic and white grout was non-detect, however, the tile is adhered to asbestos containing texture material found on the walls

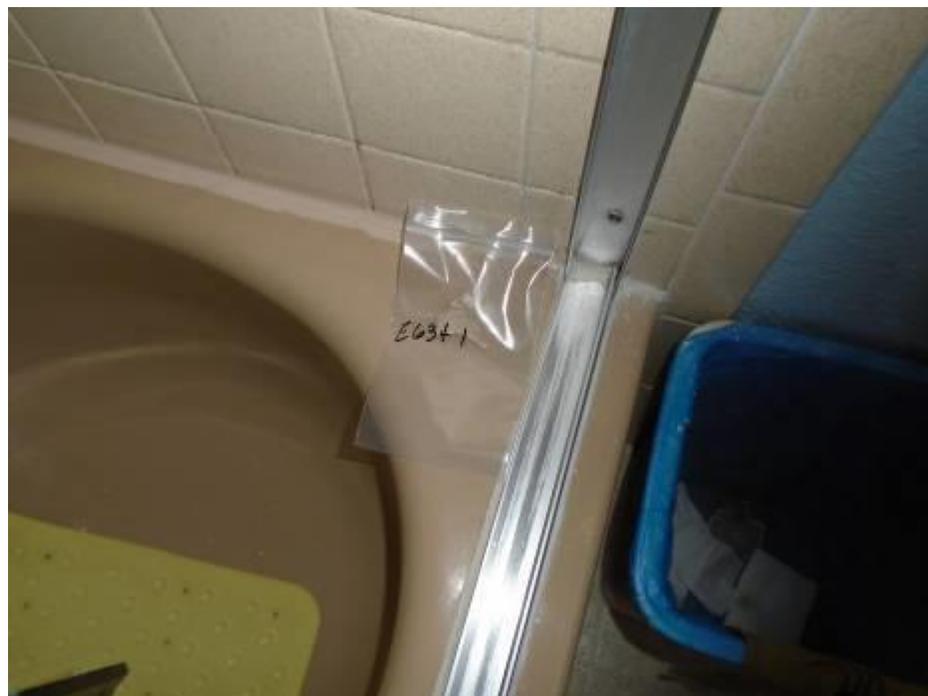
Sample E6341 of the white caulk painted beige is non-detect for asbestos

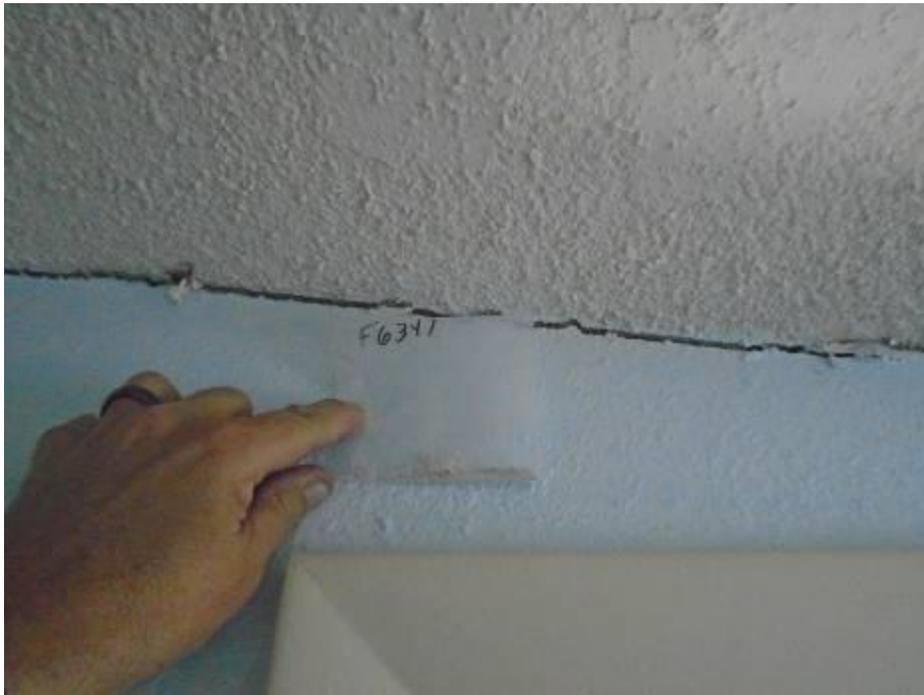
Sample F6341 of the white acoustic ceiling texture taken from the damaged wall/ceiling seam in the hallway contains 3% Chrysotile asbestos

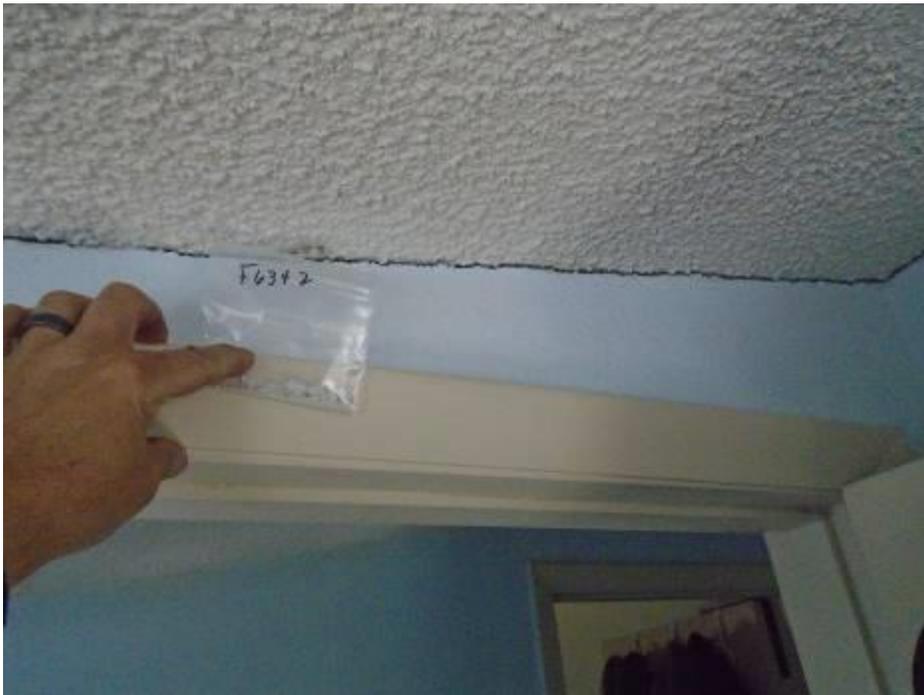
Sample F6342 of the acoustic texture material taken from the damaged wall/ceiling seam in the southwest bedroom(#2) contains 3% Chrysotile asbestos

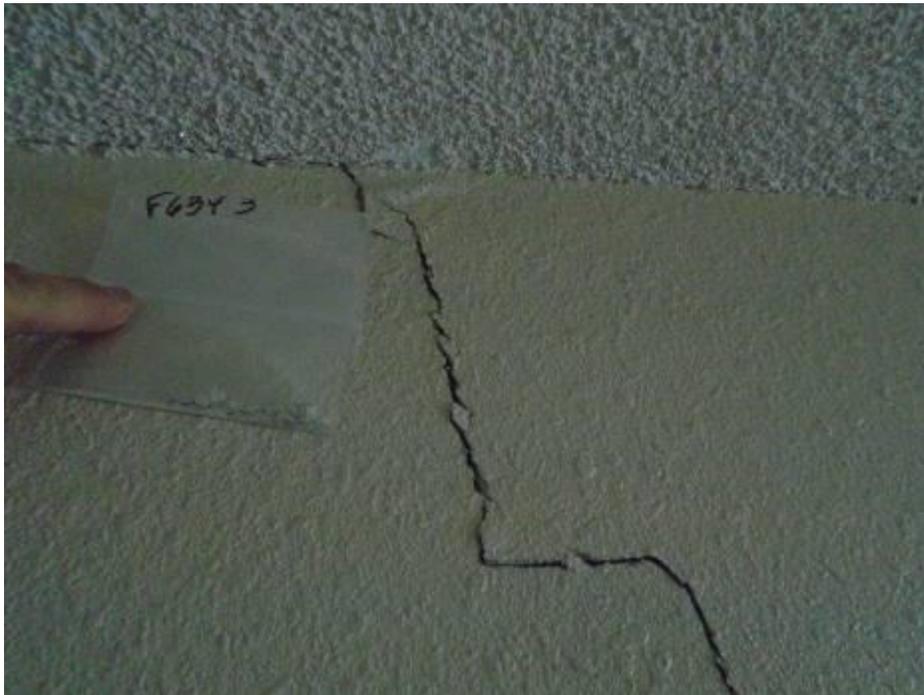
Sample F6343 of the acoustic texture material taken from the living room ceiling contains 3% Chrysotile asbestos

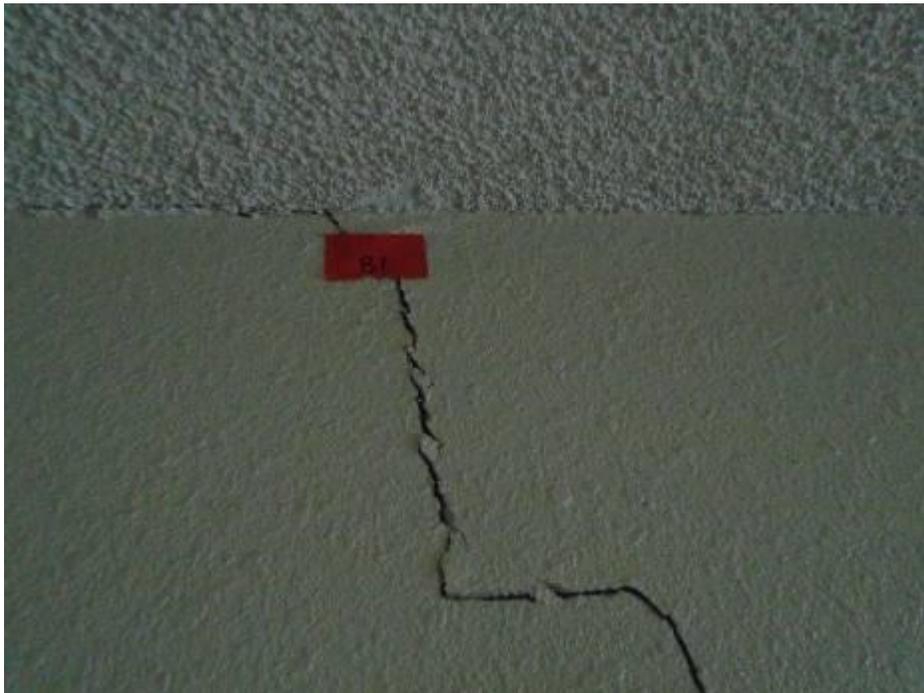
Sample B6341 of the orange peel texture material taken from the damaged east wall in the living room contains 3% Chrysotile asbestos

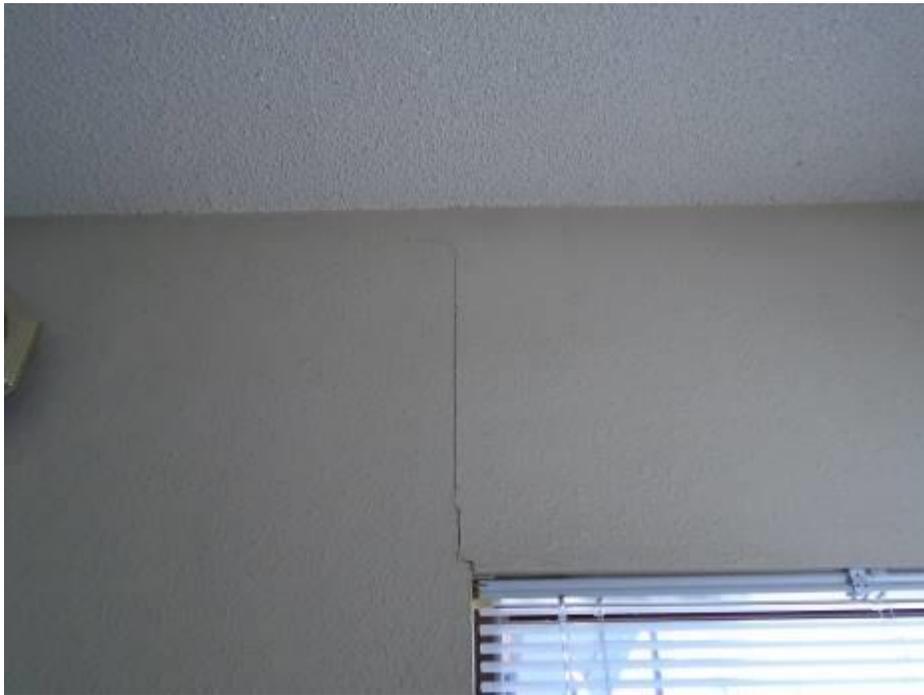
Additional view of vertical cracks found on the living room walls

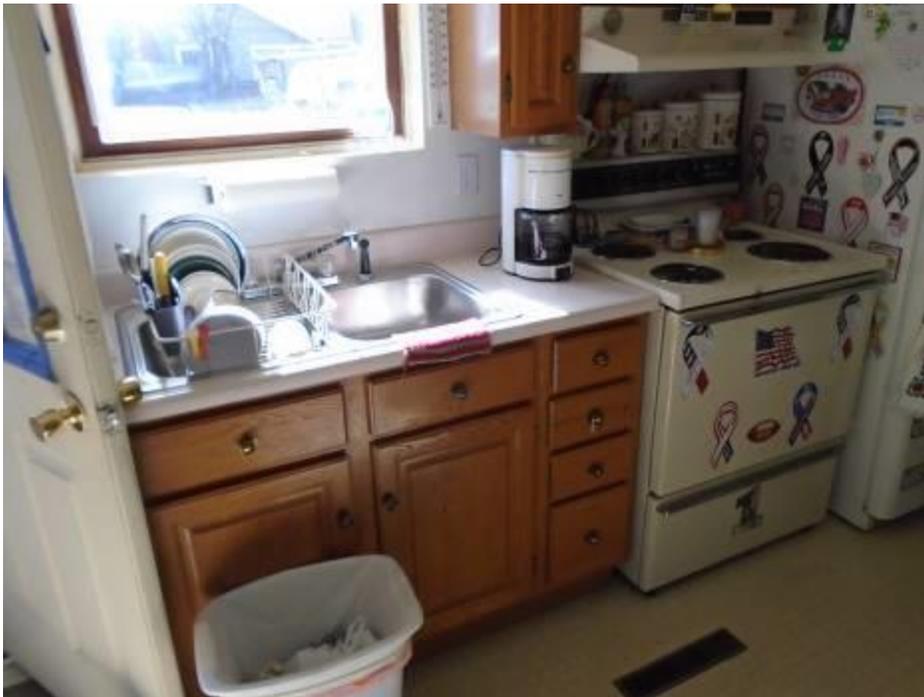
**View of kitchen base cabinet and counter top scheduled for replacement
walls have asbestos containing texture applied**
