LIMITED ASBESTOS BUILDING INSPECTION

1310 Wynkoop Dr
Colorado Springs, CO 80909

April 1, 2015

April 8, 2015

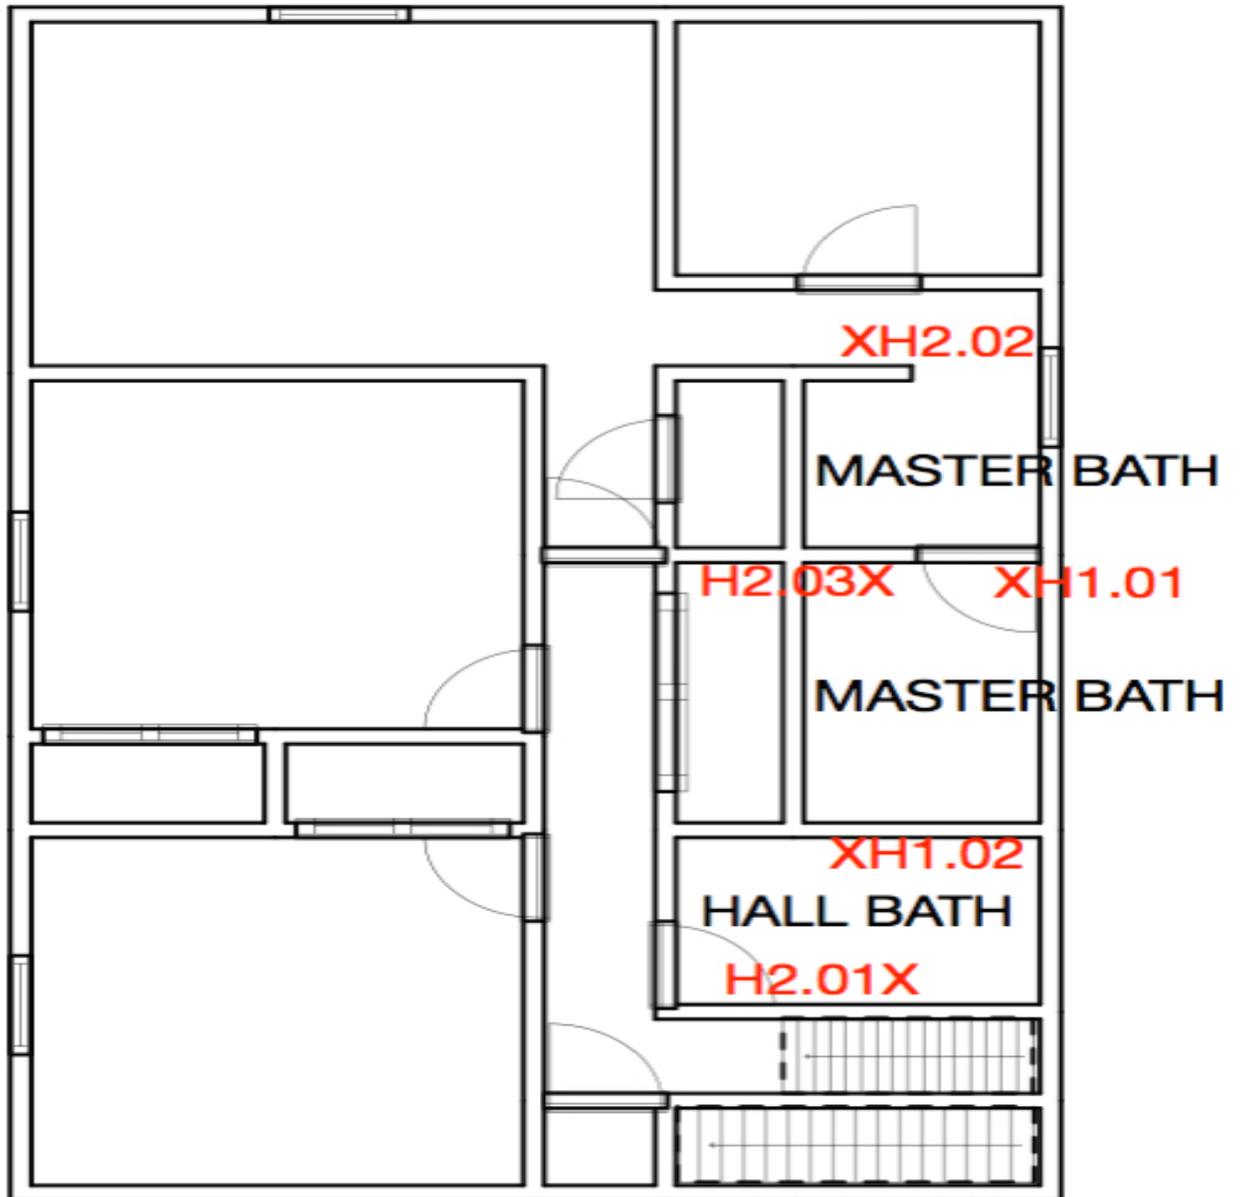
SECOND FLOOR

Bulk sampling conducted during this inspection identified that the joint compound in the master bathroom and upstairs hall bathroom of the property contains asbestos (2% Chrysotile).

Bulk sampling conducted during this inspection identified that the wall texture in the master bathroom and upstairs hall bathroom of the property contains asbestos (3% Chrysotile).

Please Note: CES recommends all renovation work impacting ACM in the building be

completed by an EPA certified and Colorado State licensed General Abatement Contractor (GAC).
