Renovation Specific Asbestos Survey Report

**4331 Deerfield Hills Rd
Colorado Springs, CO 80916**

**Anderson Property Inspections
Colorado Springs, CO**

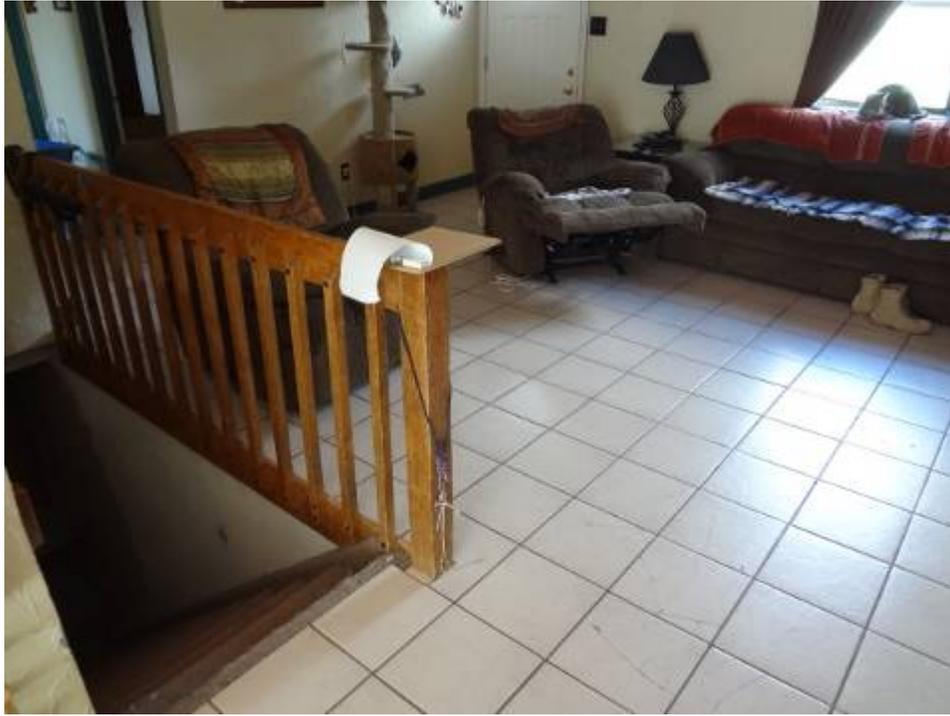
Living room overview approximate quantity of tile is 280 sqft which tested non-detect for asbestos

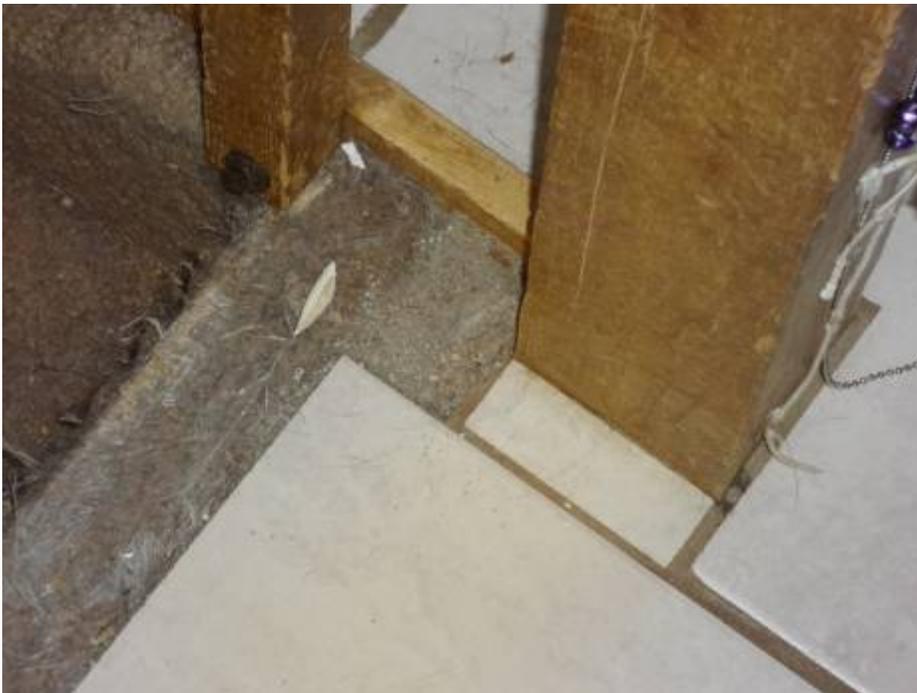
Sample of tile taken for corner post at stairs to lower level which is non-detect for asbestos

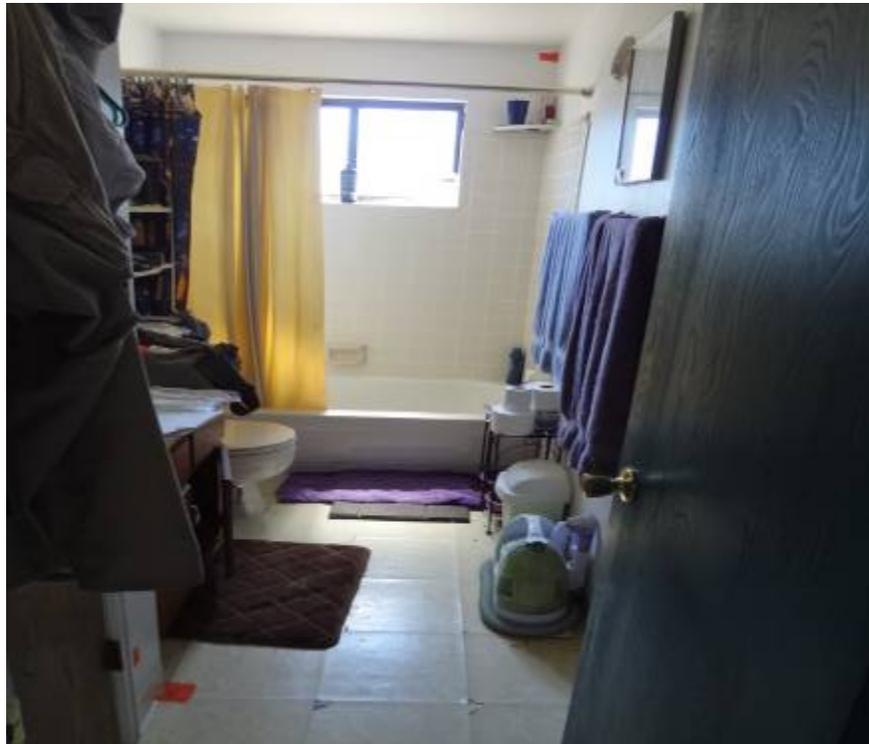
Bathroom overview all samples taken from this room are non-detect for asbestos

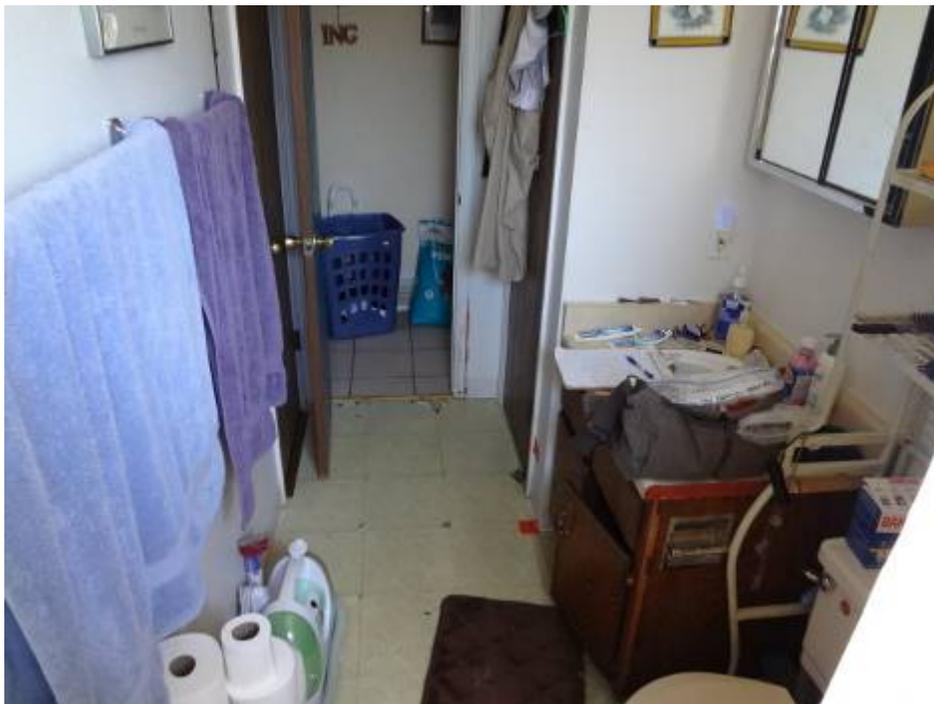
All samples of walls, flooring and mastics are non-detect for asbestos

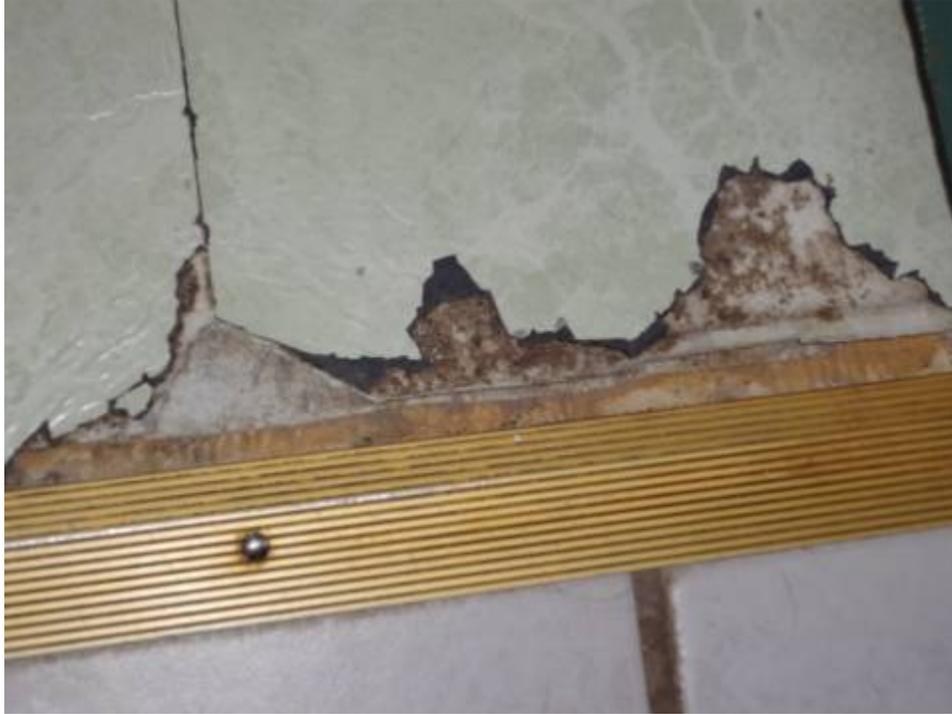
Bathroom floor has two layers both tested non-detect for asbestos

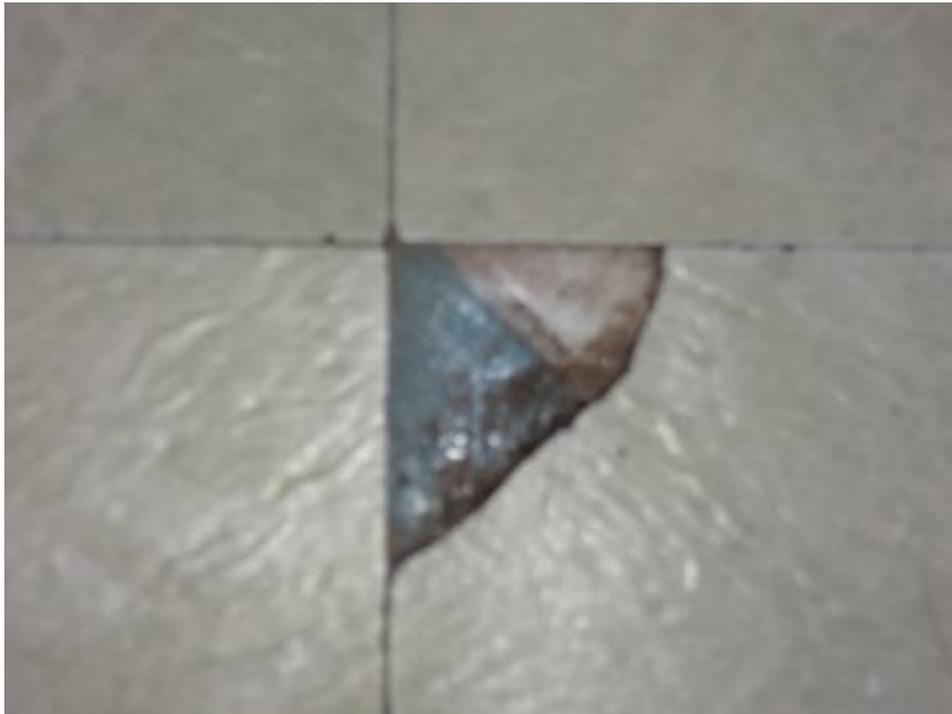
12" tile over blue and white SVF

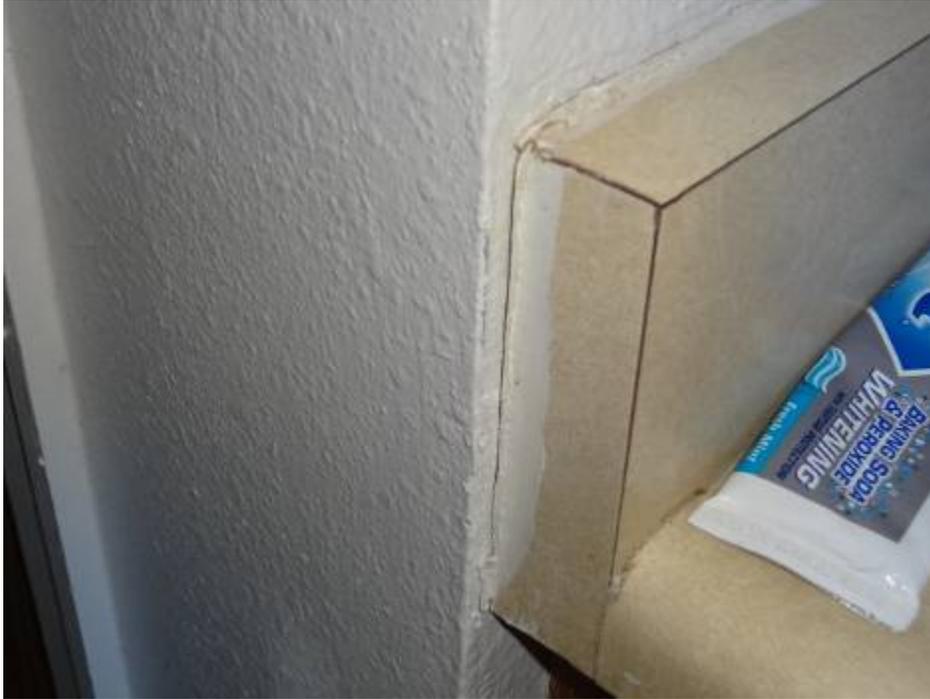
Sealant sample taken at counter top which tested non-detect for asbestos

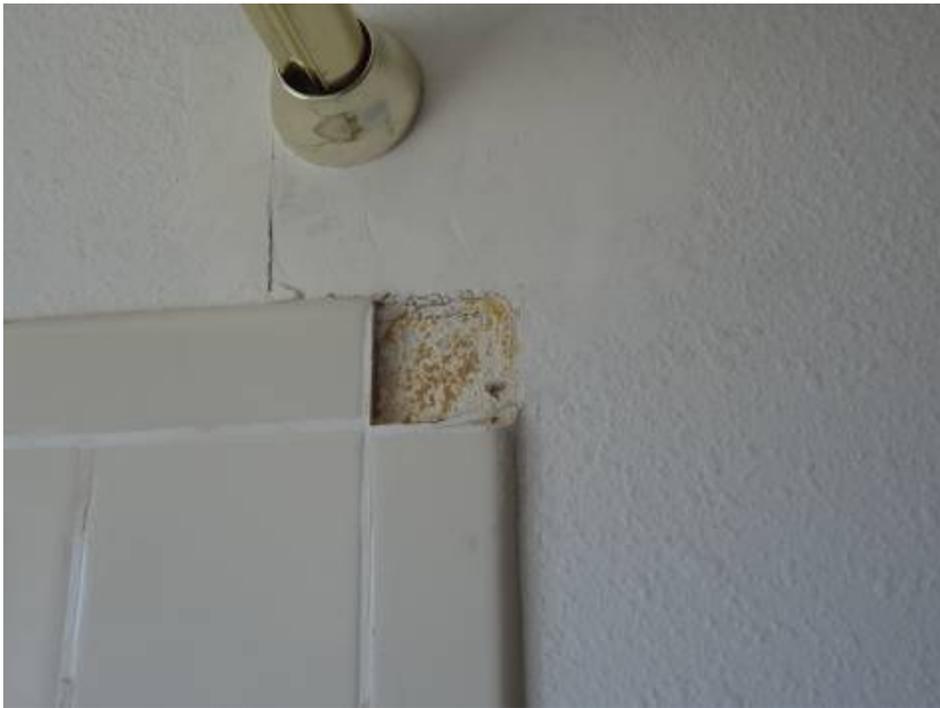
Tub surround sample tested non-detect for asbestos

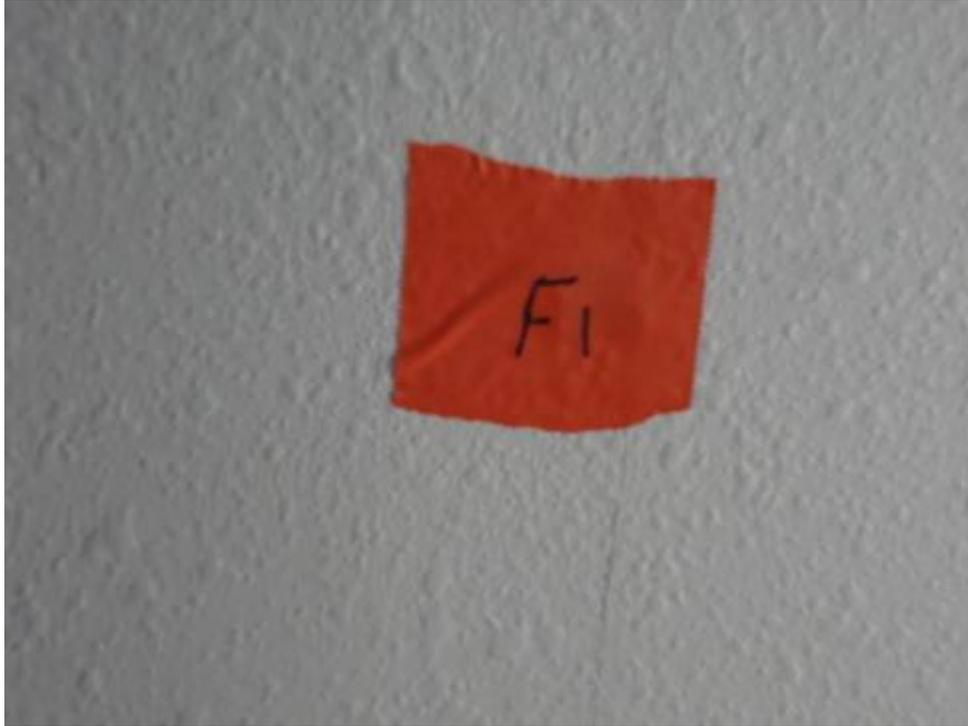
Sample F43311 taken at ceiling seam

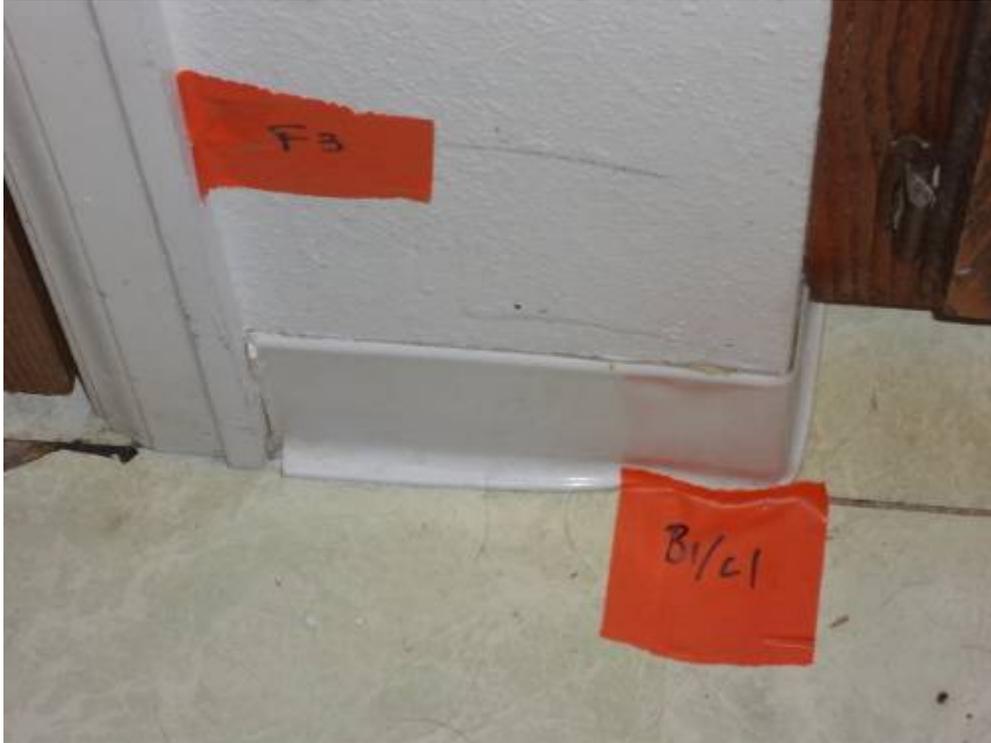
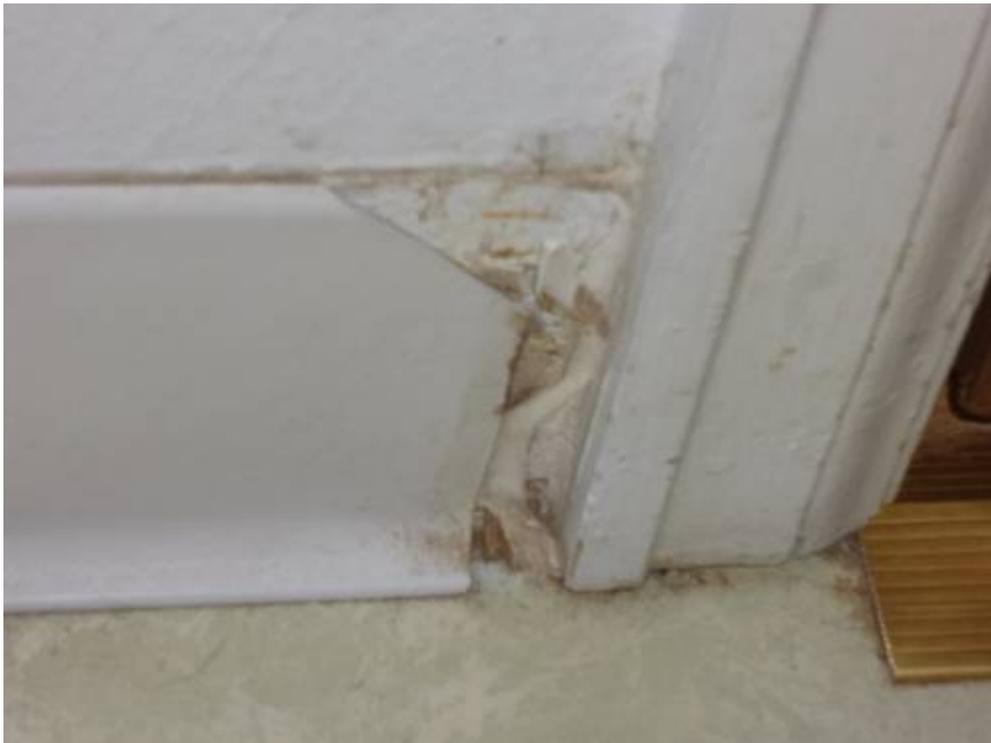
Base cove sample taken next to door to bedroom tested non-detect for asbestos
