Restoration Specific Asbestos and Lead Based Paint Survey Report

**16 W Mills St
Colorado Springs, CO 80903**

**Anderson Property Inspections
Colorado Springs, CO**

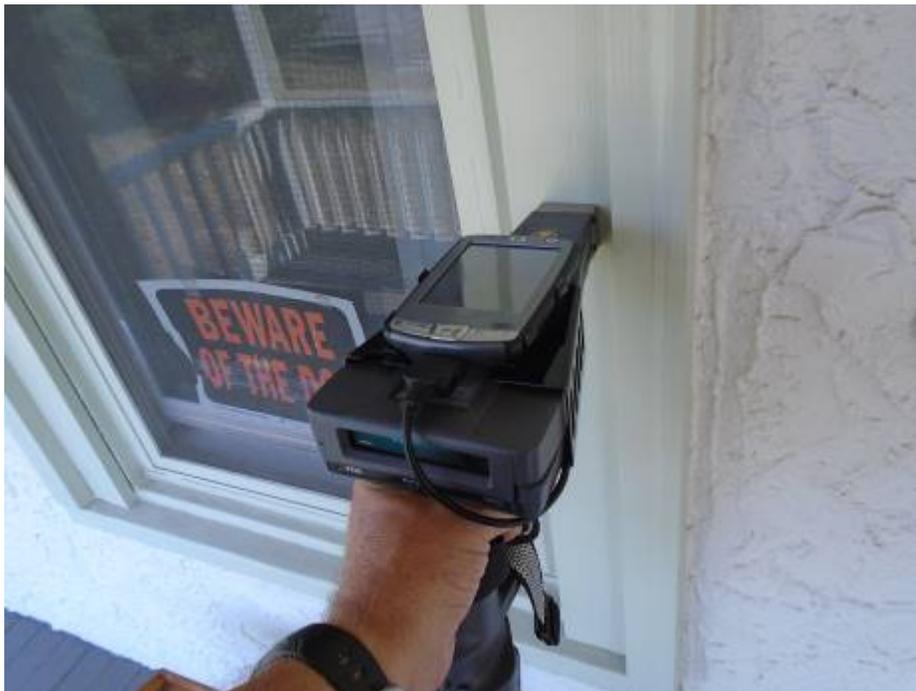
Front window trim did not test positive for lead based paint above the regulated trigger level of $(1.0\text{mg}/\text{cm}^2)$

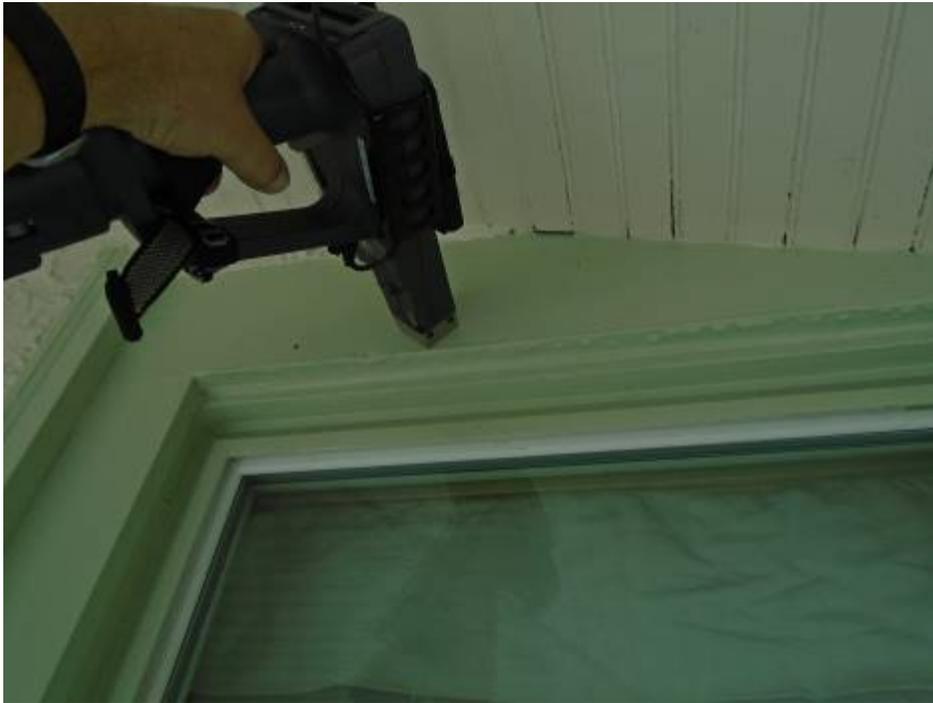
Front right window header did test positive for lead based paint above the regulated trigger level of (1.0mg/cm²)

The lead-based paint inspection did identify components with lead above the regulatory definition on building material slated for demolition as a result of this planned renovation. The components which were inventoried above that do contain lead based paint must be removed using proper protocols as defined by the [EPA's Regulations on Residential Property Renovation at 40 CFR 745.80, Subpart E.](#)

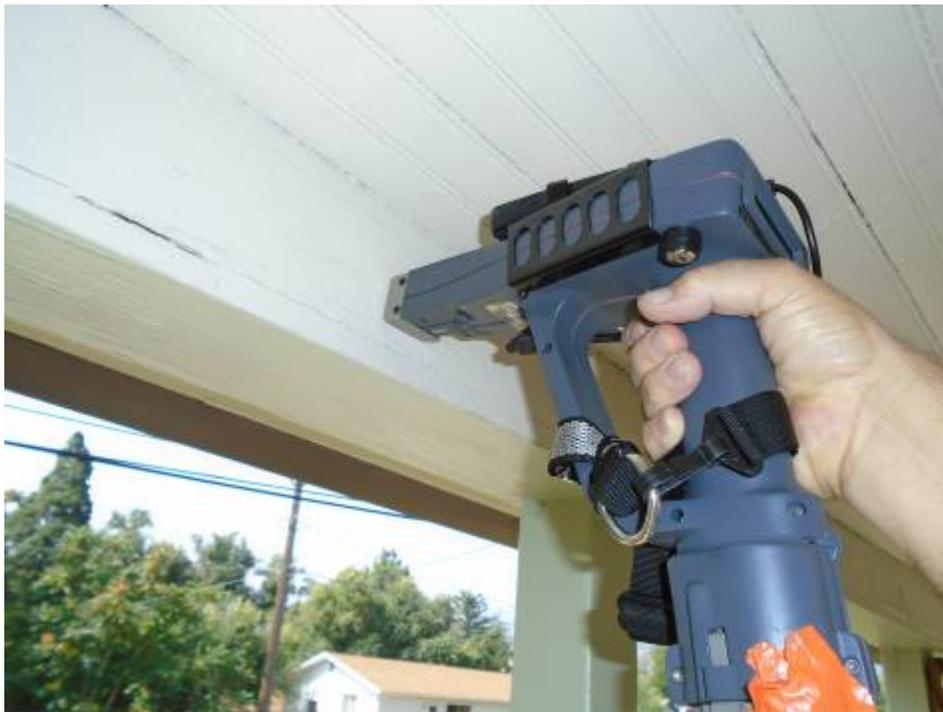
Front porch beam did test positive for lead based paint above the regulated trigger level of (1.0mg/cm²)

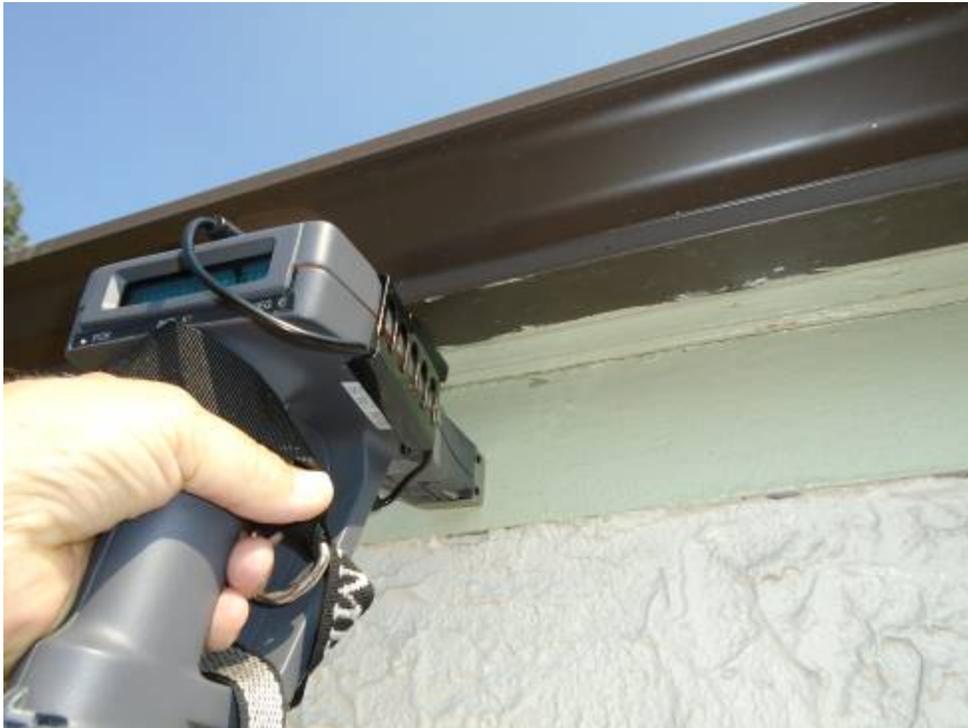
Fascia did test positive for lead based paint above the regulated trigger level of (1.0mg/cm²)

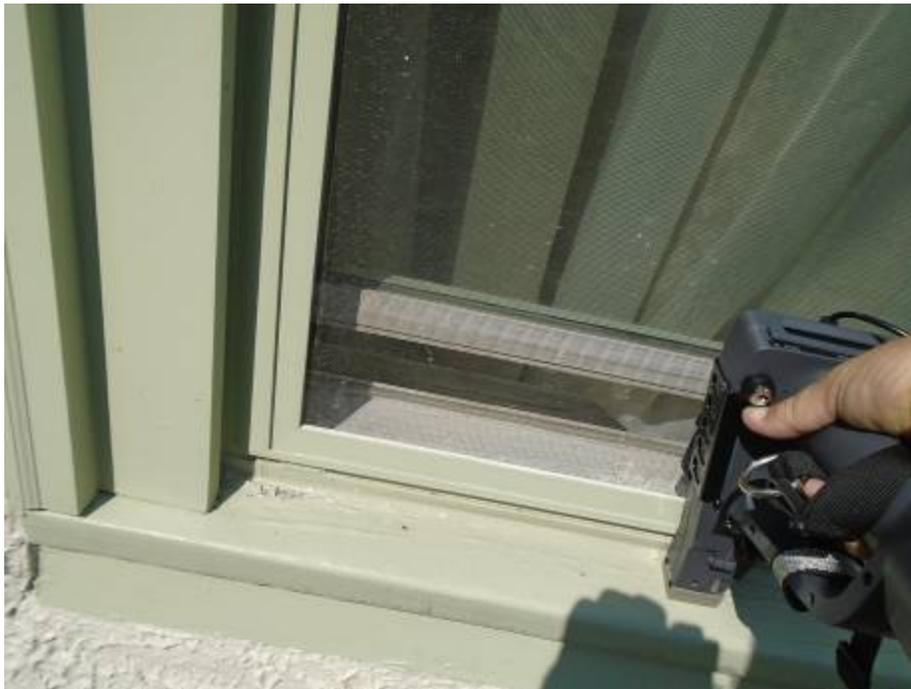
East elevation window sill did test positive for lead based paint above the regulated trigger level of (1.0mg/cm²)

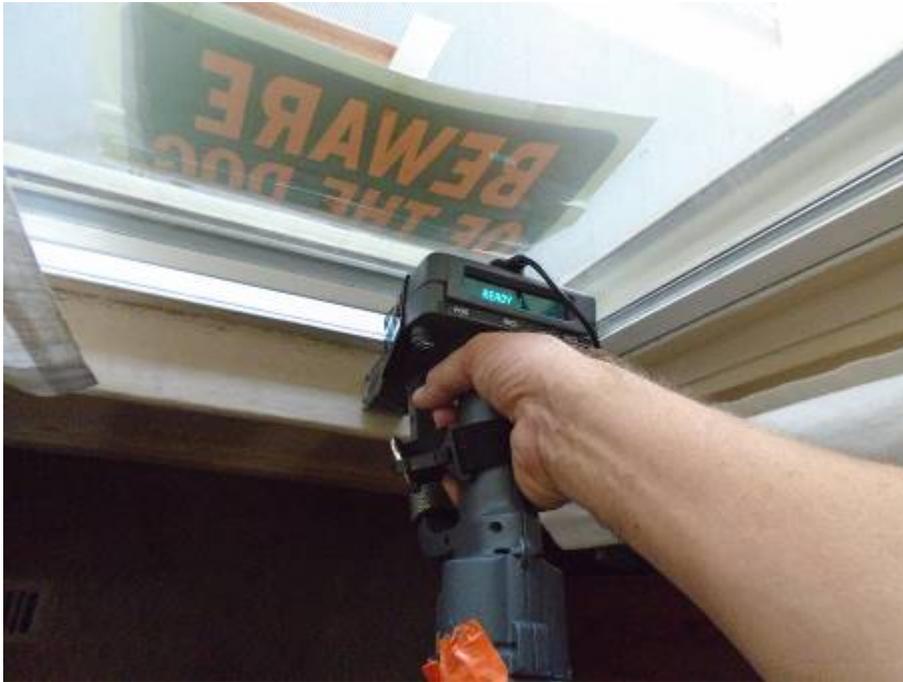
Front interior window sill did test positive for lead based paint above the regulated trigger level of (1.0mg/cm²)

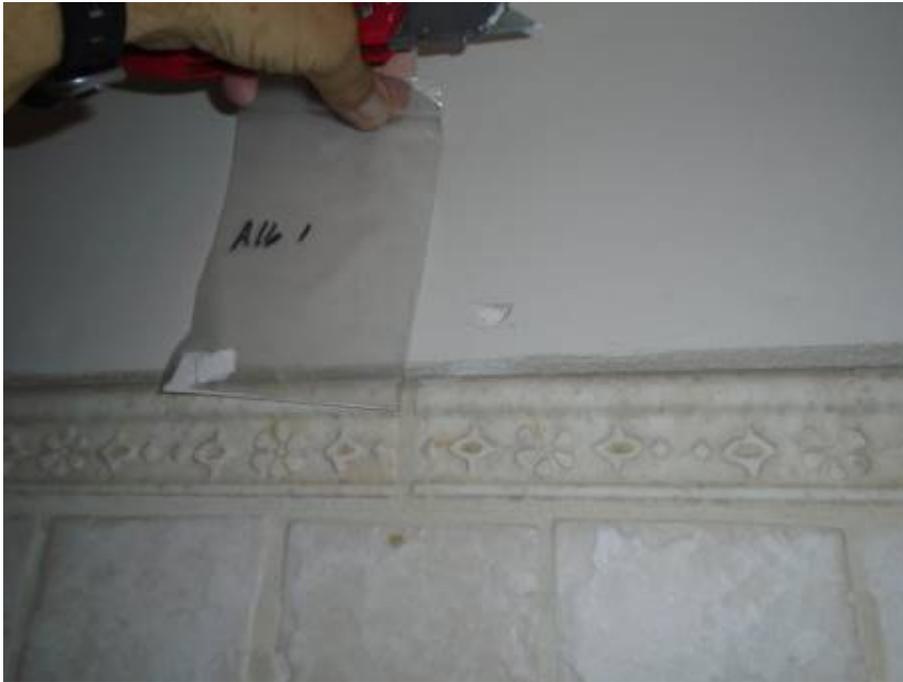
Sample A161 of the semi-smooth texture material found on the tub surround is non-detect

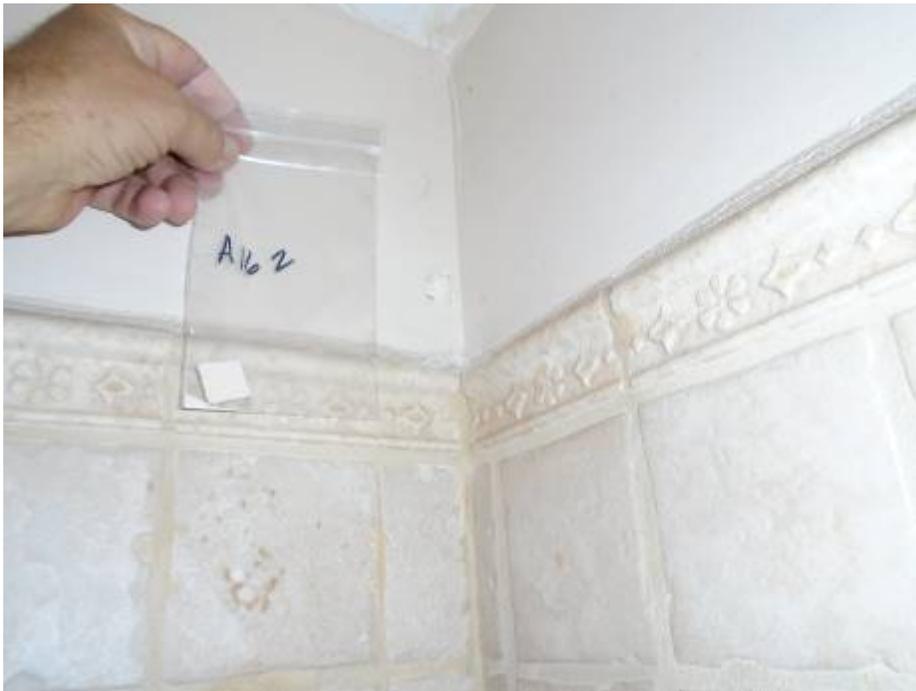
Sample A162 of the semi-smooth texture including yellow fibrous material and compound is non-detect

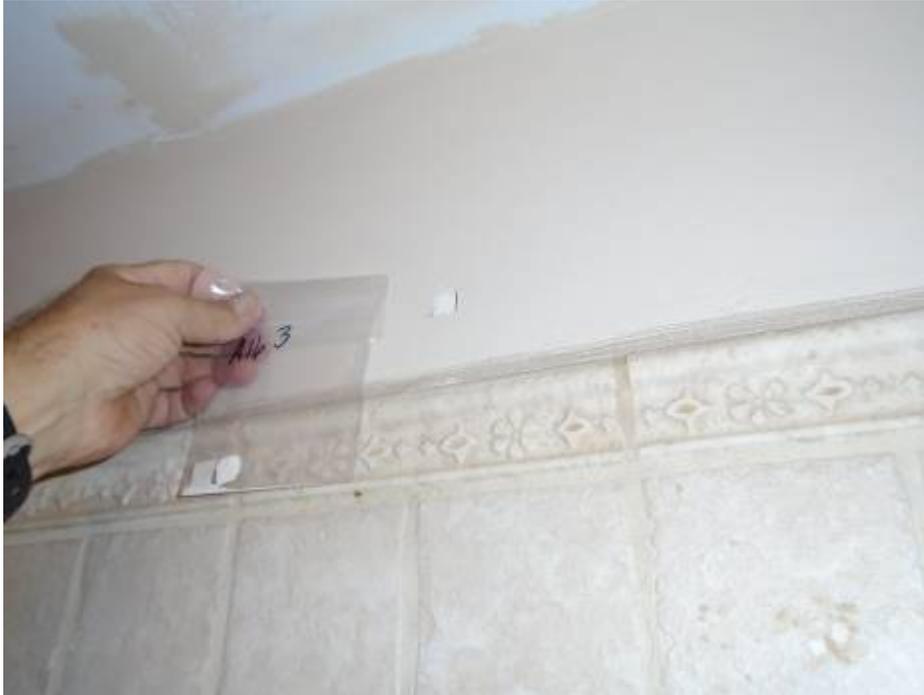
Sample A163 of the semi-smooth texture material taken from above the shower head is non-detect

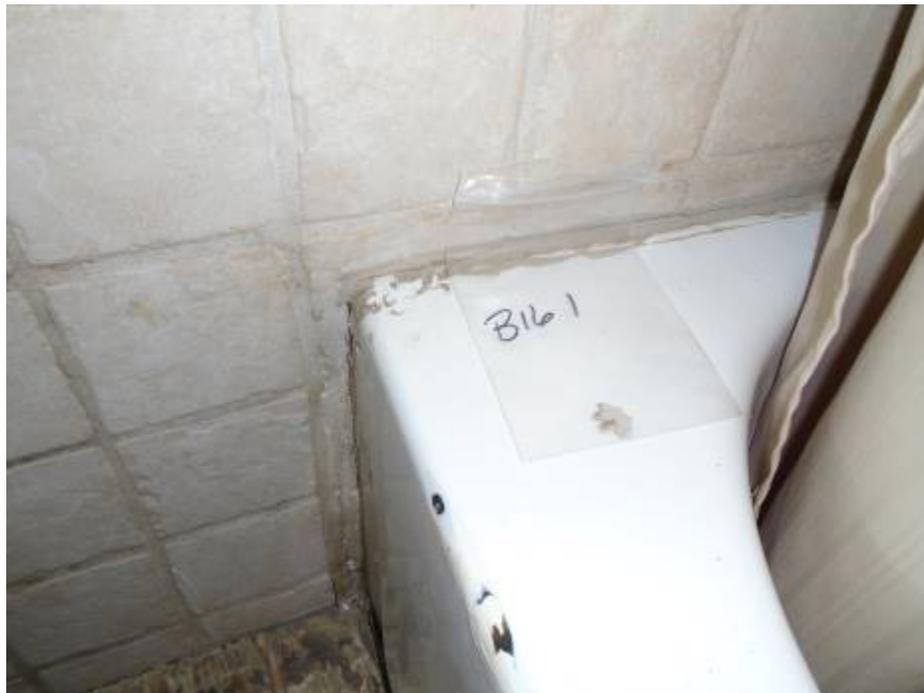
Sample B161 of the tan caulk found on the tub surround is non-detect

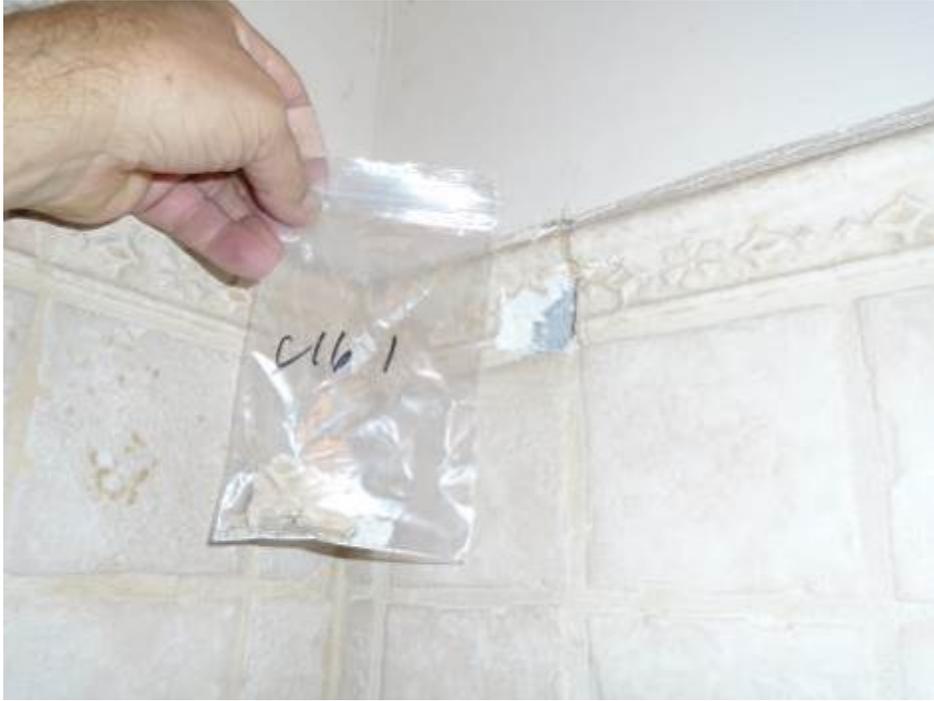
Sample C161 of the ceramic tile system found on the bath surround is non-detect for asbestos
