## **Renovation Specific Asbestos Survey Report**

**2235 Bruno Cir  
Colorado Springs, CO 80916**

**Anderson Property Inspections  
Colorado Springs, CO**

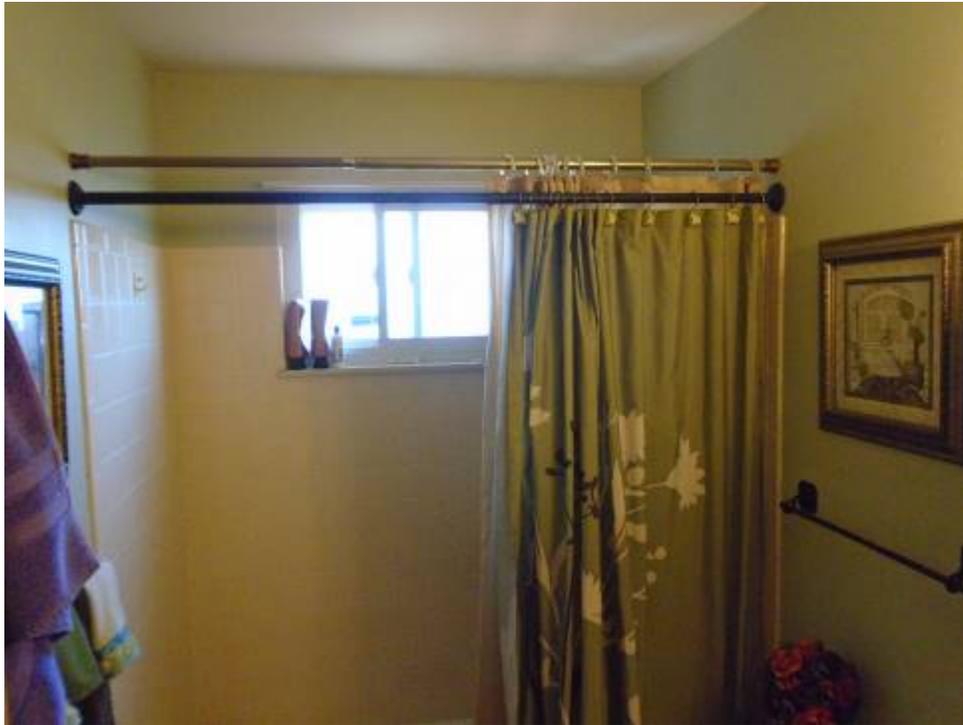
**View of the upper level bathroom**

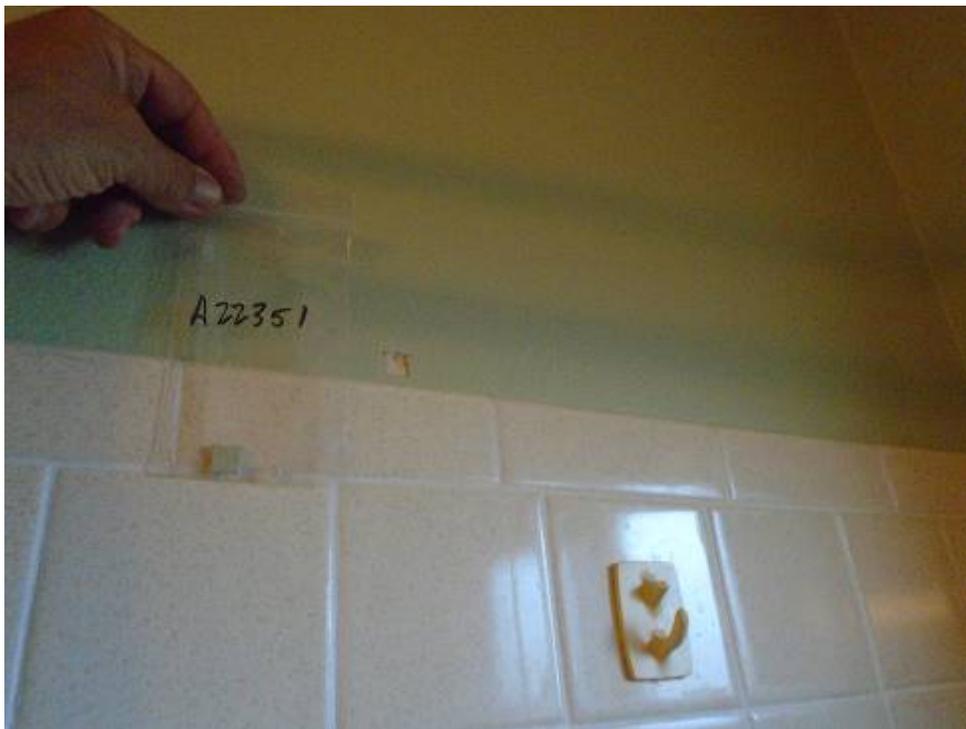
**The homogeneous orange peel texture found in both bathrooms is non-detect.  
Sample A22351 was taken from the upper level bathroom**

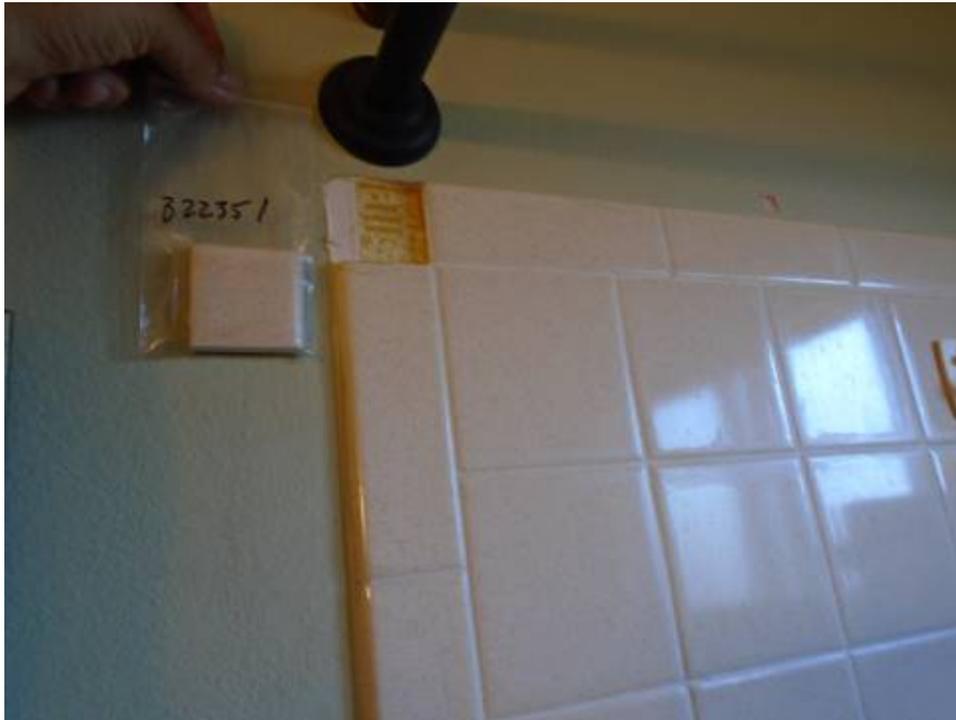
**Sample B2235 of the ceramic tile, grout and adhesive found in the upper level tub surround is non-detect for asbestos**

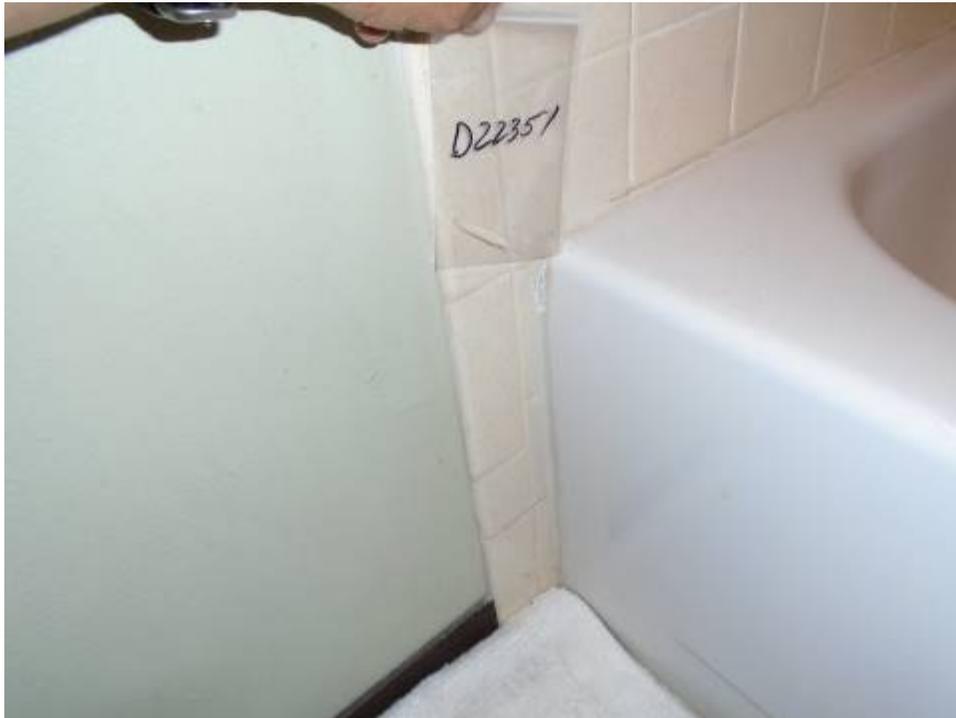
**Sample D22351 of the white sealant/caulk found on both tub surrounds is non-detect for asbestos**

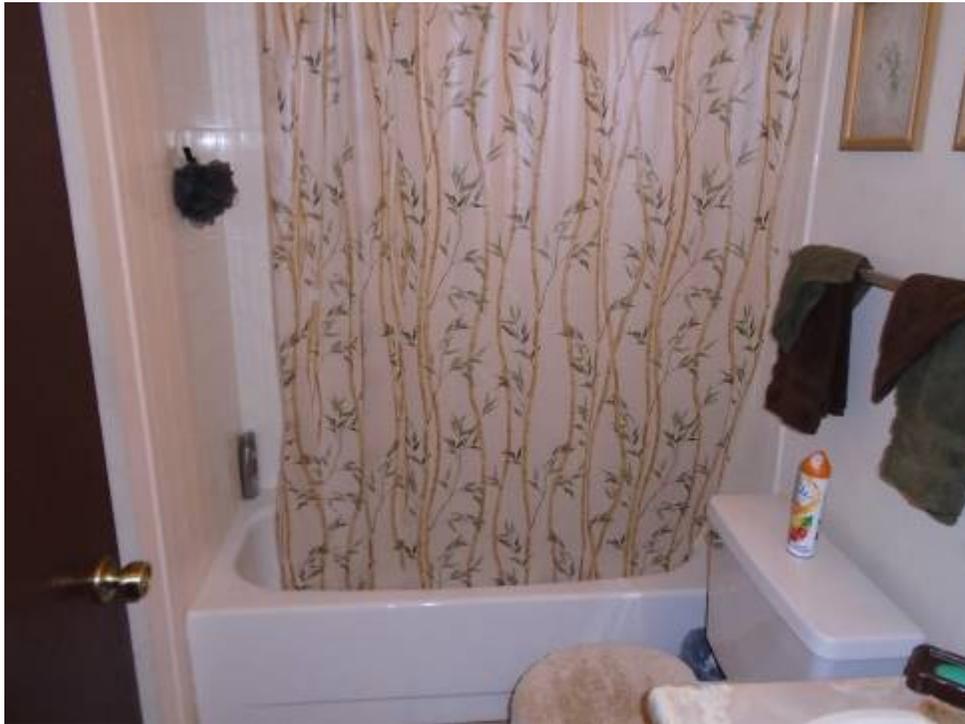
**View of the lower level bathroom all materials examined are non-detect for asbestos**

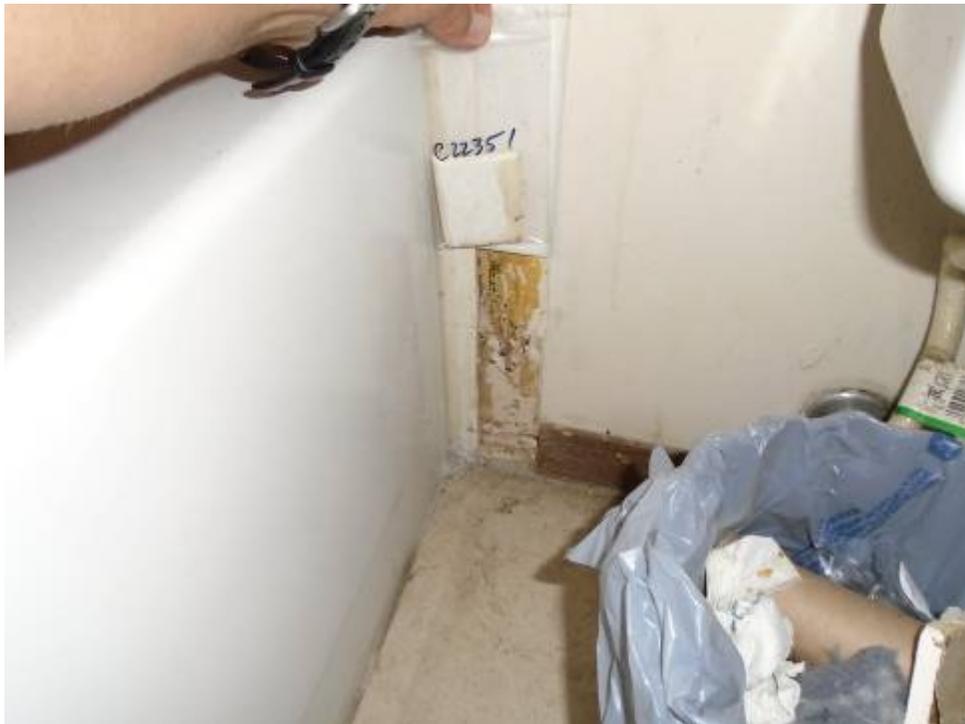
**Sample C22351 of the white/multi-colored ceramic tile, grout and adhesive is non-detect for asbestos**

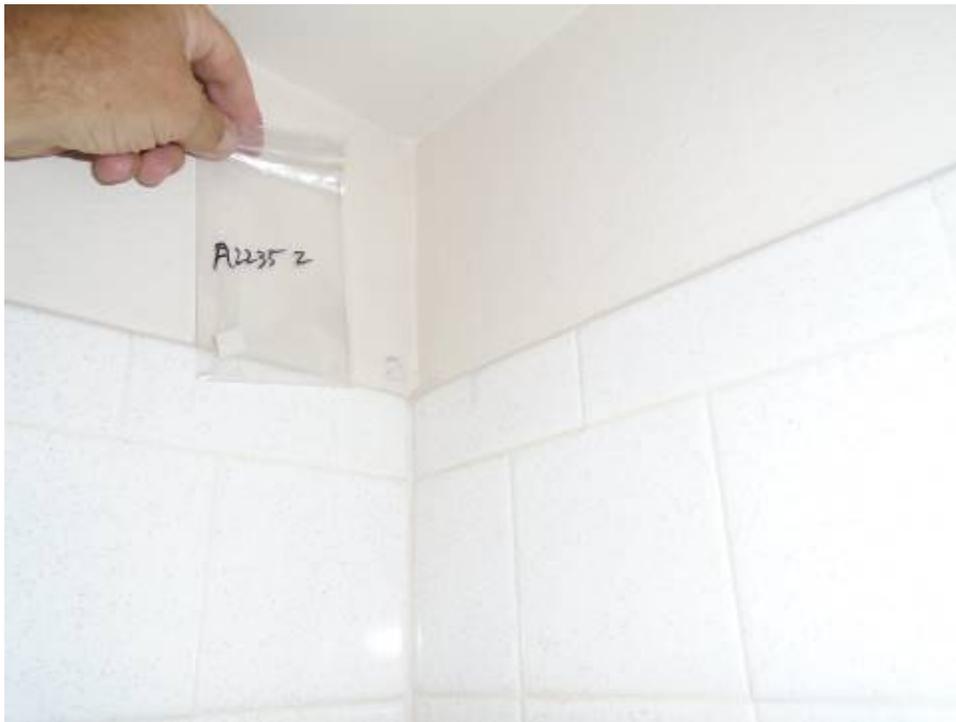
**Sample A22352 of the orange peel texture material including joint compound and tape taken from the lower level bathroom is non-detect for asbestos**

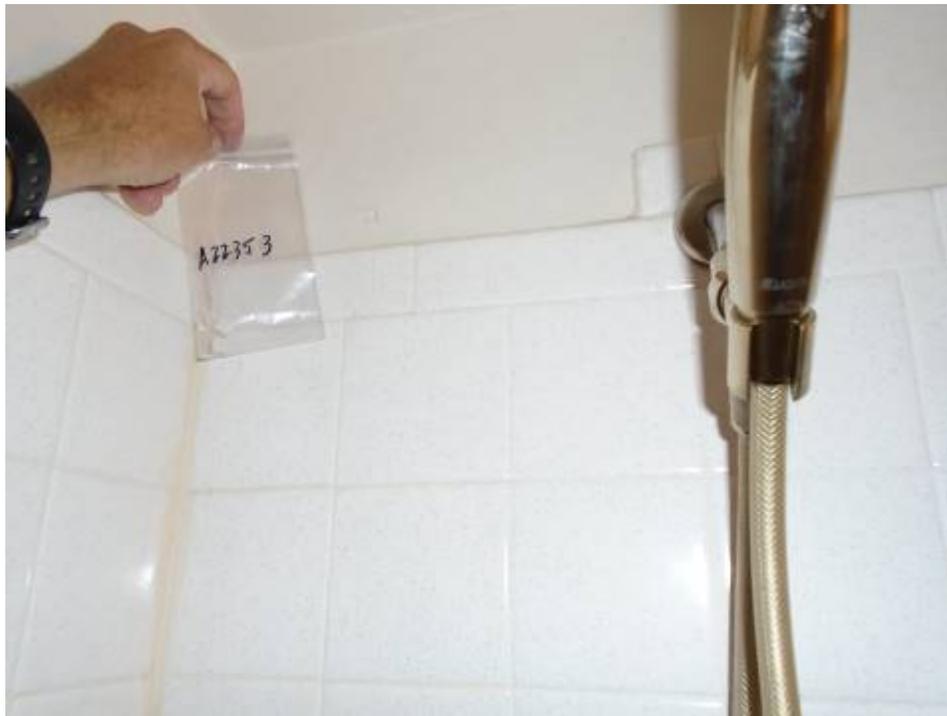
**Sample A22353 of the orange peel texture material taken from the lower level bathroom is non-detect for asbestos**
