Site Accessibility Evaluation

CSPD Impound Lot

Accessibility Evaluation

Inspection Date: 08/01/2018
Inspector: Michael Killebrew

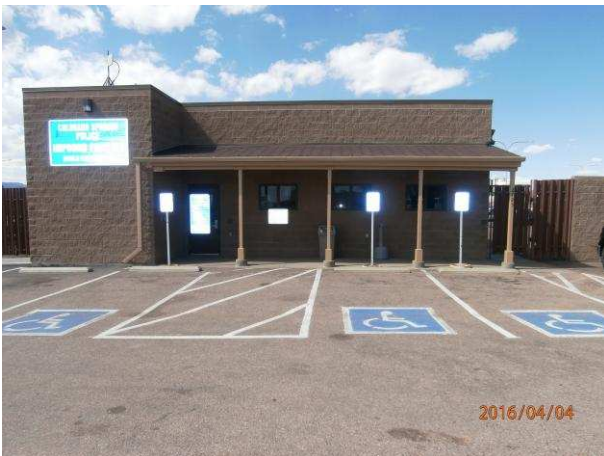
The accessible parking stall is not wide enough.

Accessible parking space on the right is 7'6"

Re-stripe parking space.

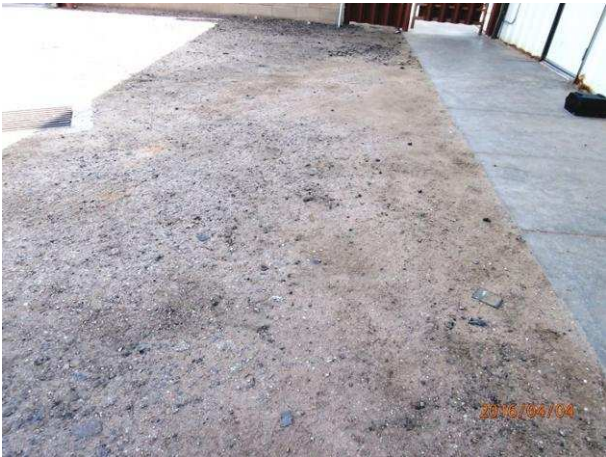
Finding 182926 Main Photo

The accessible route contains loose gravel and/or surfaces that do not provide for a stable, firm slip resistant surface.

Pick-up area surface
not firm, stable, or
slip resistant.

Pave concrete pad adjacent to walkway to allow ample space for pick-up.

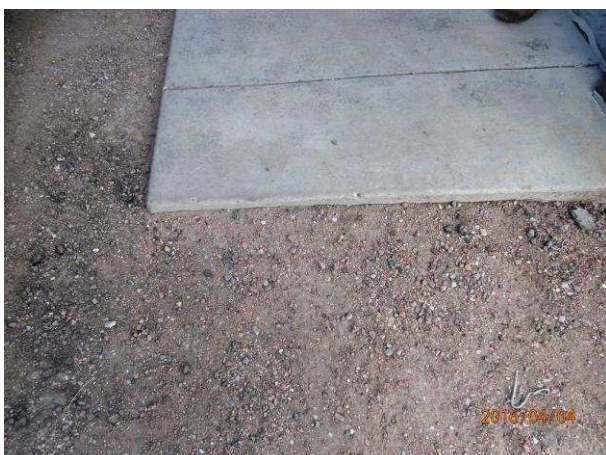
The walkway contains abrupt vertical edges and/or variations over a 1/4 inch.

There are areas of vertical displacement up to 2" where the concrete meets the loose fill

Connect the sidewalk to the future concrete pad where customers will pick up vehicles

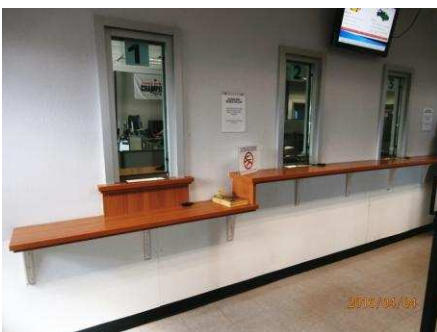
Finding 182927 Main Photo

The transaction counter is too high.

Customer service access 42" above floor grade.

Lower security window 6-8". The reach range is OK and the line of sight is marginally alright.

Until counter is corrected, staff must be ready, willing, and able to provide service at an alternate, accessible location.

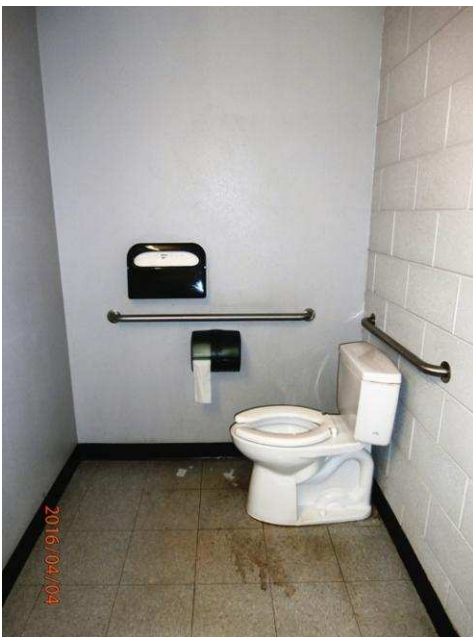
Finding 182929 Main Photo

The flush handle is located on the wrong side of the toilet.

Flush is on the closed side.

Move the flush to open side (this will require obtaining another tank).

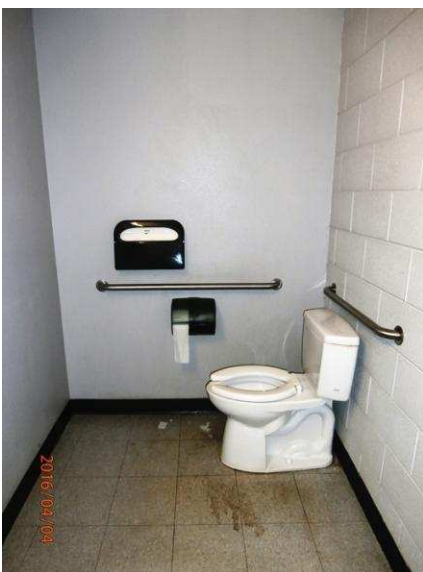
Finding 182930 Main Photo

The grab bar is not spaced correctly to the wall or other elements.

Toilet seat covers are only 3.5" above the bar.

Move the toilet seat covers to 1.5" below the grab bar.
