Site Accessibility Evaluation

Black Forest Park & Ride PU18-0082

Transit Stops

SUBJECT: Black Forest Park & Ride Self-Evaluation

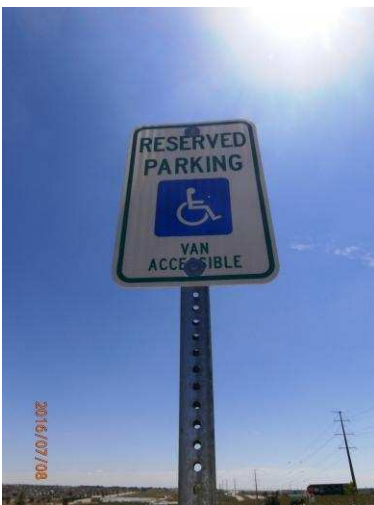
Finding: 1

The van stall is missing a separate sign identifying it as a van accessible stall.

2010 ADAS Section: 502.6

There is not a separate van accessible parking sign as required by City Code 7.4.205 C 3 F

Image of noncompliant signage at accessible parking

Install a separate van accessible parking sign under the accessible parking sign as required by City Code 7.4.205 C 3 F

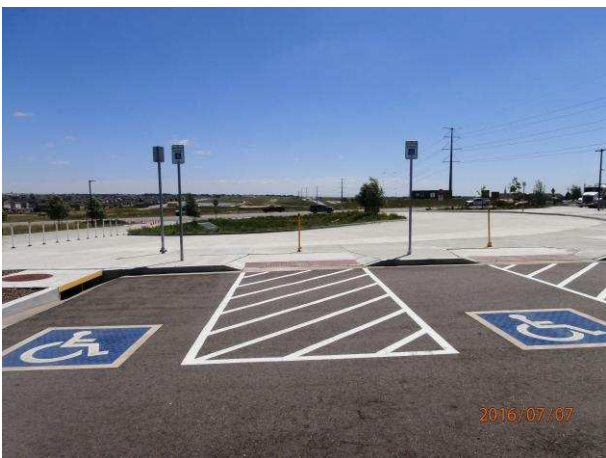
Finding: 2

There are not enough accessible stalls

There are 209 regular parking spaces and 6 accessible parking spaces. All of the accessible spaces are wide enough to qualify as van accessible. Based on 215 total parking spaces, 7 are required to be accessible, 2 of which are required to be van accessible.

There are not enough accessible parking stalls.

Image of accessible parking

Restripe the parking and access aisles. If the parking spaces are reduced to 8'-0" wide, and all but one of the access aisles are reduced to 5'-0", there may be enough space to add another accessible parking space. However, the curb ramps may not line up with the new access aisles.

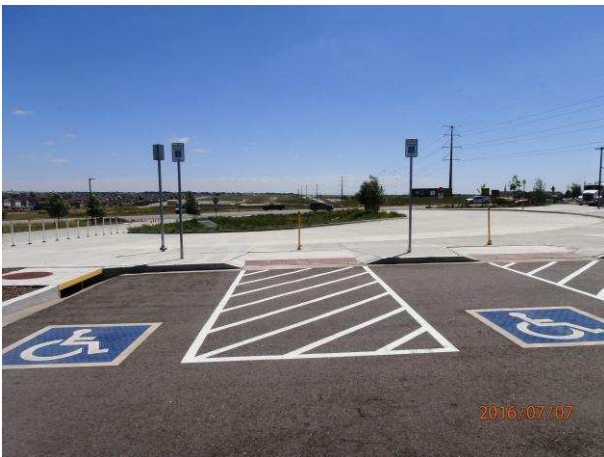
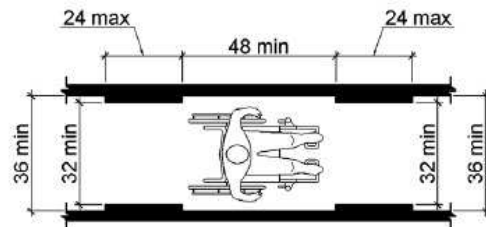
Finding: 3

The walking surface is obstructed. A 36" minimum clear walking surface is required. Many of these bollards have now fallen down into the ramp area which blocks more of the accessible route on the ramp face.

The level landing is not clear for at least 36".

Image of obstructed curb ramp landing

Move the bollard to provide at least 36" width.

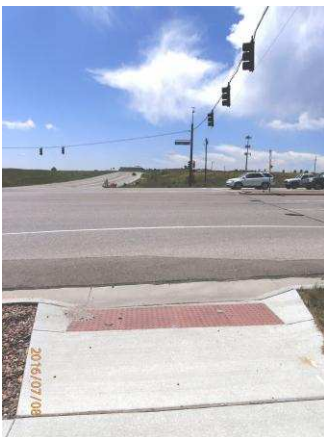
Finding: 4

There is no pedestrian access route at the street crossing.

There are not receiver curb ramps on the opposite sides of Woodmen and Black Forest.

Image of lack of connecting curb ramp

Install curb ramps and level landings on the opposite sides of the street to provide a safe refuge area for pedestrians. There is development in progress on the south side of the street. If nothing is planned then maybe better to take this ramp out.

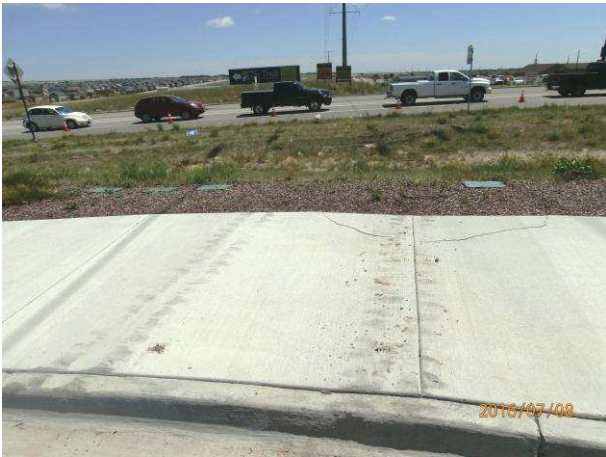
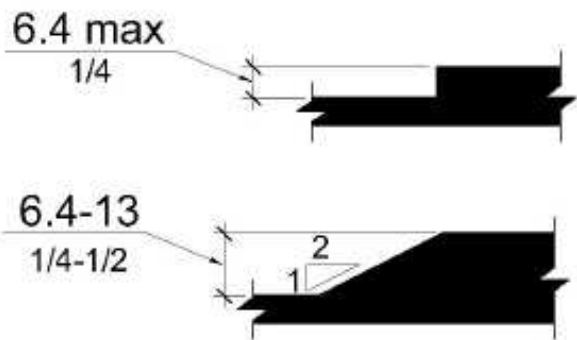
Finding: 5

The sidewalk damaged by vehicle.

The new sidewalk is fractured.

Image of fractured sidewalk

Replace the two panels.
