Site Accessibility Evaluation

**Citadel Transfer Station
PU18-0081**

**780 Citadel Dr W
East Colorado Springs, CO
80909**

SUBJECT: Citadel Transfer Station Self-Evaluation

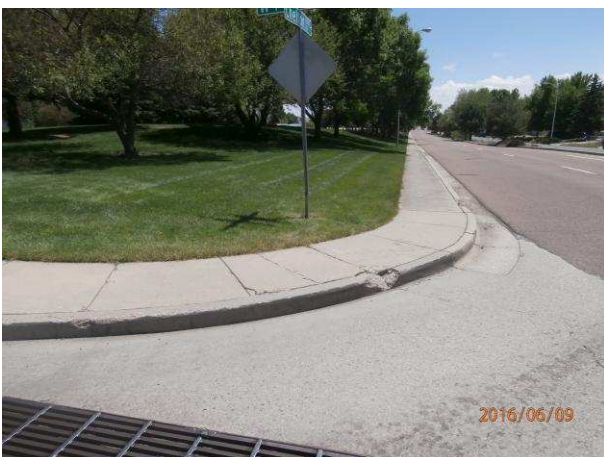
Finding: 1

There is no accessible route of travel from the public way. This is a primary entrance point to the Transfer Station.

There is not a connecting ramp at Chelton and W. Portal.

1 (High): Should be completed immediately. (Includes findings that have little or no cost, were in violation of the codes at the time of construction, or pose an imminent safety threat)

Image of curb head without curb ramp

Install a curb ramp at this corner.

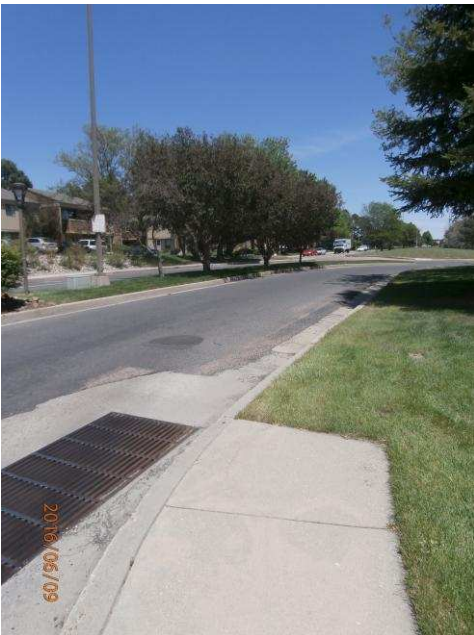
Finding: 2

There is no accessible route of travel from the public way.

The sidewalk abruptly ends near Chelton Rd and W. Portal.

Image of sidewalk abruptly ending

Probably nothing at this time. Consider sidewalk construction.

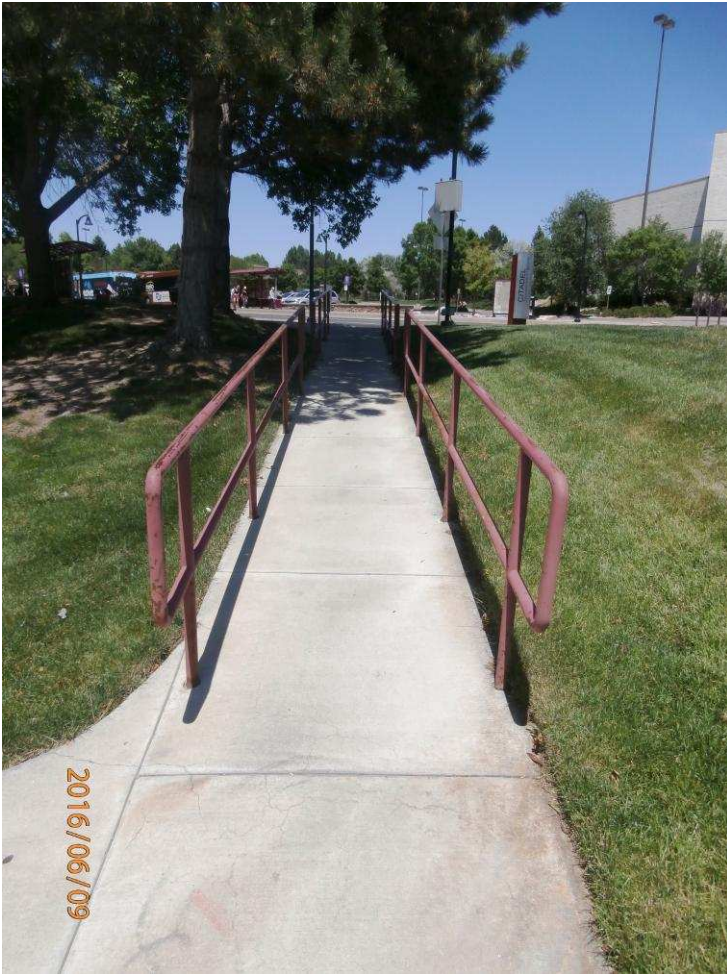
Finding #3 Continued

There are multiple issues with the ramp, including:

There is no edge protection at the edges of the ramp.

The bottom landing of the ramp has 4.5% cross slope.

The middle level landing has 3.3% running slope.

The handrails do not extend the required distances beyond the top and bottom of the ramp. The handrail at the top of the ramp is not anchored, and the vertical supports lift out of the hole.

There are multiple issues with the ramp from the sidewalk on Chelton Rd.

Image of noncompliant ramp

Add a bottom rail that restricts the opening at the bottom of the handrail to 4" maximum.

Remove and replace the bottom landing to provide maximum 2% cross slope.

Replace the middle landing and one of the ramp runs to provide the allowable running slope.

Extend the handrails the proper distances at the top and bottom of the ramp.

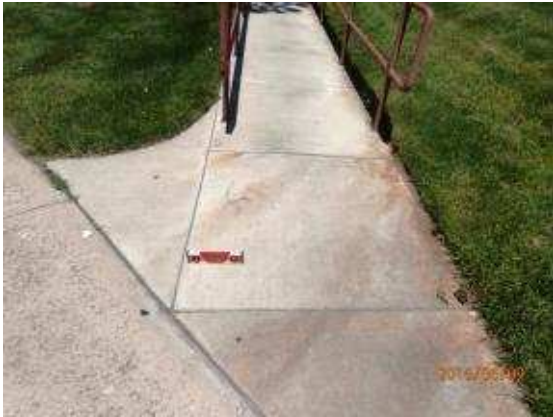
Finding #3 Additional Finding Photos

Additional image of noncompliant ramp

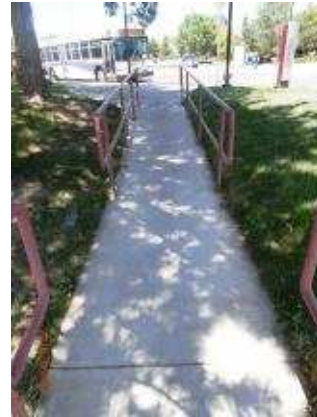
Additional image of noncompliant ramp

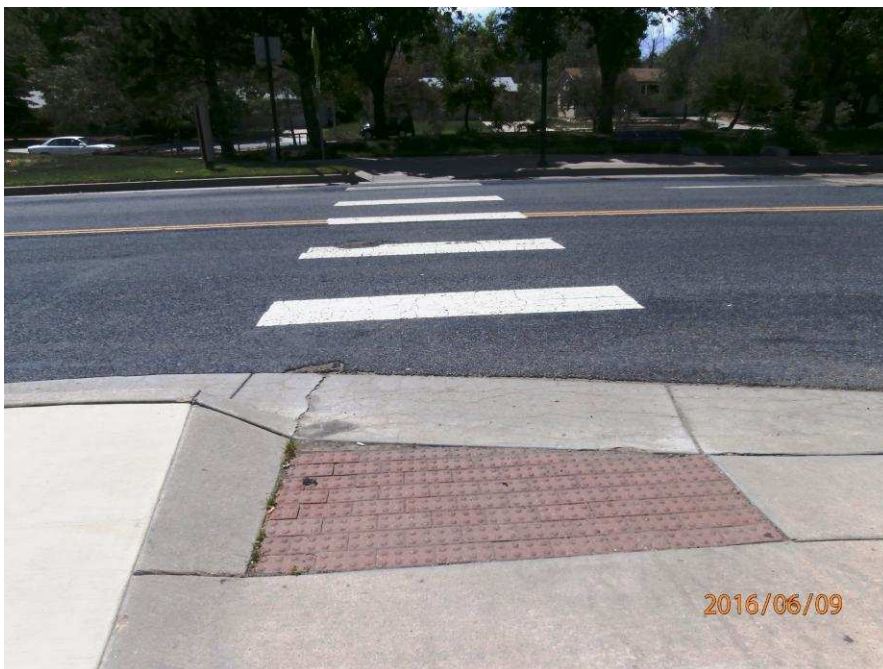
Finding: 4

There are multiple issues with this curb ramp including:

The brick paver detectable warnings are sinking, causing up to 1/2" vertical displacement.

The side flare closest to the bike rack has a 24% slope.

There are multiple issues with this curb ramp by the bike rack along Citadel Dr W.

Image of noncompliant curb ramp

Remove and replace the curb ramp.

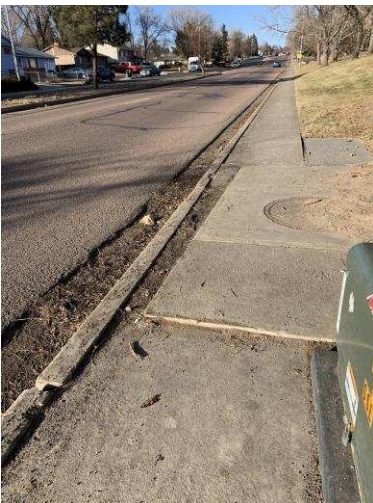
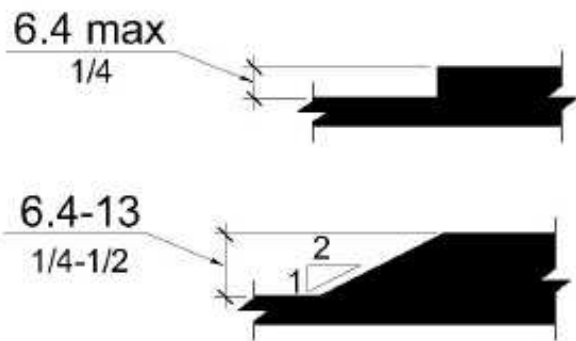
Finding: 5

The surface of the pedestrian access route has vertical discontinuities greater than 1/2 inch or between 1/4 inch and 1/2 inch that are not beveled.

There is 1-1/2" vertical displacement in the sidewalk at the storm inlet.

Remove and replace the sidewalk panels around the storm inlet.

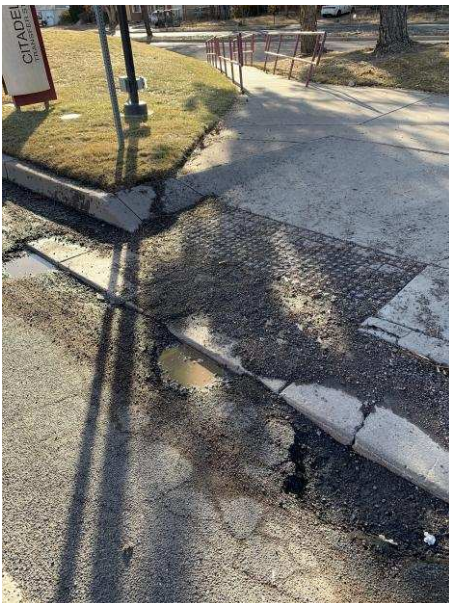
Finding: 6

The surface of the pedestrian access route is not firm, stable and slip resistant. In addition, the asphalt at the base of the curb ramp is deteriorated, with a hole 2" deep by 16" by 12".

There is considerable debris build up in the curb ramp at Citadel Dr W.

Remove and replace the asphalt at the base of the curb ramp. Keep the curb ramp clear of debris.

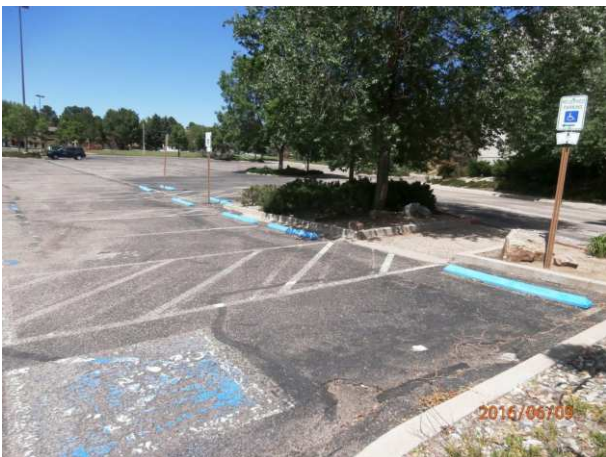
Finding: 7

The required parking signage is missing.

Accessible parking signage is missing on two of the accessible parking spaces.

Image of accessible parking spaces without signage

Install accessible parking signage.

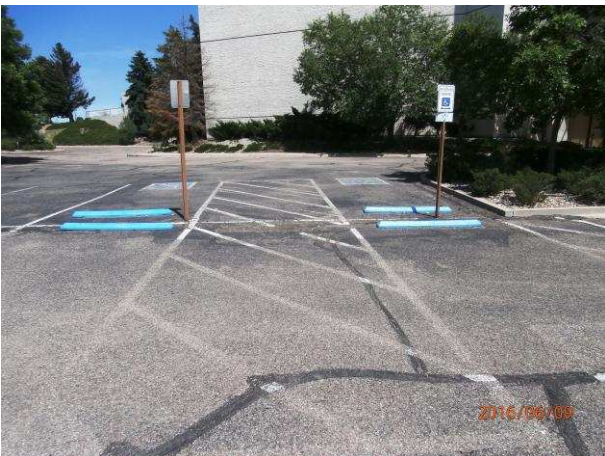
Finding: 8

The required parking signage is missing.

One of the parking spaces has a post but no sign.

Image of accessible parking without signage

Install an accessible parking sign.

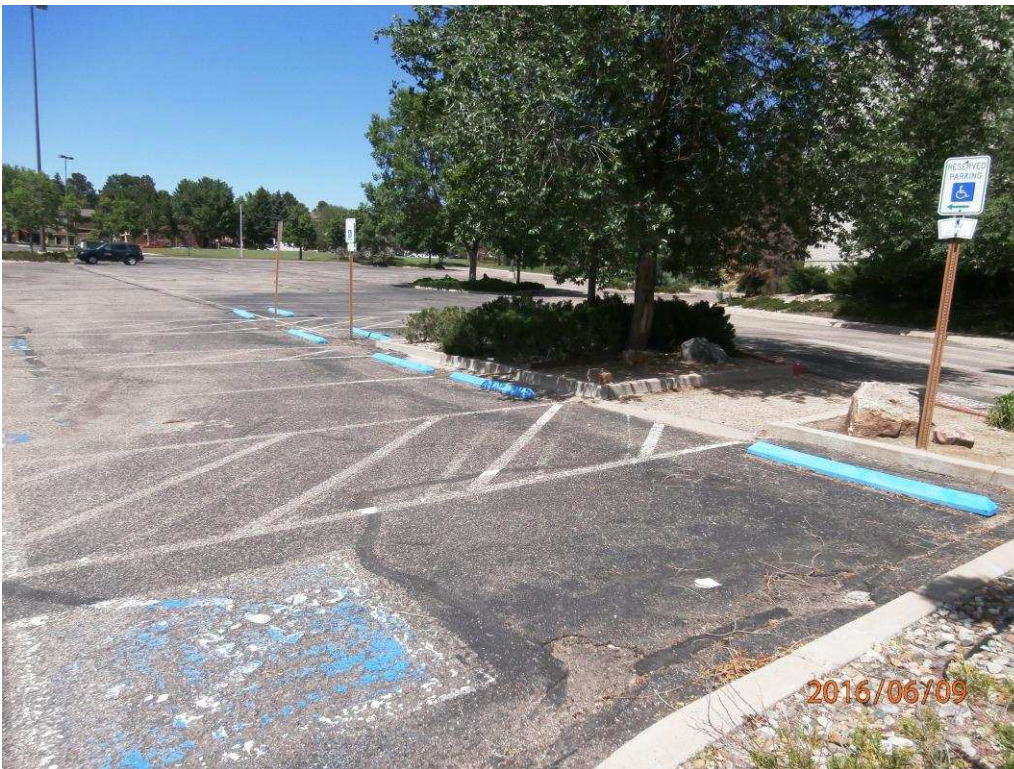
Finding: 9

The striping and markings for the accessible parking stall, loading/unloading access aisle are dilapidated and in need of repair and/or maintenance.

The striping of the parking spaces and access aisles is faded.

Image of faded accessible parking striping

Restripe the parking spaces and access aisles.

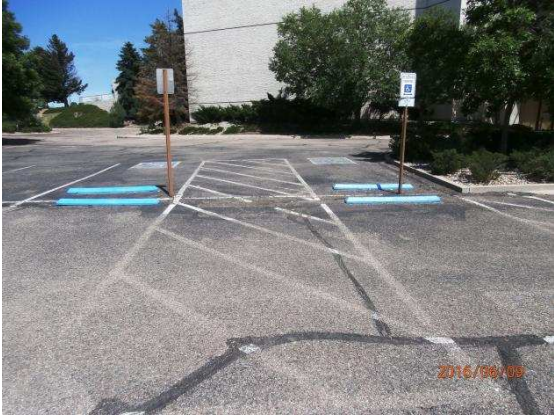
Finding #9 Additional Finding Photos

Additional image of faded markings on the parking spaces

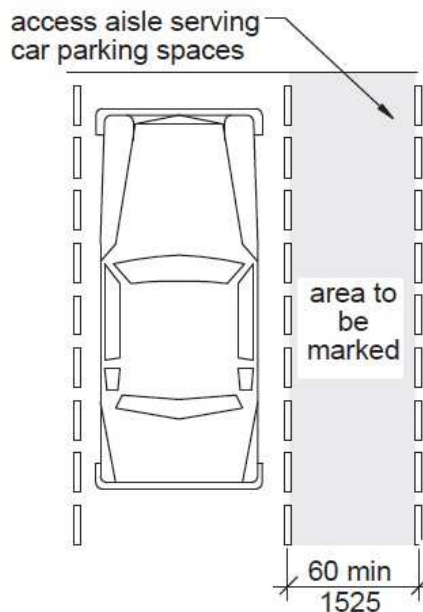
Finding: 10

The access aisle is not a minimum 5 feet wide.

One of the access aisles is 4'-6" wide.

Restripe the parking and access aisle to provide a 5'-0" wide access aisle with 8'-0" wide parking space.

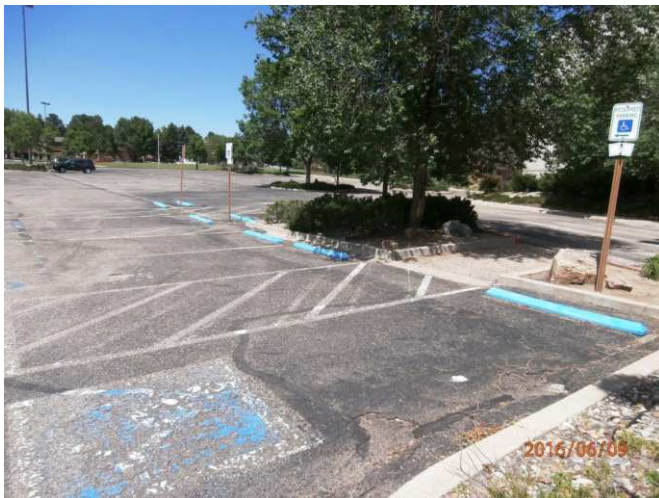
Finding: 11

The surfaces of the accessible parking spaces and access aisles are not firm, stable, and slip resistant.

The pavement in the far right accessible space is deteriorating.

Image of deteriorated pavement in the accessible parking space

Remove and replace the pavement.

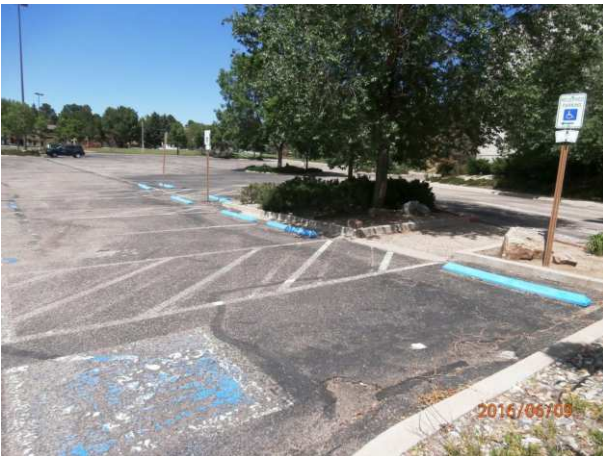
Finding: 12

The van stall signage is faded.

The van accessible parking sign is faded.

Image of faded van accessible signage

Replace the van accessible parking sign.
