Site Accessibility Evaluation

CSPD Impound Lot

**1353 S 8th St
Colorado Springs, CO
80905**

Accessibility Evaluation

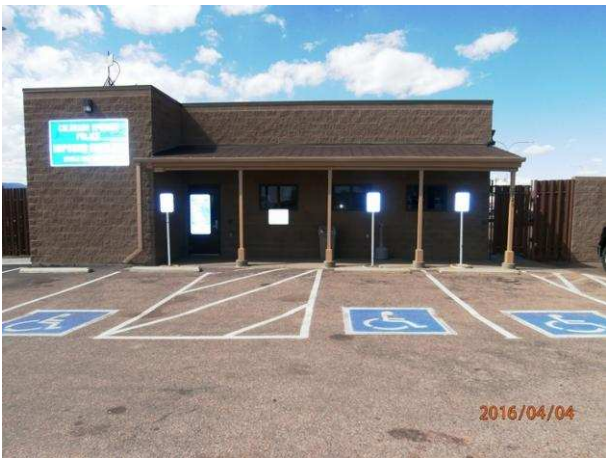
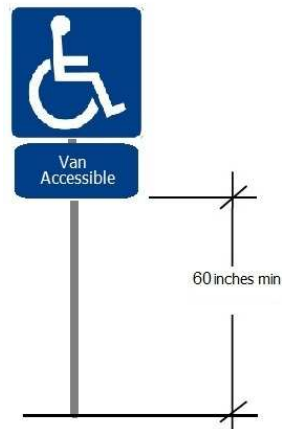
Finding 182901 Main Photo

The parking sign is mounted too low.

The three signs are mounted at 58" to the bottom edge (none are van accessible).

Raise existing signs so they are 60 inches minimum above the ground surface.

Add van access sign to the far left parking space closest to the door.

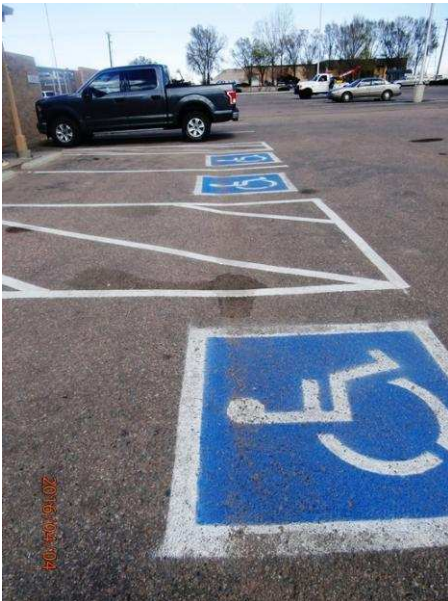
Finding 182902 Main Photo

The cross slopes (narrow dimension) and/or running slopes (long dimension) of the accessible stall exceeds 2%.

40' long x 4' wide across the parking spaces and access aisles running slopes as high as 3%.

Correct the cross slope of the stalls to 2% or less.

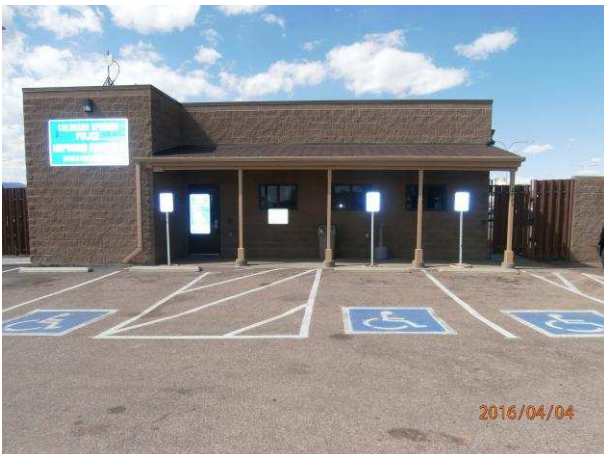
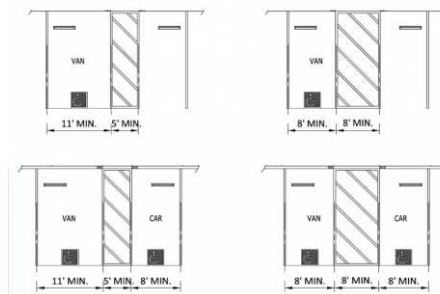
The accessible parking stall is not wide enough.

Accessible parking space on the right is 7'6"

Re-stripe parking space.

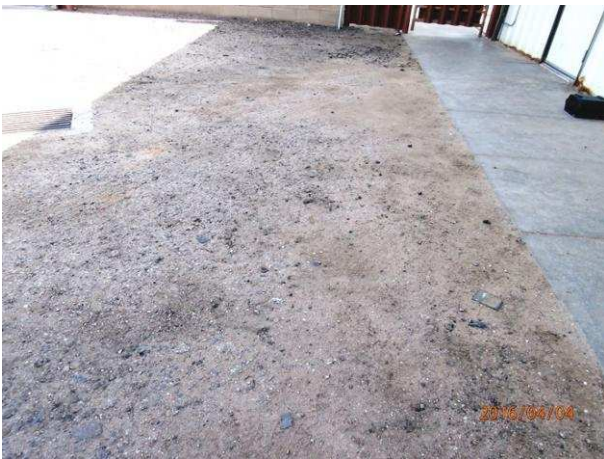
Finding 182926 Main Photo

The accessible route contains loose gravel and/or surfaces that do not provide for a stable, firm slip resistant surface.

Pick-up area surface
not firm, stable, or
slip resistant.

Pave concrete pad adjacent to walkway to allow ample space for pick-up.

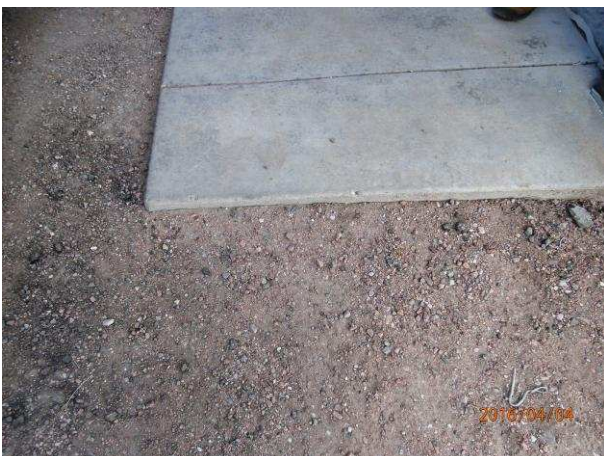
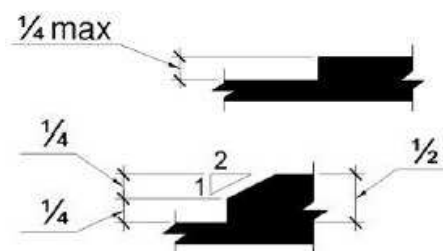
The walkway contains abrupt vertical edges and/or variations over a 1/4 inch.

There are areas of vertical displacement up to 2" where the concrete meets the loose fill

Connect the sidewalk to the future concrete pad where customers will pick up vehicles

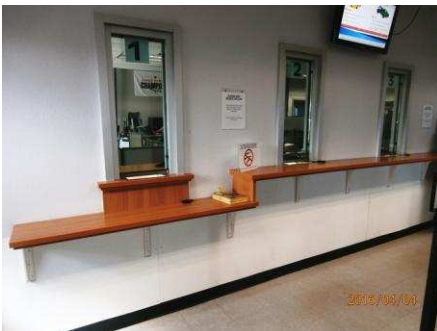
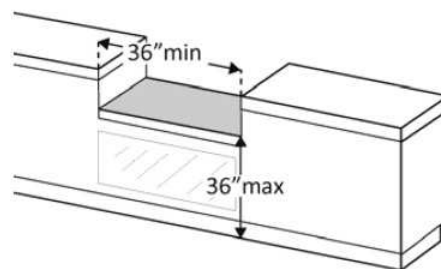
Finding 182927 Main Photo

The transaction counter is too high.

Customer service access 42" above floor grade.

Lower security window 6-8". The reach range is OK and the line of sight is marginally alright.

Until counter is corrected, staff must be ready, willing, and able to provide service at an alternate, accessible location.

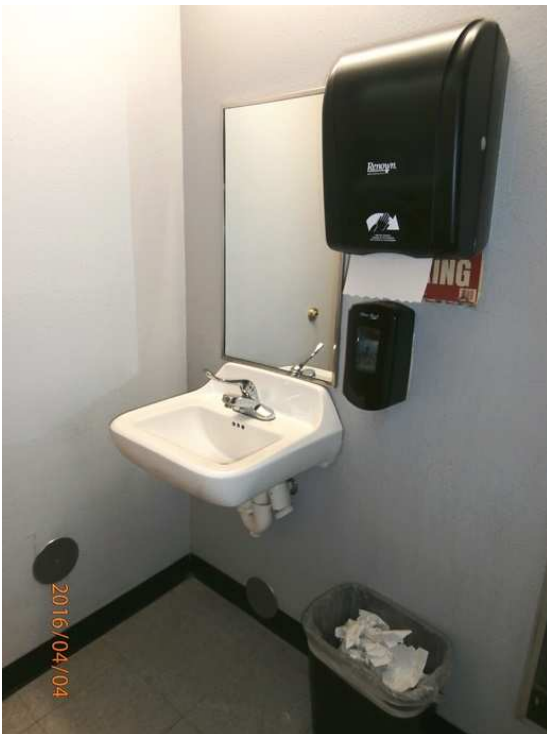
Finding 182928 Main Photo

The paper towel dispenser's operation mechanism is too high off the floor.

Towel dispenser is too high at 52".

Move dispenser down at least 4", 6" is better due to trashcan placement.

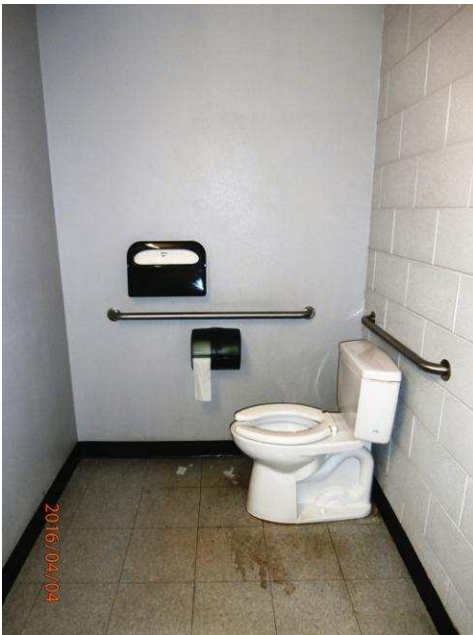
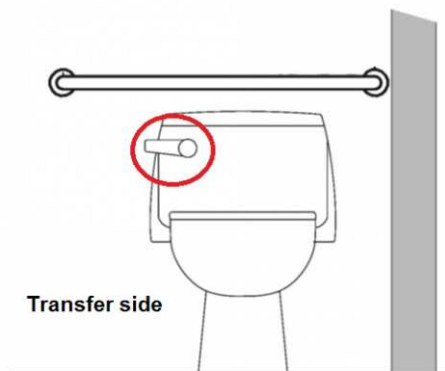
Finding 182929 Main Photo

The flush handle is located on the wrong side of the toilet.

Flush is on the closed side.

Move the flush to open side (this will require obtaining another tank).

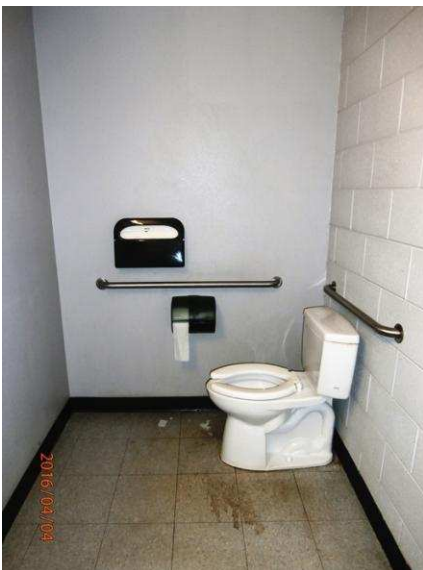
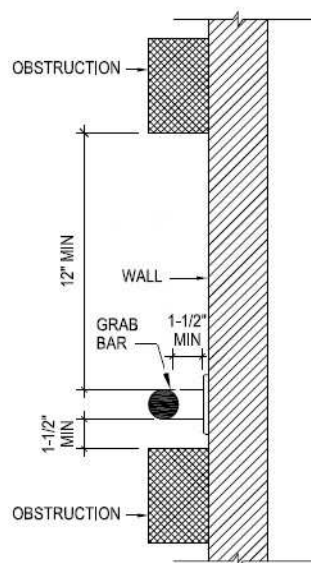
Finding 182930 Main Photo

The grab bar is not spaced correctly to the wall or other elements.

Toilet seat covers are only 3.5" above the bar.

Move the toilet seat covers to 1.5" below the grab bar.

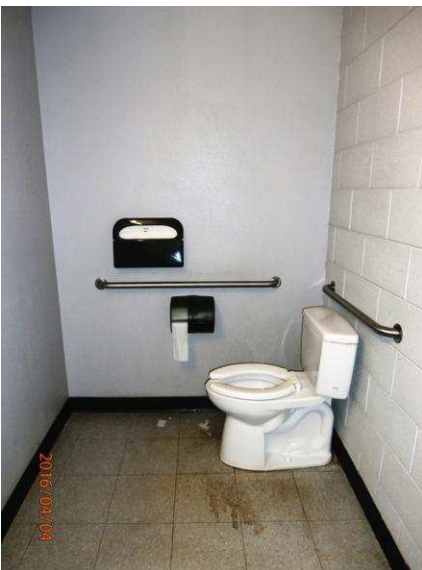
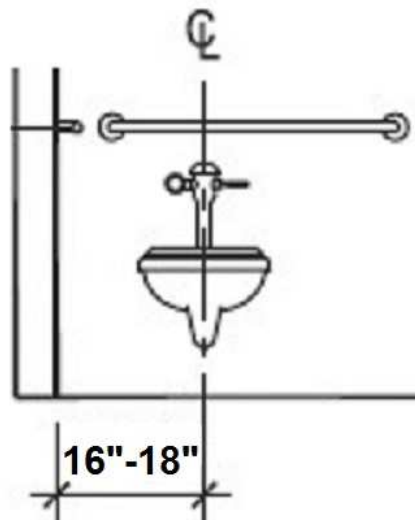
Finding 182931 Main Photo

The toilet is not located within the range allowed from the side wall or partition.

The toilet is 1/2" too far from the wall at 18.5" to the centerline of the toilet.

Move toilet over 1/2"+, (use flange) if feasible. If not the wall can be moved over the same distance

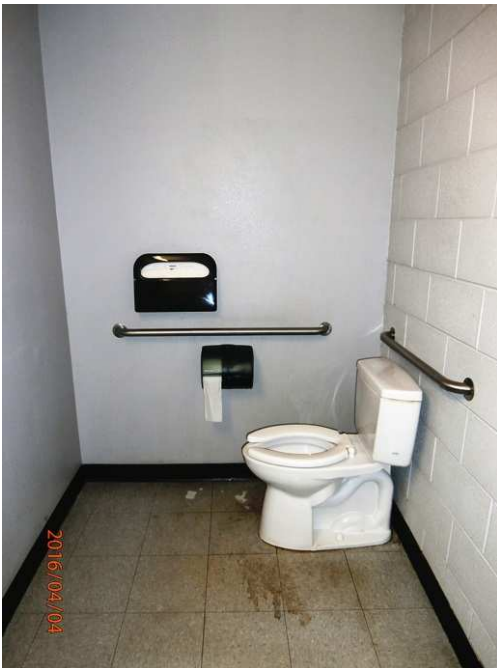
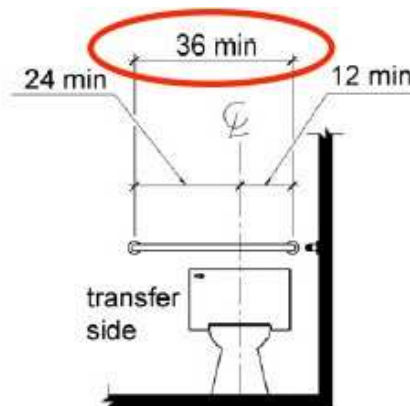
Finding 182932 Main Photo

The rear grab bar is not a minimum 36 inches in length.

Rear grab bar 30" long.

Remove existing rear grab bar and replace with 36" grab bar.
