Site Accessibility Evaluation

Fire Station 10

Accessibility Evaluation

***Inspection Date: 03/14/2017
Inspector: Michael Killebrew,
Anna Kangas***

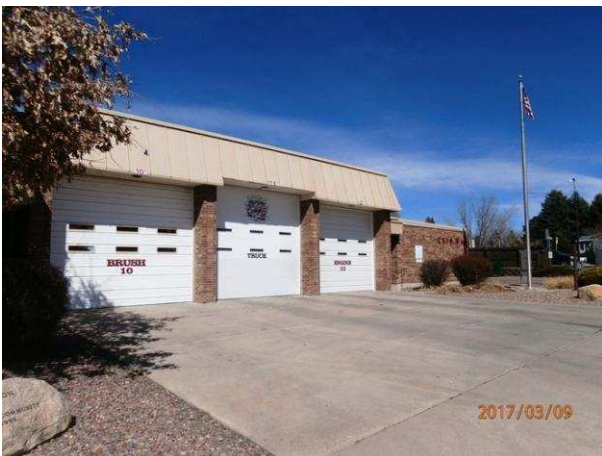
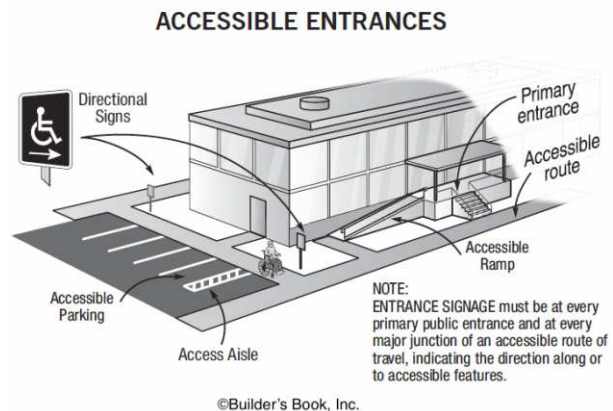
Finding: 1

There is no accessible route of travel from the public way.

There is no accessible route from the public right of way.

1 (High): Should be completed immediately. (Includes findings that have little or no cost, were in violation of the codes at the time of construction, or pose an imminent safety threat)

Create an accessible route from the public right of way adjacent to driveway. This will need to be ramp this.

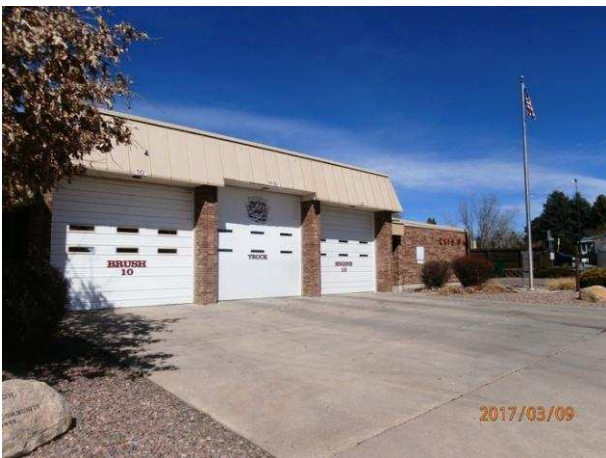
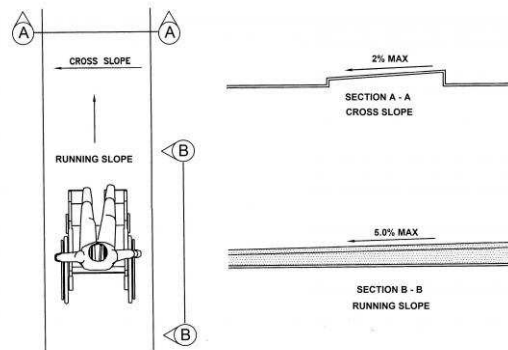
Finding: 2

The accessible path of travel contains cross slopes greater than 2%.

The cross slope of the sidewalk within the driveway area is 4%.

Remove and replace the sidewalk area to achieve 2% maximum cross slope or as close to 2% as feasible.

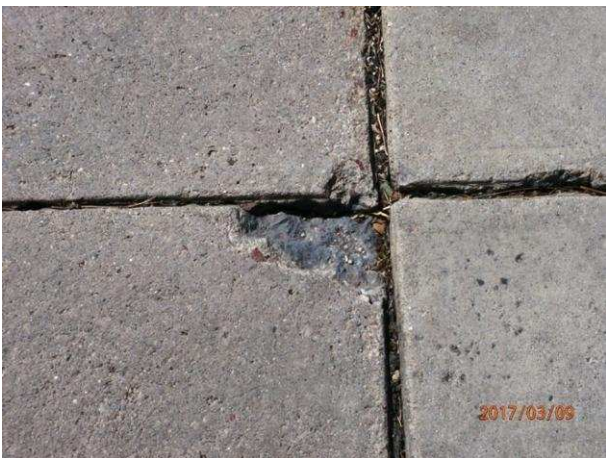
Finding: 3

The fractures in the sidewalk impede access. One of the fractures is 1" deep by 4" wide by 6" long.

There is significant spalling and fracturing of the sidewalk.

Remove and replace concrete panels as needed to create an accessible path.

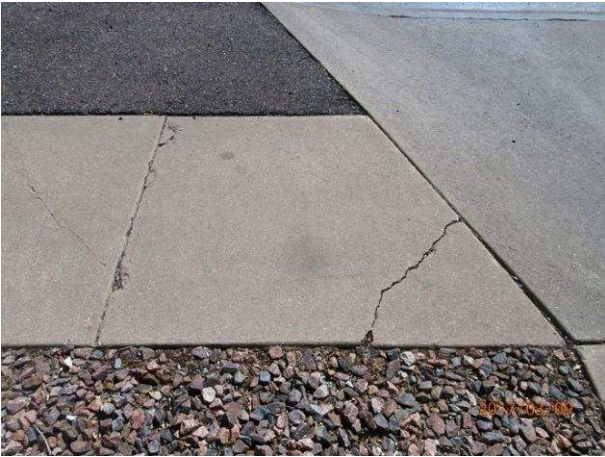
Finding #4 Continued

The walkway contains abrupt vertical edges and/or variations over a 1/4 inch.

The fracturing in the sidewalk has resulted in vertical displacement.

Remove and replace sidewalk panels as needed.

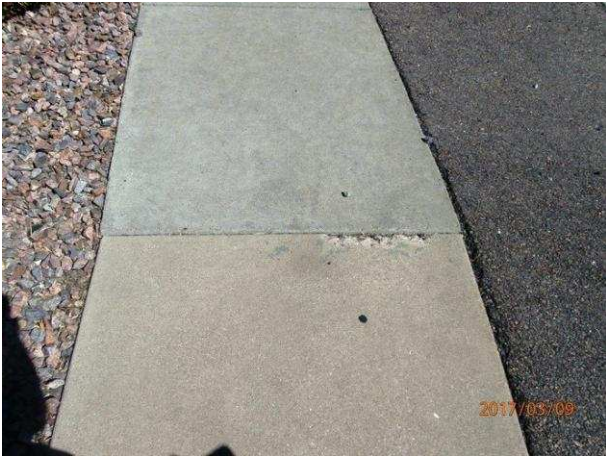
Finding #5 Continued

The walkway contains abrupt vertical edges and/or variations over a 1/4 inch. There is a chip in the sidewalk 1/2" deep by 2" wide by 14" long.

The spalling of the sidewalk has resulted in vertical displacement.

Cut and fill area.

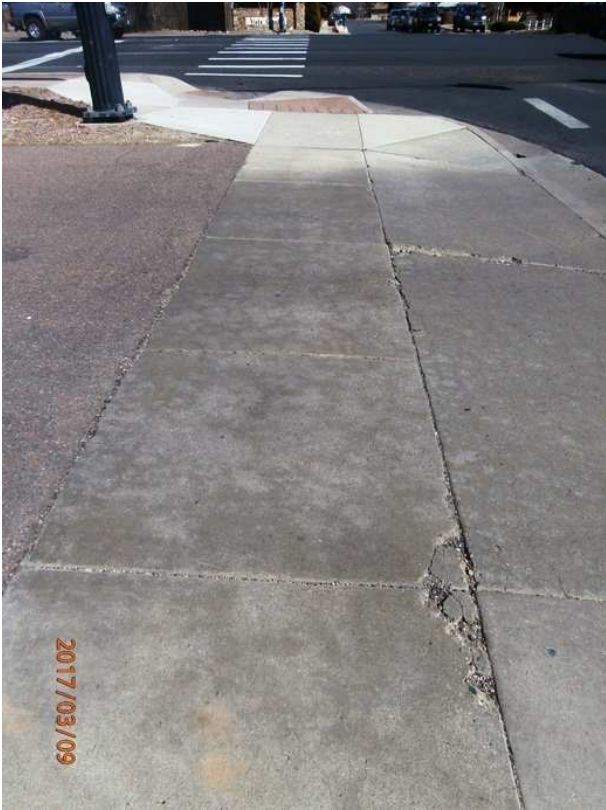
Finding #6 Continued

The walkway contains abrupt vertical edges and/or variations over a 1/4 inch.

There is significant fracturing in this section of sidewalk.

Remove and replace concrete panels as needed.

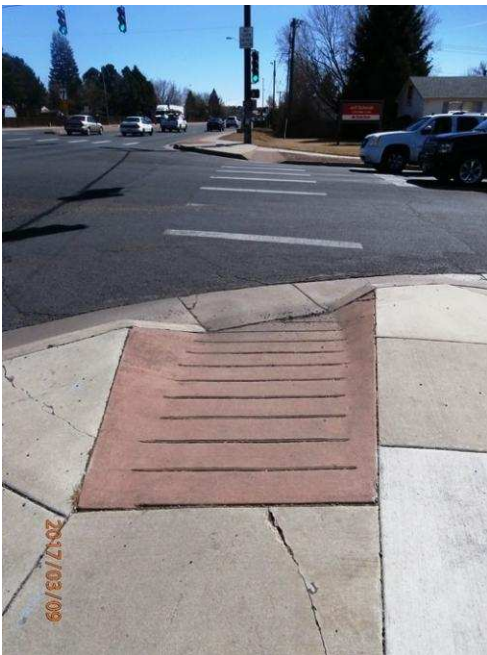
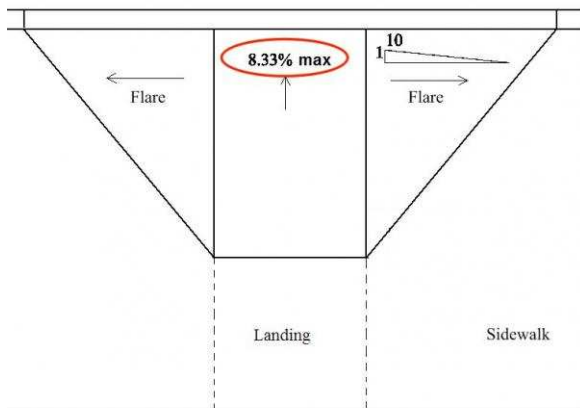
Finding: 7

The Running Slope is up to 9%, vertical displacement exceeding 3/4", the landing has fracturing with a gap exceeding 1/2" and no detectable warnings. Also, side flare exceeds 10% in attached concrete.

This curb ramp has multiple issues.

Replace this ramp. The adjoining one is worse and needs replaced as well.

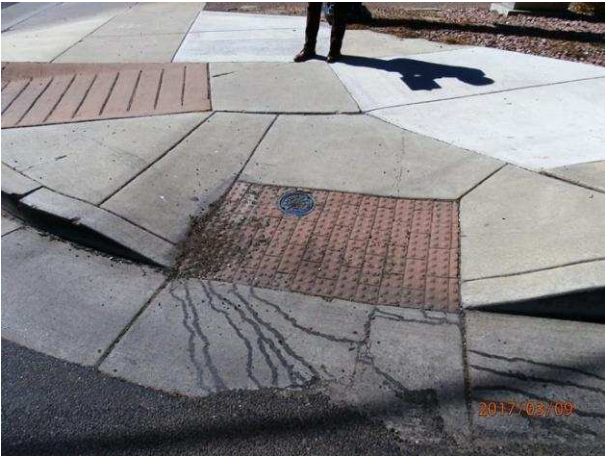
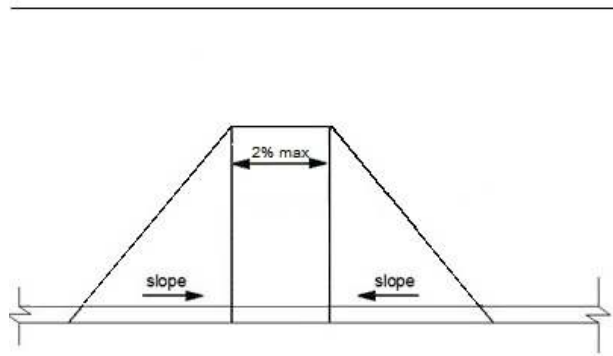
Finding #8 Continued

The cross slope of the curb ramp is 10% at the pavers at 7.5% at the above concrete ramp face.

The 9" across water main is sticking up across brick pavers 2' high.

The side flare in attached concrete is 17%

The ramp face has 1" vertical displacement from pavers to concrete.

The ramp has a landing with a 5% cross slope

This ramp has multiple problems, is failing fast and is a safety risk

Remove and replace the curb ramp crossing N Academy Blvd.

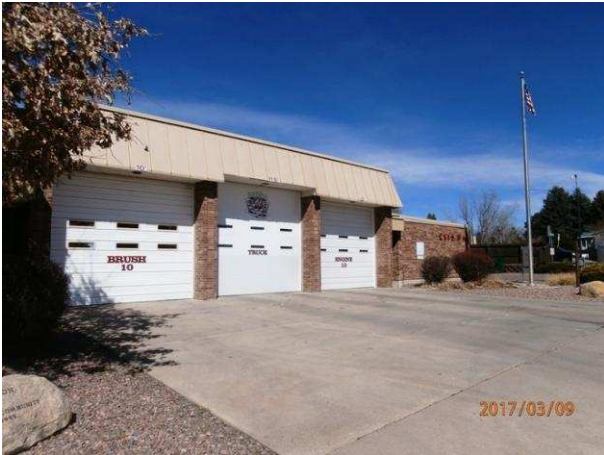
Finding #9 Continued

The walkway contains abrupt vertical edges and/or variations over a 1/4 inch.

There is a 1/2" vertical displacement at the landing at the entrance.

Grind to 1/2" or less bevel.

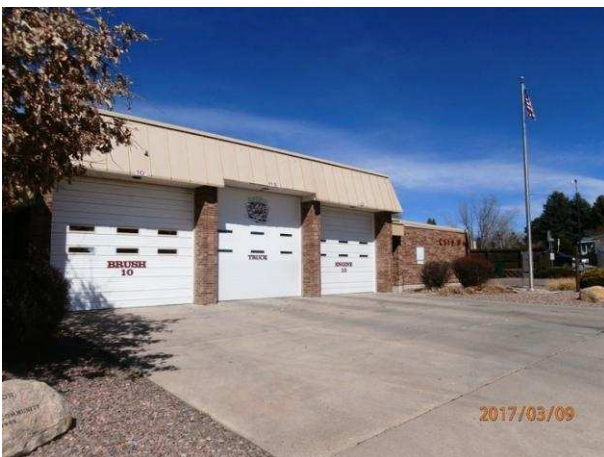
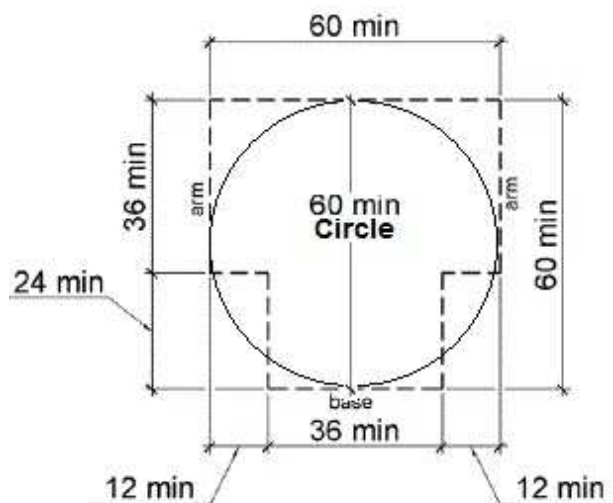
Finding: 10

The T-shaped or circular turning space contains excessive slopes.

The landing at the entrance has 3.5% running slope.

Remove and replace the landing or create an accessible route elsewhere.

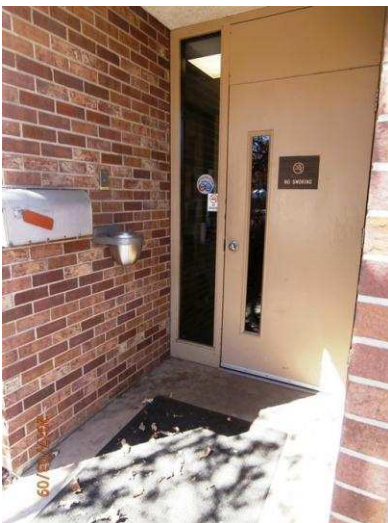
Finding: 11

The door bell is positioned too high for either a side or front approach.

The door bell is mounted at 56".

Lower the door bell to 48" or less.

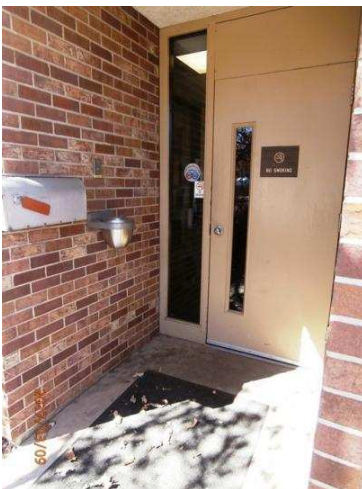
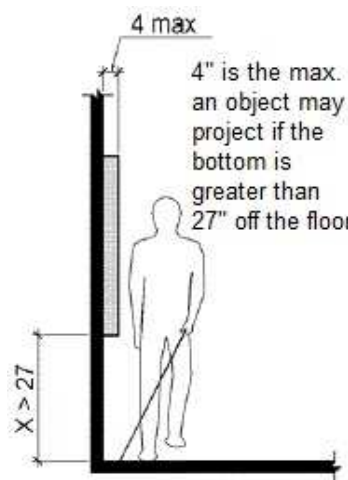
Finding: 12

The mailbox and ash can project more than 4 inches into the circulation path.

The mailbox and ash can project into the path of travel.

Remove the ash can and relocate the mailbox so that not in the path of travel.

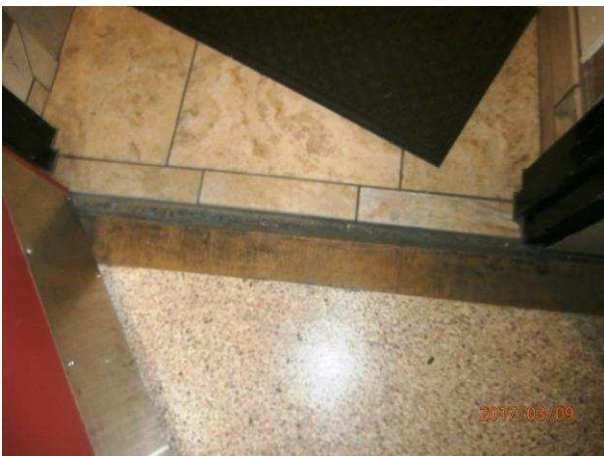
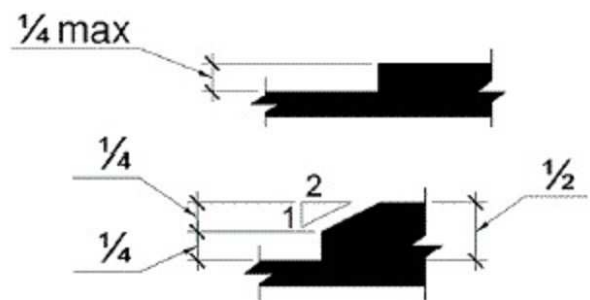
Finding: 13

The threshold is greater than 1/2 inch high.

There is 3/4" threshold into the women's restroom.

Bevel the entrance into the restroom with a bridging plate.

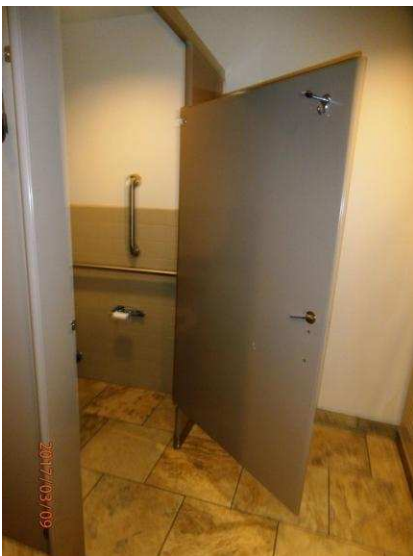
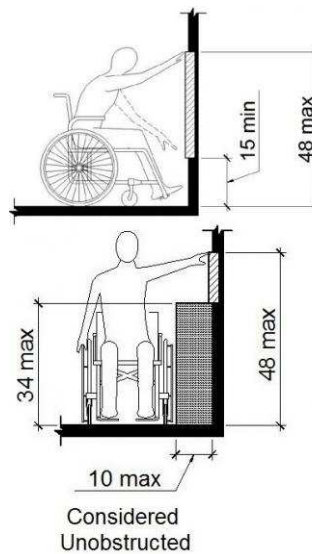
Finding: 15

The coat hook is installed greater than 48 inches above the finished floor.

The coat hooks in the women's restroom are mounted at 66".

Lower the coat hook, or install another on at 48" maximum.

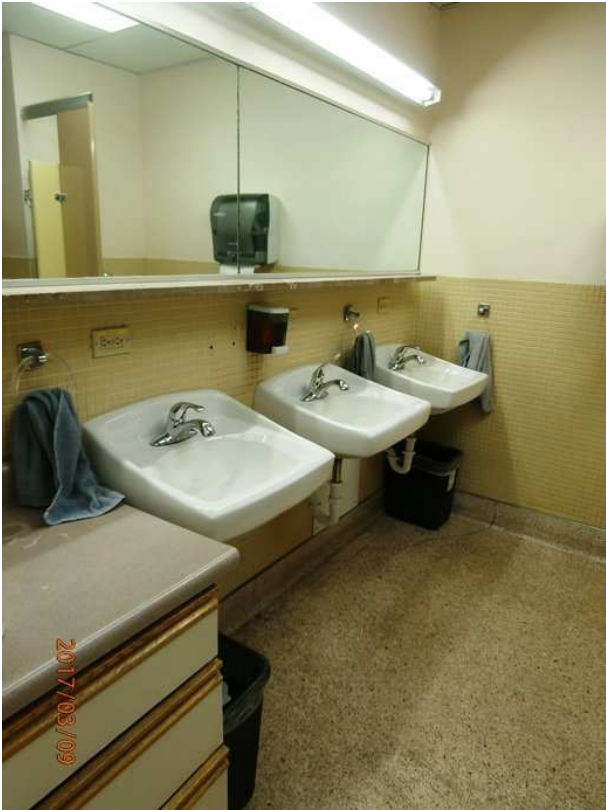
Finding #16 Continued

The owner or owners representative indicated that no public restrooms were available, however there was a non compliant restroom labeled as accessible and available to the public. If the restroom is desired to be an employee only restroom, it is recommended that the door be locked, the signs be removed and replaced with a new sign that that sates "employees only" or "private area". Any future improvements may be required under Title I of the ADA for work place reasonable accommodations.

The men's restroom is not accessible and needs to be signed for employee use only.

Add a sign indicating the restrooms are not for public use.
