Site Accessibility Evaluation

Fire Station 12

Accessibility Evaluation

***Inspection Date: 03/19/2017
Inspector: Michael Killebrew,
Anna Kangas***

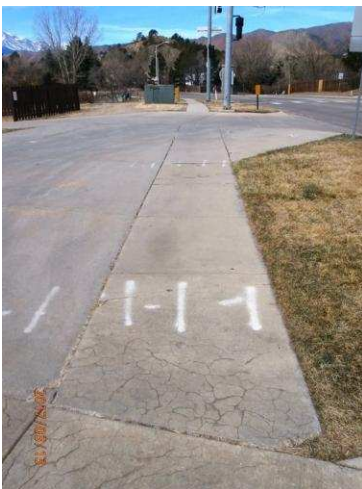
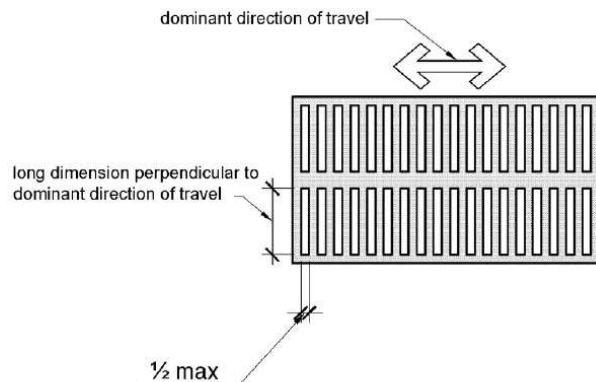
Finding: 1

The concrete expansion joint is spaced greater than a 1/2 inch. One joint is 3/4" deep by 2" wide by 11" long. Another joint is 3/4" deep by 2-1/2" wide by 46" long.

2010 ADAS Section 302.3

The sidewalk has gaps up to 2-1/2" wide and up to 3/4" deep.

Remove and replace the two concrete pads.

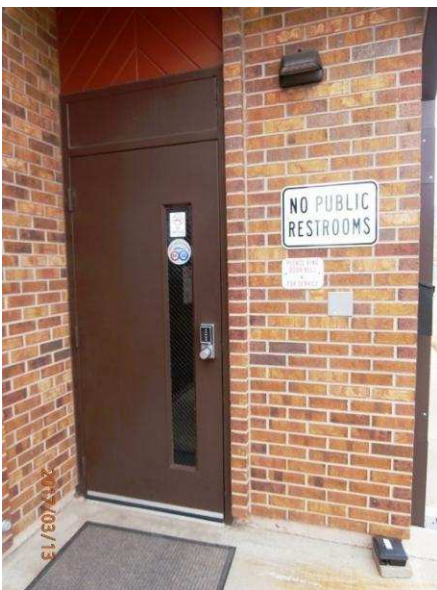
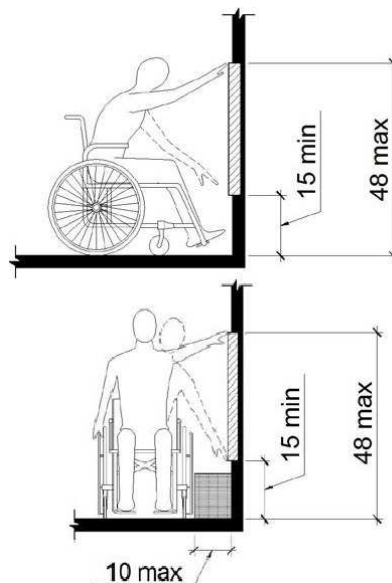
Finding: 2

The door bell is not positioned correctly for either a side or front approach.

2010 ADAS Section 308.2.1

The door bell is mounted at 54".

Lower the door bell to 48" maximum.

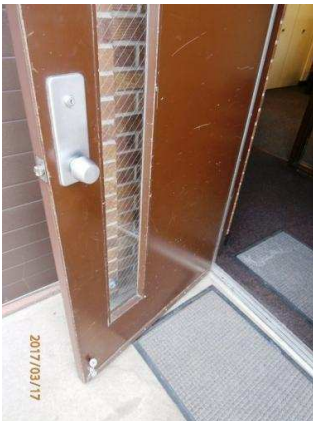
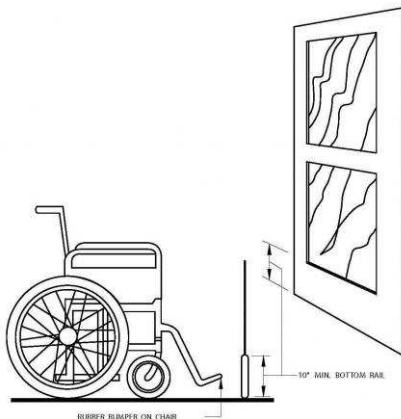
Finding: 3

The door has a door stop which prevents it from having a smooth surface at the bottom.

2010 ADAS Section 404.2.10

There is a door stop on the entry door.

Remove the door stop.

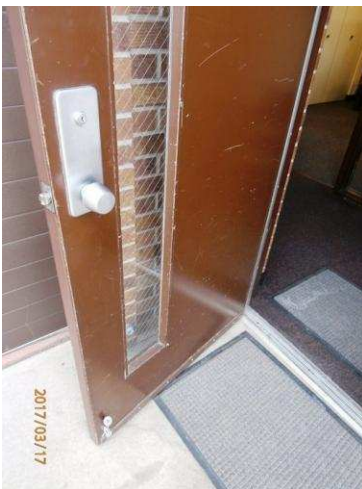
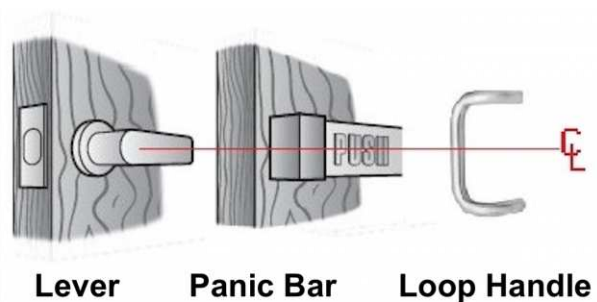
Finding: 4

The door/gate operating hardware is not accessible.

2010 ADAS Section 404.2.7

The hardware on the entry door is a knob.

Replace with lever style hardware.

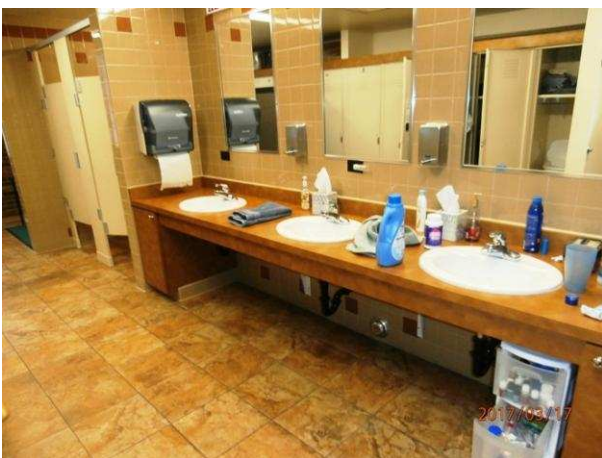
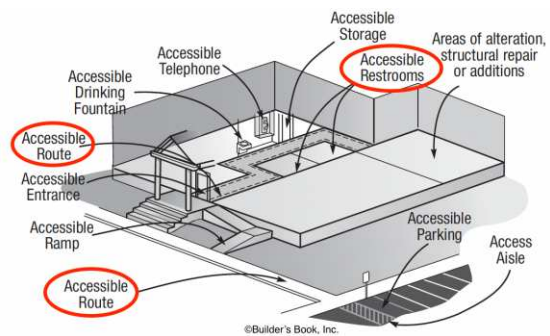
Finding: 5

The restroom facilities serving the facility are not on an accessible route and are not accessible. There are multiple issues with them, but they are not intended for public use.

2010 ADAS Section 213.1

The restrooms are not accessible.

No modifications required if these restrooms are not for public use.
