# Site Accessibility Evaluation

**Fire Station 13**  
**1475 Cresta Rd**  
**Colorado Springs, CO**  
**80906**

**Accessibility Evaluation**

***Inspection Date: 03/13/2017***  
***Inspector: Michael Killebrew,***  
***Anna Kangas***

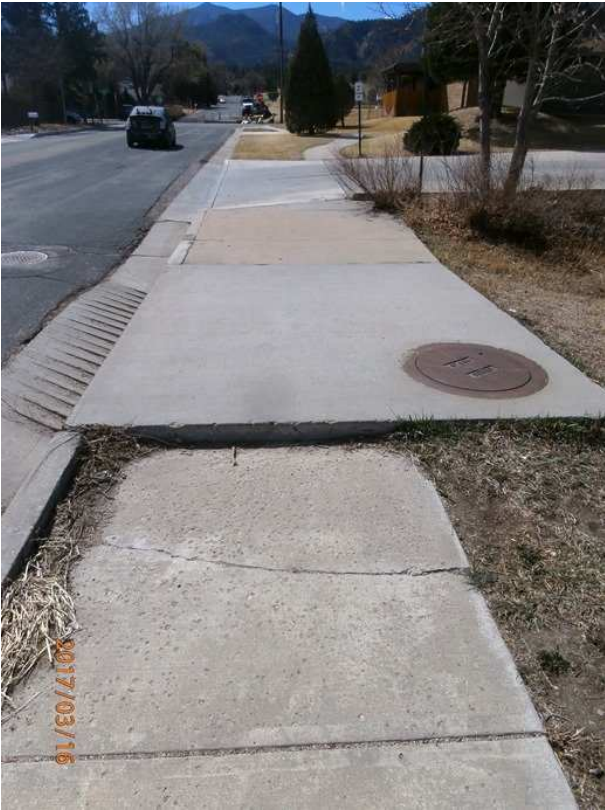
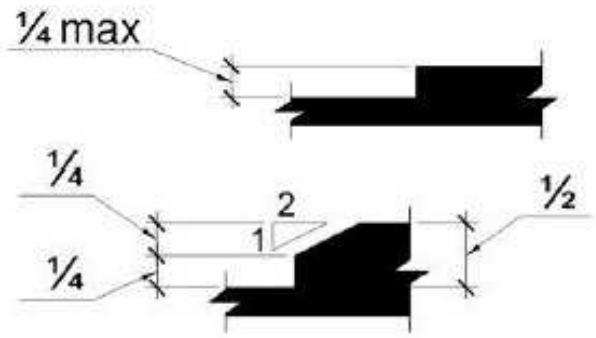
**Finding: 1**

The walkway contains abrupt vertical edges and/or variations over a 1/4 inch.

There is 3-3/4" vertical displacement at the sidewalk panel containing the storm drain.

Remove and replace the sidewalk panel to provide a level route.

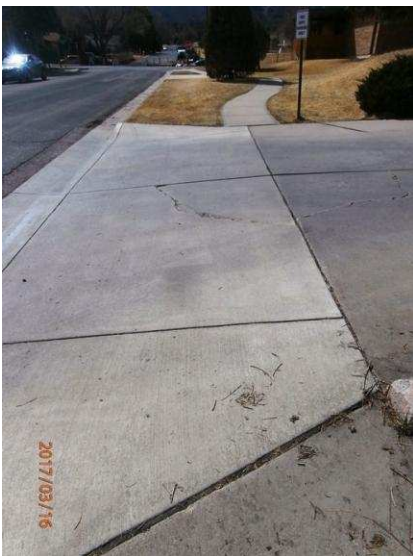
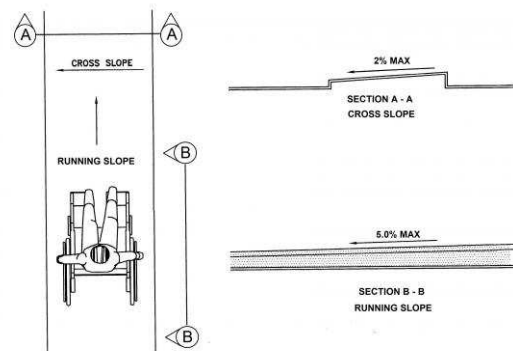
### Finding: 2

The accessible path of travel contains cross slopes greater than 2%.

The sidewalk has 5.2% cross slope.

Remove and replace the sidewalk panels to provide 2% maximum cross slope across driveway if feasible.

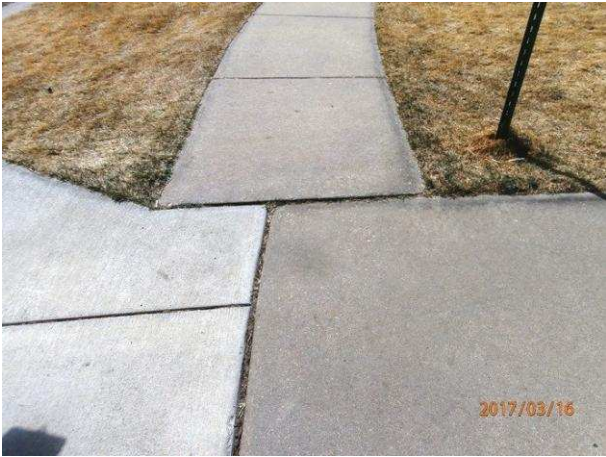
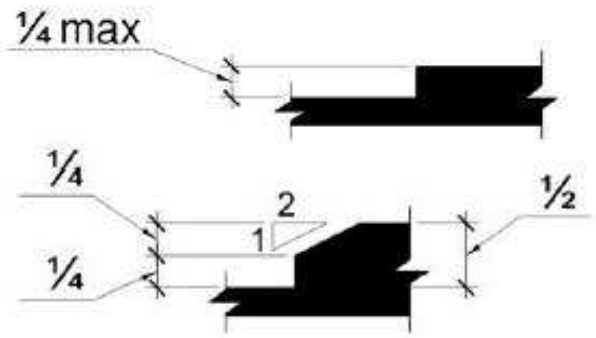
### **Finding: 3**

The walkway contains abrupt vertical edges and/or variations over a 1/4 inch.

There is 1/2" vertical displacement where the sidewalk meets the driveway.

Grind to less than 1/2" bevel.

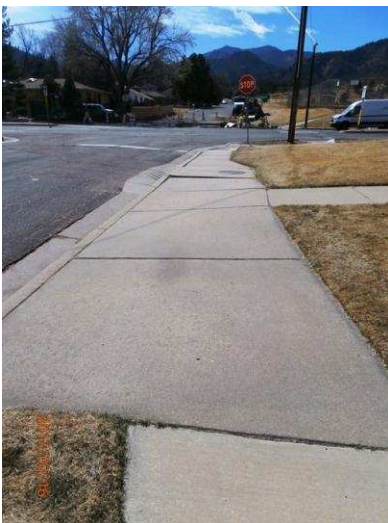
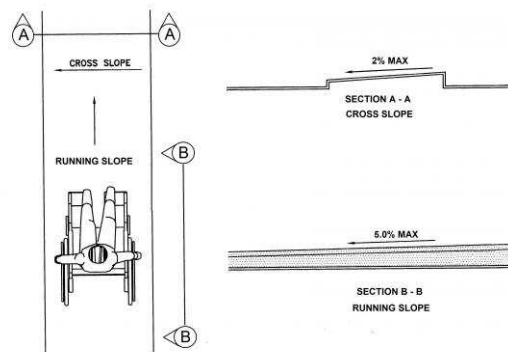
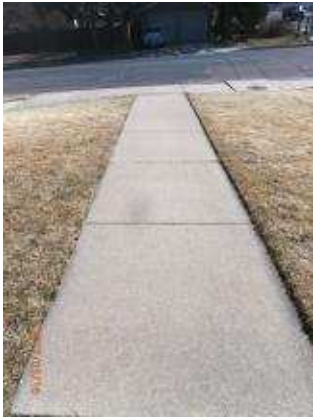
**Finding: 4**

The accessible path of travel contains cross slopes greater than 2%.

The sidewalk has 5.7% cross slope across four concrete panels.

Remove and replace the sidewalk panels to provide maximum 2% cross slope.

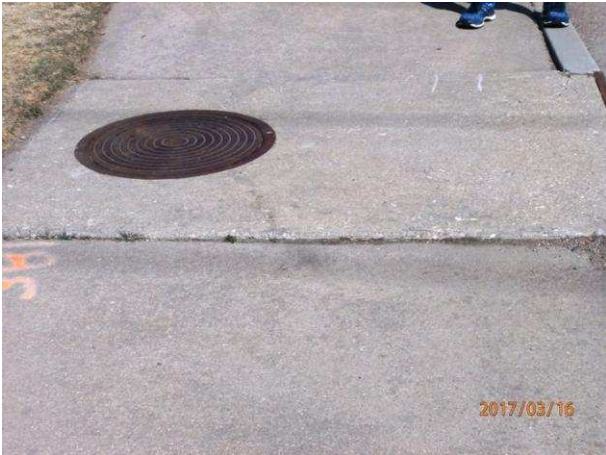
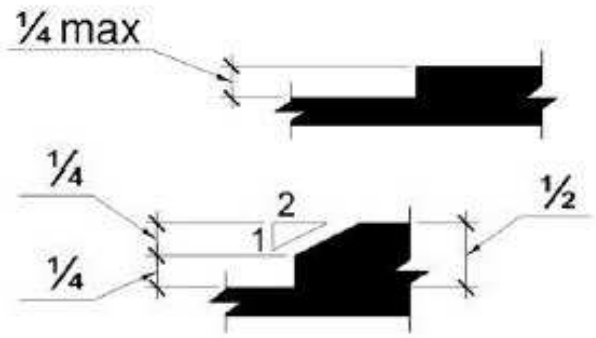
**Finding: 5**

The walkway contains abrupt vertical edges and/or variations over a 1/4 inch.

There is up to 1-3/4" vertical displacement at the concrete panel with the storm drain.

Remove and replace sidewalk panels.

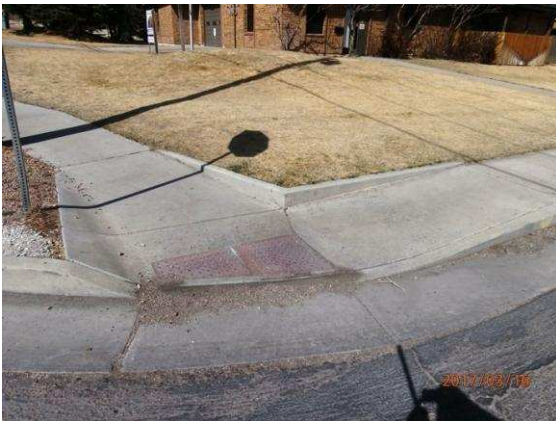
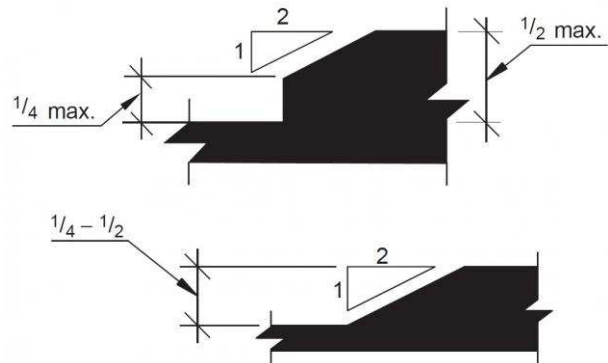
### Finding: 6

The change in level where the gutter meets the curb ramp is greater than 1/2 inch. This curb ramp is at La Veta Way.

Also, ramp lays funky with detectable warning placement. Should be oriented to direction of travel. Creates rough pivot area at domes.

Also, gutter pan to road has vertical displacement.

There is over 1/2" vertical displacement between the curb ramp and the gutter.

Replace Ramp

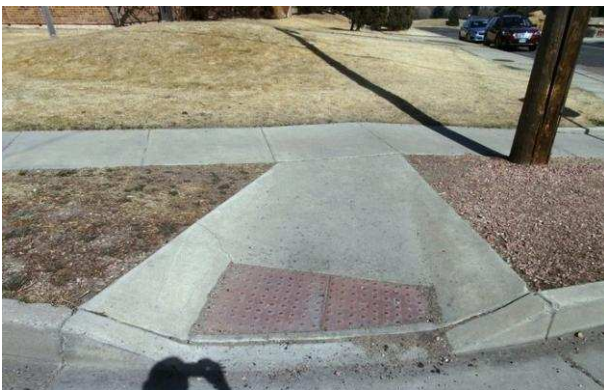
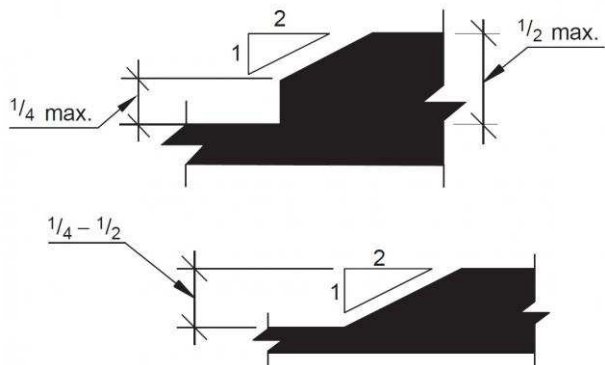
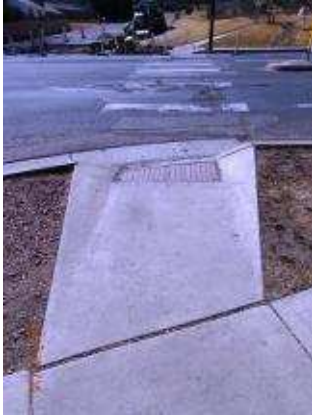
### Finding: 7

The change in level where the gutter meets the curb ramp is greater than 1/4 inch. This curb ramp crosses Cresta Rd to the high school.

There is over 1/2" vertical displacement between the curb ramp and the gutter.

Grind to flush if feasible. If not, to the maximum extent feasible.

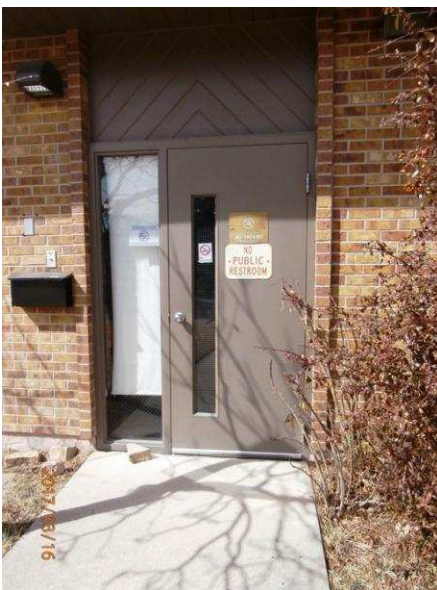
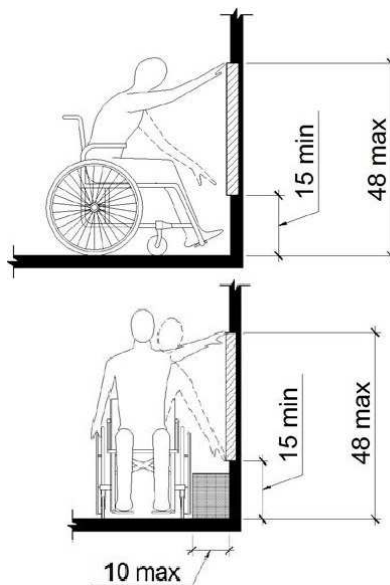
Finding: 8

The door bell is not positioned correctly for either a side or front approach.

The door bell is mounted at 57".

Lower the door bell to at or under 48".

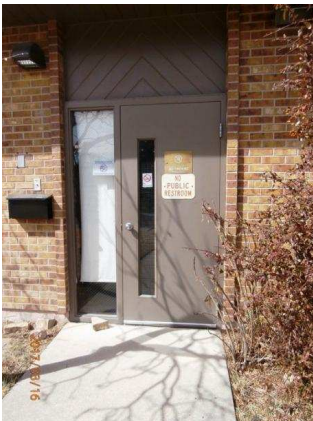
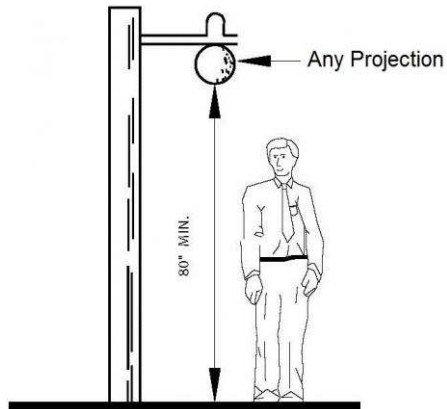
**Finding: 9**

The plantings extend down too close to the route of travel.

**The plantings adjacent to the sidewalk overhang the sidewalk.**

Keep the adjacent plantings trimmed.

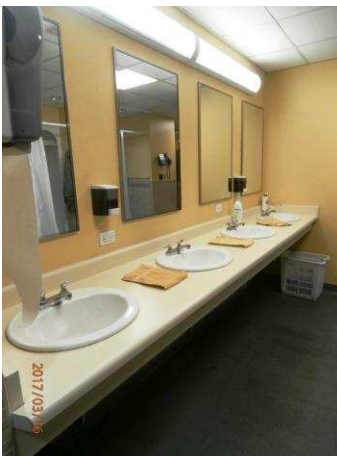
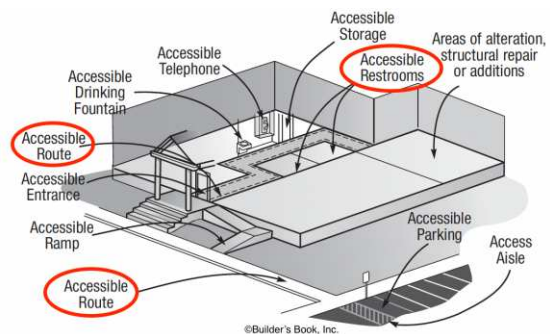
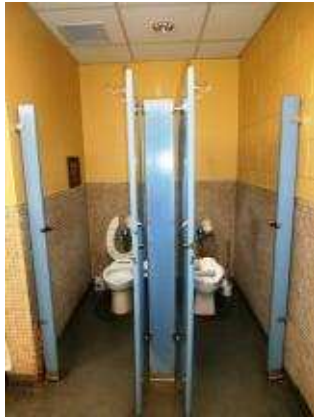
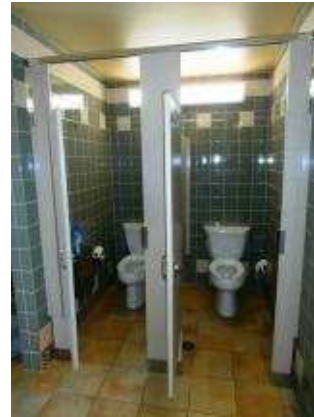
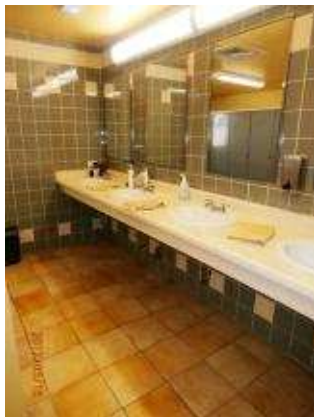
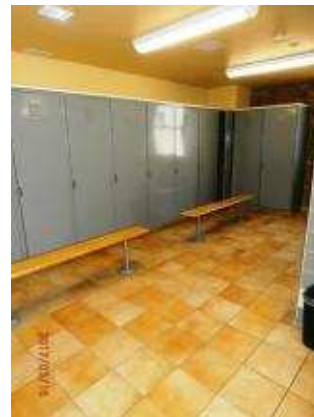
### Finding: 10

The restroom facilities serving the facility are not on an accessible route and are not accessible. The restrooms are not intended for public use.

The restrooms are not accessible.

As long as the restrooms are not for public use, they do not need to be made accessible.
