Site Accessibility Evaluation

Fire Station 15

**4770 Scarlet Dr
Briargate, CO 80920**

Accessibility Evaluation

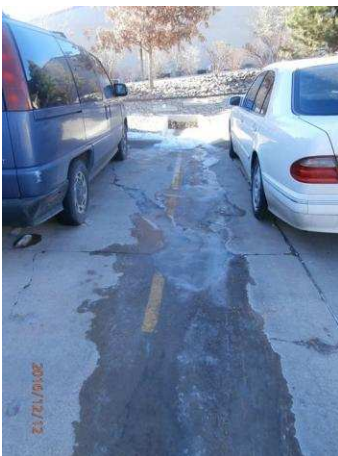
Finding: 1

There are no accessible parking stalls.

There are 9 parking spaces but none of them are marked as accessible.

Either create accessible parking or post "Employee Parking Only".

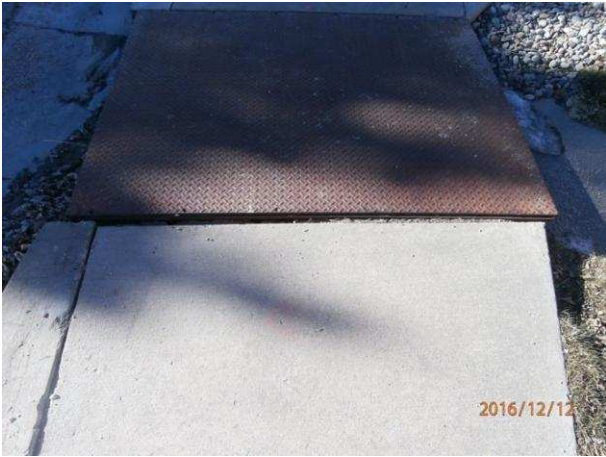
Finding #2 Continued

The walkway contains abrupt vertical edges and/or variations over a 1/4 inch.

In the sidewalk to the main entrance, there is a metal plate covering a drainage area. There is a 1" gap between the sidewalk and metal plate.

Fill the gap and fix the plate in place.

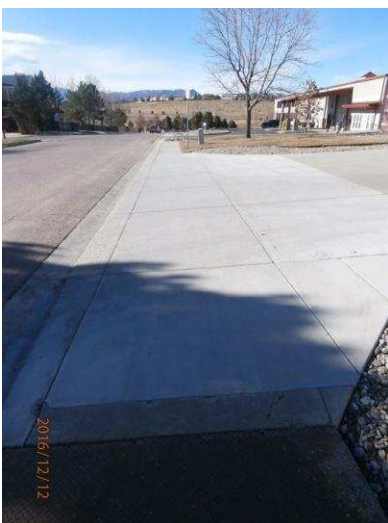
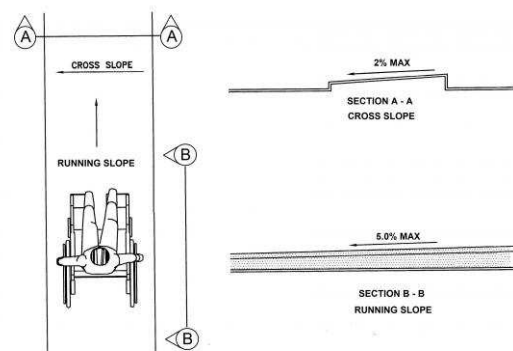
Finding: 3

The accessible path of travel contains cross slopes greater than 2%.

There is 3% cross slope in the section of sidewalk at the driveway.

Remove and replace the sidewalk to achieve maximum 2% cross slope.

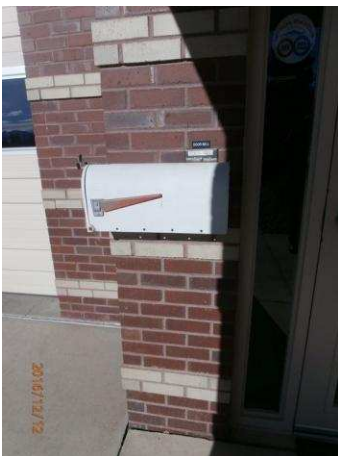
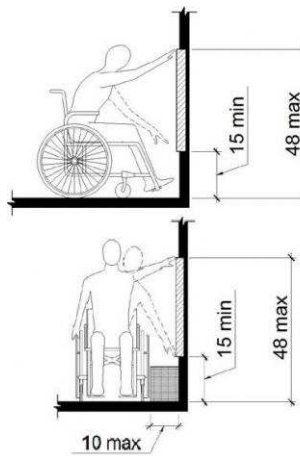
Finding: 4

The door bell is positioned too high for either a side or front approach.

The door bell is mounted at 50" and is obstructed by the mailbox.

Lower the doorbell to 48" and move the mailbox so the door bell can be seen and accessed.

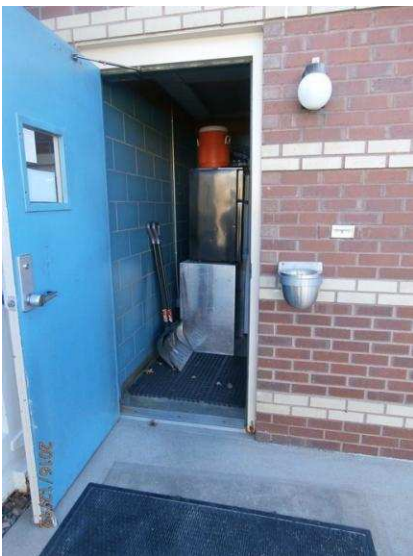
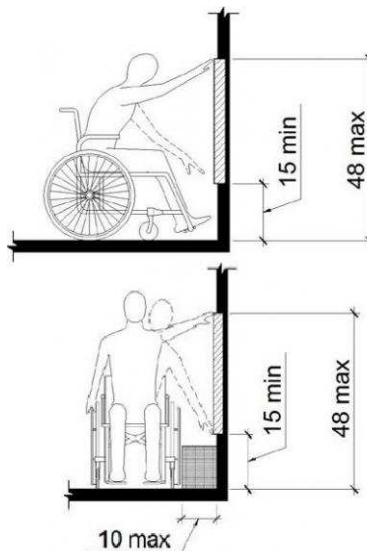
Finding: 5

The door bell is not positioned correctly for either a side or front approach.

The door bell at the rear entrance is mounted at 49-1/2".

Lower the door bell to 48" maximum.

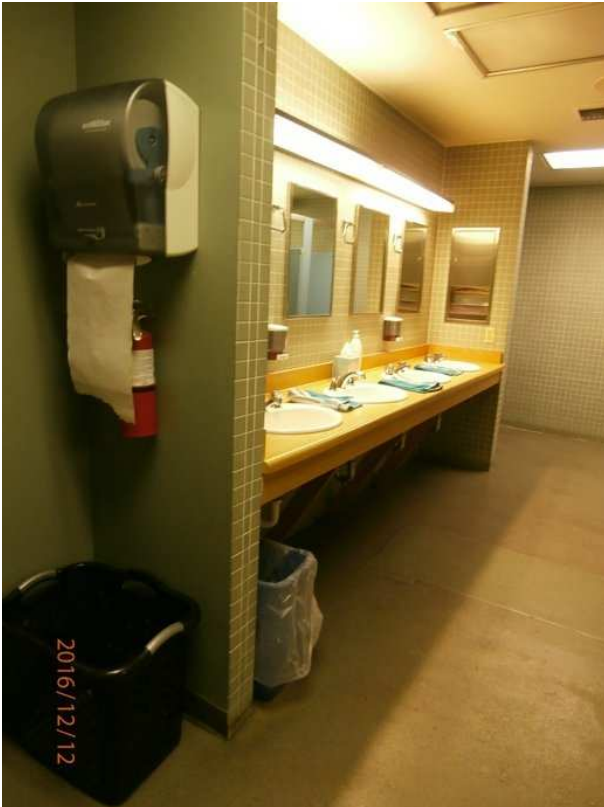
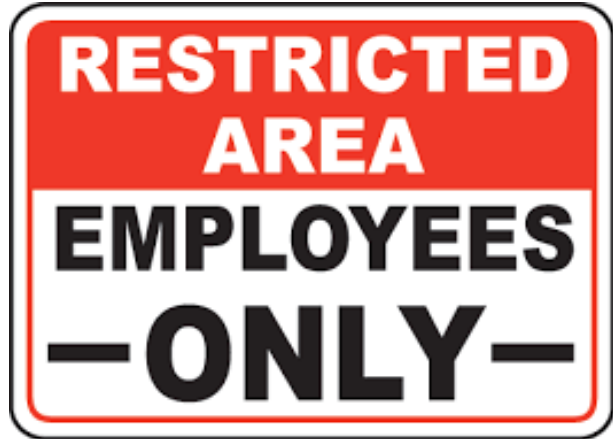
Finding #6 Continued

The restrooms have multiple issues, but are not intended for public use.

The restrooms are not accessible.

Install signage indicating the restrooms are not for public use.
