# Site Accessibility Evaluation

### Fire Station 18

6830 Hadler View  
Colorado Springs, CO  
80919

SUBJECT: Fire Station 18 Self-Evaluation

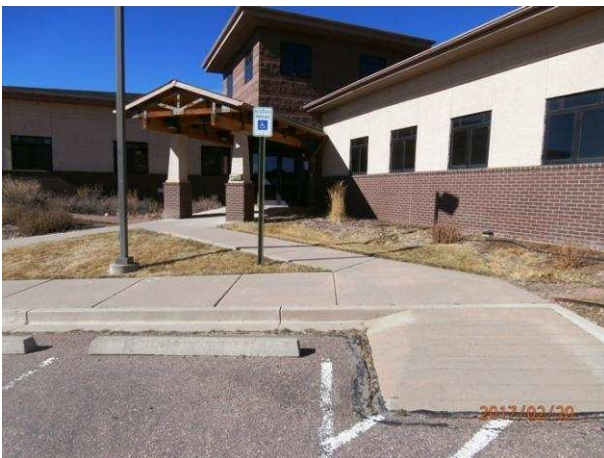
**Finding: 1**

The van stall is missing a sign identifying it as a van accessible stall.

There is no van accessible sign on either accessible parking space.

1 (High): Should be completed immediately. (Includes findings that have little or no cost, were in violation of the codes at the time of construction, or pose an imminent safety threat)

Add a van accessible sign.

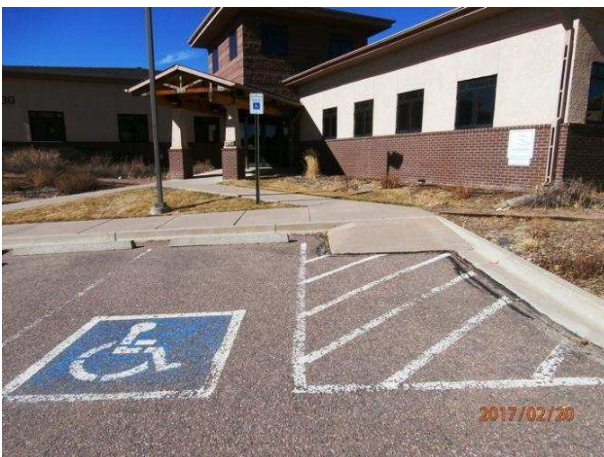
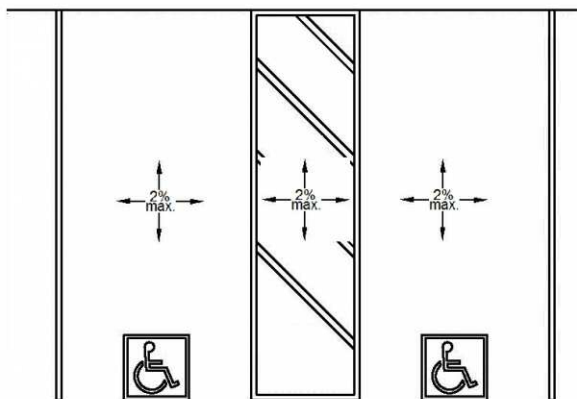
**Finding: 2**

The accessible parking stall's access aisle contains a built up curb ramp which results in significant slopes greater than 2 percent.

There is a ramp in the access aisle.

1 (High): Should be completed immediately. (Includes findings that have little or no cost, were in violation of the codes at the time of construction, or pose an imminent safety threat)

Move the ramp to the sidewalk area.

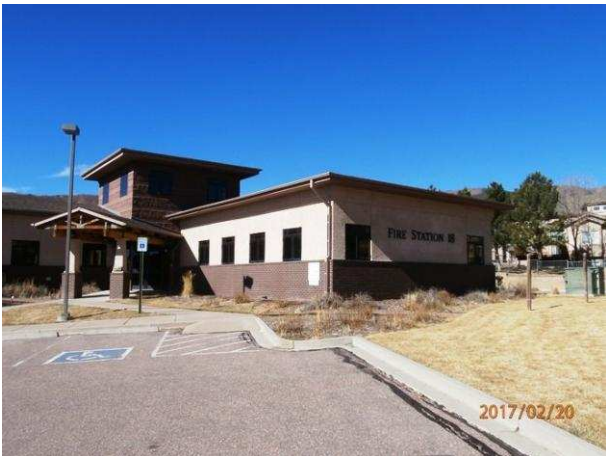
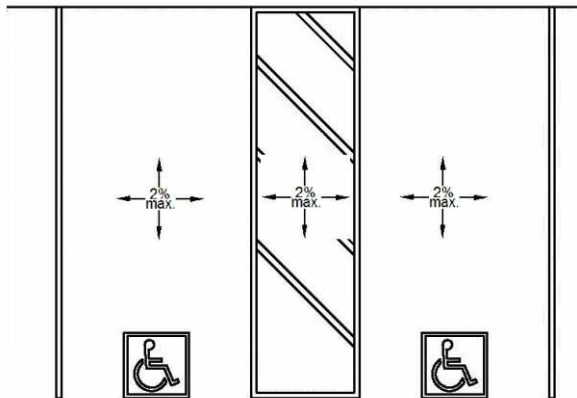
**Finding: 3**

The cross slope (narrow dimension) of the parking stall exceeds 2%.

The cross slope in the accessible parking is 3.5%.

1 (High): Should be completed immediately. (Includes findings that have little or no cost, were in violation of the codes at the time of construction, or pose an imminent safety threat)

Replace the pavement so the cross slope is 2% maximum or as close to this as is feasible.

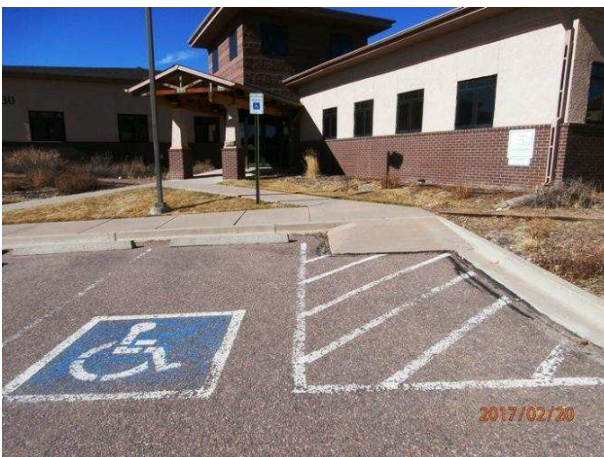
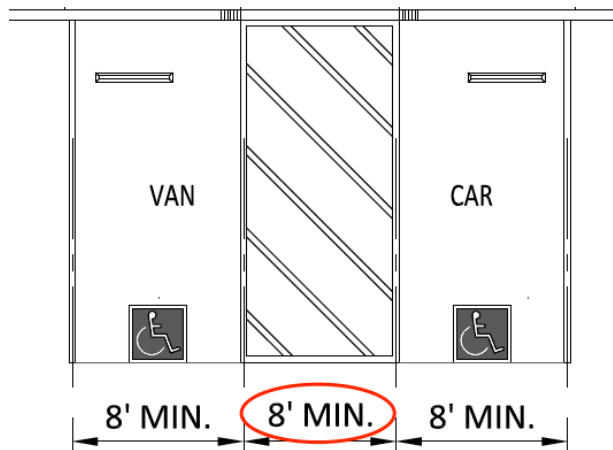
Finding: 4

Since there is only one accessible parking space, it should be van accessible. This requires the parking space to be 8'-0" wide with an 8'-0" wide access aisle, or an 11'-0" wide space with a 5'-0" wide access aisle.

There is only one accessible parking space, and the access aisle is 6'-8".

1 (High): Should be completed immediately. (Includes findings that have little or no cost, were in violation of the codes at the time of construction, or pose an imminent safety threat)

Explore ways to make the access aisle wider.

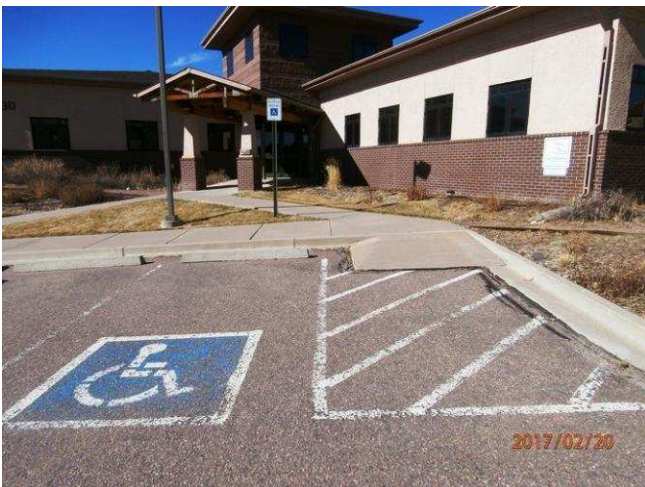
**Finding: 5**

In addition to the gap at the edge of the curb, the gutter pan is 17" wide.

The change in level where the gutter meets the curb ramp is greater than 1/4 inch.

There's a 4" wide by 1-3/4" deep gap at the gutter pan at the access aisle.

1 (High): Should be completed immediately. (Includes findings that have little or no cost, were in violation of the codes at the time of construction, or pose an imminent safety threat)

Fill the gap if we need to gain the additional 17" to the curb for access aisle width.

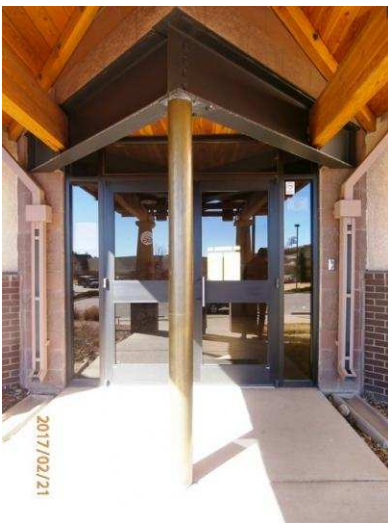
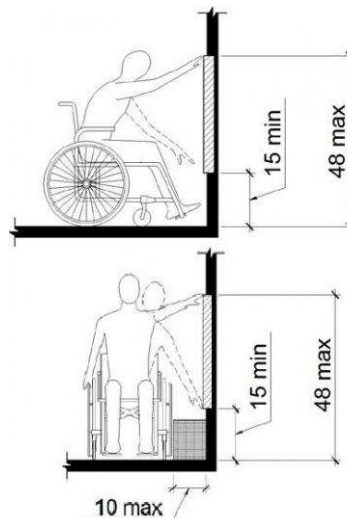
### Finding: 6

The door bell is positioned too high for either a side or front approach.

The door bell is mounted at 50".

1 (High): Should be completed immediately. (Includes findings that have little or no cost, were in violation of the codes at the time of construction, or pose an imminent safety threat)

Lower the door bell to 48" maximum.

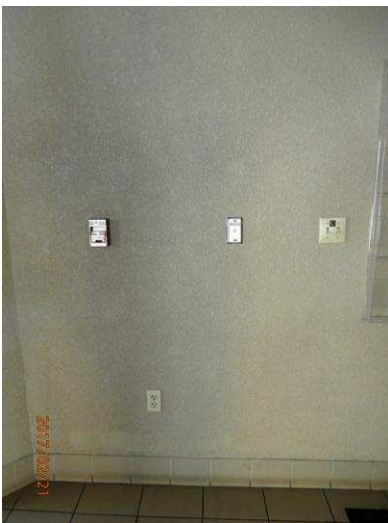
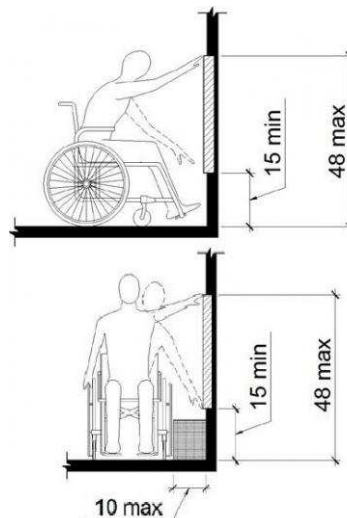
**Finding: 7**

The door bell is positioned too high for either a side or front approach.

The interior door bell is mounted at 50".

1 (High): Should be completed immediately. (Includes findings that have little or no cost, were in violation of the codes at the time of construction, or pose an imminent safety threat)

Lower the door bell to 48" maximum.

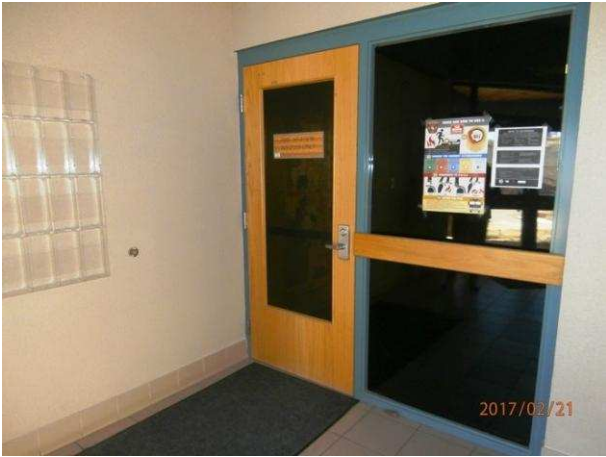
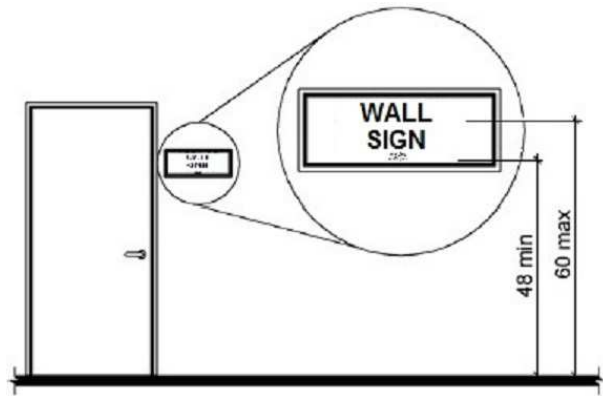
Finding #8 Continued

Compliant room identification signs are missing on the strike side of the door.

**There is not a sign at the interior door to the fire station.**

**2 (Important): Should be completed as soon as possible. (Includes findings that would remove barriers to the greatest number of people to your goods and services)**

**Install a sign with tactile/Braille.**

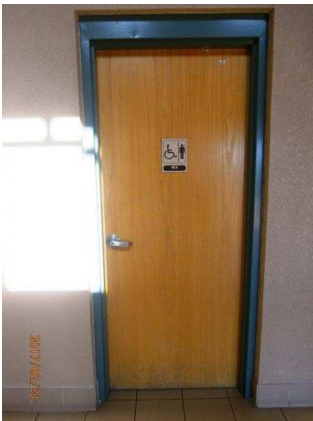
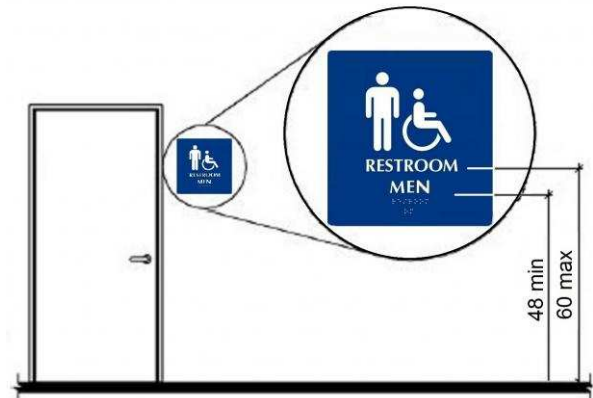
### Finding: 9

The wall sign is mounted too high.

The restroom sign is mounted at 61".

2 (Important): Should be completed as soon as possible. (Includes findings that would remove barriers to the greatest number of people to your goods and services)

Lower the sign to 60" to the top edge.

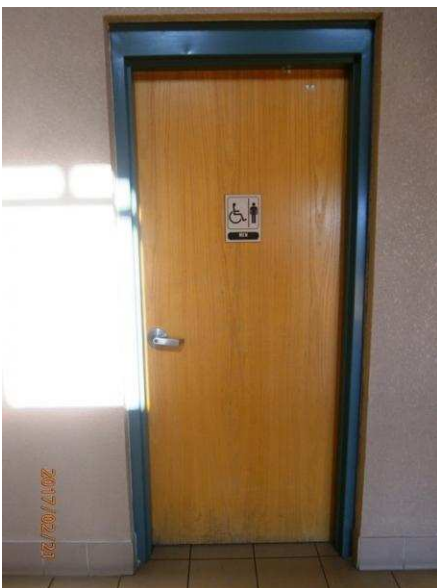
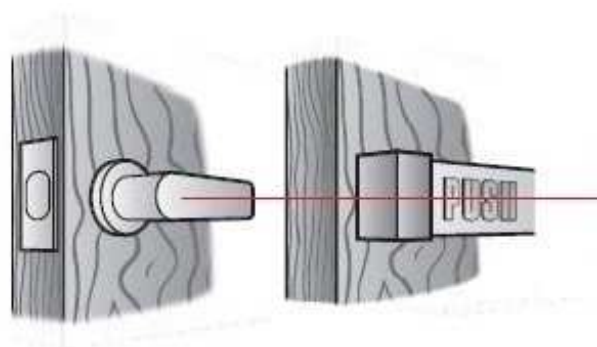
**Finding: 10**

The force required to operate the door hardware exceeds the maximum.

The restroom door requires 13 lbs of force to open.

3 (Moderate): Should be completed as soon as possible, but there may be other items that will provide greater access to persons with disabilities. (Includes findings that have a high financial impact on the entity in relationship to the degree of access provided)

Adjust the door closer to 5lbs maximum.

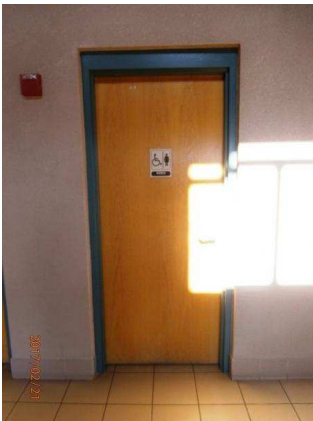
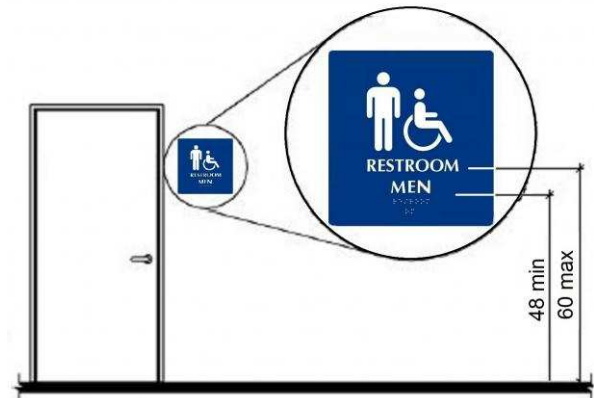
### Finding: 11

The wall sign is mounted too high.

The restroom sign is mounted at 61".

2 (Important): Should be completed as soon as possible. (Includes findings that would remove barriers to the greatest number of people to your goods and services)

Lower the sign to 60" to the top edge.

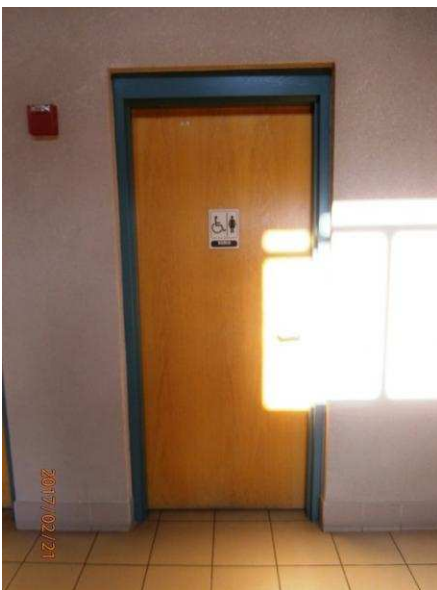
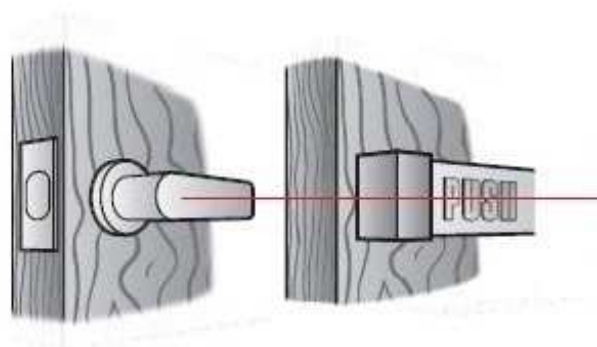
### Finding: 12

The force required to operate the door hardware exceeds the maximum.

The restroom door requires 9 lbs of force to open.

3 (Moderate): Should be completed as soon as possible, but there may be other items that will provide greater access to persons with disabilities. (Includes findings that have a high financial impact on the entity in relationship to the degree of access provided)

Adjust the door closer to 5lbs to the top edge.

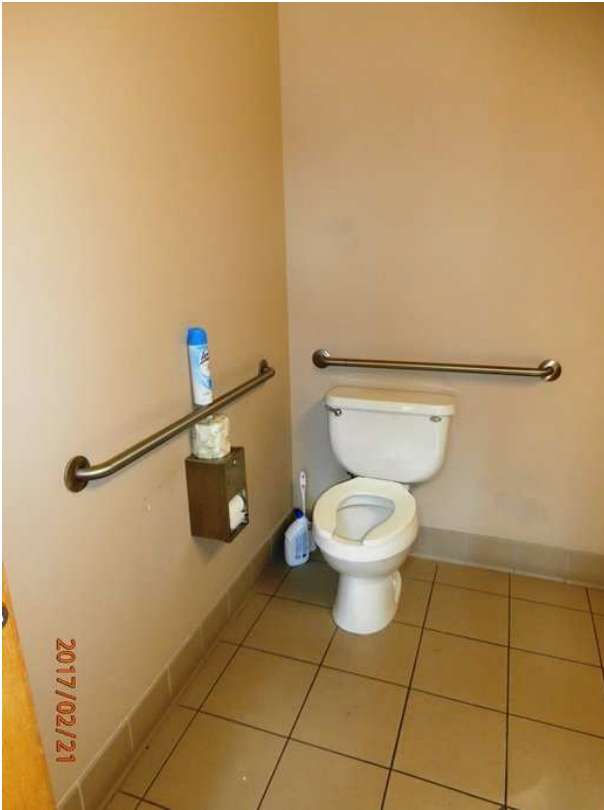
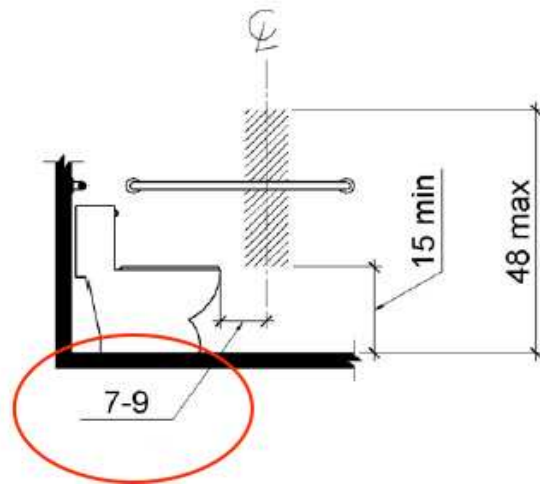
Finding #13 Continued

The toilet paper is not installed within the compliant range.

**The toilet paper dispenser is mounted 4" from the front of the toilet.**

**3 (Moderate): Should be completed as soon as possible, but there may be other items that will provide greater access to persons with disabilities. (Includes findings that have a high financial impact on the entity in relationship to the degree of access provided)**

**Move the toilet paper dispenser to 7 to 9" from the front of the toilet.**

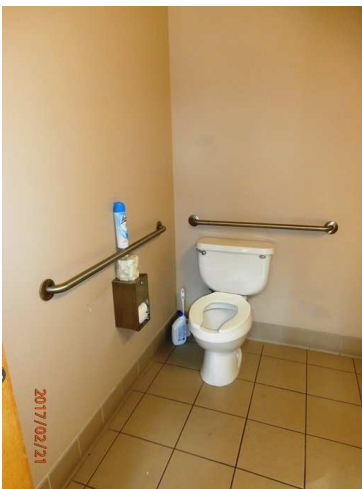
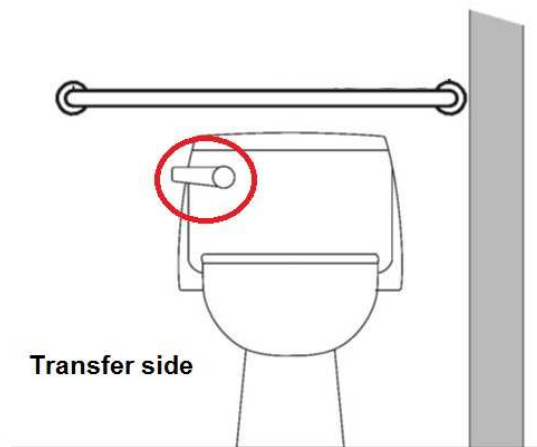
### Finding: 14

The flush handle is located on the wrong side of the toilet.

The flush handle is on the wrong side of the toilet.

3 (Moderate): Should be completed as soon as possible, but there may be other items that will provide greater access to persons with disabilities. (Includes findings that have a high financial impact on the entity in relationship to the degree of access provided)

Replace the tank so the flush handle is on the open side of the toilet.

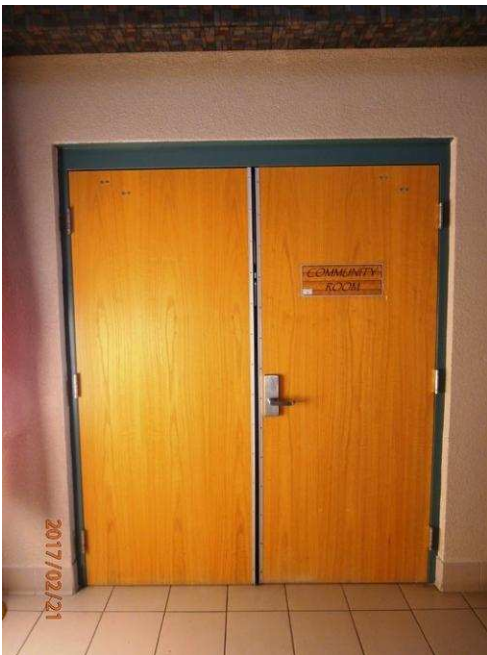
**Finding: 15**

The Braille is not the correct type.

The community room sign is not tactile/Braille.

2 (Important): Should be completed as soon as possible. (Includes findings that would remove barriers to the greatest number of people to your goods and services)

Install another sign with tactile/Braille to the right of the double doors 60" to the top edge.

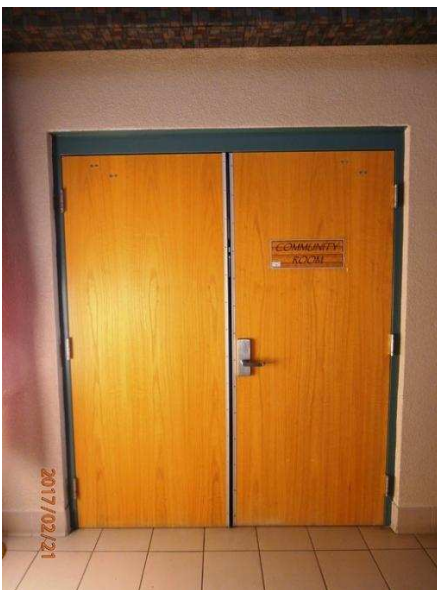
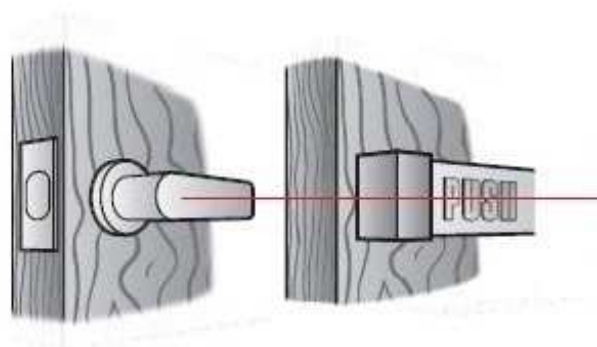
**Finding: 16**

The force required to operate the door hardware exceeds the maximum.

The doors into the community room require 9 and 10 lbs of force to open.

2 (Important): Should be completed as soon as possible. (Includes findings that would remove barriers to the greatest number of people to your goods and services)

Adjust the door closers to 5lbs maximum.

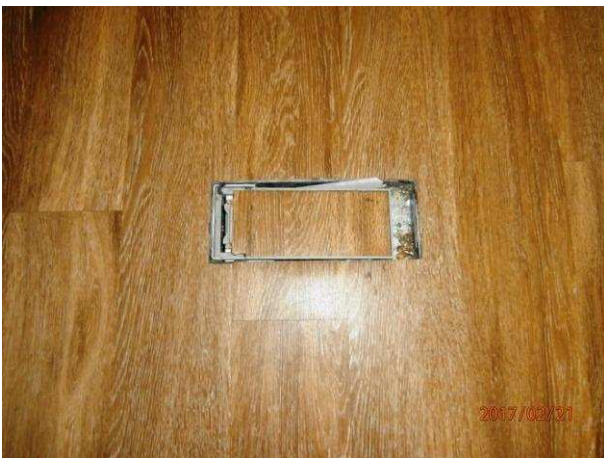
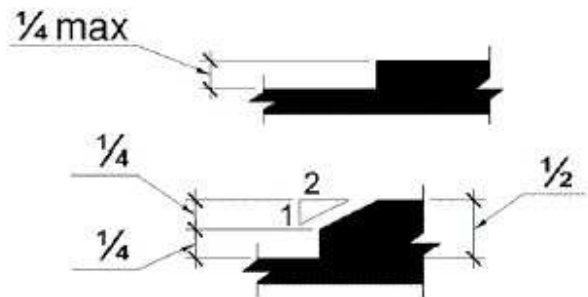
**Finding: 17**

The broken access panel causes a 1" by 4" by 1" deep gap in the floor.

There is a change in level greater than 1/4 inch.

The floor access panel for audio/video is broken.

1 (High): Should be completed immediately. (Includes findings that have little or no cost, were in violation of the codes at the time of construction, or pose an imminent safety threat)

Replace the access panel.
