# Site Accessibility Evaluation

### Fire Station 19

**Accessibility Evaluation**

***Inspection Date: 12/14/2016  
Inspector: Michael Killebrew,  
Anna Kangas***

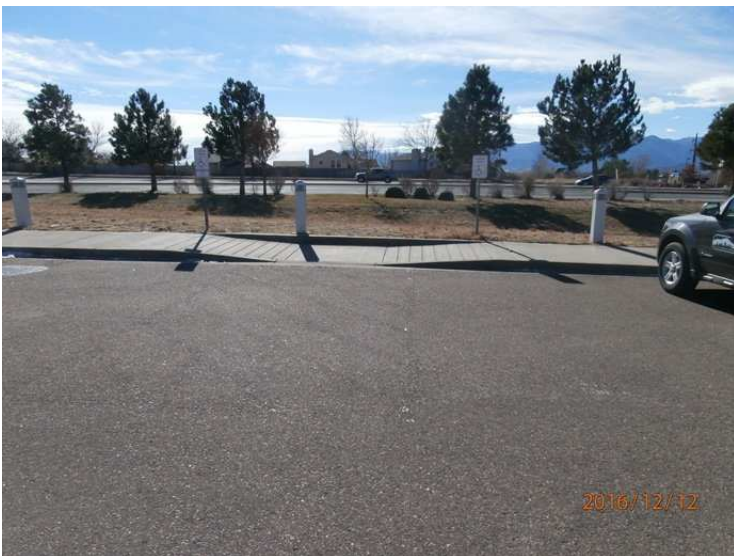
### Finding: 1

The striping and markings for the accessible parking stall, loading/unloading access aisle are dilapidated and in need of repair and/or maintenance.

The parking lot striping has faded and the number of parking spaces can't be determined.

1 (High): Should be completed immediately. (Includes findings that have little or no cost, were in violation of the codes at the time of construction, or pose an imminent safety threat)

Repaint the striping. At least one van accessible space with an access aisle should be provided.

Parking was restriped.

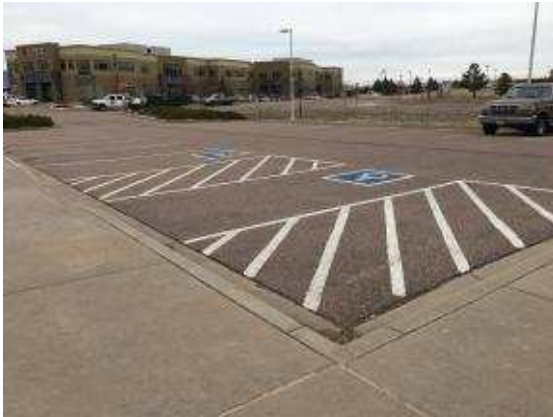
Finding 184337 Additional Photo

CORRECTED

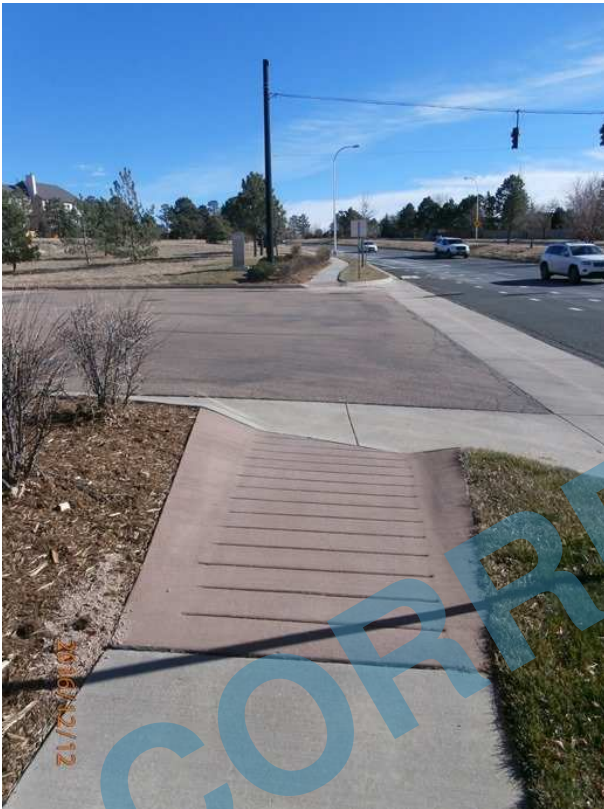
### Finding: 2

The detectable warning is missing at the curb ramp.

**There are no detectable warnings on this curb ramp.**

**1 (High): Should be completed immediately. (Includes findings that have little or no cost, were in**

**Install detectable warnings.**

**Detectable warnings were installed.**

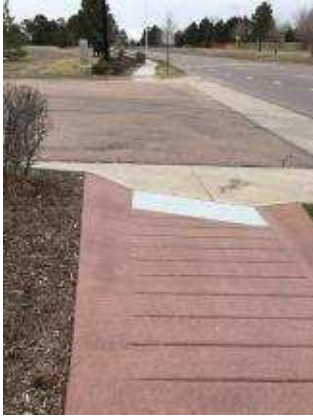
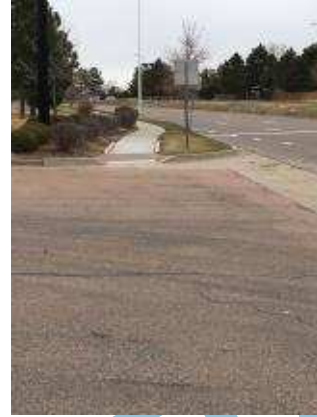
Finding 184338 Additional Photo

CORRECTED

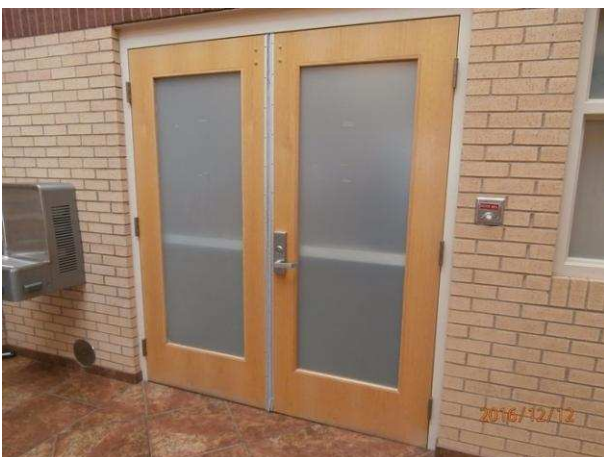
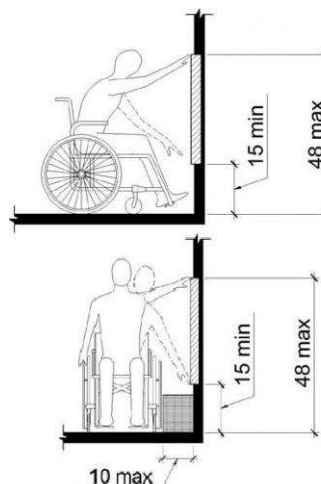
### Finding: 3

The door bell is positioned too high for either a side or front approach.

The door bell in the foyer is mounted at 49-1/2".

2 (Important): Should be completed as soon as possible. (Includes findings that would remove barriers to the greatest number of people to your goods and services)

Lower the door bell to at or under 48".

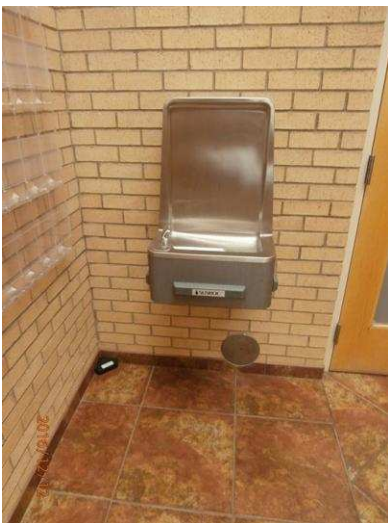
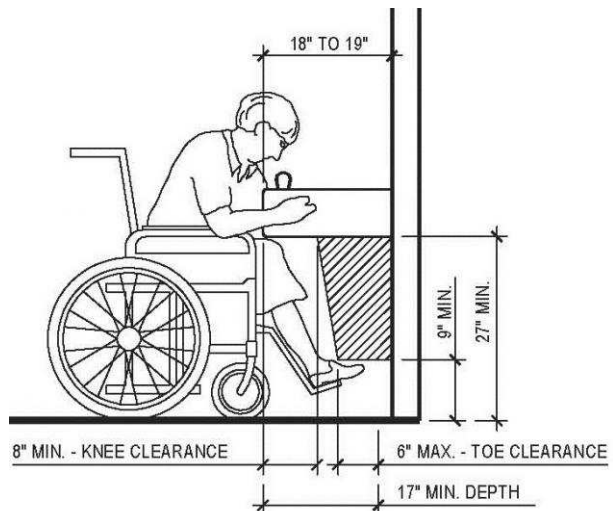
### Finding: 4

There is not enough knee clearance under the drinking fountain.

The drinking fountain has 26-1/2" knee clearance.

4 (Low): Should be completed as soon as possible due to being a technical violation, but may not result in providing greater access to persons with disabilities. (Includes findings that are technically violations but provide a moderate to low increase in accessibility compared to the financial impact on the entity)

Raise the drinking fountain 1/2".

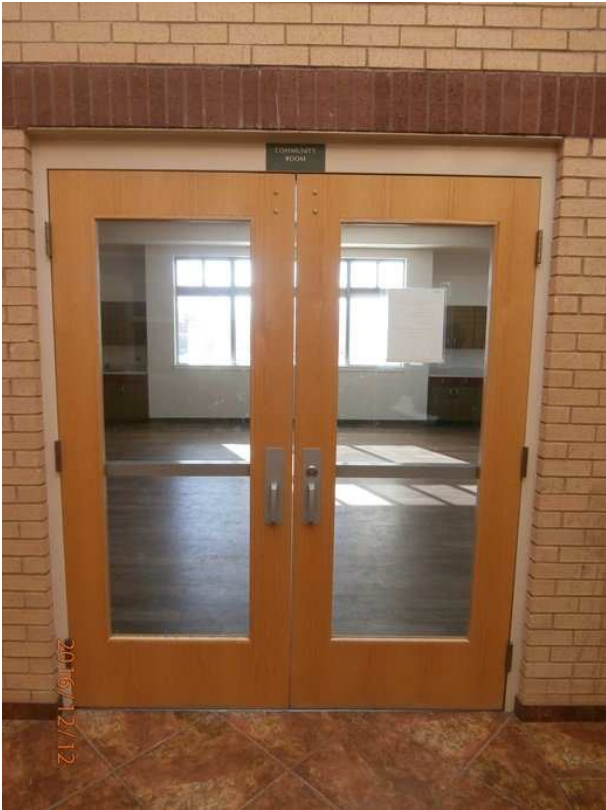
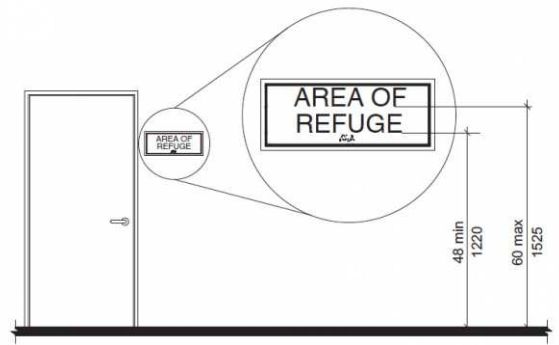
Finding #5 Continued

The wall sign is mounted too high.

The signage for the community room is mounted at 84" above the double doors.

2 (Important): Should be completed as soon as possible. (Includes findings that would remove barriers to the greatest number of people to your goods and services)

Install a tactile/Braille sign to the right side of the double doors 60" to the top edge.

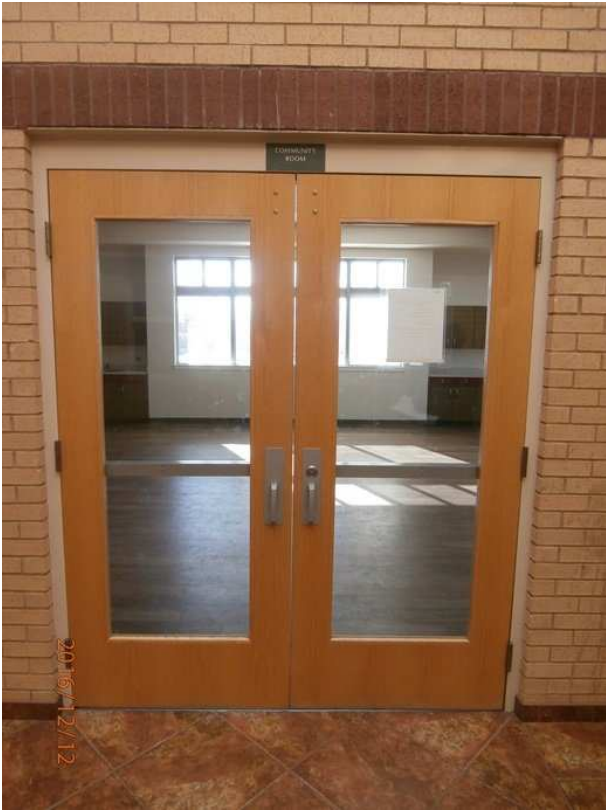
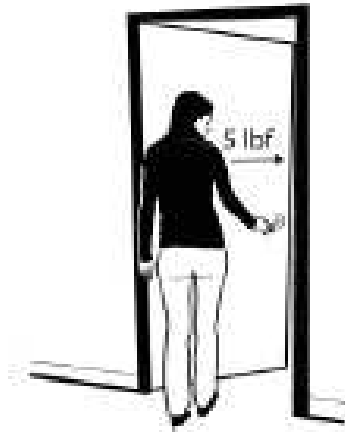
### Finding #6 Continued

The door exceeds the maximum pressure to open the door.

The doors into the community room require 18 and 20 lbs of force to operate.

1 (High): Should be completed immediately. (Includes findings that have little or no cost, were in violation of the codes at the time of construction, or pose an imminent safety threat)

Adjust the door tension to 5lbs maximum.

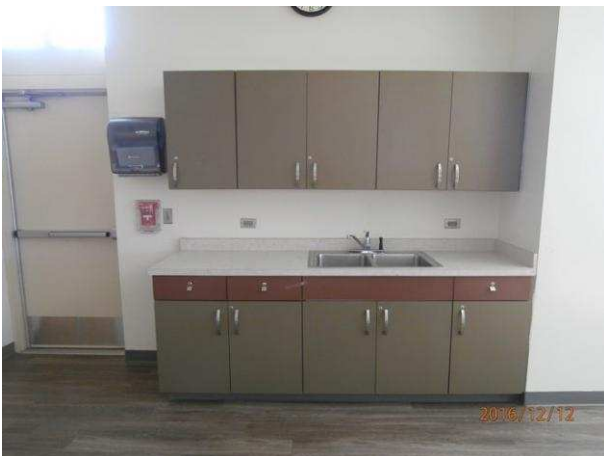
**Finding: 7**

The paper towel dispenser's operation mechanism is too high off the floor.

the paper towel dispenser is mounted at 59-1/2" to the operable part.

3 (Moderate): Should be completed as soon as possible, but there may be other items that will provide greater access to persons with disabilities. (Includes findings that have a high financial impact on the entity in relationship to the degree of access provided)

Lower the paper towel dispenser to 48" or lower to operable part.

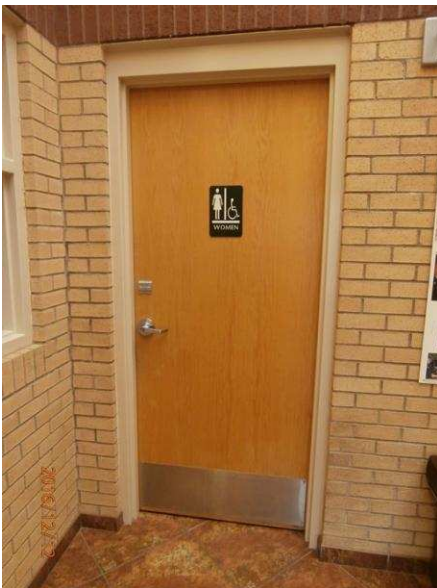
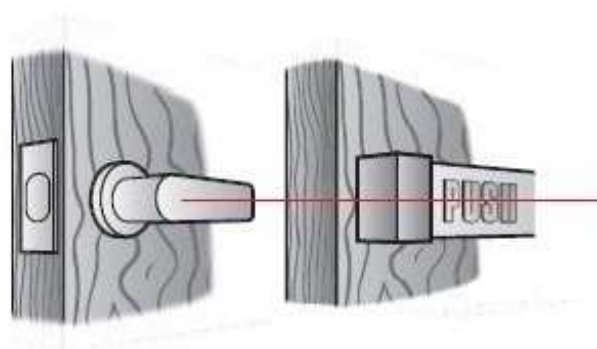
### Finding: 8

The force required to operate the door hardware exceeds the maximum.

The restroom door requires 20 lbs of force to operate.

3 (Moderate): Should be completed as soon as possible, but there may be other items that will provide greater access to persons with disabilities. (Includes findings that have a high financial impact on the entity in relationship to the degree of access provided)

Adjust the door closer to 5lbs force to operate.

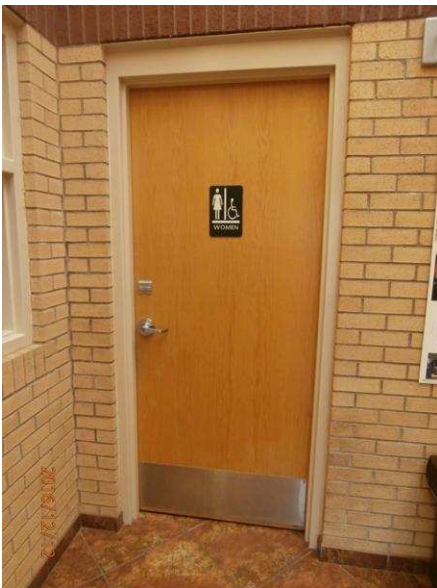
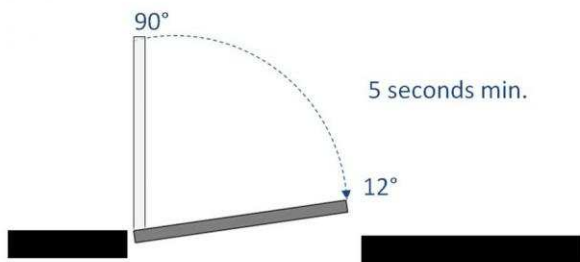
### Finding: 9

The door is equipped with a door closer and returns to a closed position too quickly.

The restroom door closes too fast.

3 (Moderate): Should be completed as soon as possible, but there may be other items that will provide greater access to persons with disabilities. (Includes findings that have a high financial impact on the entity in relationship to the degree of access provided)

Adjust the door closer.

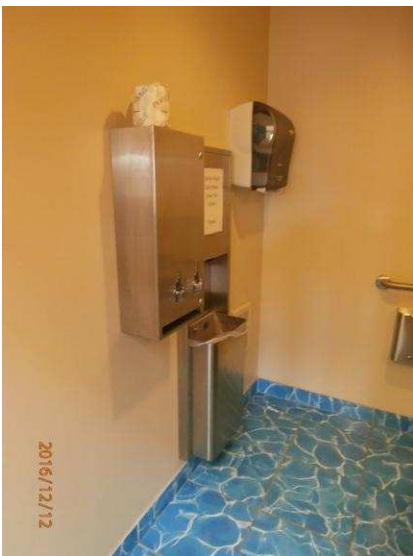
### Finding: 10

The paper towel dispenser's operation mechanism is too high off the floor.

The paper towel dispenser is mounted at 57" to the operable part.

3 (Moderate): Should be completed as soon as possible, but there may be other items that will provide greater access to persons with disabilities. (Includes findings that have a high financial impact on the entity in relationship to the degree of access provided)

Lower the paper towel dispenser to 48" to the operable portion.

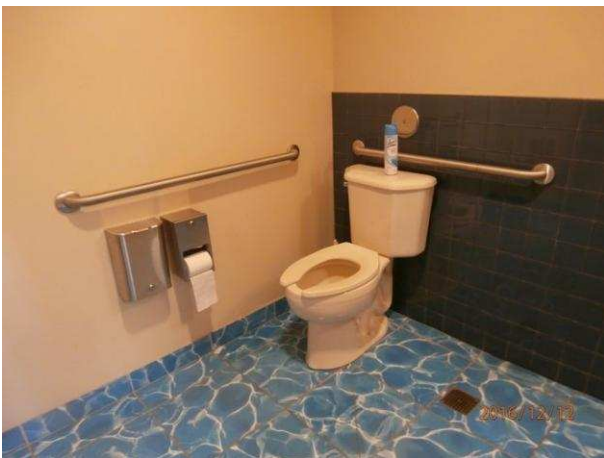
### Finding: 11

The flush handle is located on the wrong side of the toilet.

The flush handle is on the wrong side of the toilet.

3 (Moderate): Should be completed as soon as possible, but there may be other items that will provide greater access to persons with disabilities. (Includes findings that have a high financial impact on the entity in relationship to the degree of access provided)

Install a new tank with the flush handle on the open side.

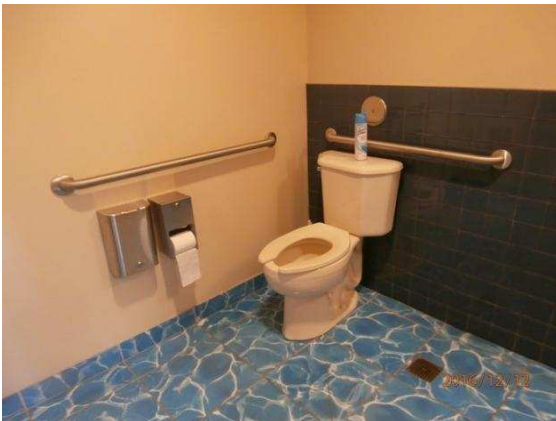
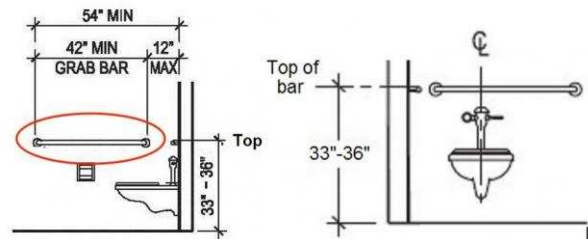
### Finding: 12

The side and rear grab bars are too high.

The grab bars are mounted at 36-3/4".

3 (Moderate): Should be completed as soon as possible, but there may be other items that will provide greater access to persons with disabilities. (Includes findings that have a high financial impact on the entity in relationship to the degree of access provided)

Lower the grab bars to under 36" to the top edge.

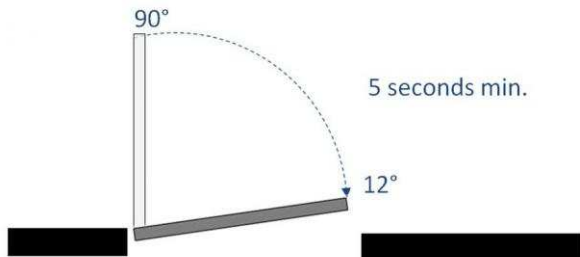
### Finding: 14

The door is equipped with a door closer and returns to a closed position too quickly.

The door into the restroom closes too fast.

3 (Moderate): Should be completed as soon as possible, but there may be other items that will provide greater access to persons with disabilities. (Includes findings that have a high financial impact on the entity in relationship to the degree of access provided)

Adjust the door closer.

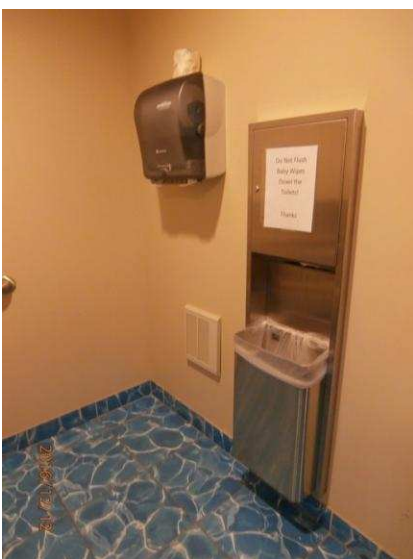
**Finding: 15**

The paper towel dispenser's operation mechanism is too high off the floor.

The paper towel dispenser is mounted at 56" to the operable part.

3 (Moderate): Should be completed as soon as possible, but there may be other items that will provide greater access to persons with disabilities. (Includes findings that have a high financial impact on the entity in relationship to the degree of access provided)

Lower the paper towel dispenser to under 48" to the operable feature.

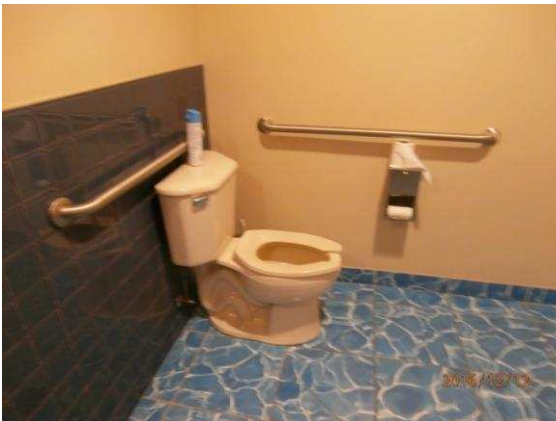
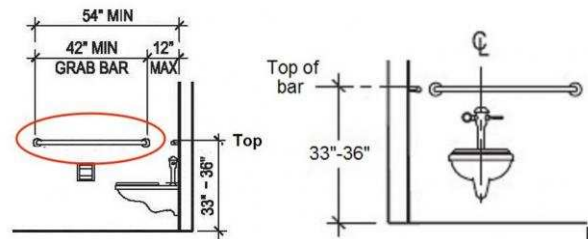
### Finding: 16

The side and rear grab bars are too high.

The grab bars are mounted at 36-3/4".

3 (Moderate): Should be completed as soon as possible, but there may be other items that will provide greater access to persons with disabilities. (Includes findings that have a high financial impact on the entity in relationship to the degree of access provided)

Lower the grab bars to under 36" to the top edge.
