Site Accessibility Evaluation

Fire Station 1

Accessibility Evaluation

***Inspection Date: 12/07/2017
Inspector: Michael Killebrew,
Anna Kangas***

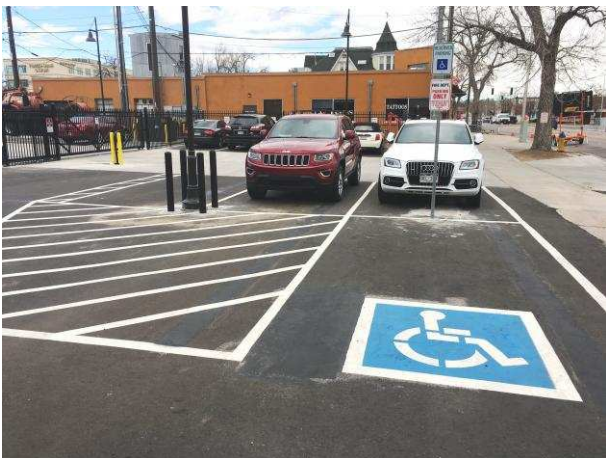
Finding 184726 Main Photo

The van stall is missing a sign identifying it as a van accessible stall.

The van accessible parking space is not signed as such.

1 (High): Should be completed immediately. (Includes findings that have little or no cost, were in violation of the codes at the time of construction, or pose an imminent safety threat)

Add a van accessible sign to the existing post.

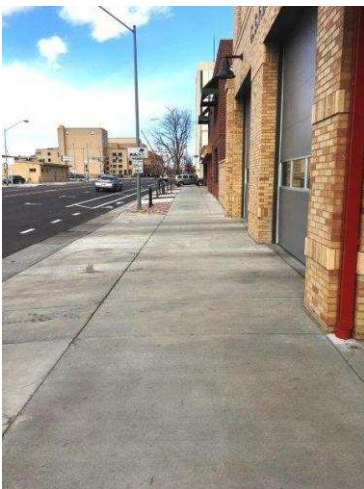
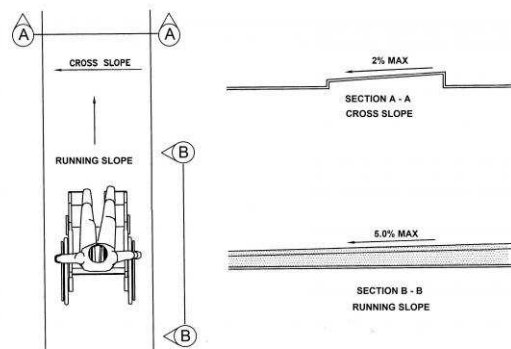
The accessible path of travel contains cross slopes greater than 2%.

The cross slope at the front of the fire station is 3 to 3.8% for about 100' of sidewalk.

1 (High): Should be completed immediately. (Includes findings that have little or no cost, were in violation of the codes at the time of construction, or pose an imminent safety threat)

If feasible, remove and replace concrete panels as needed to achieve 2% maximum cross slope.

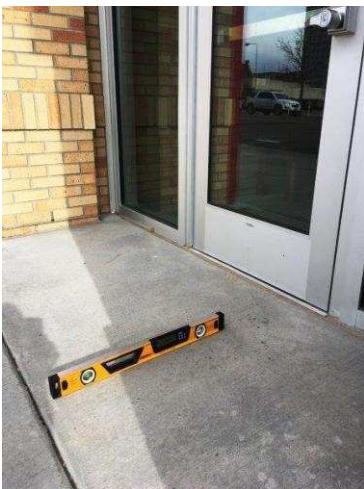
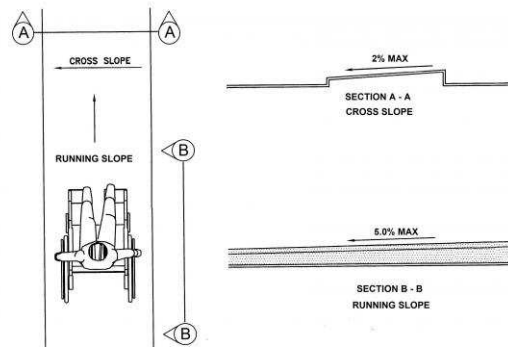
The running slope of the landing at the front door is 4.2%. It should be at 2% maximum.

There is not a level landing at the front door.

Remove and replace the landing if feasible.
