Site Accessibility Evaluation

Fire Station 21

Accessibility Evaluation

SUBJECT: Fire Station 21 Self-Evaluation

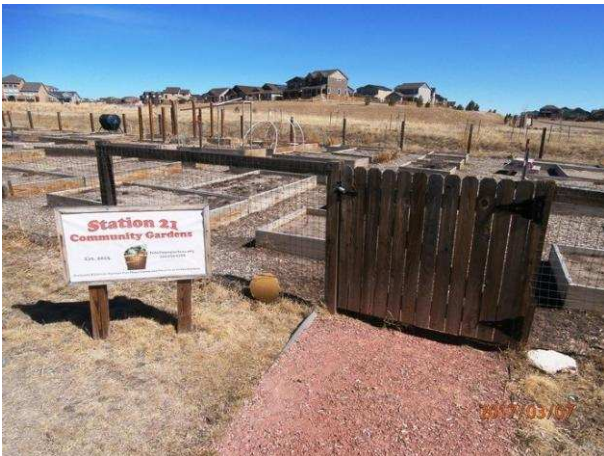
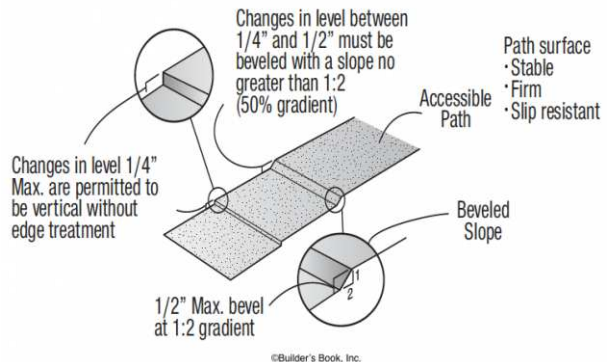
Finding: 1

The accessible route contains loose gravel and/or surfaces that do not provide for a stable, firm slip resistant surface.

2010 ADAS Section: 302.1

The community garden is accessed via a loose chip rock path.

Pave a path between the driveway and the community garden. The new pavement would be about 25' in length. The existing gravel path is about 4' wide.

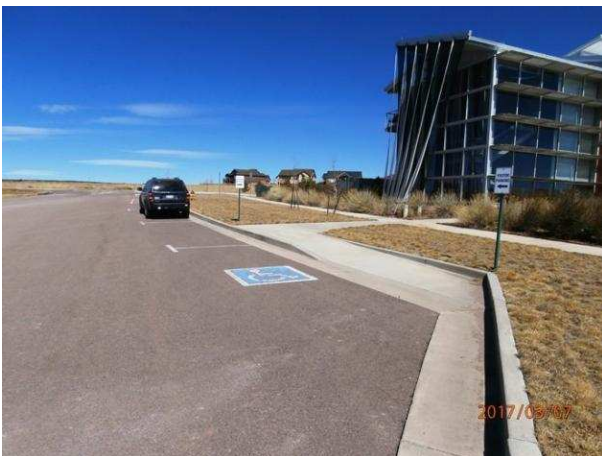
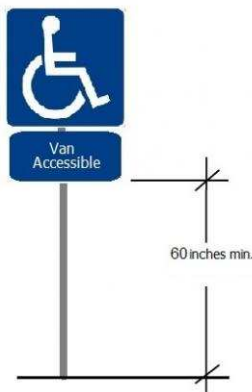
Finding: 2

The required parking signage is missing.

2010 ADAS Section: 502.6

The accessible parking space does not have post-mounted signage.

Install post-mounted signage at the accessible parking space, including a van accessible sign.

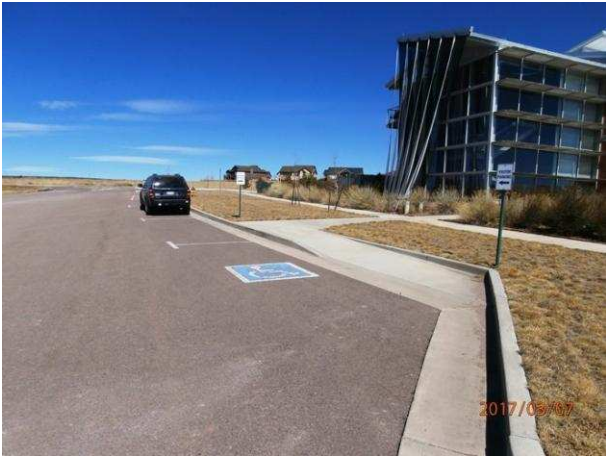
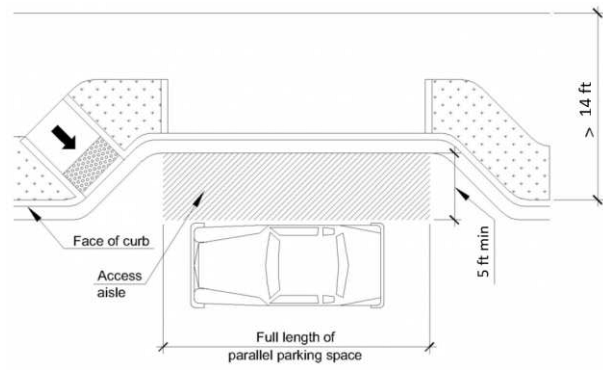
Finding #3 Continued

The access aisle is missing for the accessible parking space. The parallel AC space is 22' long with asphalt to hashing and 6'11" wide. If you include the gutter pan, the width of the AC parking increases to 8'11" wide. We need 13' of space.

2011 PROWAG Section: R309.2.1

There are not access aisles at the accessible parking spaces.

Add access aisles.

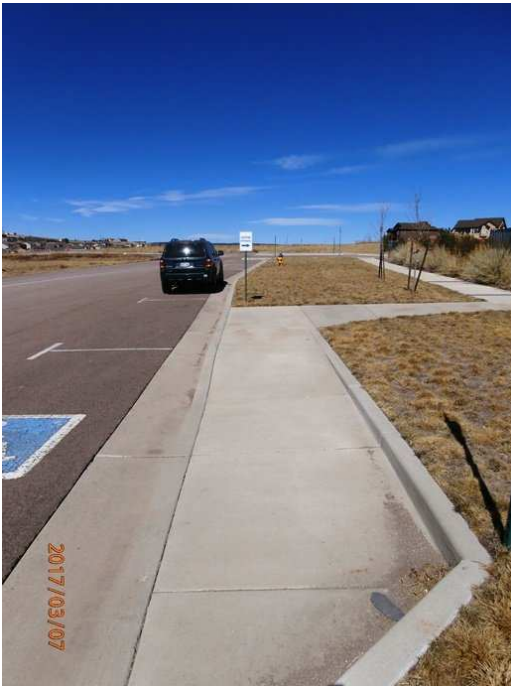
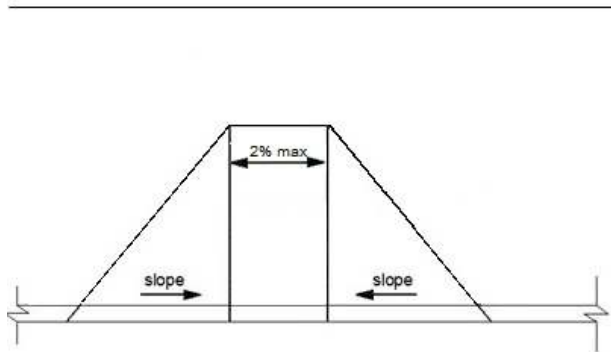
Finding: 4

The curb ramp on the accessible route contains cross slopes greater than 2%.

2010 ADAS Section: 405.3

The curb ramp has cross slope of 4.5%.

Remove and replace the curb ramp.

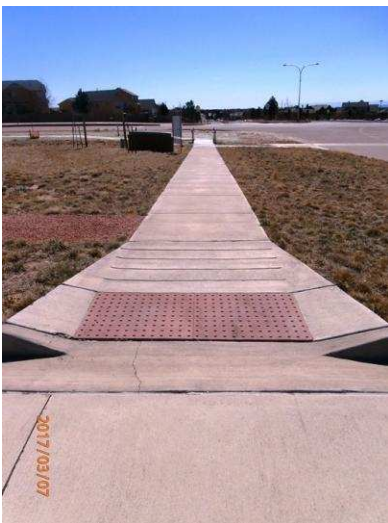
Finding: 5

The change in level where the gutter meets the curb ramp is greater than 1/4 inch.

2010 ADAS Section: 303.3

There is 1/2" gap and 3/8" vertical displacement at the bottom of the curb ramp.

Fill the gap; this will also create a transition for the vertical displacement.

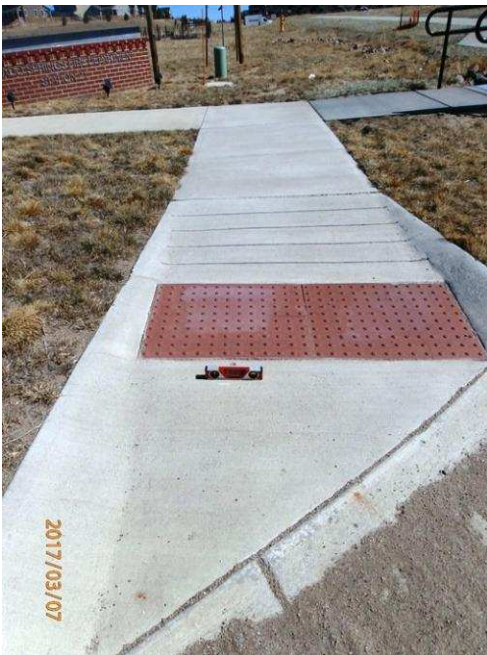
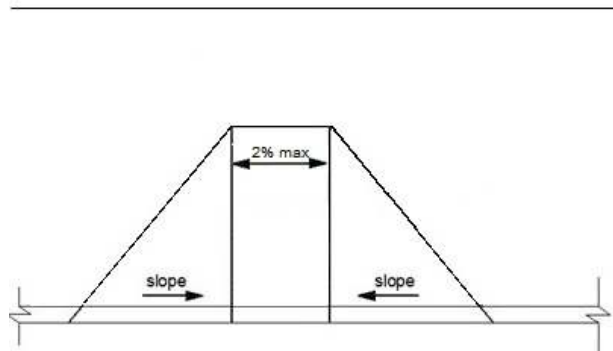
Finding: 6

The curb ramp on the accessible route contains cross slopes greater than 2%.

2010 ADAS Section: 405.3

The curb ramp has cross slope of 4%.

Remove and replace curb ramp. It might be this ramp must be sloped due to adjoining street. However, it appears this is not the case.

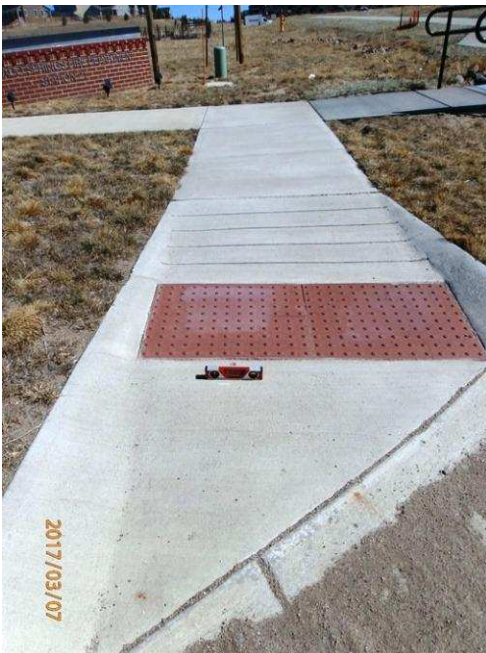
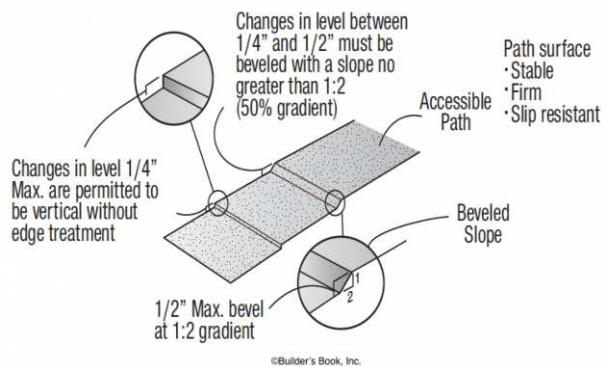
Finding: 7

The surface of the curb ramp is not firm, stable and/or slip resistant..

2010 ADAS Section: 302.1

The gutter of the curb ramp is full of debris and dirt.

Keep the curb ramp gutter clear of debris and dirt.

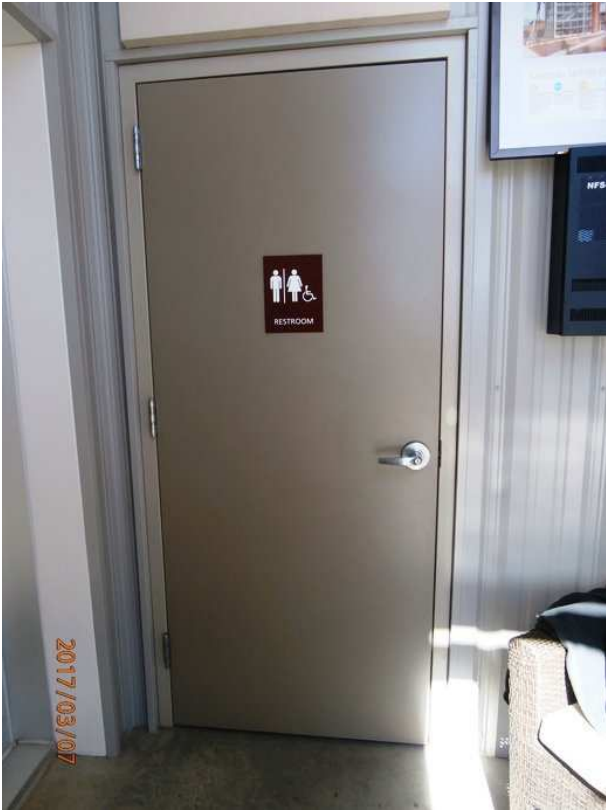
Finding #8 Continued

The door exceeds the maximum pressure to open the door.

2010 ADAS Section: 404.2.9

The door into the unisex restroom requires 10 lbs of force to open.

Adjust the door closer.

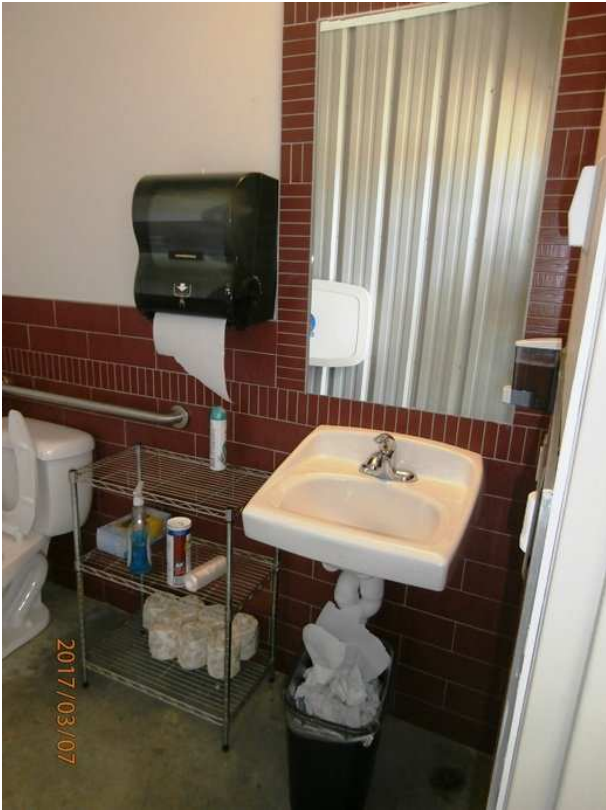
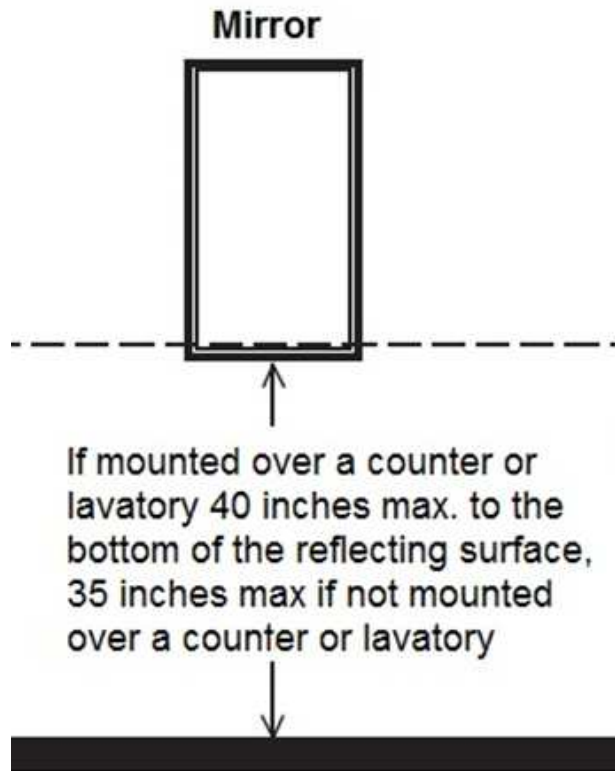
Finding #9 Continued

The mirror is mounted too high.

2010 ADAS Section: 603.3

The mirror is mounted at 41" to the reflective surface.

Due to how the mirror is mounted, it may be more economical to add a full length mirror on an adjacent wall rather than lowering the mirror above the lavatory. The bottom edge of the reflective surface of the full length mirror should be at 35" maximum from the floor.

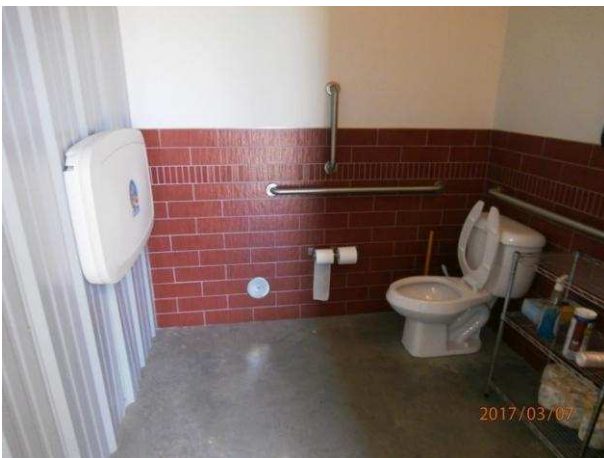
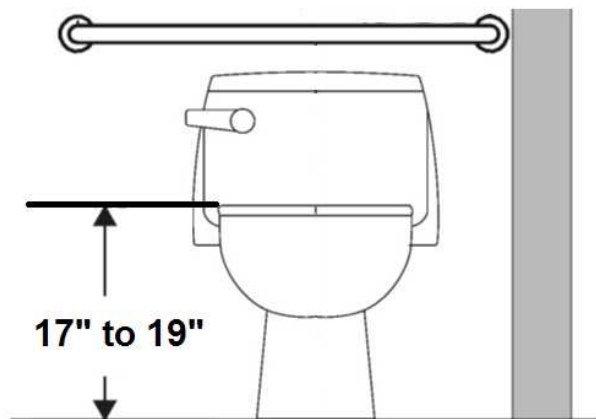
Finding: 10

The toilet seat is not located within the range allowed off the floor.

2010 ADAS Section: 604.4

The toilet seat is 16-1/2" high.

The toilet seat needs to be 17" to 19" to the top of the seat. Explore a high-profile toilet seat (maximum 2" height). Otherwise, the toilet base will need to be replaced which is likely the needed course as the flush is on the wrong side and tank will need replaced.

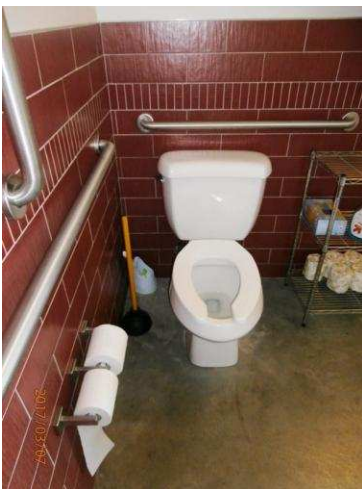
Finding: 11

The flush handle is located on the wrong side of the toilet.

2010 ADAS Section: 604.6

The flush handle is on the wrong side of the toilet.

Replace the tank so the flush handle is on the open side of the toilet.
