Site Accessibility Evaluation

Fire Station 22

Accessibility Evaluation

***Inspection Date: 12/12/2016
Inspector: Michael Killebrew,
Anna Kangas***

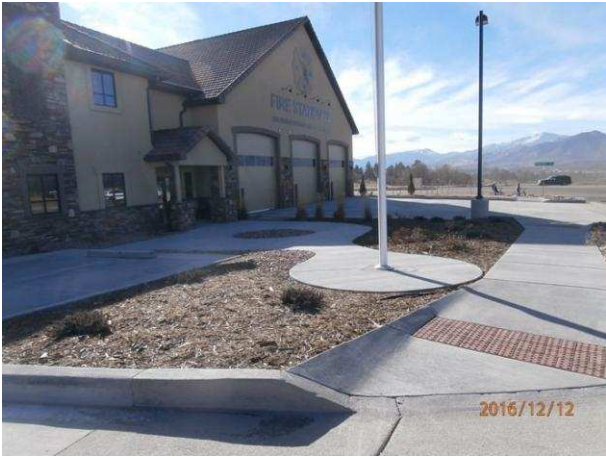
Finding #1 Continued

The building entrance is not located on an accessible route.

There is not an accessible route to the front entrance from the parking.

Add concrete panels between the sidewalk and flagpole to create an accessible path to the front entrance.

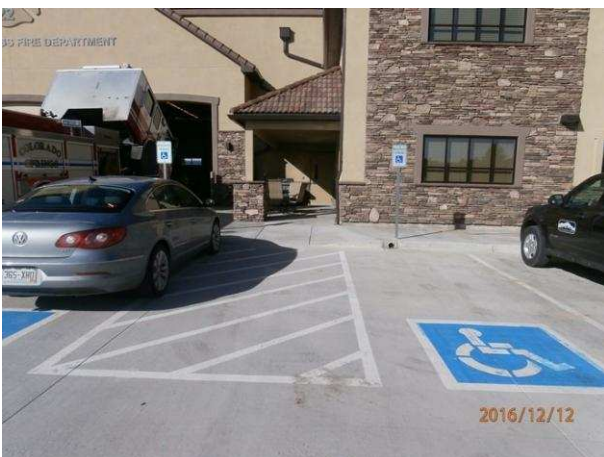
The van stall is missing a sign identifying it as a van accessible stall.

There are two accessible spaces, but neither is signed as van accessible.

Add van accessible signage to the left accessible parking space.

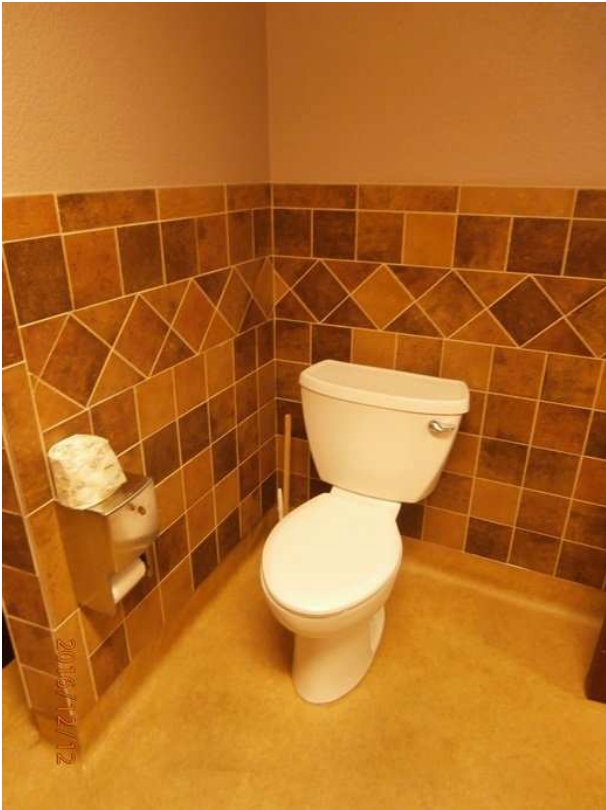
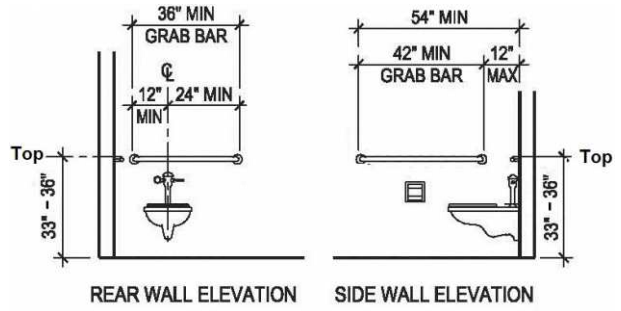
Finding #3 Continued

Accessible toilets must have grab bars installed.

The men's restroom does not have grab bars.

Either add grab bars to this restroom, or designate both restrooms as unisex, and the current women's restroom as the accessible restroom.

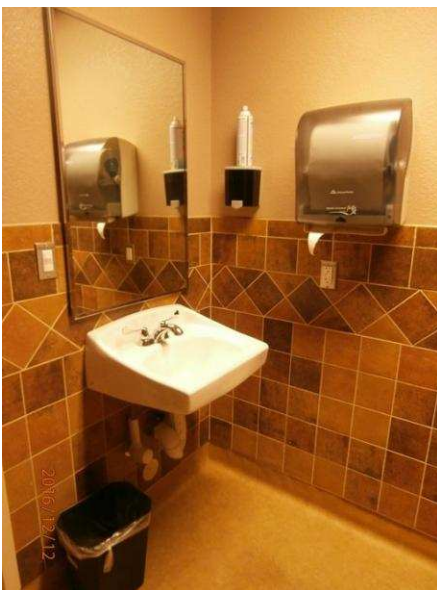
The paper towel dispenser's operation mechanism is too high off the floor.

The paper towel dispenser is mounted at 53" to the sensor.

Lower the paper towel dispenser to 48" maximum to the sensor.

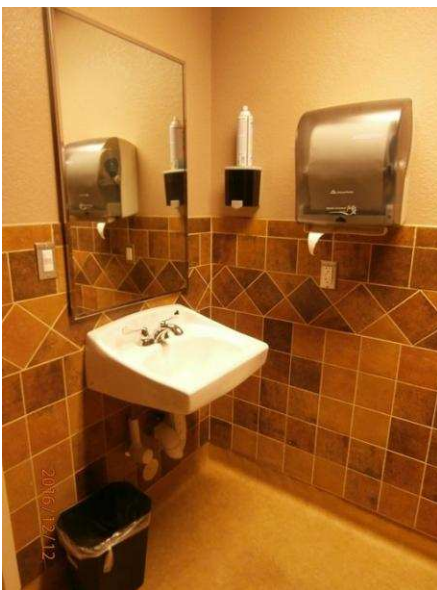
The soap dispenser's operation mechanism is too high off the floor.

The soap dispenser is mounted at 54" to the operable part.

Lower the soap dispenser to 48" maximum to the operable part.

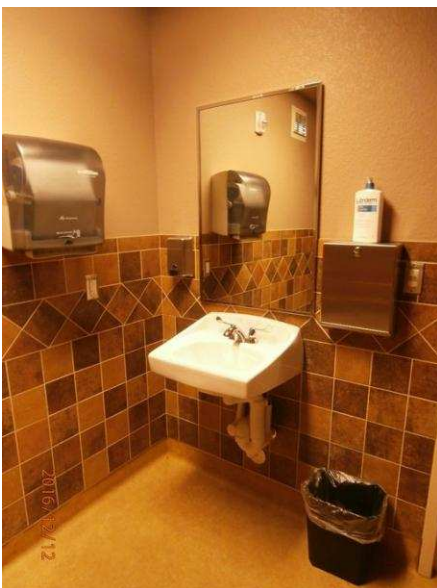
The paper towel dispenser's operation mechanism is too high off the floor.

The paper towel dispenser is mounted at 53" to the sensor.

Lower the paper towel dispenser to 48" maximum to the sensor.
