Site Accessibility Evaluation

Fire Station 2

**314 E San Miguel St
Colorado Springs, CO
80903**

Accessibility Evaluation

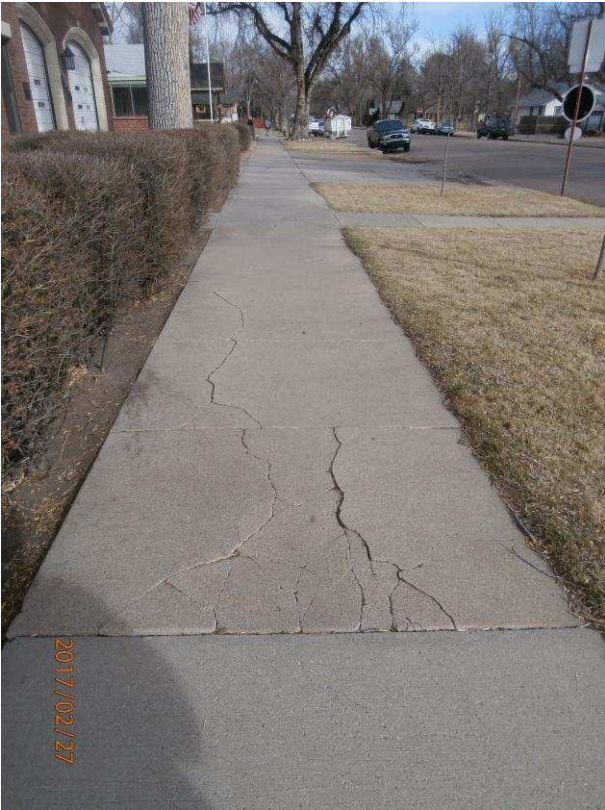
Finding #1 Continued

These three concrete pads have vertical displacement up to 1/2" due to fracturing in the concrete. The fracturing is also causing cross slopes up to 3.2%.

The walkway contains abrupt vertical edges and/or variations over a 1/4 inch.

Three concrete pads are in disrepair.

Remove and replace the concrete.

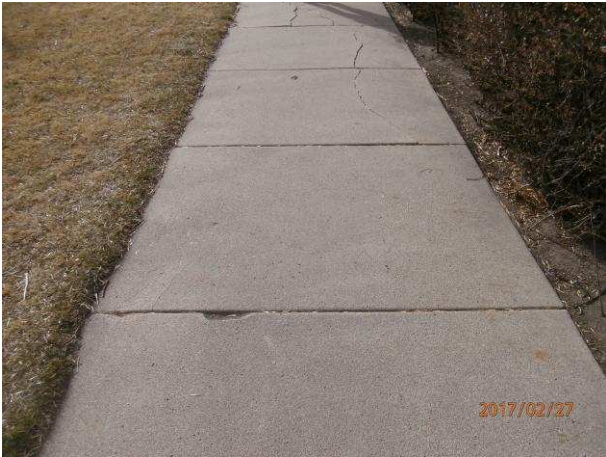
Finding #2 Continued

The sidewalk has a 1-1/2" wide by 7" long by 1/2" deep gap in the concrete.

The walkway contains abrupt vertical edges and/or variations over a 1/4 inch.

The walkway has a gap in the concrete.

Remove and replace a portion of the panel or this pad.

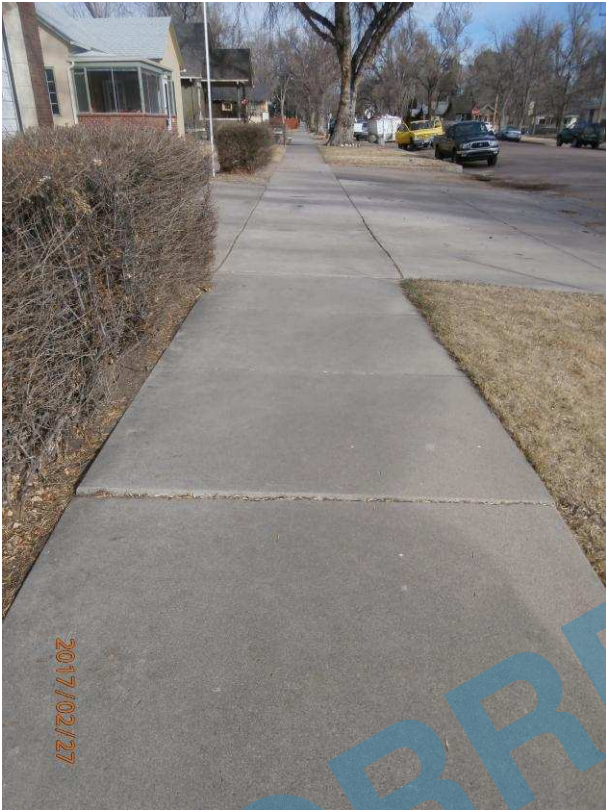
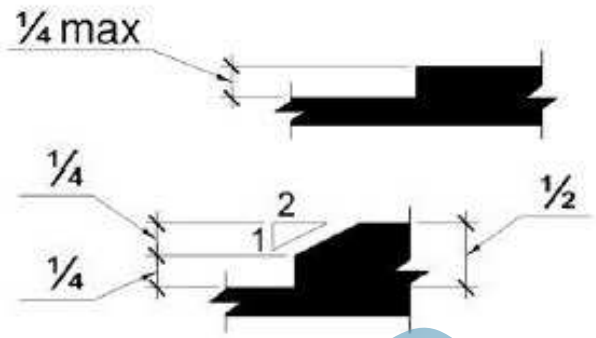
Finding #3 Continued

The walkway contains abrupt vertical edges and/or variations over a 1/4 inch.

The sidewalk has vertical displacement up to 1".

CORRECTED

Grind the area to less than 1/2" or replace due to vertical displacement and cross slope.

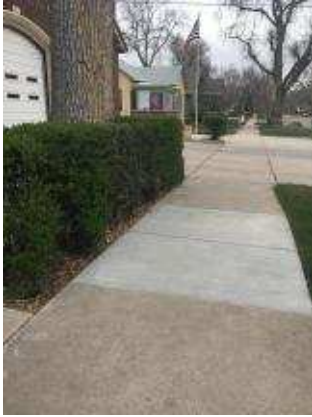
Finding 184225 Additional Photo

CORRECTED

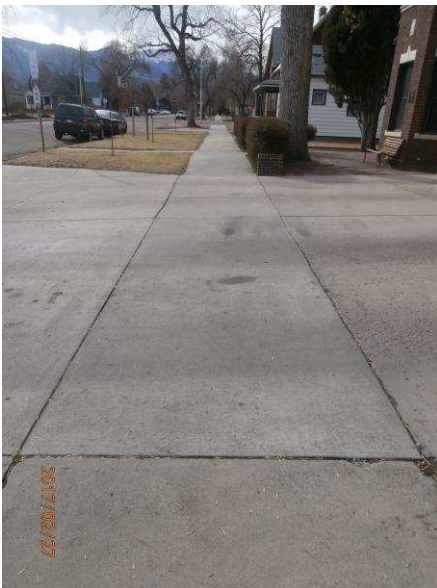
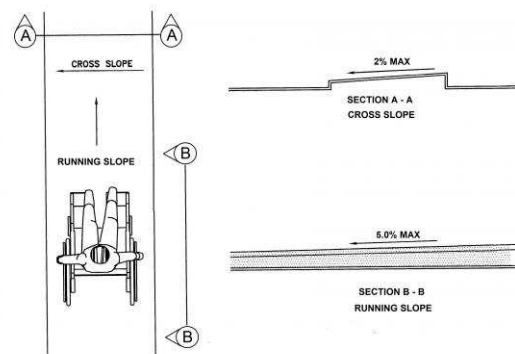
The accessible route of travel on the walk or sidewalk contains cross slopes greater than 2%.

The cross slope of the accessible route within the driveway is up to 3%.

Remove and replace panels as feasible to create a pedestrian access route.

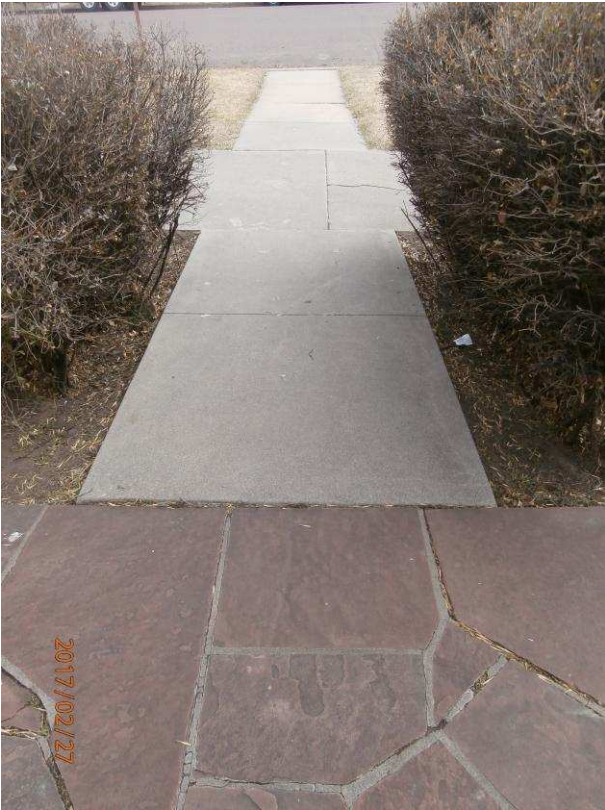
Finding #5 Continued

The walkway contains abrupt vertical edges and/or variations over a 1/4 inch.

In addition to the vertical displacement between the concrete and flagstone, the joints in the flagstone are deteriorating.

There is 1/2" vertical displacement between the concrete and the flagstones.

Explore methods of filling the joints in flagstone and reducing the vertical displacement between the materials or simply tear out and replace.

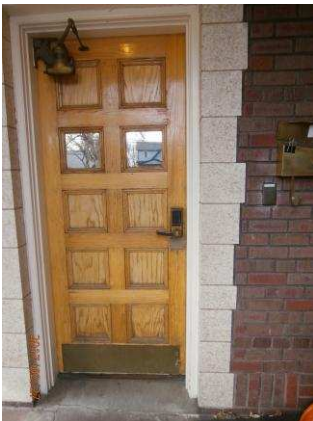
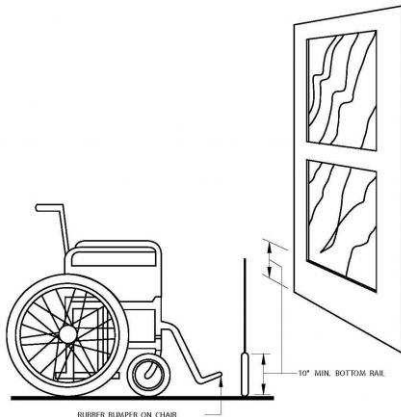
The door has a door stop which prevents it from having a smooth surface at the bottom.

The front door has a door stop.

Replace the door stop with a different hold open device that does not impede wheelchair access.

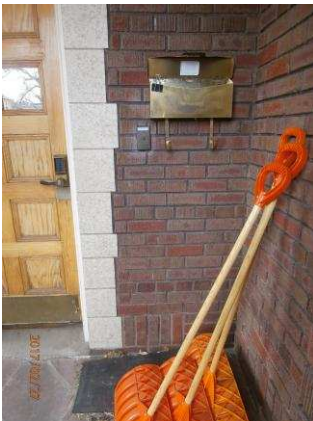
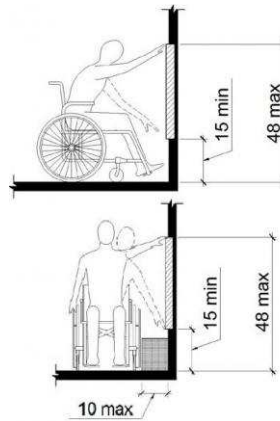
The door bell is positioned too high for either a side or front approach.

The door bell is mounted at 50-1/2".

Lower the door bell to maximum 48" high.

Also, keep a 30" x 48" clear area at the door bell to allow for approach. The snow shovels need to be stored outside this area.

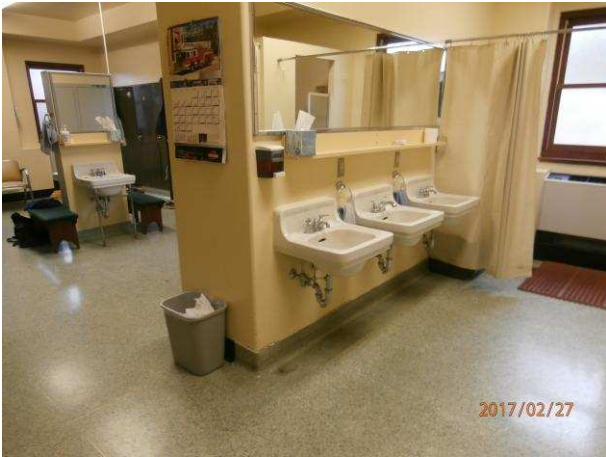
Finding #8 Continued

The owner or owners representative indicated that no public restrooms were available, however there was a non compliant restroom labeled as accessible and available to the public. If the restroom is desired to be an employee only restroom, it is recommended that the door be locked, the signs be removed and replaced with a new sign that that sates "employees only" or "private area". Any future improvements may be required under Title I of the ADA for work place reasonable accommodations.

The restrooms are not accessible.

Add signage that restrooms are for employee use only, and that no accessible restrooms are available.
