Site Accessibility Evaluation

Fire Station 3

**922 W Colorado Ave
Colorado Springs, CO
80905**

Accessibility Evaluation

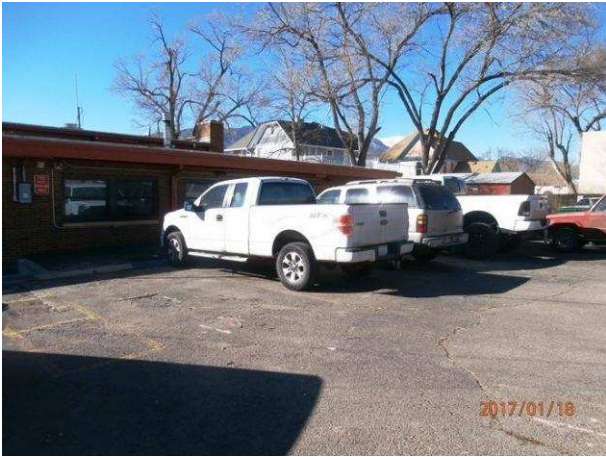
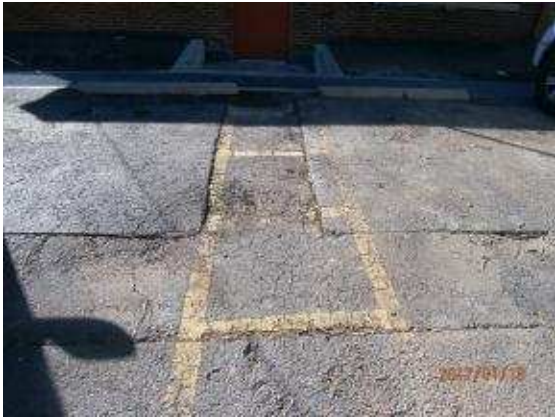
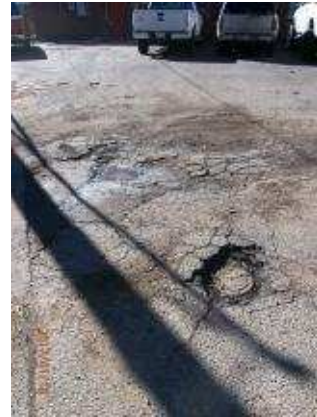
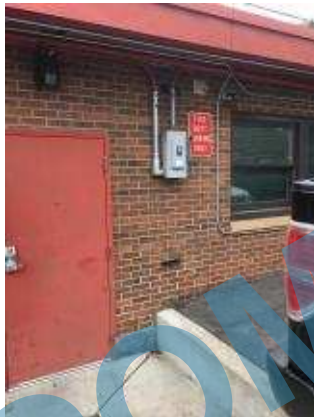
Finding #1 Continued

There are no accessible parking stalls. The parking lot serves the fire department personnel. There is not an accessible route to the rear entrance of the fire station.

The parking lot only has 6 spaces and none are designated as accessible.

The lot is signed for "Fire Dept Parking Only". Add another sign at parking entrance as this small sign is hard to see.

Keep the parking lot for fire department personnel only. Install a sign indicating the accessible entrance is in front. Consider adding an accessible space on the street.

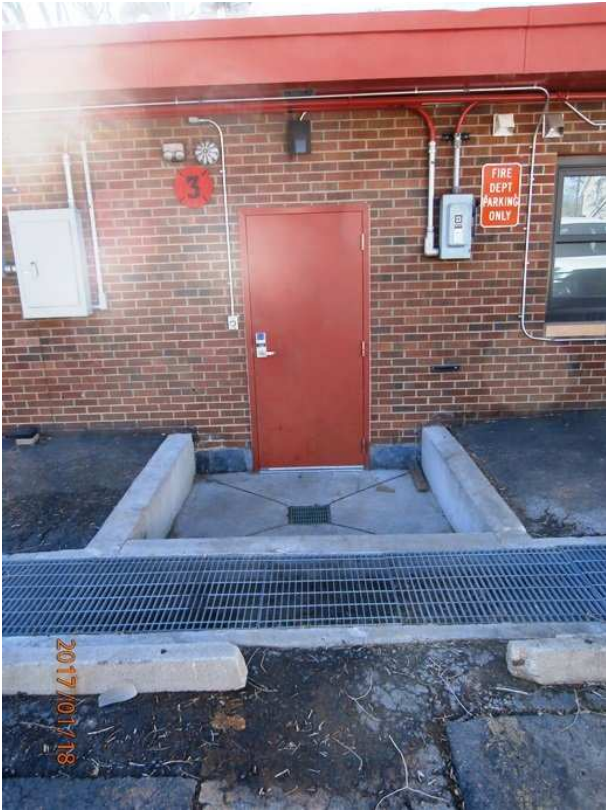
Finding #2 Continued

The rear entrance may only be accessed by 2 steps, totalling 14".

This path of travel requires crossing a drainage grate with holes greater than 1/2" in the path of travel.

The walkway contains abrupt vertical edges and/or variations over a 1/4 inch.

The rear entrance is not accessible.

Leave as is, and install signage indicating the front entrance is the accessible entrance.

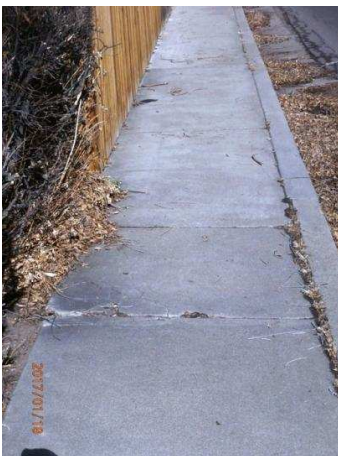
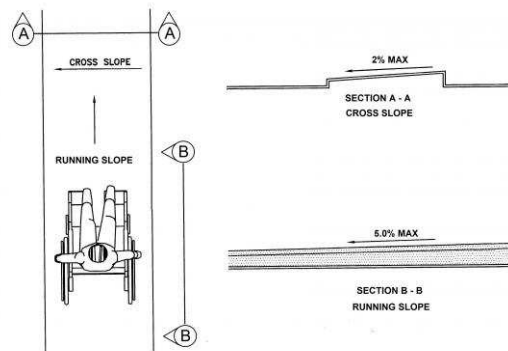
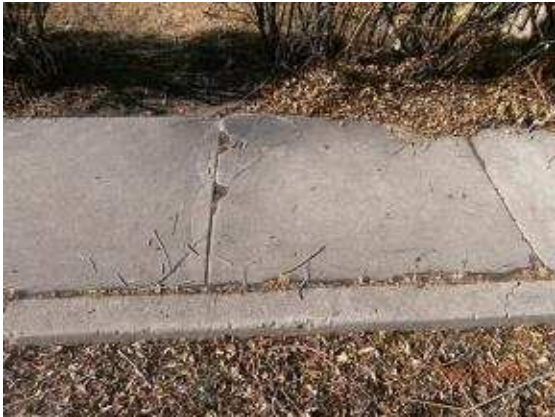
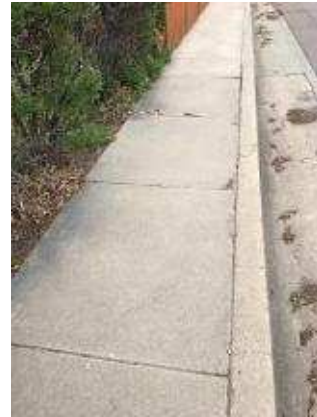
Finding #3 Additional Finding Photos

The accessible route of travel between the building and the public way on the site contains cross slopes greater than 2%. The cross slope is up to 6.1% in 11 concrete panels. The sidewalk is 4'-0" wide.

The sidewalk to the front entrance has cross slopes up to 4%.

Remove and replace approximately 11 concrete panels as needed.

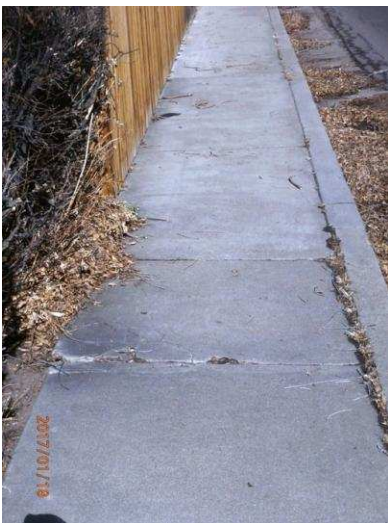
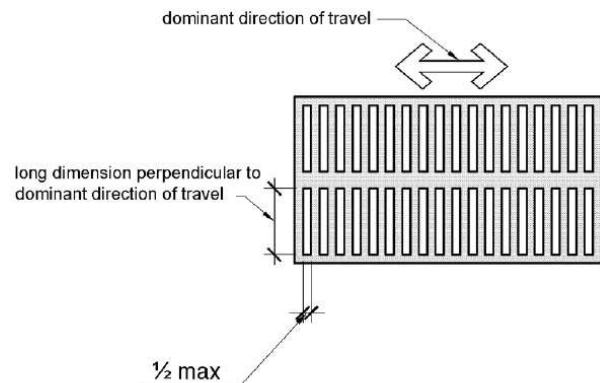
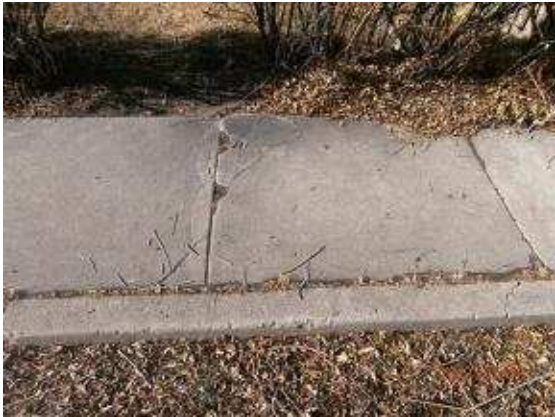
Finding #4 Additional Finding Photos

The concrete expansion joint is spaced greater than a 1/2 inch. Four concrete panels are affected.

The sidewalk to the front entrance has 1/2" gaps.

Replace the concrete panels.

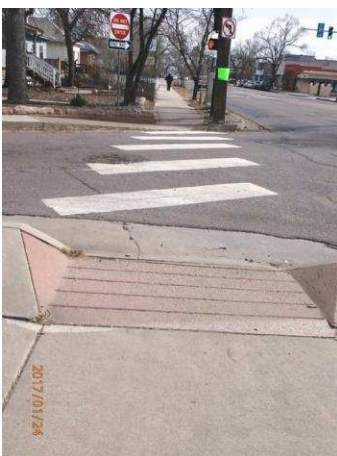
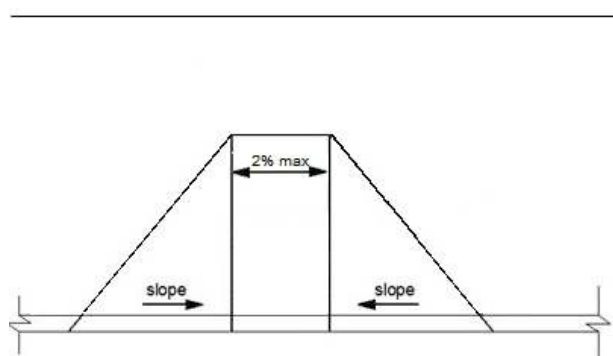
The curb ramp on the accessible route contains cross slopes greater than 2%.

Another issue is that it lacks detectable warnings.

The cross slope of the landing at the top of the curb ramp is 3.1%.

Replace curb ramp and landing

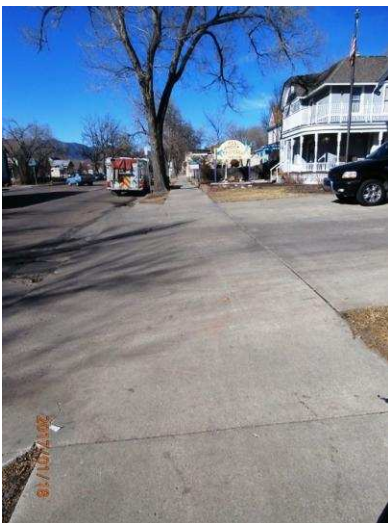
The accessible path of travel contains cross slopes greater than 2%.

The cross slope of the accessible route in the driveway is up to 7.5%.

Remove and replace the paving as much as feasible to try to obtain maximum 2% cross slope.

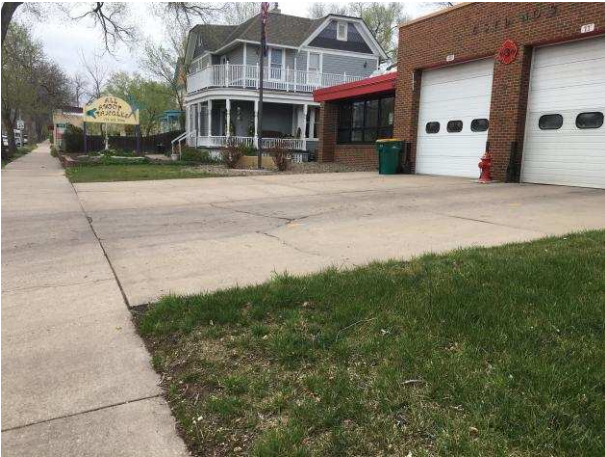
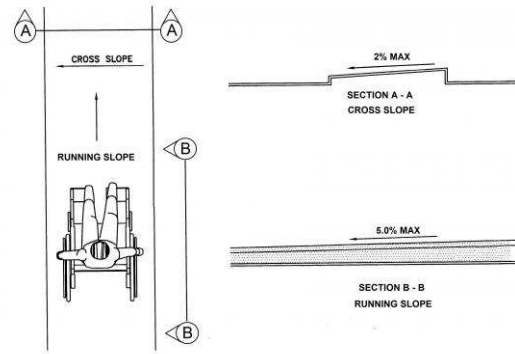
Finding #7 Continued

The accessible route contains running slopes greater than 5 percent across the width of the walk and has not been constructed as a ramp (i.e. handrails, wheel guides, etc.). The driveway has running slope up to 6.3%.

There is not an accessible route from the public way to the front entrance.

Create an accessible route from the sidewalk to the entry of the building. It either needs to be angled to create an accessible route under 5% or we need a ramp with provisions if adjacent to the driveway.

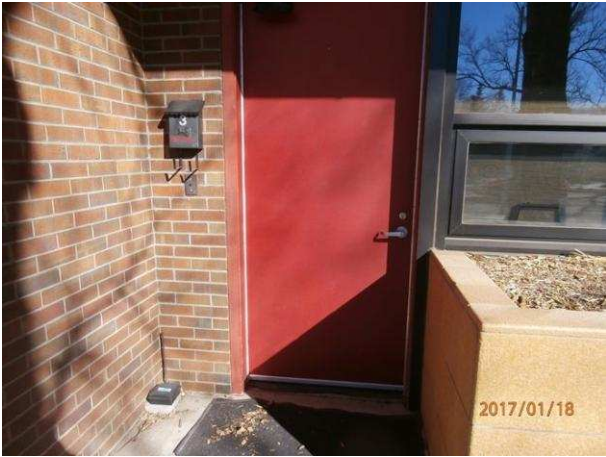
Finding #8 Continued

The door bell is small and difficult to see.

Compliant room identification signs are missing on the strike side of the door.

There is not a sign at the door bell.

Add signage.

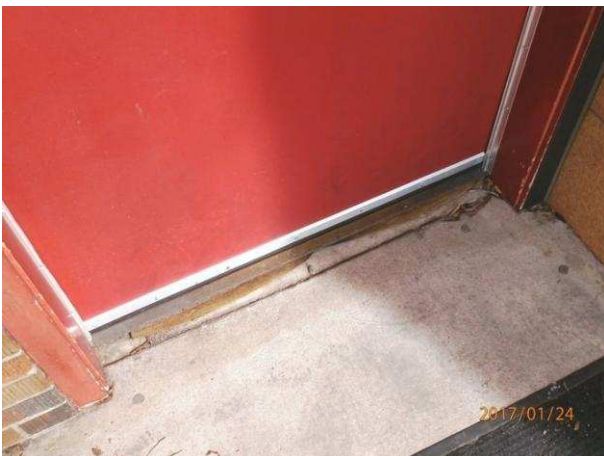
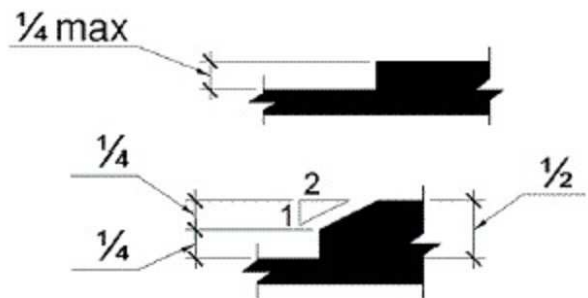
The threshold has a vertical change greater than 1/4 inch high.

The threshold at the front door has a lip ranging from 1/4" to 3/8".

Explore method to level out the threshold.
