Site Accessibility Evaluation

Fire Station 4

**2280 Southgate Rd
Colorado Springs, CO
80906**

***Inspection Date: 03/12/2017
Inspector: Michael Killebrew,
Anna Kangas***

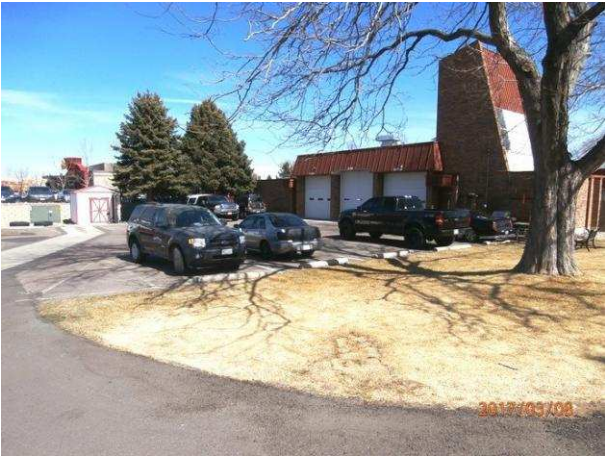
Finding #1 Continued

There are no accessible parking stalls, however there is only enough parking in this lot for fire department personnel. The lot is posted "No entry Fire Department Parking Only" and "Warning Fire Department Access Only".

There is no accessible parking in this parking lot.

2 (Important): Should be completed as soon as possible. (Includes findings that would remove barriers to the greatest number of people to your goods and services)

Keep this lot for fire department parking only, but consider adding signage indicating the location of the accessible entrance.

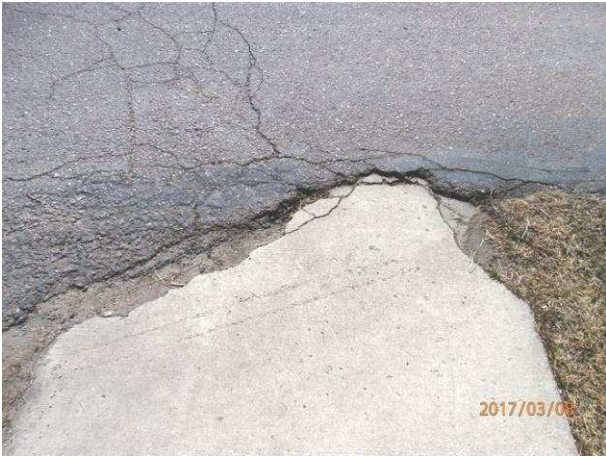
Finding #2 Continued

The walkway contains abrupt vertical edges and/or variations over a 1/4 inch.

There is 1" vertical lip where the sidewalk meets the asphalt driveway.

1 (High): Should be completed immediately. (Includes findings that have little or no cost, were in violation of the codes at the time of construction, or pose an imminent safety threat)

CORRECTED

Remove and replace the end of the sidewalk. Patch asphalt as needed.

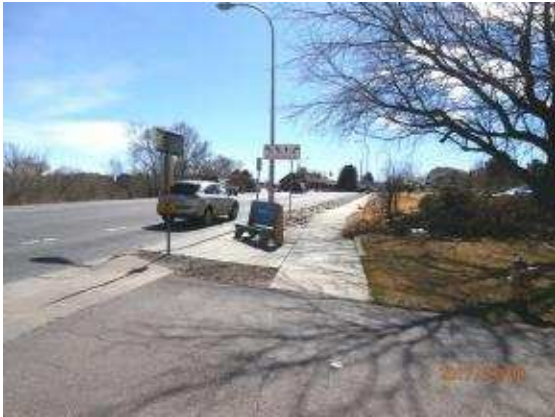
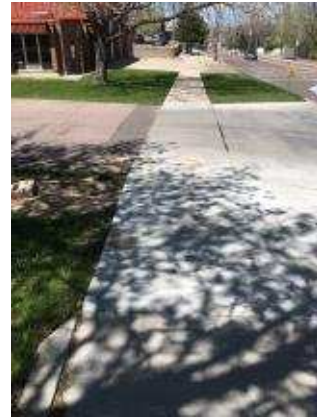
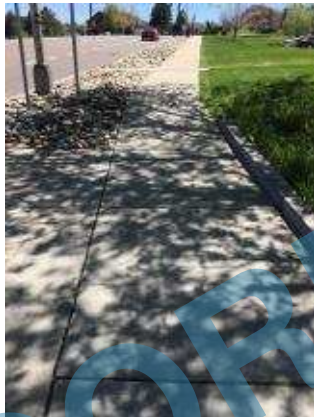
Finding #2 Additional Finding Photos

CORRECTED

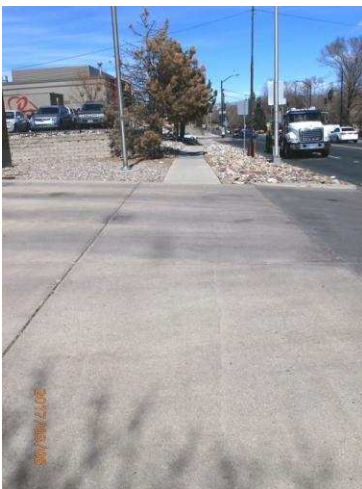
The accessible path of travel contains cross slopes greater than 2%.

The sidewalk portion of the driveway has cross slopes ranging from 2.5% to 4% (mostly 3%).

1 (High): Should be completed immediately. (Includes findings that have little or no cost, were in violation of the codes at the time of construction, or pose an imminent safety threat)

Remove and replace concrete as feasible and needed to maintain 2% cross slope.

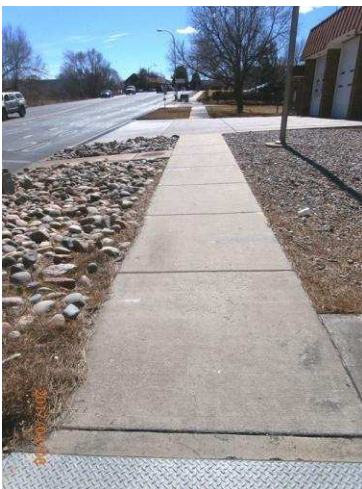
The accessible path of travel contains cross slopes greater than 2%.

The sidewalk on Southgate has 11 pads with cross slopes ranging from 2.3% to 5%.

1 (High): Should be completed immediately. (Includes findings that have little or no cost, were in violation of the codes at the time of construction, or pose an imminent safety threat)

Remove and replace concrete as needed to maintain 2% maximum cross slope.

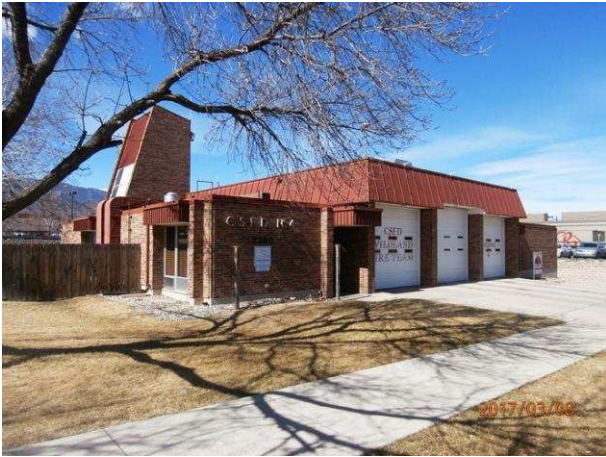
Finding #5 Continued

The building entrance is not located on an accessible route.

There is no accessible entrance to the front door.

1 (High): Should be completed immediately. (Includes findings that have little or no cost, were in violation of the codes at the time of construction, or pose an imminent safety threat)

Add about 15' of sidewalk to the front door adjacent to the drive.

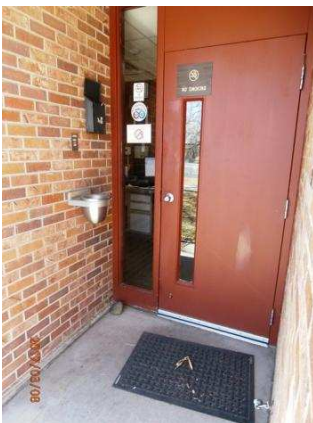
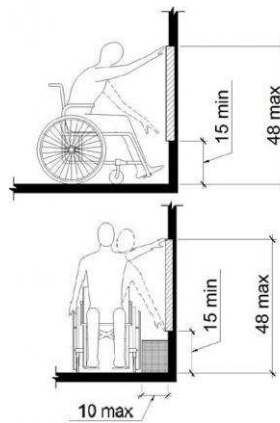
Finding 184245 Main Photo

The door bell is positioned too high for either a side or front approach.

In addition to being mounted too high, the door bell is mounted over an ash can.

The door bell is mounted at 57-1/2".

1 (High): Should be completed immediately. (Includes findings that have little or no cost, were in violation of the codes at the time of construction, or pose an imminent safety threat)

Lower the door bell to 48" maximum, and move the ash can to accommodate a 30" by 48" area for approach.

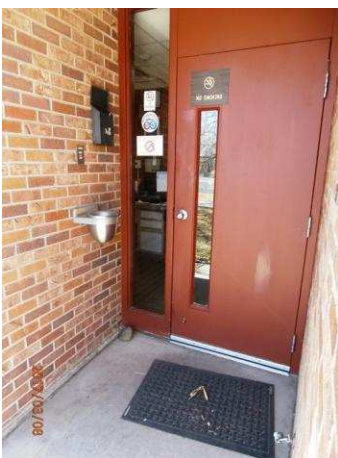
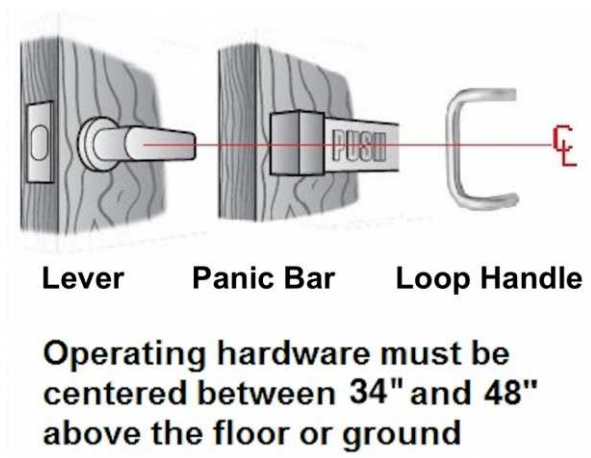
The door/gate operating hardware is not accessible.

The door hardware into the front entrance is a knob.

1 (High): Should be completed immediately. (Includes findings that have little or no cost, were in violation of the codes at the time of construction, or pose an imminent safety threat)

Replace the knob with lever-style hardware.

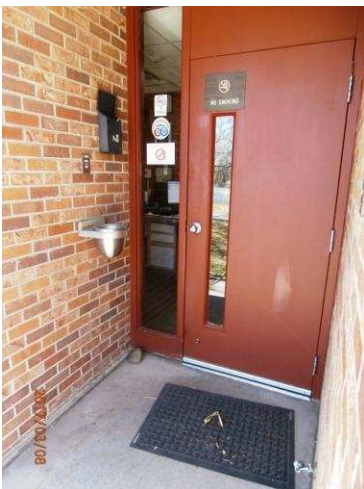
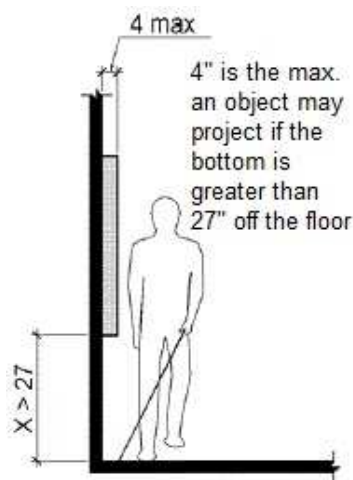
The ashcan projects more than 4 inches into the circulation path.

The ash can projects into the path of travel more than 4".

1 (High): Should be completed immediately. (Includes findings that have little or no cost, were in violation of the codes at the time of construction, or pose an imminent safety threat)

Remove ashcan

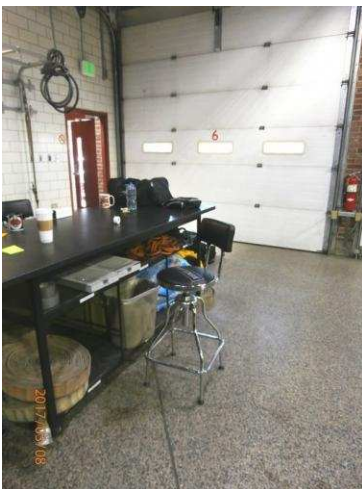
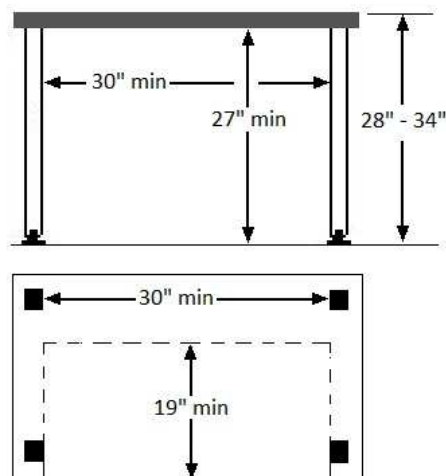
The top of the table surface is not within the compliant height range.

The table in the bay area is 37" to the top edge.

4 (Low): Should be completed as soon as possible due to being a technical violation, but may not result in providing greater access to persons with disabilities. (Includes findings that are technically violations but provide a moderate to low increase in accessibility compared to the financial impact on the entity)

No action needed unless this table is used for public functions.
