Site Accessibility Evaluation

Fire Station 5

**2830 W Colorado Ave
Colorado Springs, CO
80904**

SUBJECT: Fire Station 5 Self-Evaluation

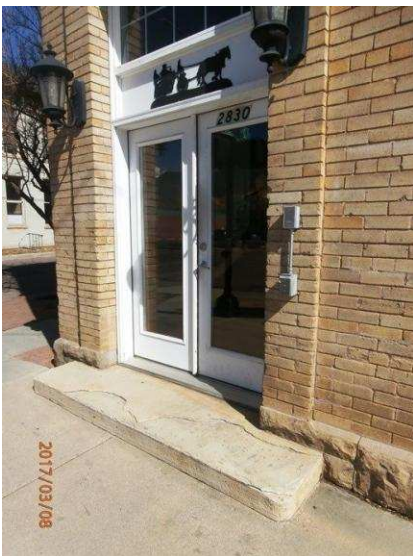
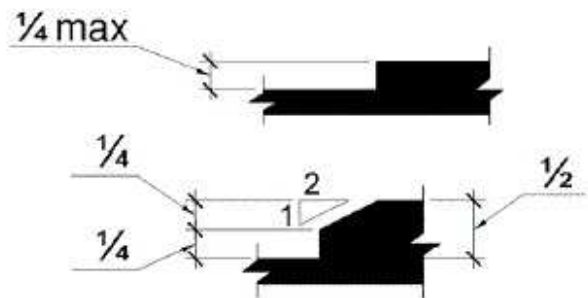
Finding: 1

The front entrance has a 5" step and a 1-1/2" threshold to enter the building.

2010 ADAS Section: 303.3

There is not an accessible entrance to the fire station.

Barrier Priority:

1 (High): Should be completed immediately. (Includes findings that have little or no cost, were in violation of the codes at the time of construction, or pose an imminent safety threat)

Due to the age and configuration of the station, leave as is. However, staff must be ready, willing and able to assist someone outside or open bay doors to provide service.

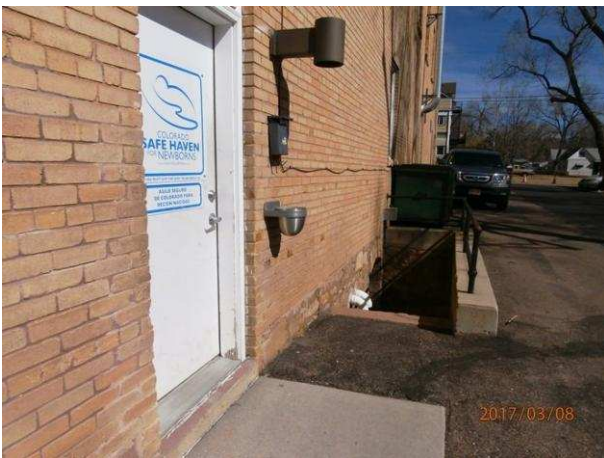
Finding: 2

The side entrance has a 3-3/4" step and a 1" threshold to enter the building.

2010 ADAS Section: 303.3

There is not an accessible entrance to the fire station.

Due to the age and configuration of the station, leave as is. However, staff must be ready, willing and able to assist someone outside or open bay doors to provide service. Add sign with arrow indicating to ring front bell for service.

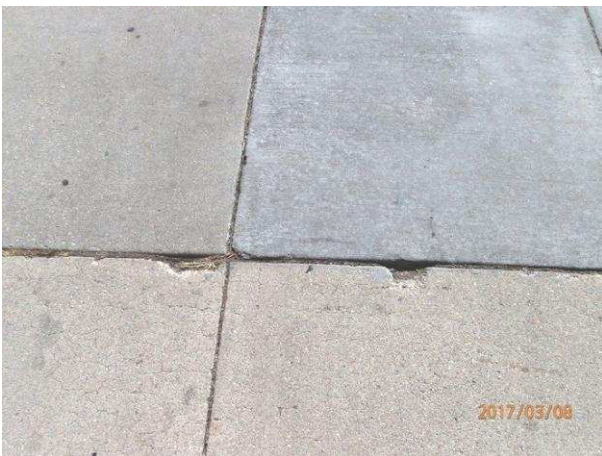
Finding: 3

The concrete expansion joint is spaced greater than a 1/2 inch.

2010 ADAS Section: 302.3

The sidewalk leading to the entrance on W. Colorado Avenue has a 1" deep by 2" wide gap.

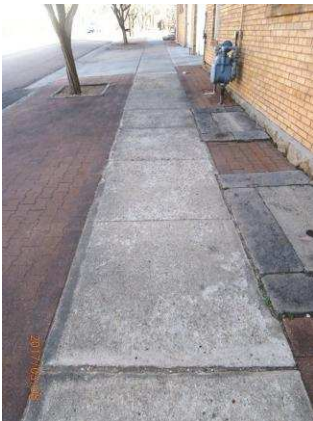
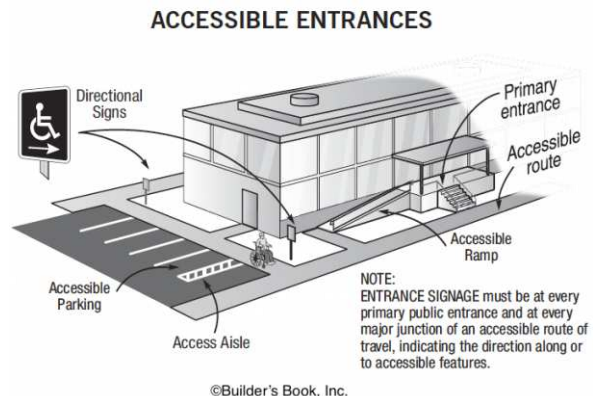
Finding: 4

Seven of the concrete pads are spalling 1/2" to 3/4" deep. The concrete pads are approximately 4'-0" by 4'-0", for a total of about 28 linear feet of concrete requiring replacement.

There is no accessible route of travel from the public way.

2010 ADAS Section: 206.2.1

The sidewalk on 29th Street has 7 concrete pads with spalling.

Remove and replace sidewalk panels.

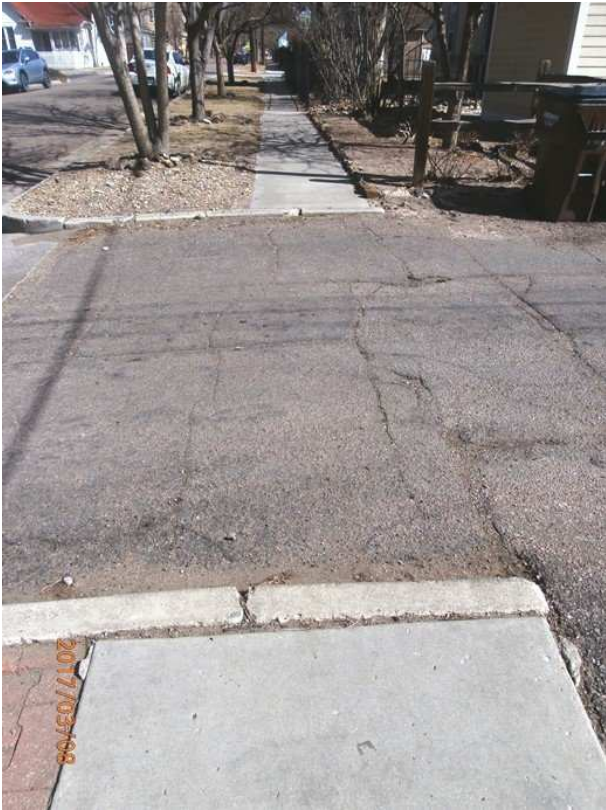
Finding #5 Continued

The walkway contains abrupt vertical edges and/or variations over a 1/4 inch.

2010 ADAS Section: 303.3, 303.2

There is a 2-3" tall curb at the driveway, without a curb ramp.

Add a curb ramp/transition.

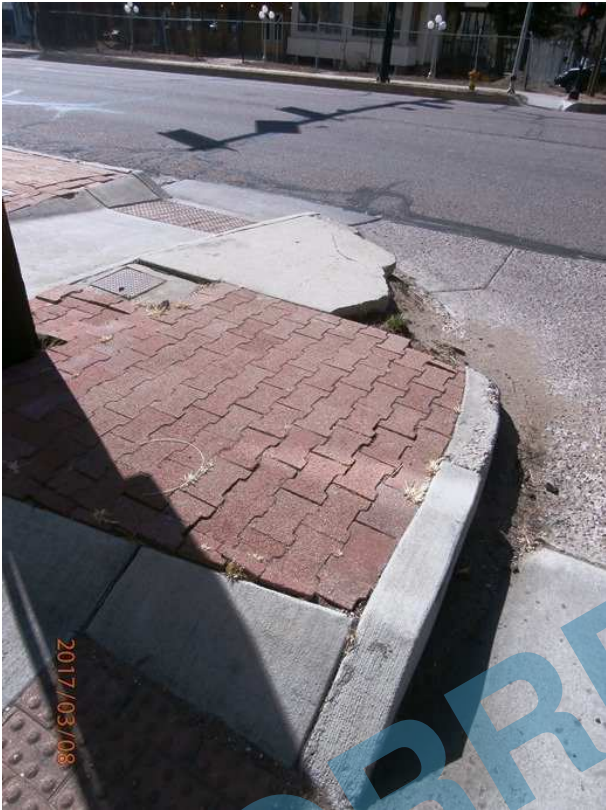
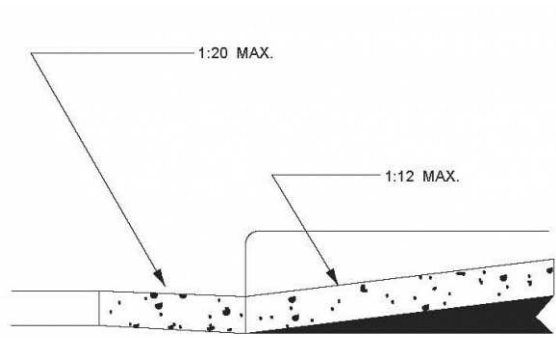
Finding #6 Continued

The transition from the curb ramp to the walk, gutter or street is not flush and free of abrupt changes in level.

2010 ADAS Section: 406.2

The pie-shaped area between the curb ramps is deteriorating.

Replace the pie-shaped area.

As of April 2019, the corner are had been replaced.

CORRECTED

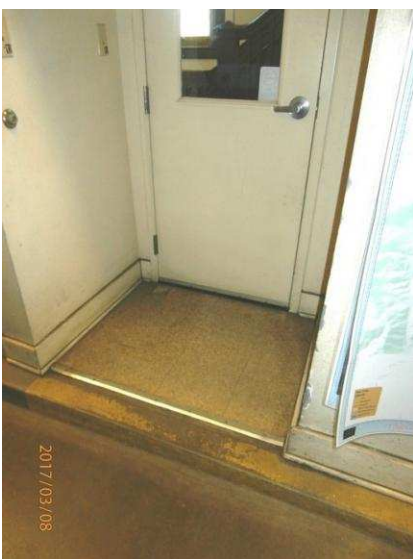
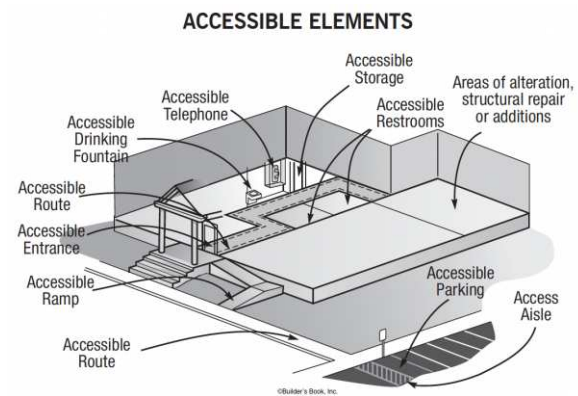
Finding: 7

There is no accessible route to the room near the front entrance where blood pressure checks are performed, due to the step at the front entrance and numerous level changes within the building.

2010 ADAS Section: 206.2.2

The room near the front entrance is not accessible.

Perform blood pressure checks in the bay area, as there is not a threshold issue at the bay doors.

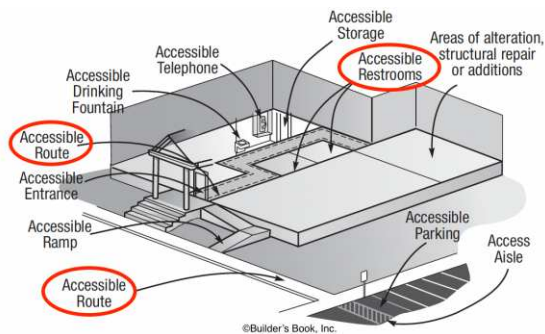
Finding: 8

The restroom facilities serving the facility are not on an accessible route.

The restrooms were not evaluated since there is not an accessible route to them and they are not intended to be public restrooms.

2010 ADAS Section: 213.1

The restrooms are not accessible.

Do not offer the restrooms to the public.
