Site Accessibility Evaluation

Fire Station 7

**3901 Palmer Park Blvd
Colorado Springs, CO
80909**

Accessibility Evaluation

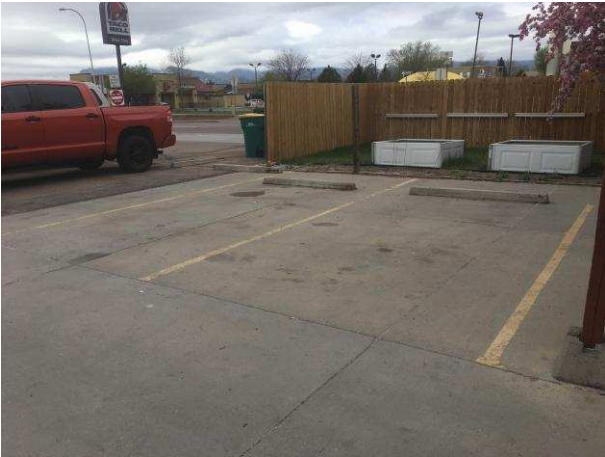
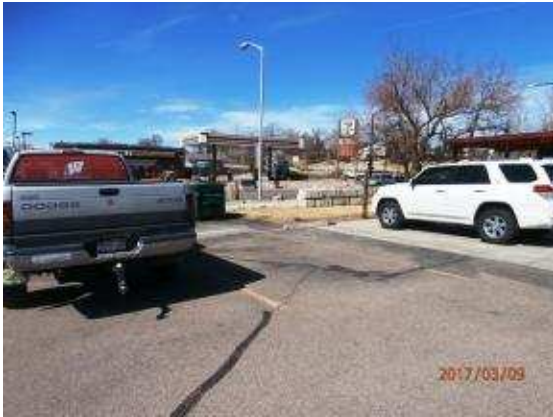
Finding: 1

There are no accessible parking stalls and patients needing blood pressure checks park at the adjacent 7-Eleven. There is limited safe parking in this commercial area.

2010 ADAS Section: 208.2

There are not any accessible parking spaces at the Fire Station.

1 (High): Should be completed immediately. (Includes findings that have little or no cost, were in violation of the codes at the time of construction, or pose an imminent safety threat)

Along the southwest corner of the fire station's rear parking lot, stripe three regular parking spaces and 1 van accessible parking space. We do not need signage and anyone can park in the accessible space.

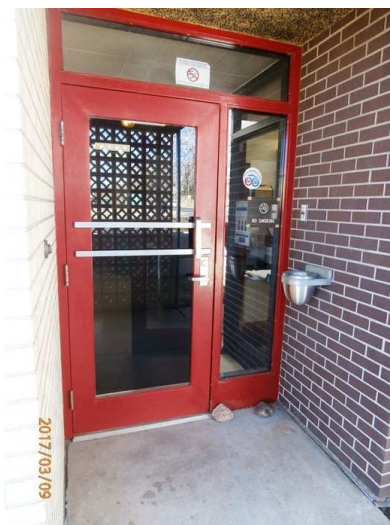
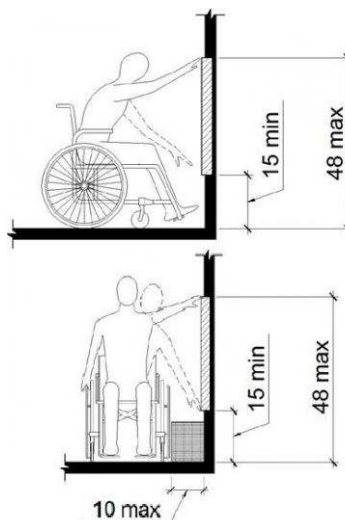
Finding: 2

The door bell is positioned too high for either a side or front approach.

2010 ADAS Section: 308.1

The door bell is mounted at 55".

2 (Important): Should be completed as soon as possible. (Includes findings that would remove barriers to the greatest number of people to your goods and services)

Lower the door bell to 48" maximum.

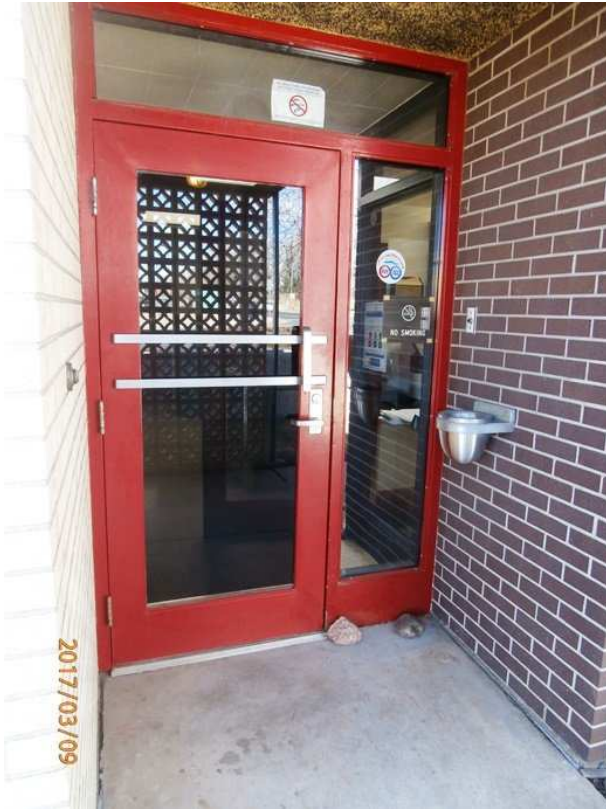
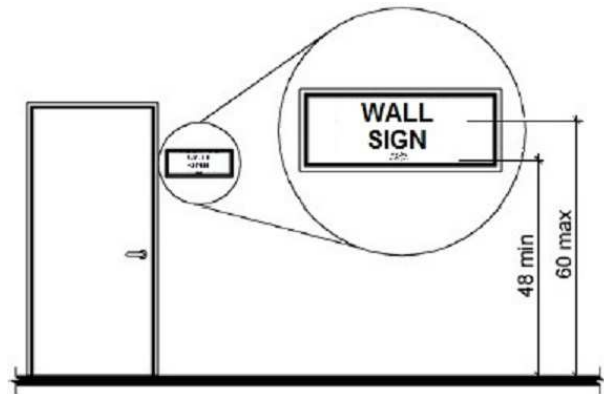
Finding: 3

Door bell should have a sign to make it more conspicuous.

2010 ADAS Section: 216.2, 703.4.2

There is not a wall sign indicating the location of the door bell.

1 (High): Should be completed immediately. (Includes findings that have little or no cost, were in violation of the codes at the time of construction, or pose an imminent safety threat)

Add information sign indicating door bell.

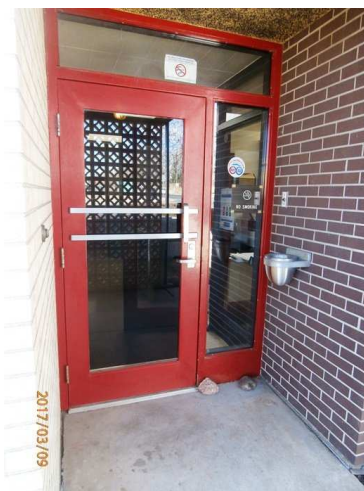
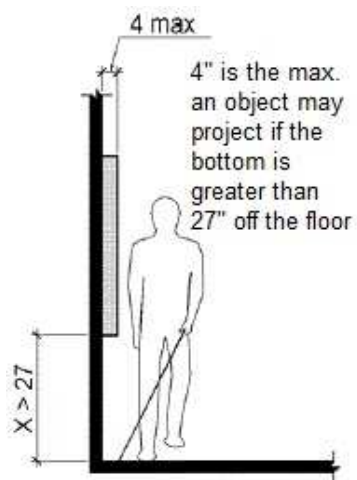
Finding: 4

The ash can projects more than 4 inches into the circulation path.

2010 ADAS Section: 307.2

The ash can projects more than 4" into the path of travel.

1 (High): Should be completed immediately. (Includes findings that have little or no cost, were in violation of the codes at the time of construction, or pose an imminent safety threat)

Remove the ash can.

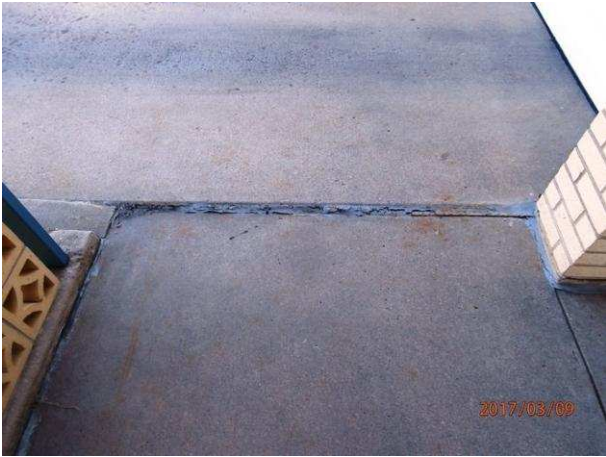
Finding: 5

The walkway contains abrupt vertical edges and/or variations over a 1/4 inch.

2010 ADAS Section: 303.3, 303.2

There is 1" vertical displacement in the sidewalk at the entrance.

1 (High): Should be completed immediately. (Includes findings that have little or no cost, were in violation of the codes at the time of construction, or pose an imminent safety threat)

cut out and re-pour or add metal bridge plate.

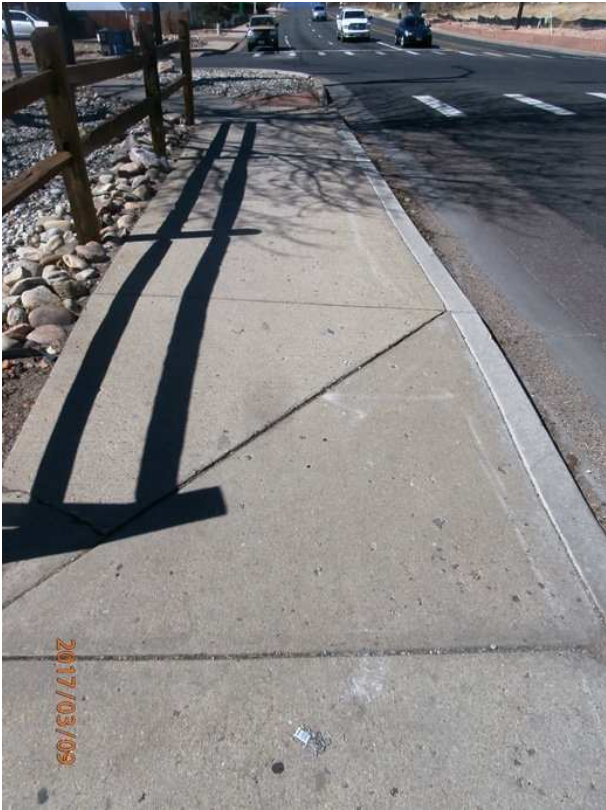
Finding: 6

The walkway contains abrupt vertical edges and/or variations over a 1/4 inch.

2010 ADAS Section: 303.3, 303.2

There is 3/4" vertical displacement where the driveway apron and sidewalk join.

1 (High): Should be completed immediately. (Includes findings that have little or no cost, were in violation of the codes at the time of construction, or pose an imminent safety threat)

Remove and replace concrete panels as needed to achieve compliance, or grind edge to less than 1/2".

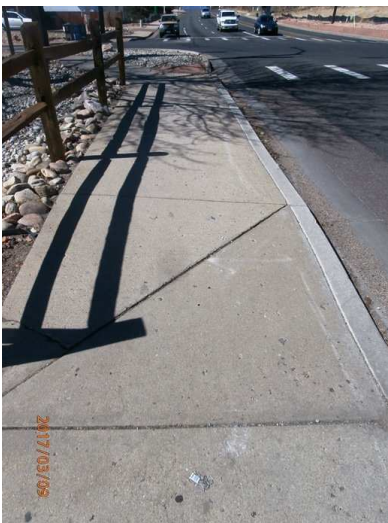
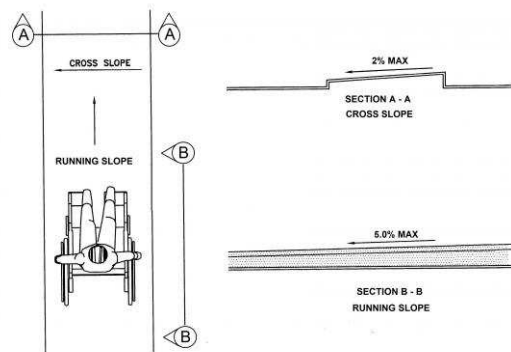
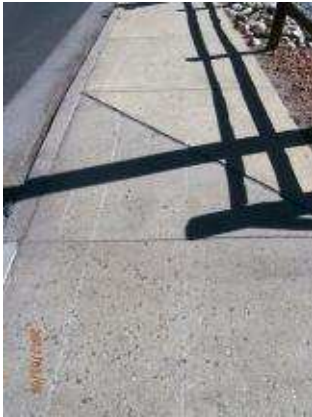
Finding: 7

The accessible route on the site contains running slopes greater than 5% and has not been constructed as a ramp (i.e. handrails, wheel guides, etc.).

2010 ADAS Section: 403.3

The running slope of this section of sidewalk is 6.9%.

1 (High): Should be completed immediately. (Includes findings that have little or no cost, were in violation of the codes at the time of construction, or pose an imminent safety threat)

Remove and replace concrete panels as needed to achieve maximum running slope of 5%.

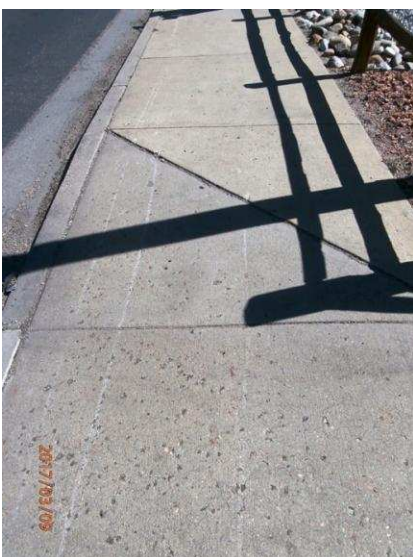
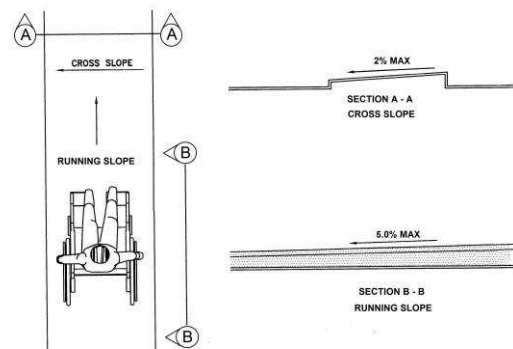
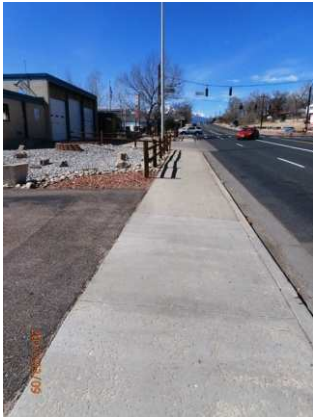
Finding: 8

The accessible path of travel contains cross slopes greater than 2%.

2010 ADAS Section: 403.3

The cross slope of these six panels exceeds 3%.

1 (High): Should be completed immediately. (Includes findings that have little or no cost, were in violation of the codes at the time of construction, or pose an imminent safety threat)

Remove and replace panels as needed to achieve 2% maximum cross slope.

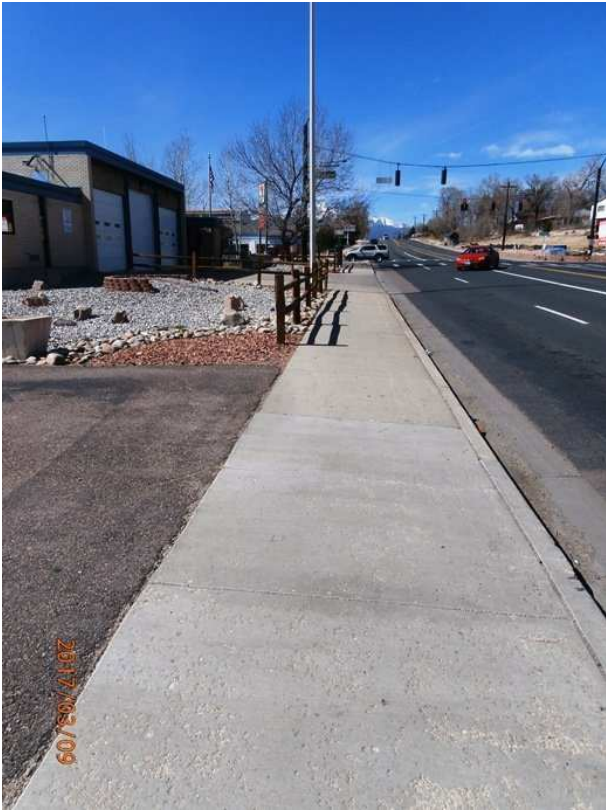
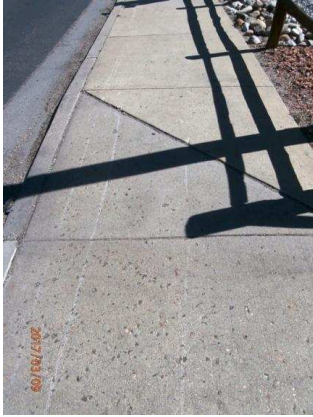
Finding: 9

The walkway contains abrupt vertical edges and/or variations over a 1/4 inch.

2010 ADAS Section: 303.3, 303.2

There is considerable spalling in this sidewalk, causing 1/2" or greater vertical displacement.

1 (High): Should be completed immediately. (Includes findings that have little or no cost, were in violation of the codes at the time of construction, or pose an imminent safety threat)

This section of sidewalk would be avoided as would the cross slope in this area if we wrap up and use asphalt as the route.

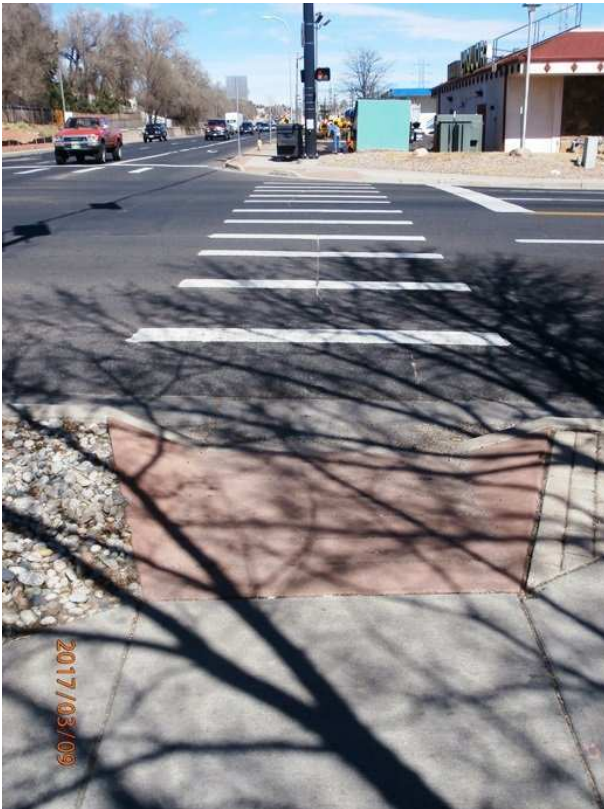
Finding: 10

Detectable warning are missing.

2011 PROWAG Section: R208.1

There are no detectable warnings on the curb ramp at Palmer Park Blvd.

1 (High): Should be completed immediately. (Includes findings that have little or no cost, were in

Install detectable warnings.

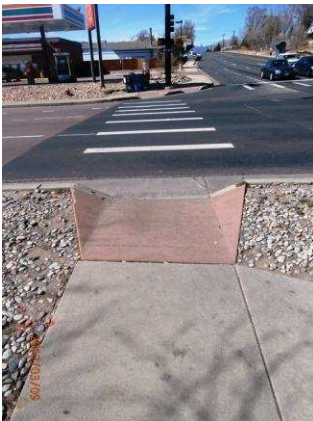
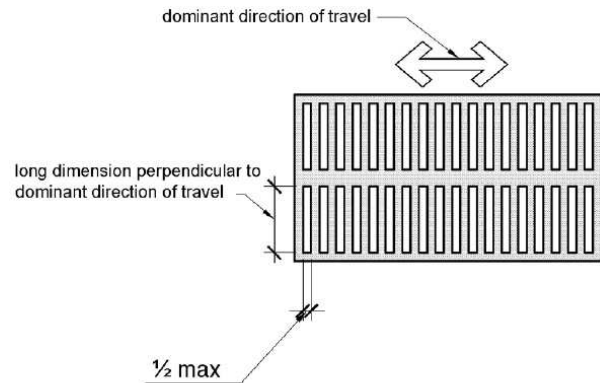
Finding: 11

The curb ramp surface has openings that are greater than 1/2 inch.

There are no detectable warnings on this curb ramp at Academy Blvd.

2010 ADAS Section: 302.3

There is a 1" gap at the top of the ramp where it meets the landing.

1 (High): Should be completed immediately. (Includes findings that have little or no cost, were in violation of the codes at the time of construction, or pose an imminent safety threat)

Fill the gap and add detectable warnings.

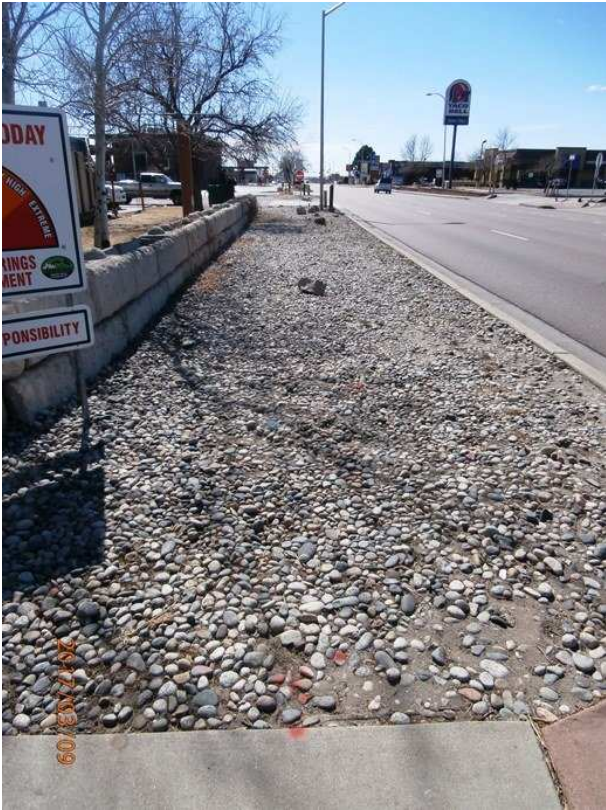
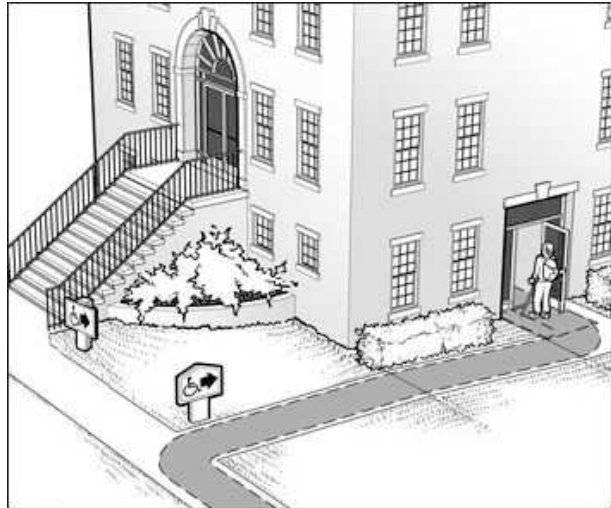
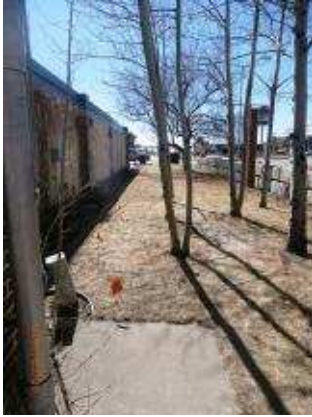
Finding: 12

The building entrance is not located on an accessible route.

2010 ADAS Section: 206.2.1

There is not an accessible route from the current and proposed parking to the fire station or in the public right of way

1 (High): Should be completed immediately. (Includes findings that have little or no cost, were in violation of the codes at the time of construction, or pose an imminent safety threat)

Put in AC route from parking area behind fire station (FS); explore installing AC route inside FS perimeter along west side of fence. If not in the interior we should look at adding sidewalk on exterior of fence in the PROW.

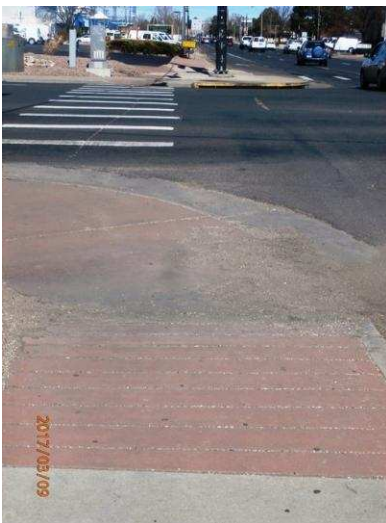
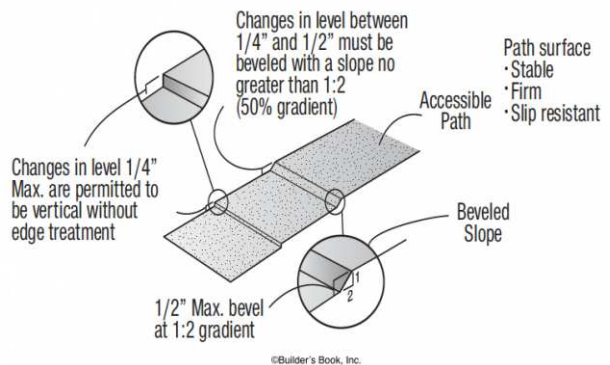
Finding: 13

The surface of the curb ramp is not firm, stable and/or slip resistant..
The curb ramp also is missing detectable warnings.

2010 ADAS Section: 302.1

There is considerable debris build-up at the curb ramp at Academy Blvd and Palmer Park Blvd.

1 (High): Should be completed immediately. (Includes findings that have little or no cost, were in violation of the codes at the time of construction, or pose an imminent safety threat)

Keep the curb ramp clear of debris. This may require evaluating and re-routing stormwater runoff or moving/completely redoing the ramp. Also detectable warnings need to be added to the ramp.

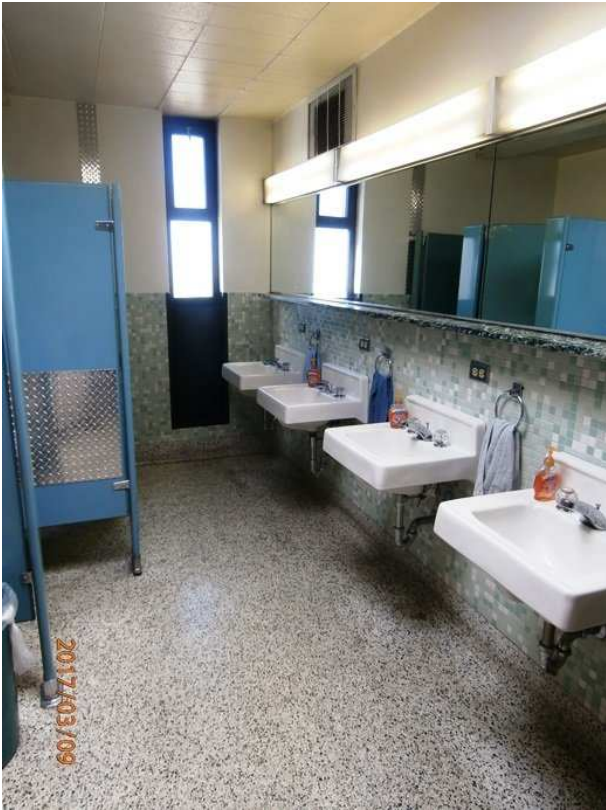
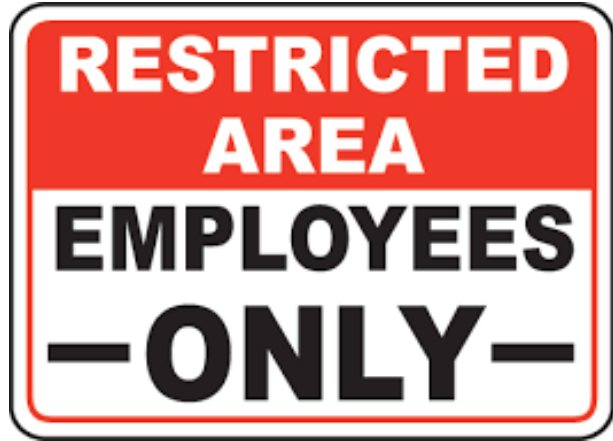
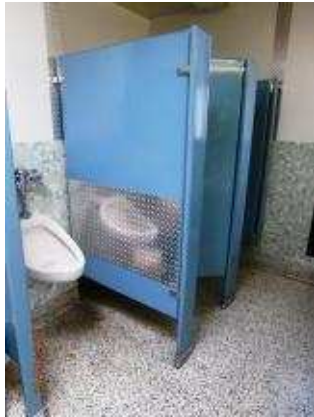
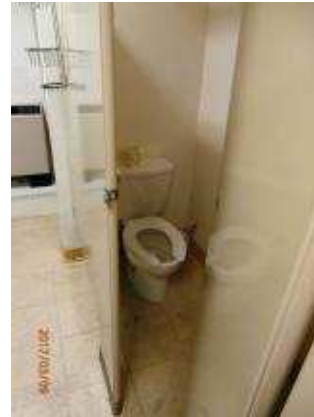
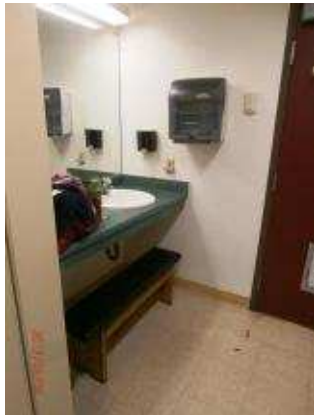
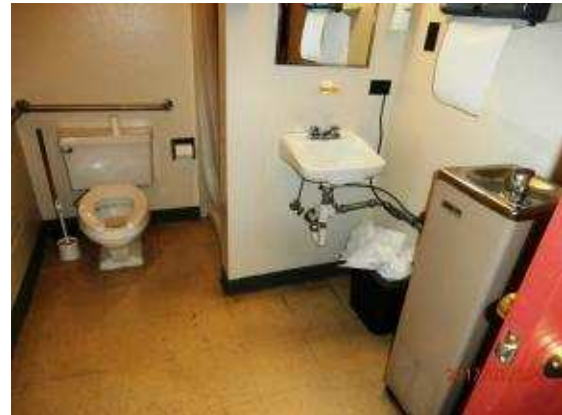
Finding: 14

There are multiple issues with the restrooms but they are not intended for public use.

The owner or owners representative indicated that no public restrooms were available, however there was a non compliant restroom labeled as accessible and available to the public. If the restroom is desired to be an employee only restroom, it is recommended that the door be locked, the signs be removed and replaced with a new sign that that sates "employees only" or "private area". Any future improvements may be required under Title I of the ADA for work place reasonable accommodations.

2010 ADAS Section: 213.1

The restrooms are not accessible.

3 (Moderate): Should be completed as soon as possible, but there may be other items that will provide greater access to persons with disabilities. (Includes findings that have a high financial impact on the entity in relationship to the degree of access provided)

Add signage indicating the restrooms are not for public use.
