Exterior - Parking

Finding: 1

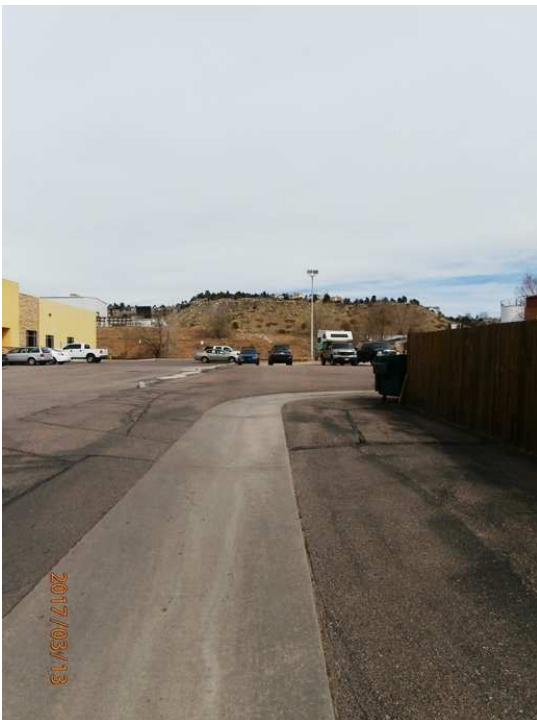
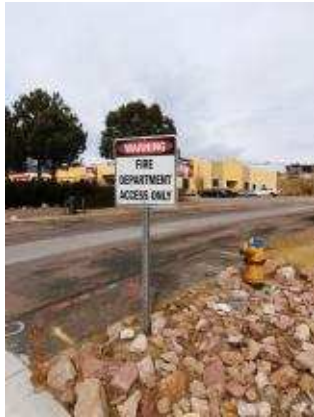
The parking lot is not striped. There is no on-street parking available near the fire station. If accessible parking is created, an accessible route to the building entrance is required as well.

The parking lot is not marked.

Stripe the parking lot, including a van accessible parking space and access aisle.

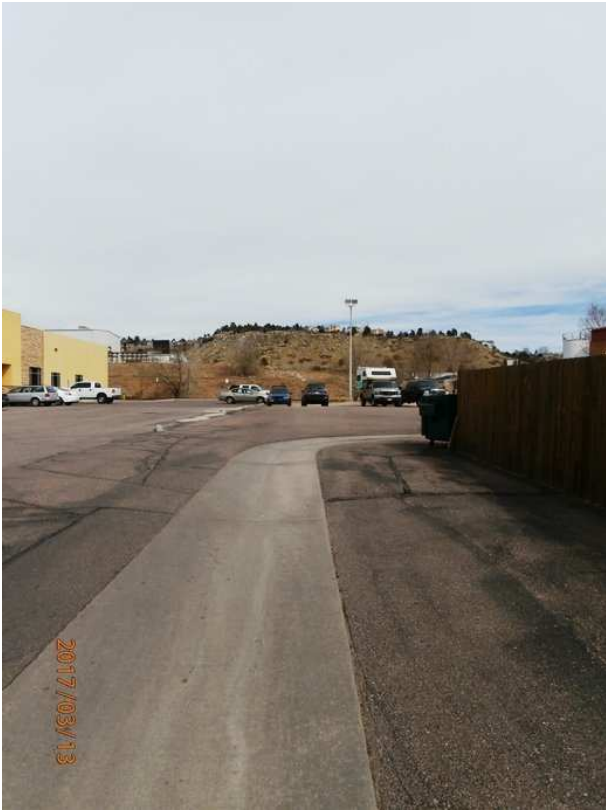
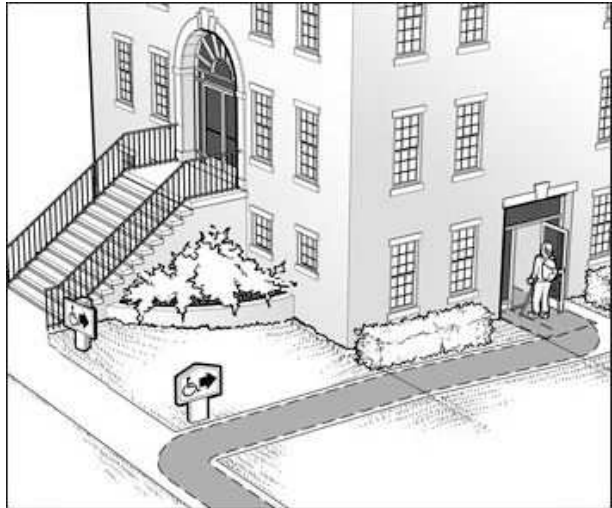
Finding #2 Continued

The building entrance is not located on an accessible route. The route will be a non-comporting vehicular way.

There will be no accessible route to building entrance if we create accessible parking.

Explore feasibility of creating an accessible route from the back to the front parking lot.

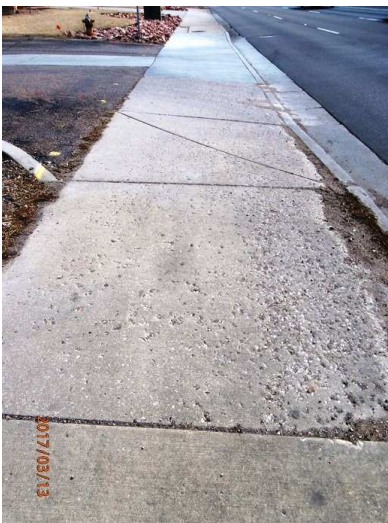
Finding: 3

The accessible path of travel contains cross slopes greater than 2%. This sidewalk is near the driveway to the fire station parking lot.

There is 3% cross slope in this section of sidewalk.

Remove and replace the sidewalk as needed.

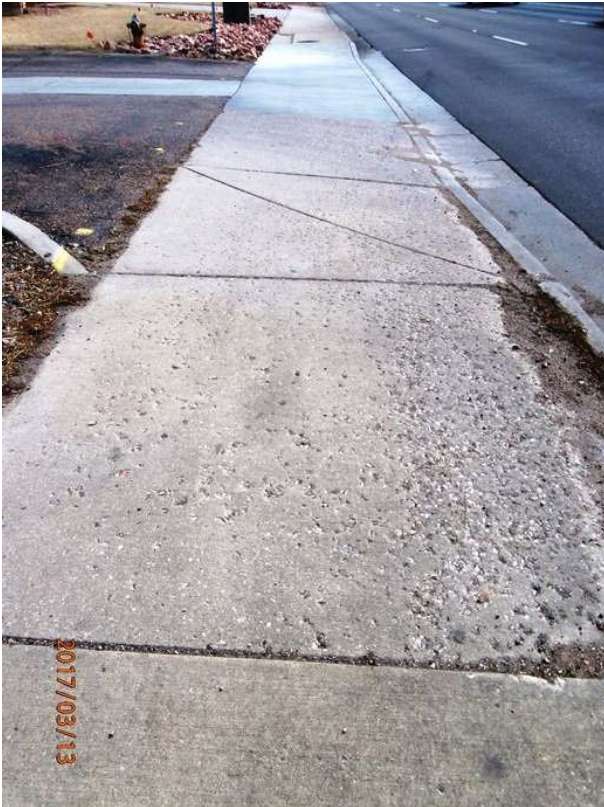
Finding #4 Continued

The walkway contains abrupt vertical edges and/or variations over a 1/4 inch. This section of sidewalk is adjacent to the driveway entrance to the fire station parking lot.

There is considerable spalling in this section of the section.

Remove and replace concrete panels as needed.

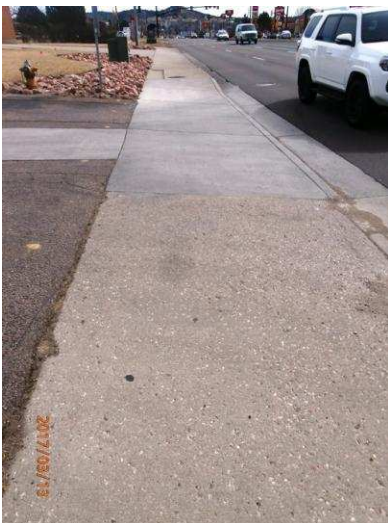
Finding: 5

The accessible path of travel contains cross slopes greater than 2%. This sidewalk includes the driveway apron.

The sidewalk has cross slope up to 6%.

Remove and replace sidewalk as needed to achieve 2% maximum cross slope or to the maximum extent feasible.

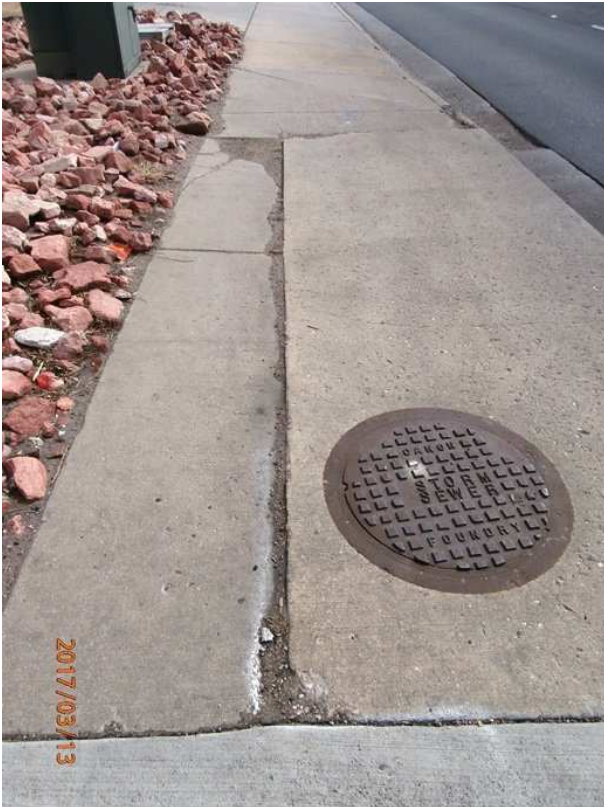
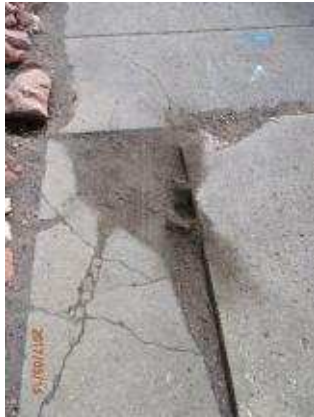
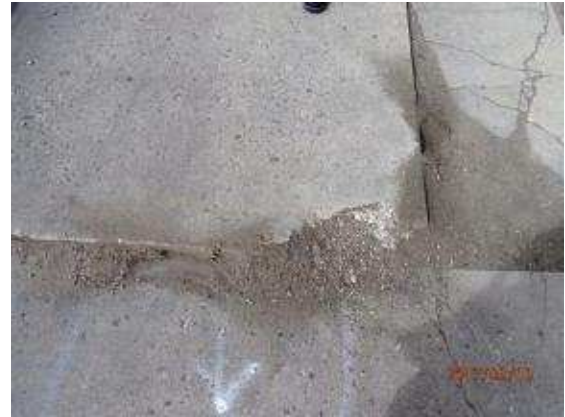
Finding #6 Continued

The walkway contains abrupt vertical edges and/or variations over a 1/4 inch. This is a trip hazard as well as an accessibility issue.

There is 3/4" to 2-1/2" vertical displacement at the storm drain.

Remove and replace panels as needed.

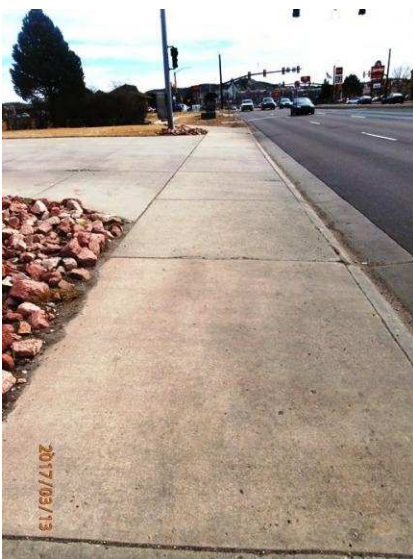
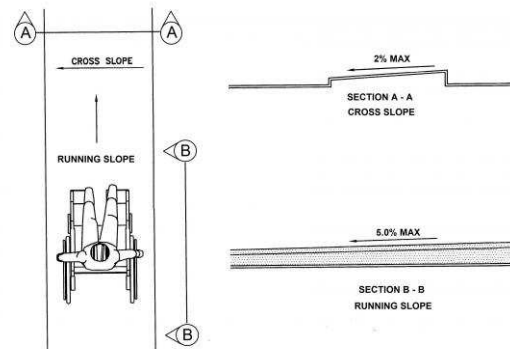
Finding: 7

The accessible path of travel contains cross slopes greater than 2% in the driveway area.

The cross slope of this section of sidewalk is 5%.

Remove and replace concrete as needed to achieve maximum 2% cross slope.

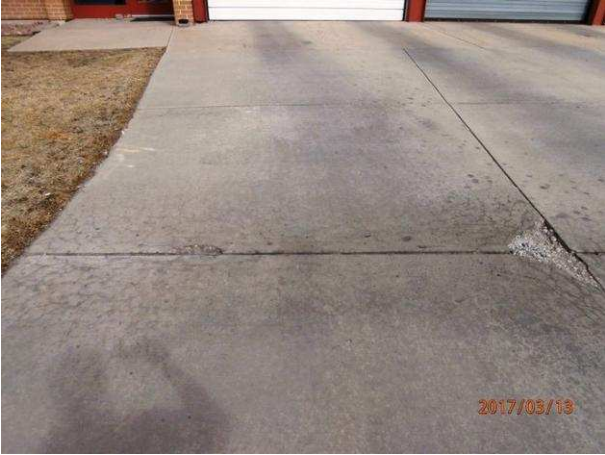
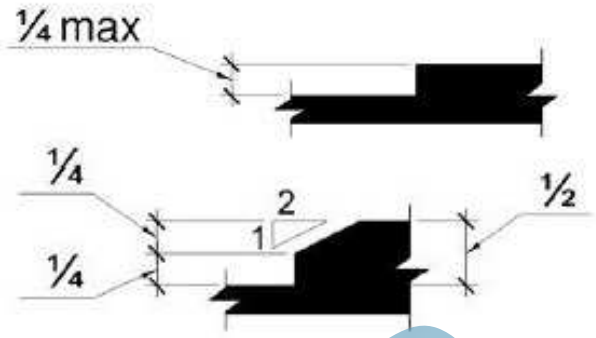
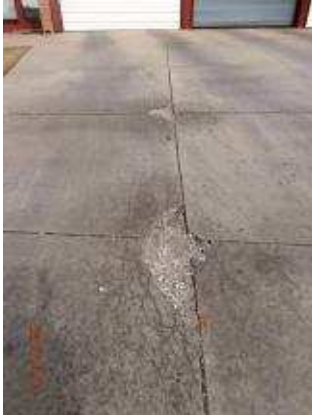
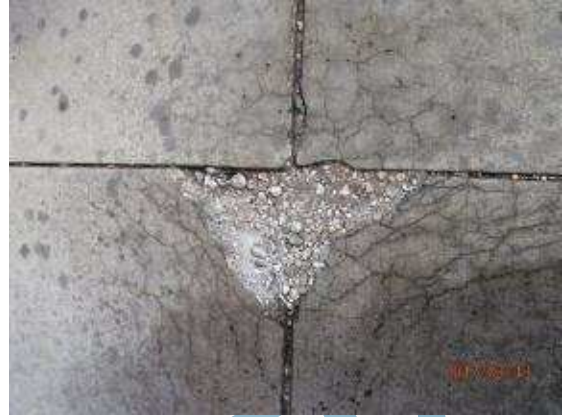
Finding #8 Continued

The walkway contains abrupt vertical edges and/or variations over a 1/4 inch. This is the approach to the fire station entrance. The largest section of spalling is 2" deep by 17" wide by 36" long.

There is considerable spalling in this section of the section.

Remove and replace concrete panels as needed.

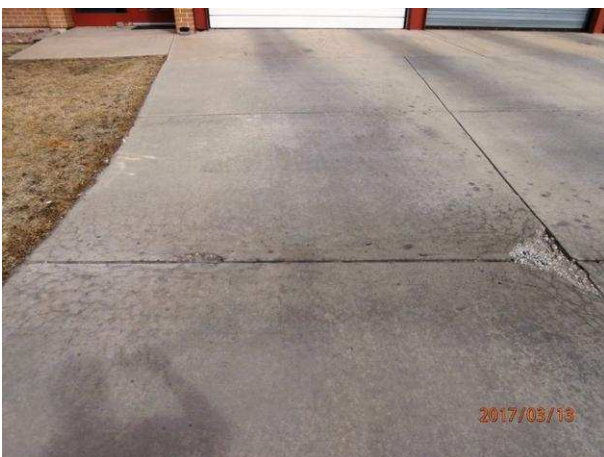
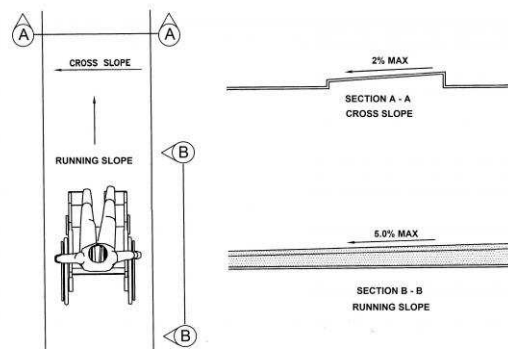
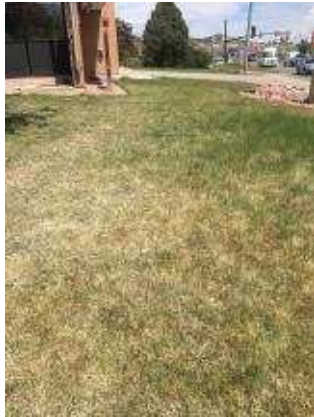
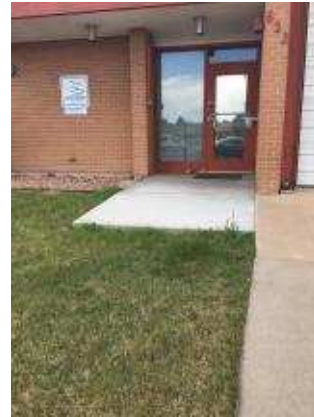
Finding: 9

The accessible route on the site contains running slopes greater than 5% and has not been constructed as a ramp (i.e. handrails, wheel guides, etc.).

The running slope of the sidewalk to the entrance is 7%.

In lieu of making the front entrance accessible from Garden of the Gods, install a 3'-0" wide sidewalk from the entrance to the west driveway. This new sidewalk will be approximately 52'-0" long.

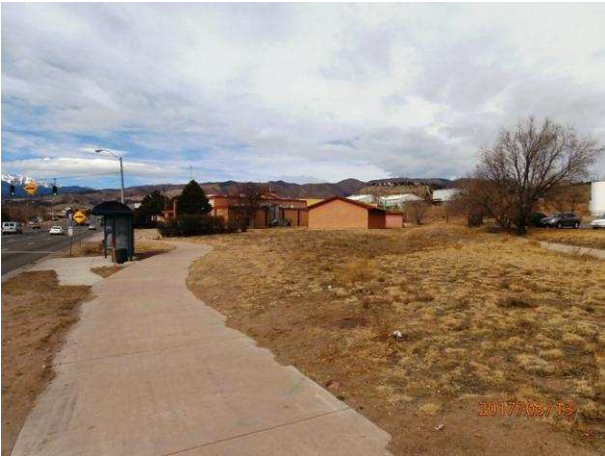
Finding #10 Continued

The walkway contains abrupt vertical edges and/or variations over a 1/4 inch.

An 8" core drill hole was made in the sidewalk and not properly filled.

Fill the hole or remove and replace concrete panels as needed.

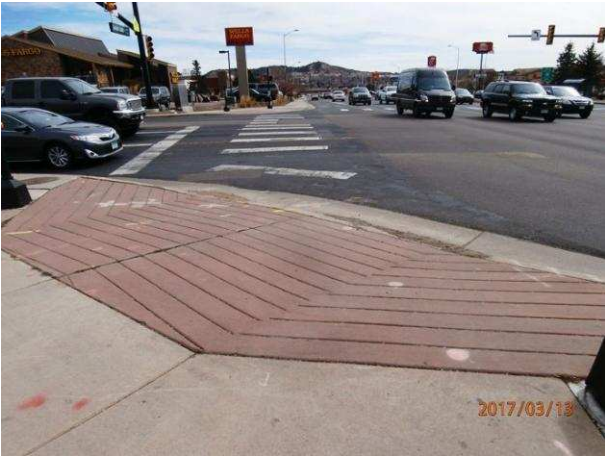
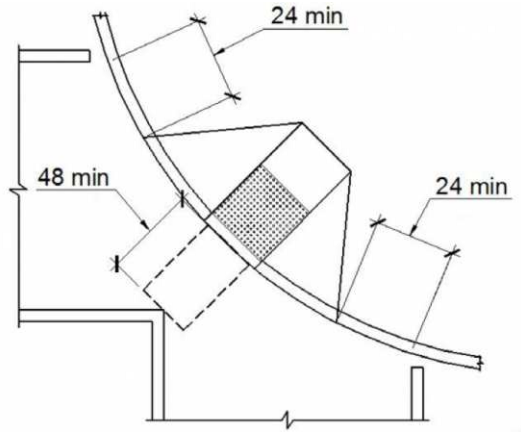
Finding #11 Continued

The flared sides of the curb ramp are not within the markings. The narrow entry area of this radial almost makes it a directional.

The Ramp also is missing detectable warnings.

The cross walk lines do not line up with the curb ramp.

Replace this ramp if not feasible to skew the striping.

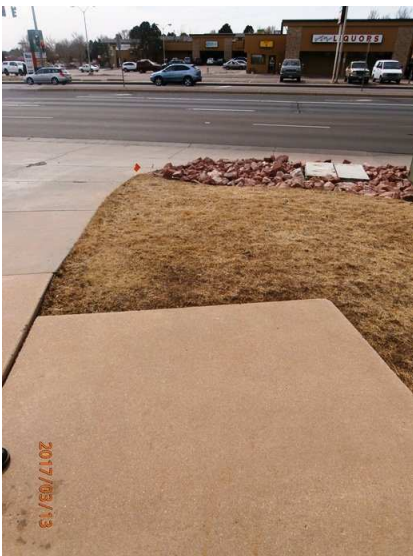
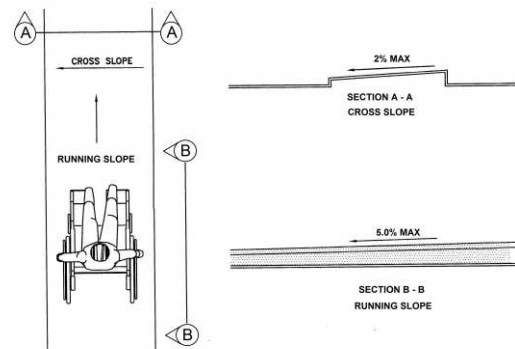
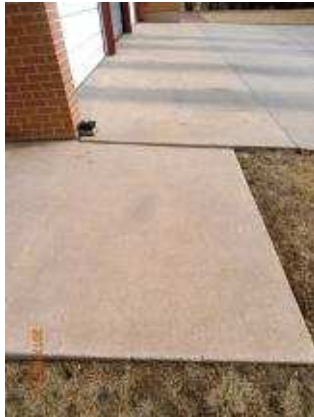
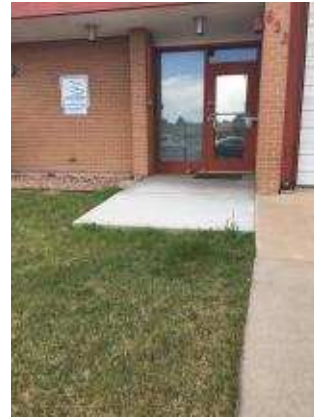
Finding: 12

The accessible path of travel between building entrances contains cross slopes greater than 2%.

The landing at the fire station entrance has 5% cross slope.

Remove and replace concrete panel as needed to achieve maximum 2% cross slope.

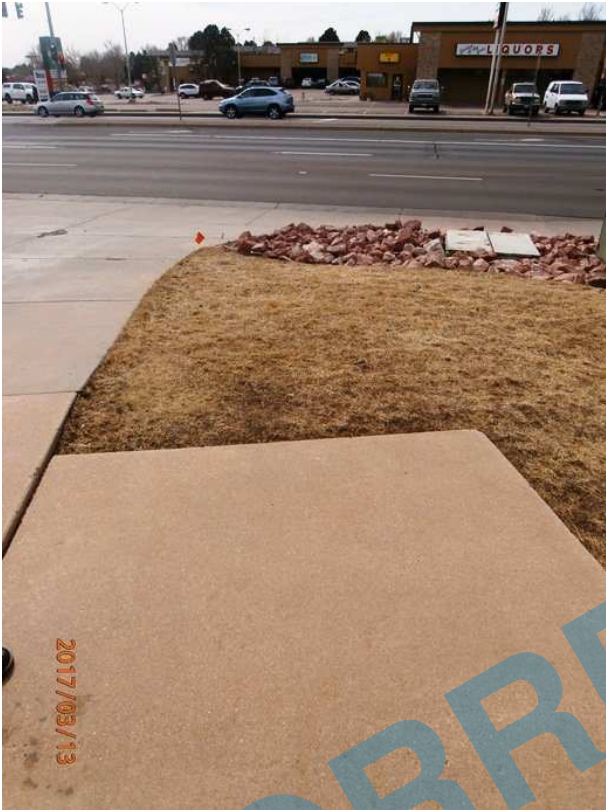
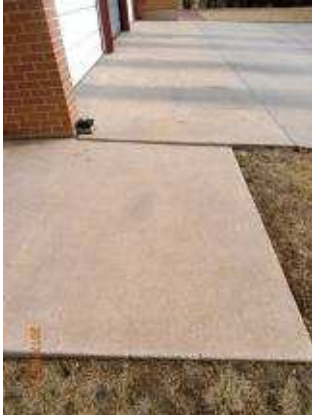
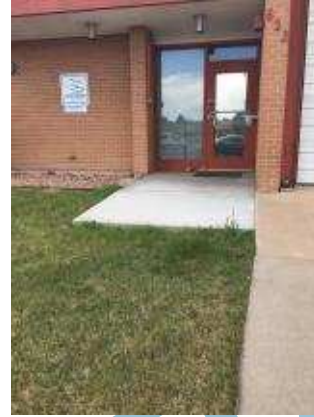
Finding #13 Continued

The walkway contains abrupt vertical edges and/or variations over a 1/4 inch.

There is 1" vertical displacement in the sidewalk at the entrance.

Grind the displacement to less than 1/2".

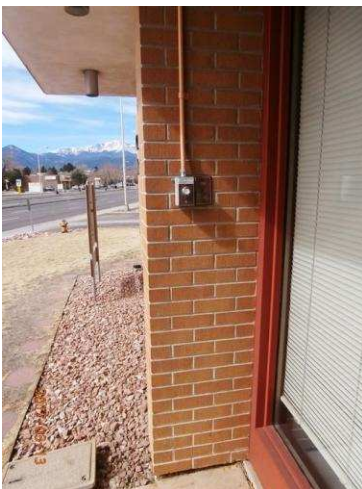
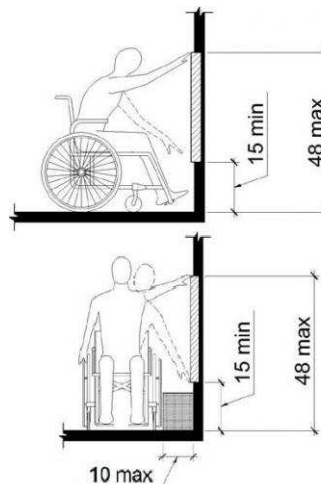
Finding: 14

The door bell is positioned too high for either a side or front approach.

The door bell at the front entrance is mounted at 55".

Lower the door bell to 48" maximum.

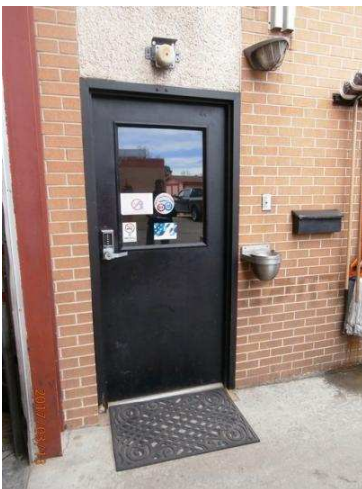
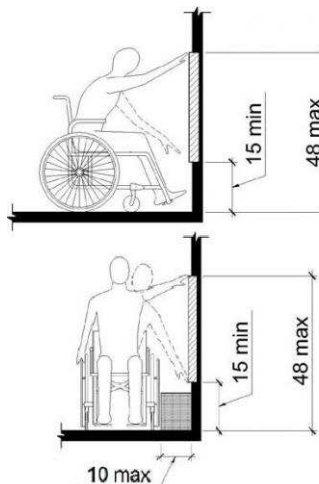
Finding: 15

The door bell is positioned too high for either a side or front approach.

The door bell at the rear entrance is mounted at 55-1/2".

Lower the door bell if we create parking in the back and this becomes the accessible route.

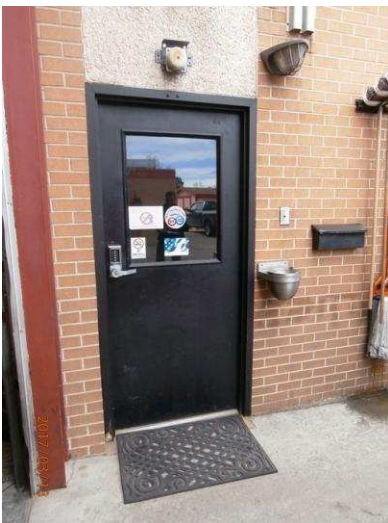
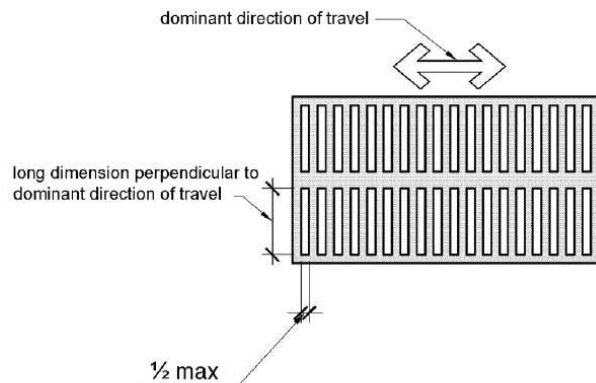
Finding: 16

Gratings are spaced greater than a 1/2 inches in the direction of traffic flow.

The mat at the rear door has openings greater than 1/2".

Replace with a mat having openings less than 1/2" in the direction of travel.

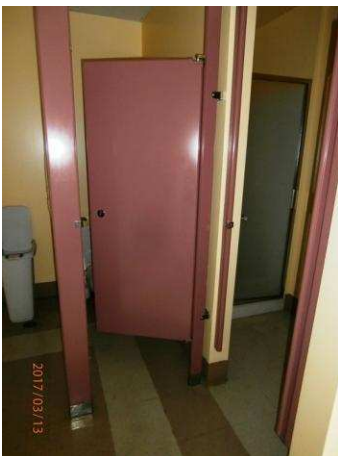
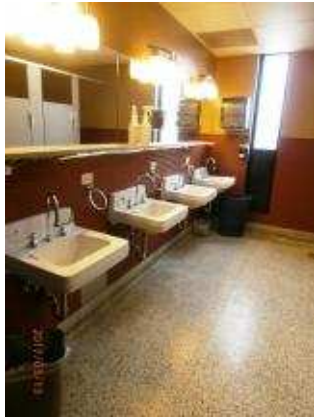
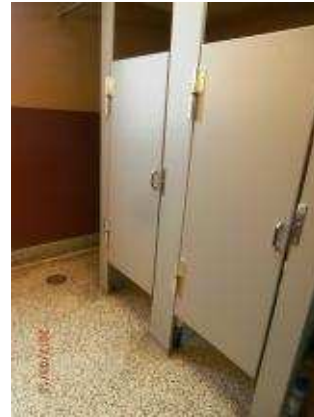
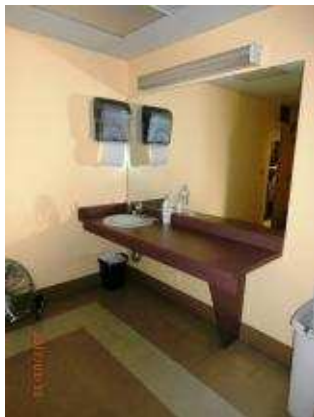
Finding: 17

The restroom facilities serving the facility are not on an accessible route and are not accessible. There are multiple deficiencies, but these restrooms are not intended for public use.

The restrooms are not accessible.

Add signage indicating there are no public restrooms.
