Site Accessibility Evaluation

John Blair Bridge Open Space

Accessibility Evaluation

SUBJECT: John Blair Bridge Open Space Self-Evaluation

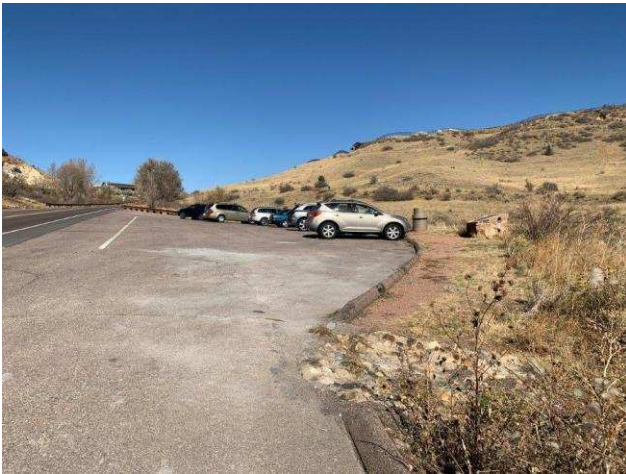
Finding 187785 Main Photo

There are no accessible parking stalls. Normally accessible parking is required. The grade is off at this location.

There are no marked accessible parking stalls.

There is space for around 15 stalls - so only 1 van accessible space is advised.

Add an accessible parking space here closest to the trail since this and the trail is hard surface.

1 (High): Should be completed immediately. (Includes findings that have little or no cost, were in violation of the codes at the time of construction, or pose an imminent safety threat)

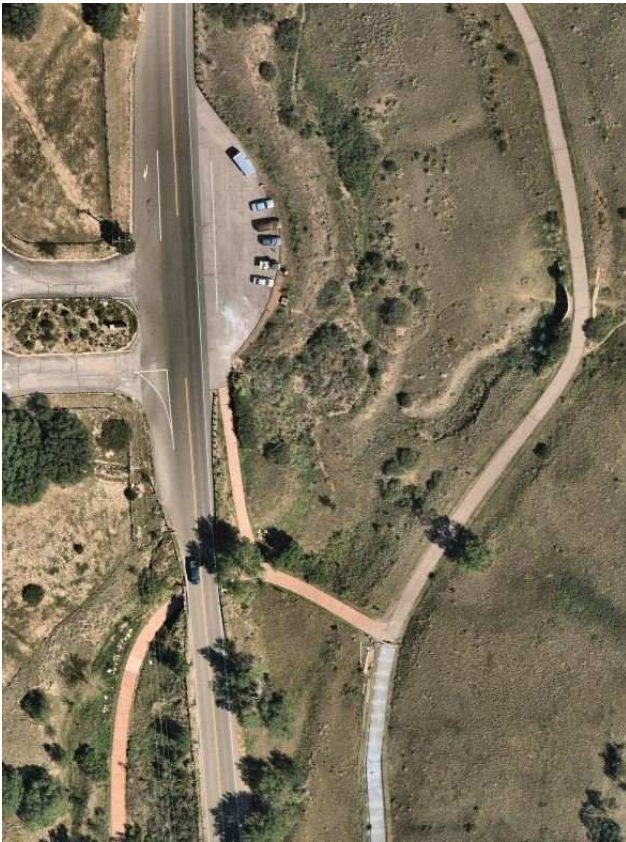
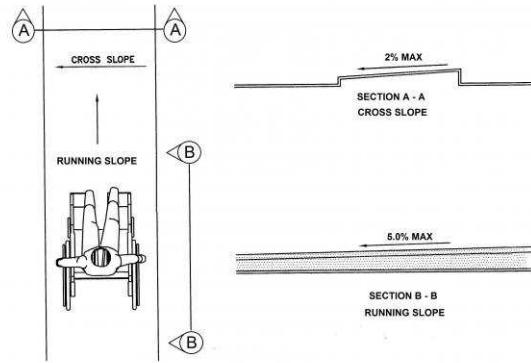
Finding #2 Continued

The accessible route on the site has running slopes greater than 5%. This can be acceptable in open space shared use path trails.

The shared use path trails were not accessed at this time. It is known that many will exceed 5% grade. Even so, the ADA would not be used to access this area as this standard would not be required.

At some future date the hard surface shared use path trails should be re-assessed.

2 (Important): Should be completed as soon as possible. (Includes findings that would remove barriers to the greatest number of people to your goods and services)
