Site Accessibility Evaluation

**North Academy Super Stop
PU18-0079**

**4110 N Academy Blvd
Northeast Colorado
Springs, CO 80918**

SUBJECT: North Academy Super Stop Self-Evaluation

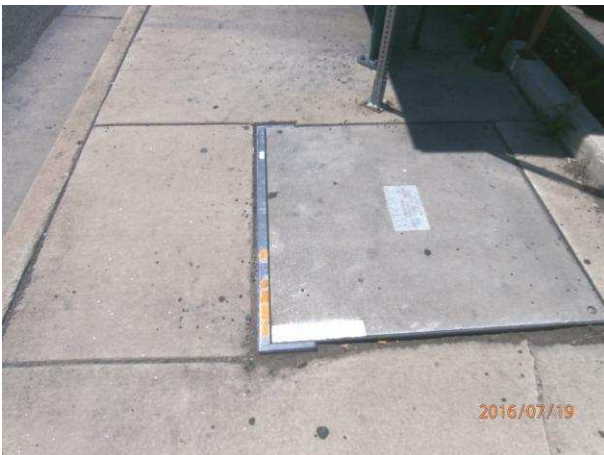
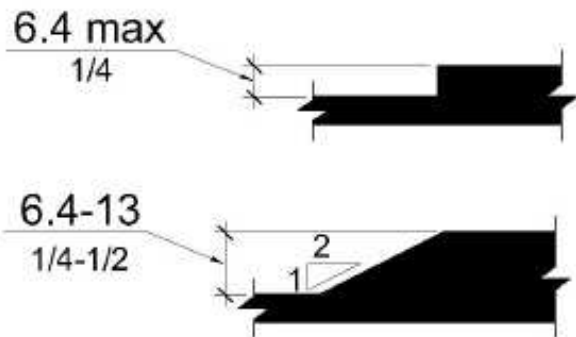
Finding: 1

The surface of the pedestrian access route has vertical discontinuities greater than 1/2 inch or between 1/4 inch and 1/2 inch that are not beveled.

There is 3/4" vertical displacement around the utility vault in the sidewalk.

1 (High): Should be completed immediately. (Includes findings that have little or no cost, were in violation of the codes at the time of construction, or pose an imminent safety threat)

Image of vertical displacement in sidewalk

Remove and replace the concrete panels around the vault, or re-set the vault flush with the concrete surface.

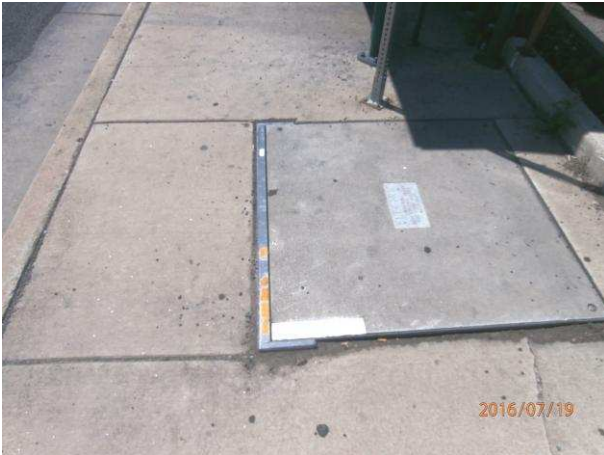
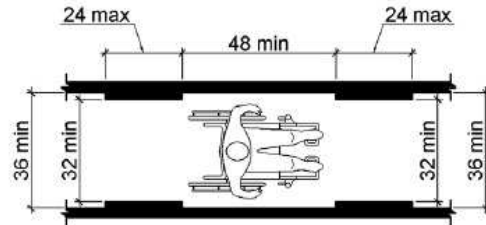
Finding: 2

There is displacement between the sidewalk and curb.

There is 33-1/2" between the vault and the inside edge of the curb.

1 (High): Should be completed immediately. (Includes findings that have little or no cost, were in violation of the codes at the time of construction, or pose an imminent safety threat)

Image of narrow sidewalk

The width will be addressed if the panels are replaced and made flush with the utility vault.
