Site Accessibility Evaluation

**Pikes Peak Community
College Transfer Station
PU18-0083**

**5675 S Academy Blvd
Colorado Springs, CO
80906**

SUBJECT: Pikes Peak Community College Transfer Station Self-Evaluation

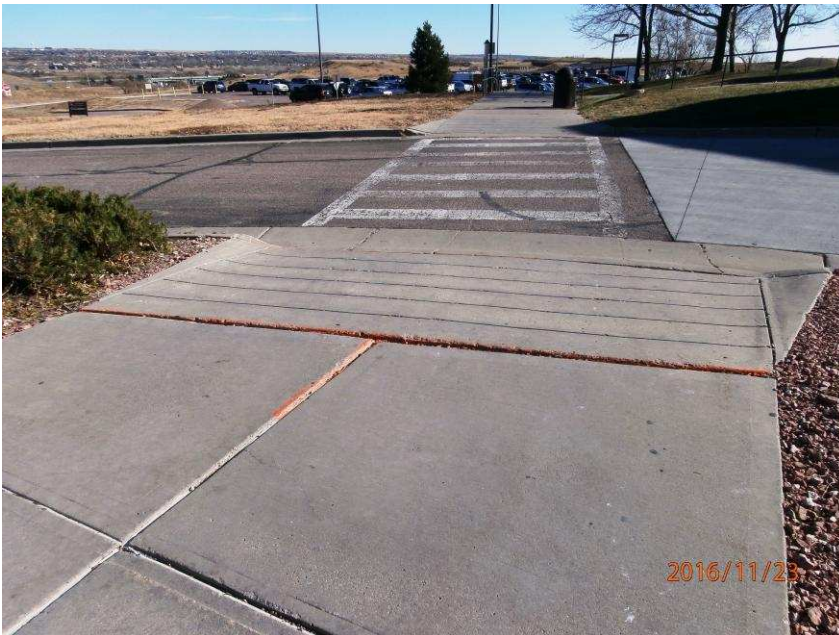
Finding: 1

There are multiple issues with this curb ramp including:

The top of the curb ramp has 1" vertical displacement with a 1-1/4" wide gap.

The bottom of the curb ramp has 3/4" vertical displacement and 3/4" wide gap, and is deteriorating.

There are multiple issues with this curb ramp from the parking area to the transfer station.

Image of noncompliant curb ramp

Remove and replace the curb ramp.

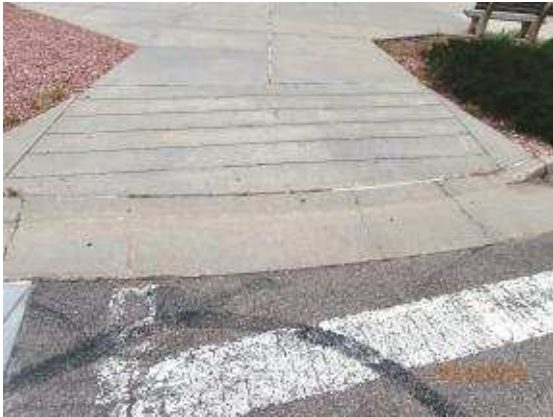
Finding #1 Additional Finding Photos

Additional image of noncompliant curb ramp

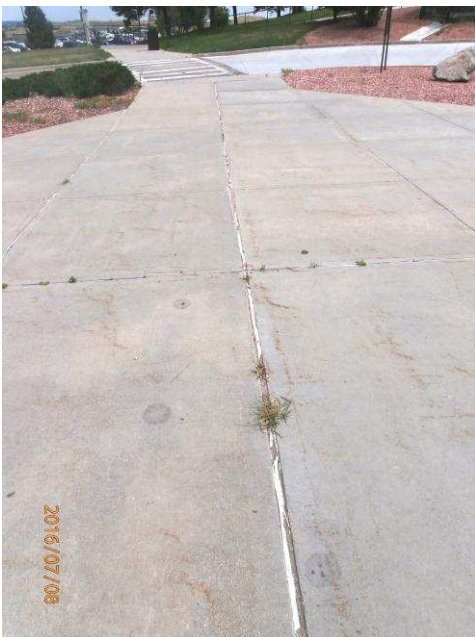
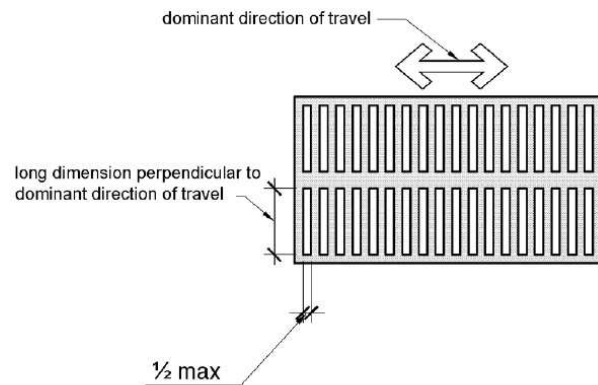
Finding: 2

The concrete expansion joint is spaced greater than 1/2 inch.

There is a 1" wide gap for the length of 7 panels.

Image of gap in sidewalk

Clean out and fill the gap.

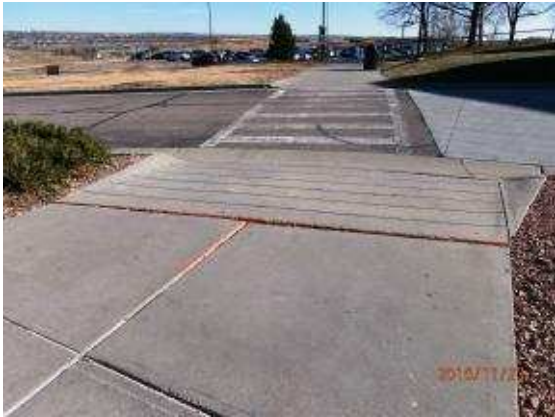
Finding #2 Additional Finding Photos

Additional image of gaps in sidewalk

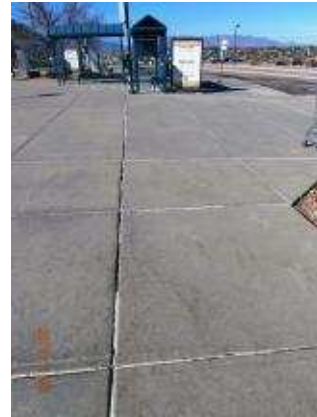
Additional image of gaps in sidewalk

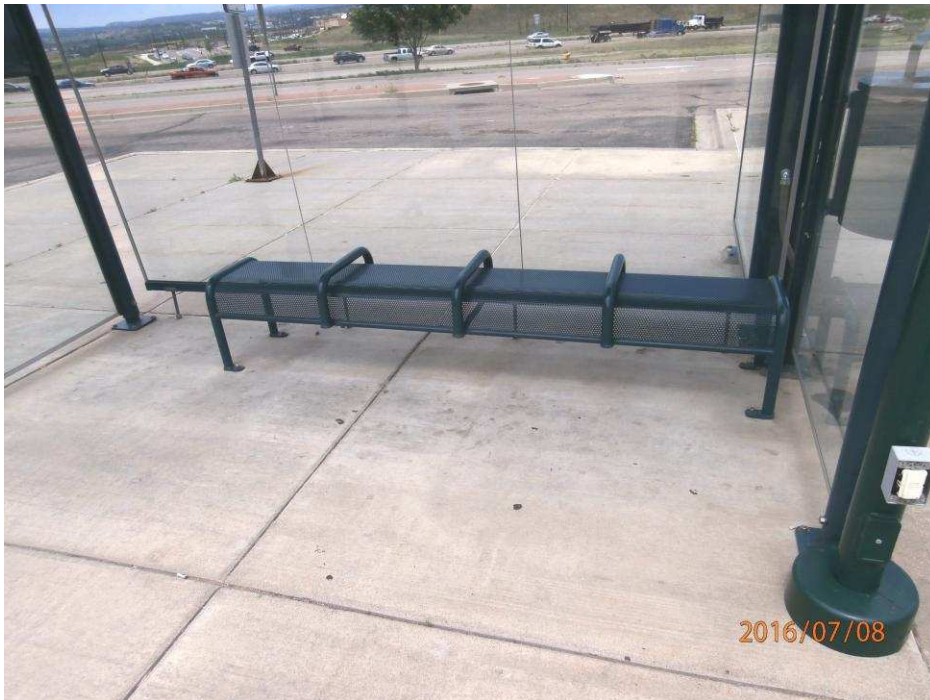
Finding: 3

In front of the bus shelter, there is 1" vertical displacement.

Image of vertical displacement at bus stop

Grind to less than 1/2".

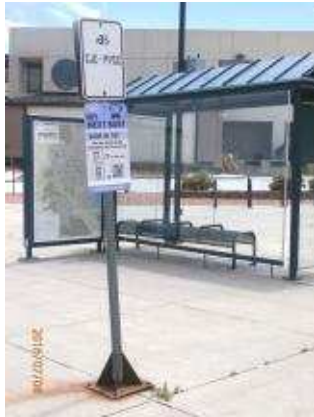
Finding #3 Additional Finding Photos

Additional image of displacement at bus stop

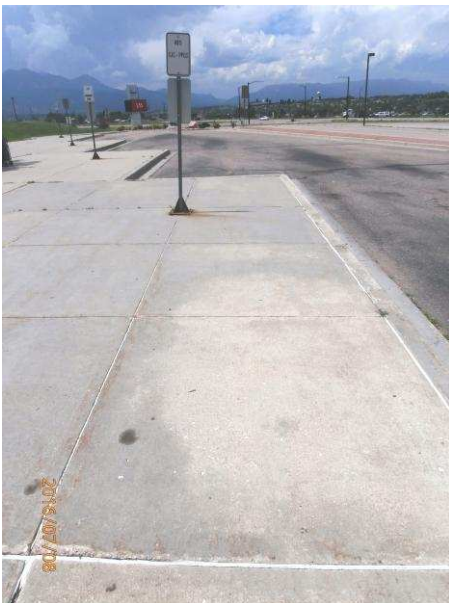
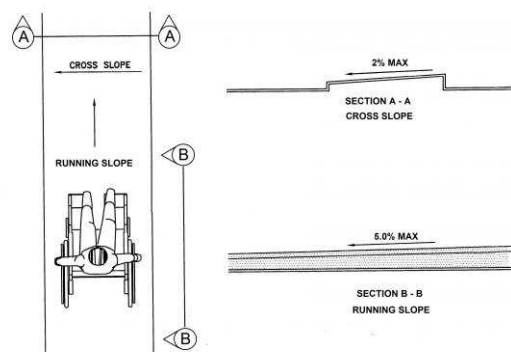
Finding: 4

The accessible route contains running slopes greater than 5 percent and cross slopes greater than 2 percent across the width of the walk and has not been constructed as a ramp (i.e. handrails, wheel guides, etc.).

The running and cross slopes of 2 panels are up to 4%.

Image of sidewalk with excessive running and cross slopes

Remove and replace the panels to provide maximum 2% slopes.

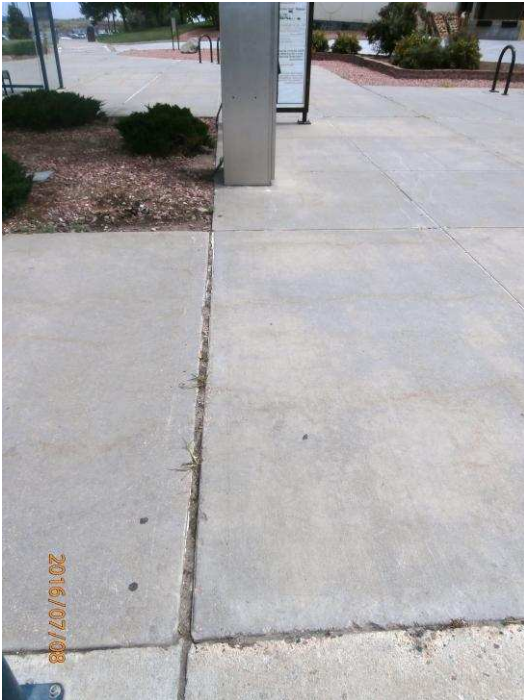
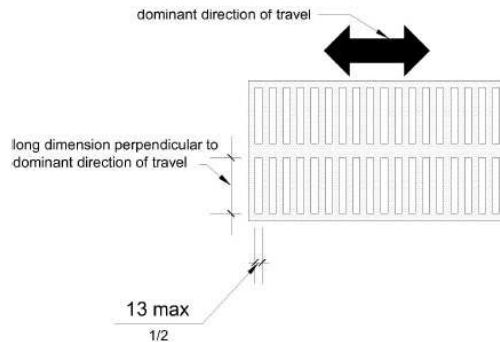
Finding: 5

The surface of the pedestrian access route has openings greater than 1/2 inch.

Near the ticket kiosk, there are up to 1-1/2" wide gaps and up to 1" vertical displacement.

Grind to less than 1/2" bevel. Clean out and fill gap.

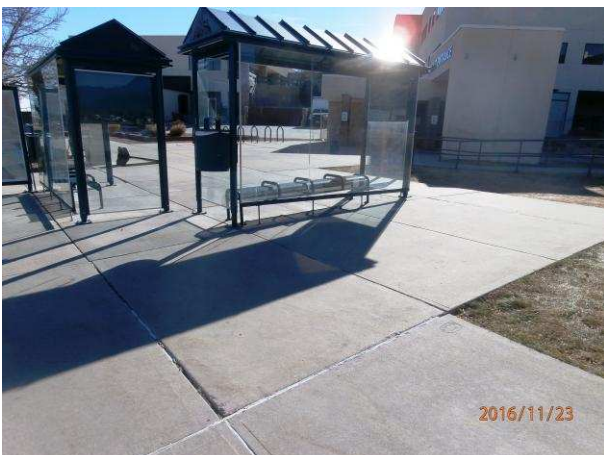
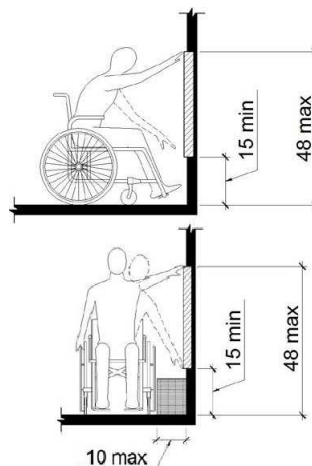
Finding: 6

The trash can is positioned too high for either a side or front approach.

The trash can on the right of the last shelter is 50-1/2" to the operable portion.

Image of bus shelter trash can

The trash can is not required to meet reach ranges. However, when this trash can is replaced, replace with one that is maximum 48" to the operable part.

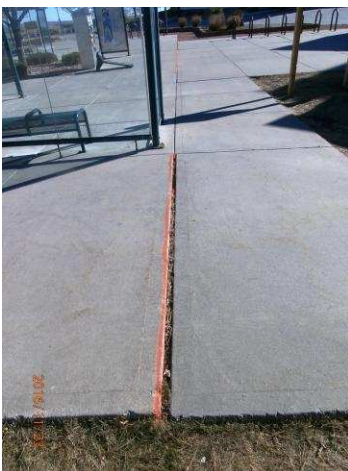
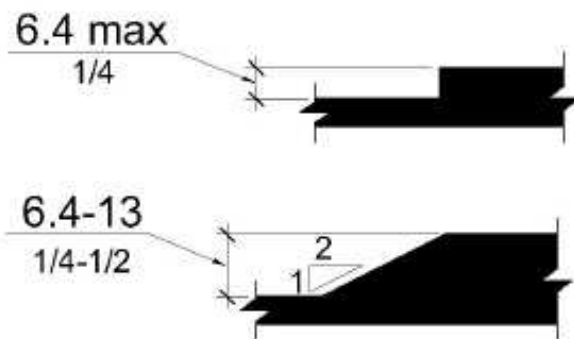
Finding: 7

There are 6 panels with slopes between 2% and 3%.

There is a gap up to 1-3/4" wide, up to 1-1/2" deep, with up to 3/4" vertical displacement.

There are several issues with the sidewalk near the last shelter.

Image of sidewalk with excessive slopes

Remove and replace the panels.

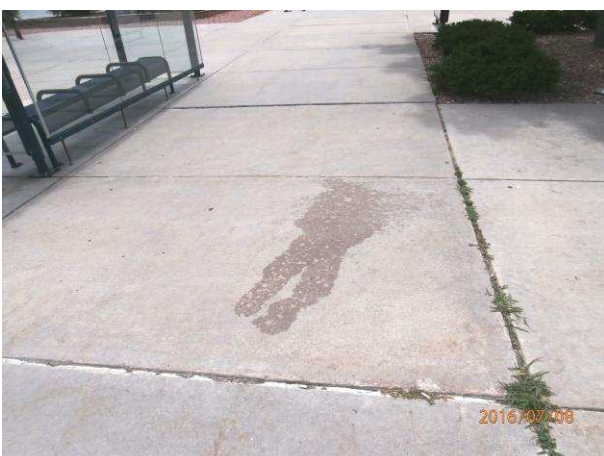
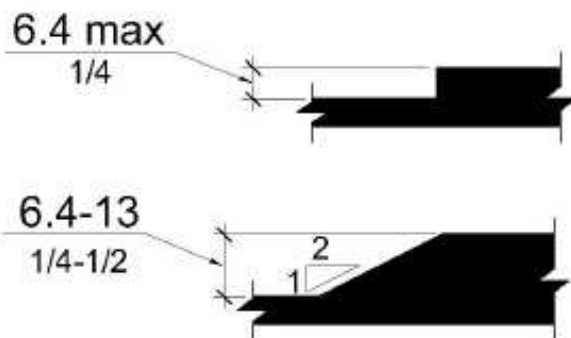
Finding: 8

There are gaps up to 1-1/2" wide, and up to 1/2" vertical displacement.

Near bay #35, there are multiple issues with the sidewalk.

Image of gaps and vertical displacement in sidewalk

Grind to less than 1/2" vertical displacement. Clean out and fill gap.

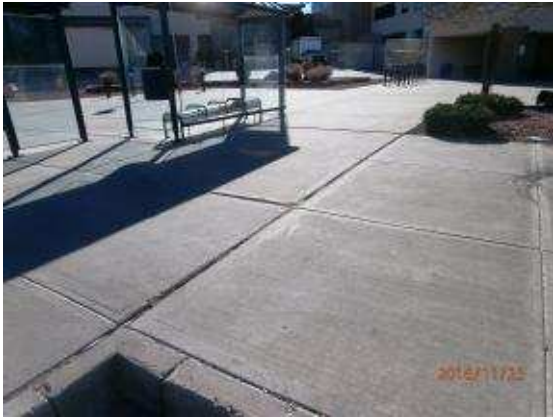
Finding #8 Additional Finding Photos

Additional image of gaps and vertical displacement

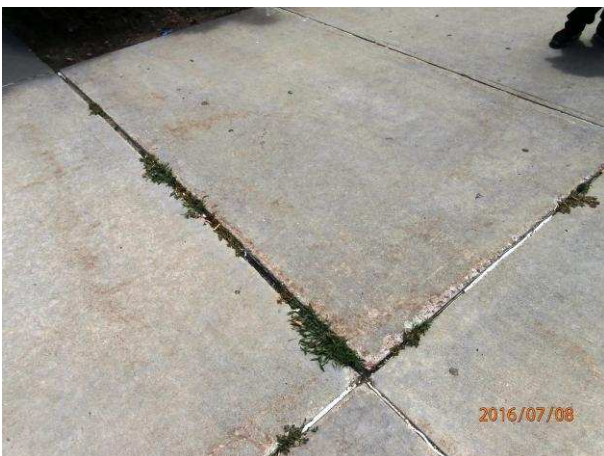
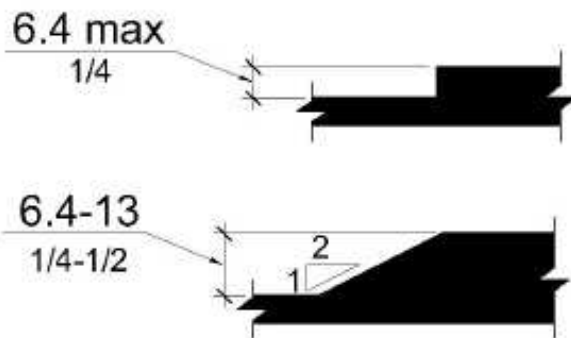
Finding: 9

There is a 1" gap and up to 3/4" vertical displacement.

There are multiple issues with the sidewalk near bay #27.

Image of gaps and vertical displacement in sidewalk.

Grind to less than 1/2". Clean out and fill gaps.

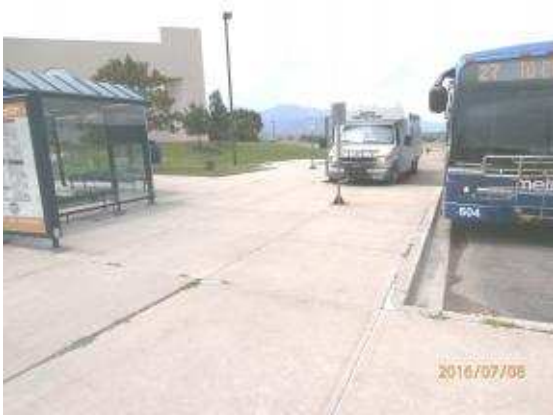
Finding #9 Additional Finding Photos

Additional image of gaps and vertical displacement

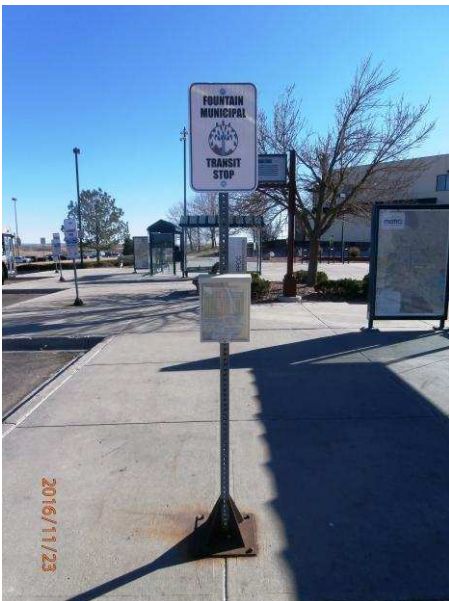
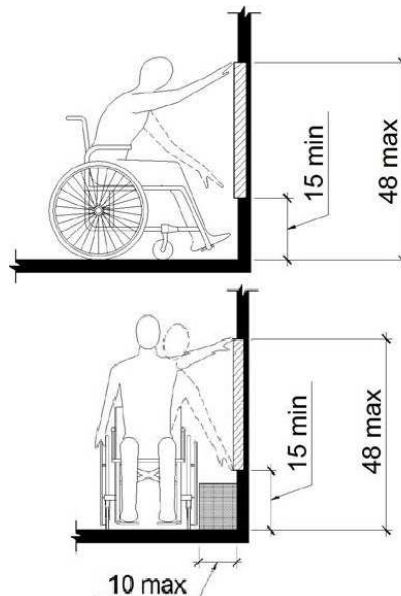
Finding: 10

The bus schedules are positioned too high for either a side or front approach.

The reach range to the bus schedules is 52".

Image of bus stop schedules mounted too high

Lower the bus schedule box to 48" maximum.
