CHEYENNE CAÑON EXISTING BRIDGE

NEEDS FOR REPLACEMENT:

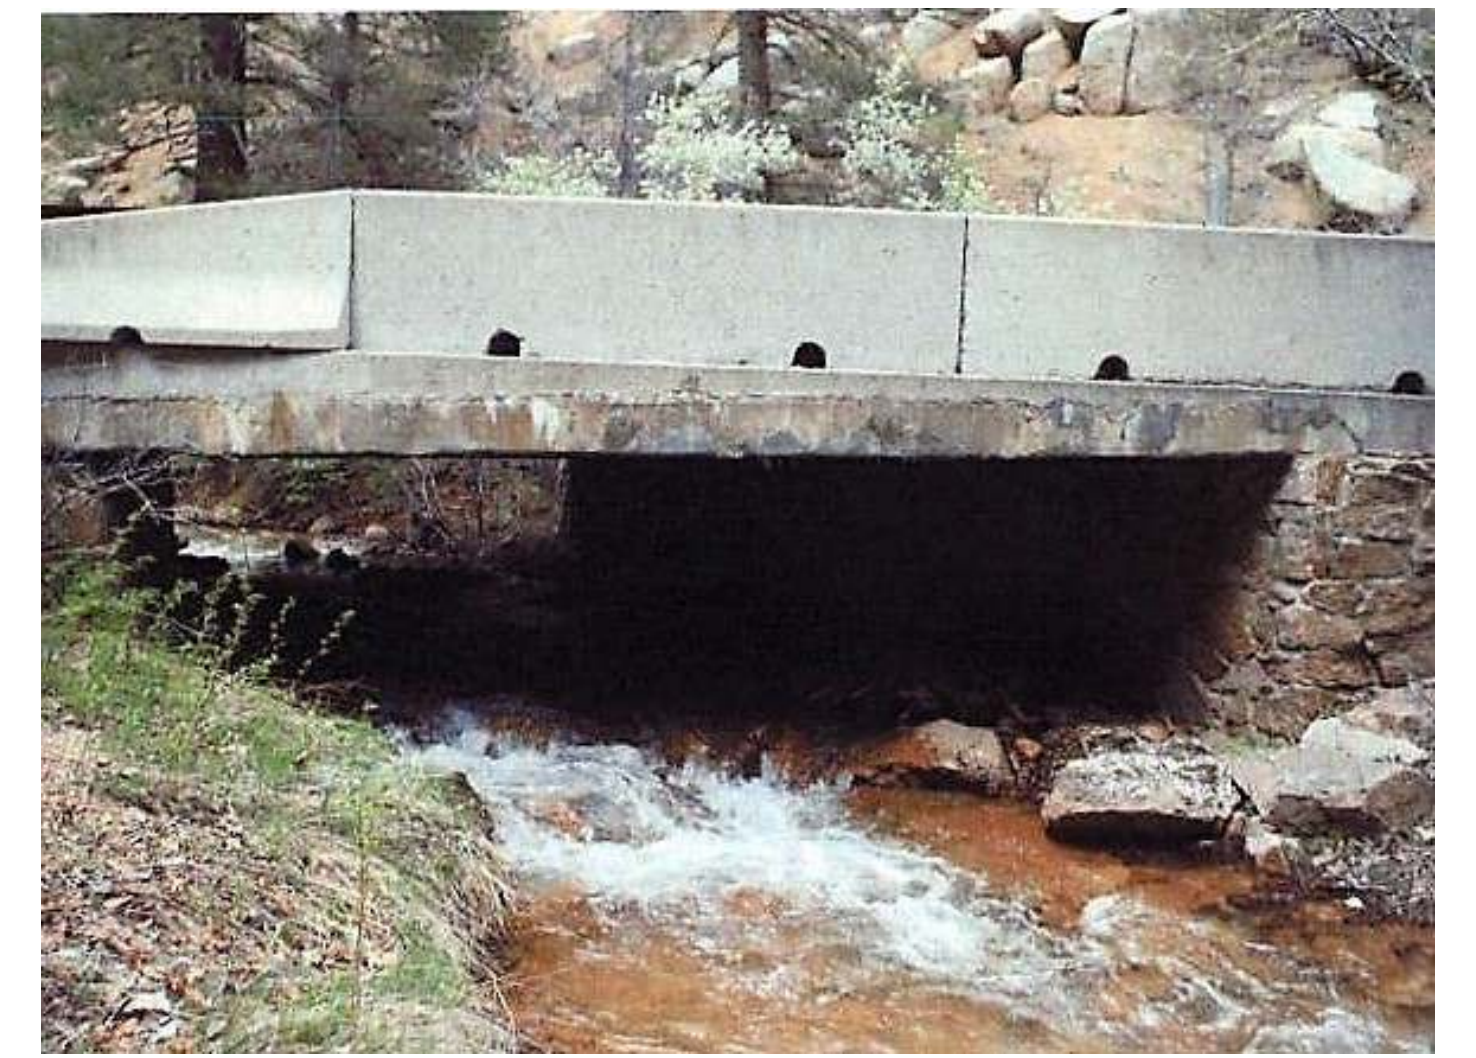
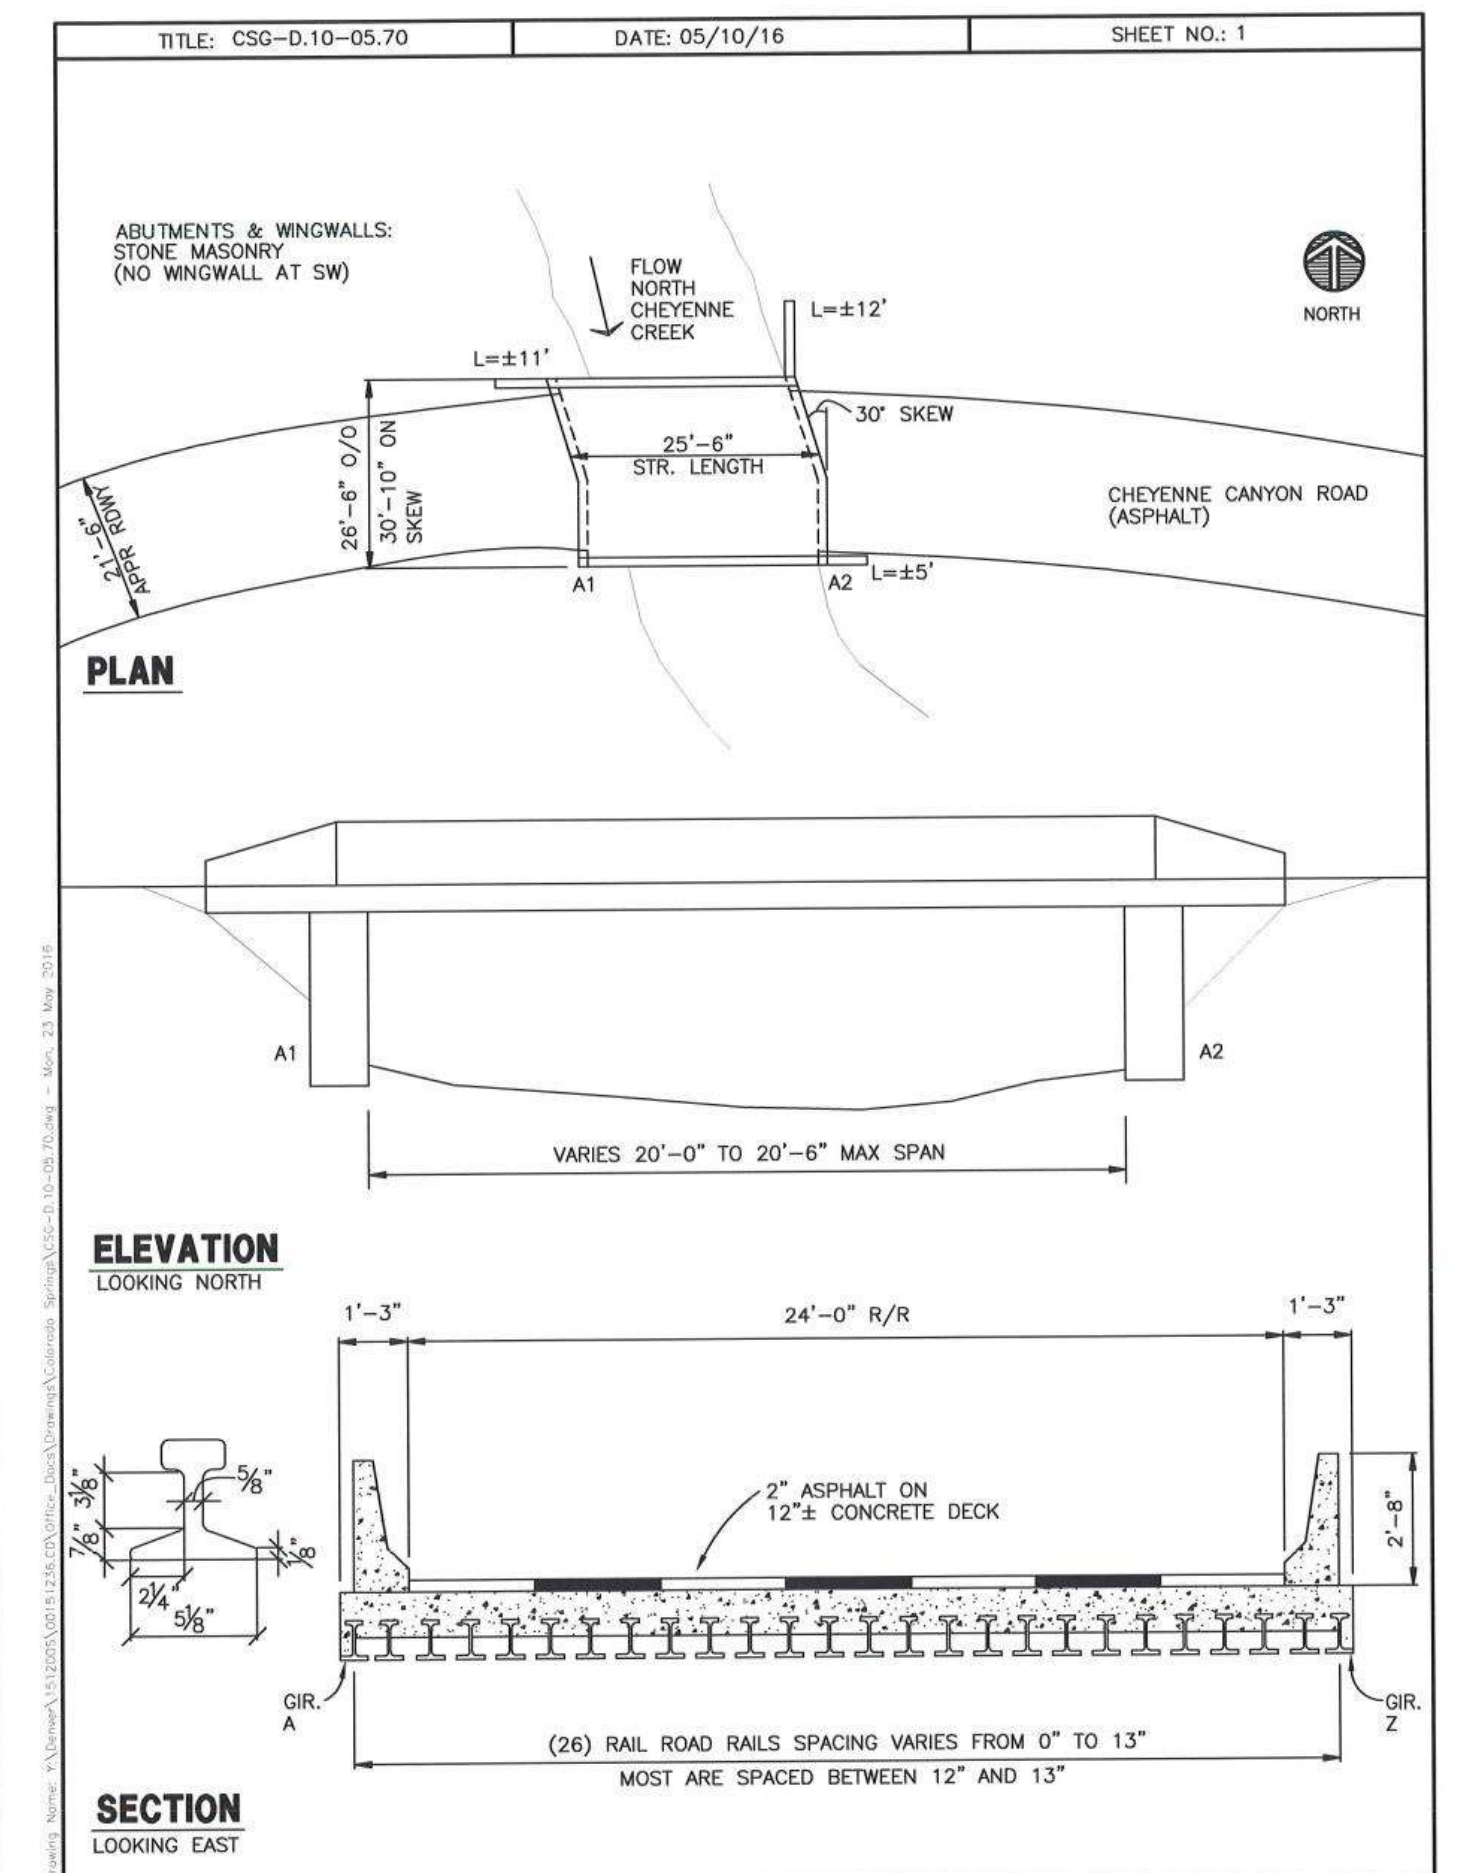
BRIDGE C (CSG-D.10-05.70)

Type of Bridge: Railroad rails with concrete deck

Year Constructed: 1950/1922

Sufficiency Rating: 52

Load Posting: 20 Tons

Skew: 30 degrees (downstream portion of bridge has less skew)

Superstructure Condition: Fair

Deck Condition: Fair

Abutment Condition: Good

Deck Geometry: Poor

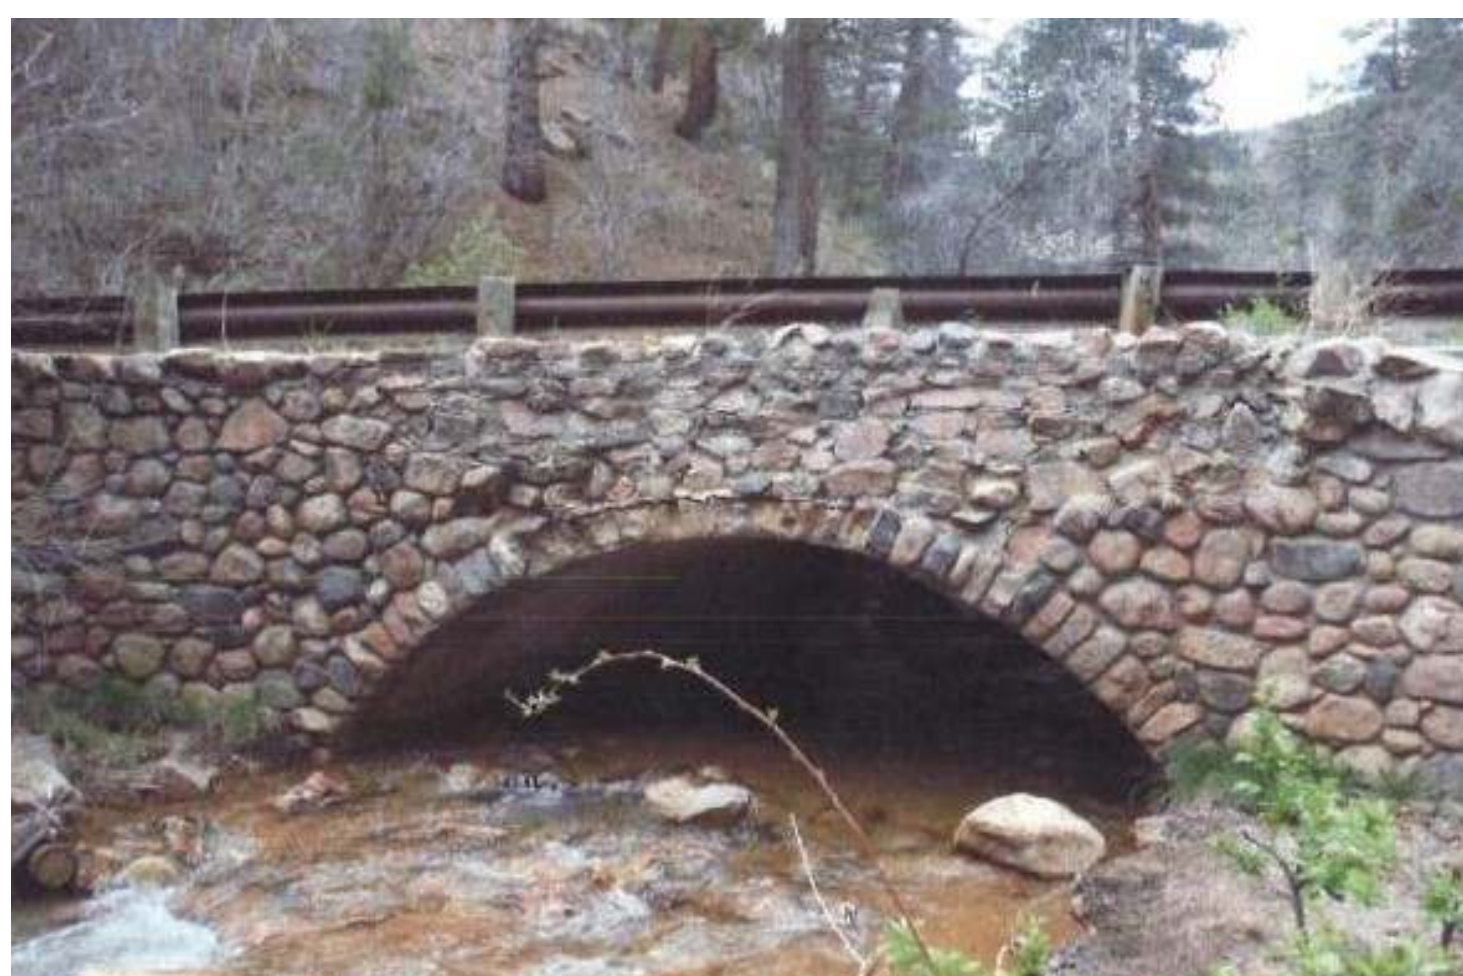
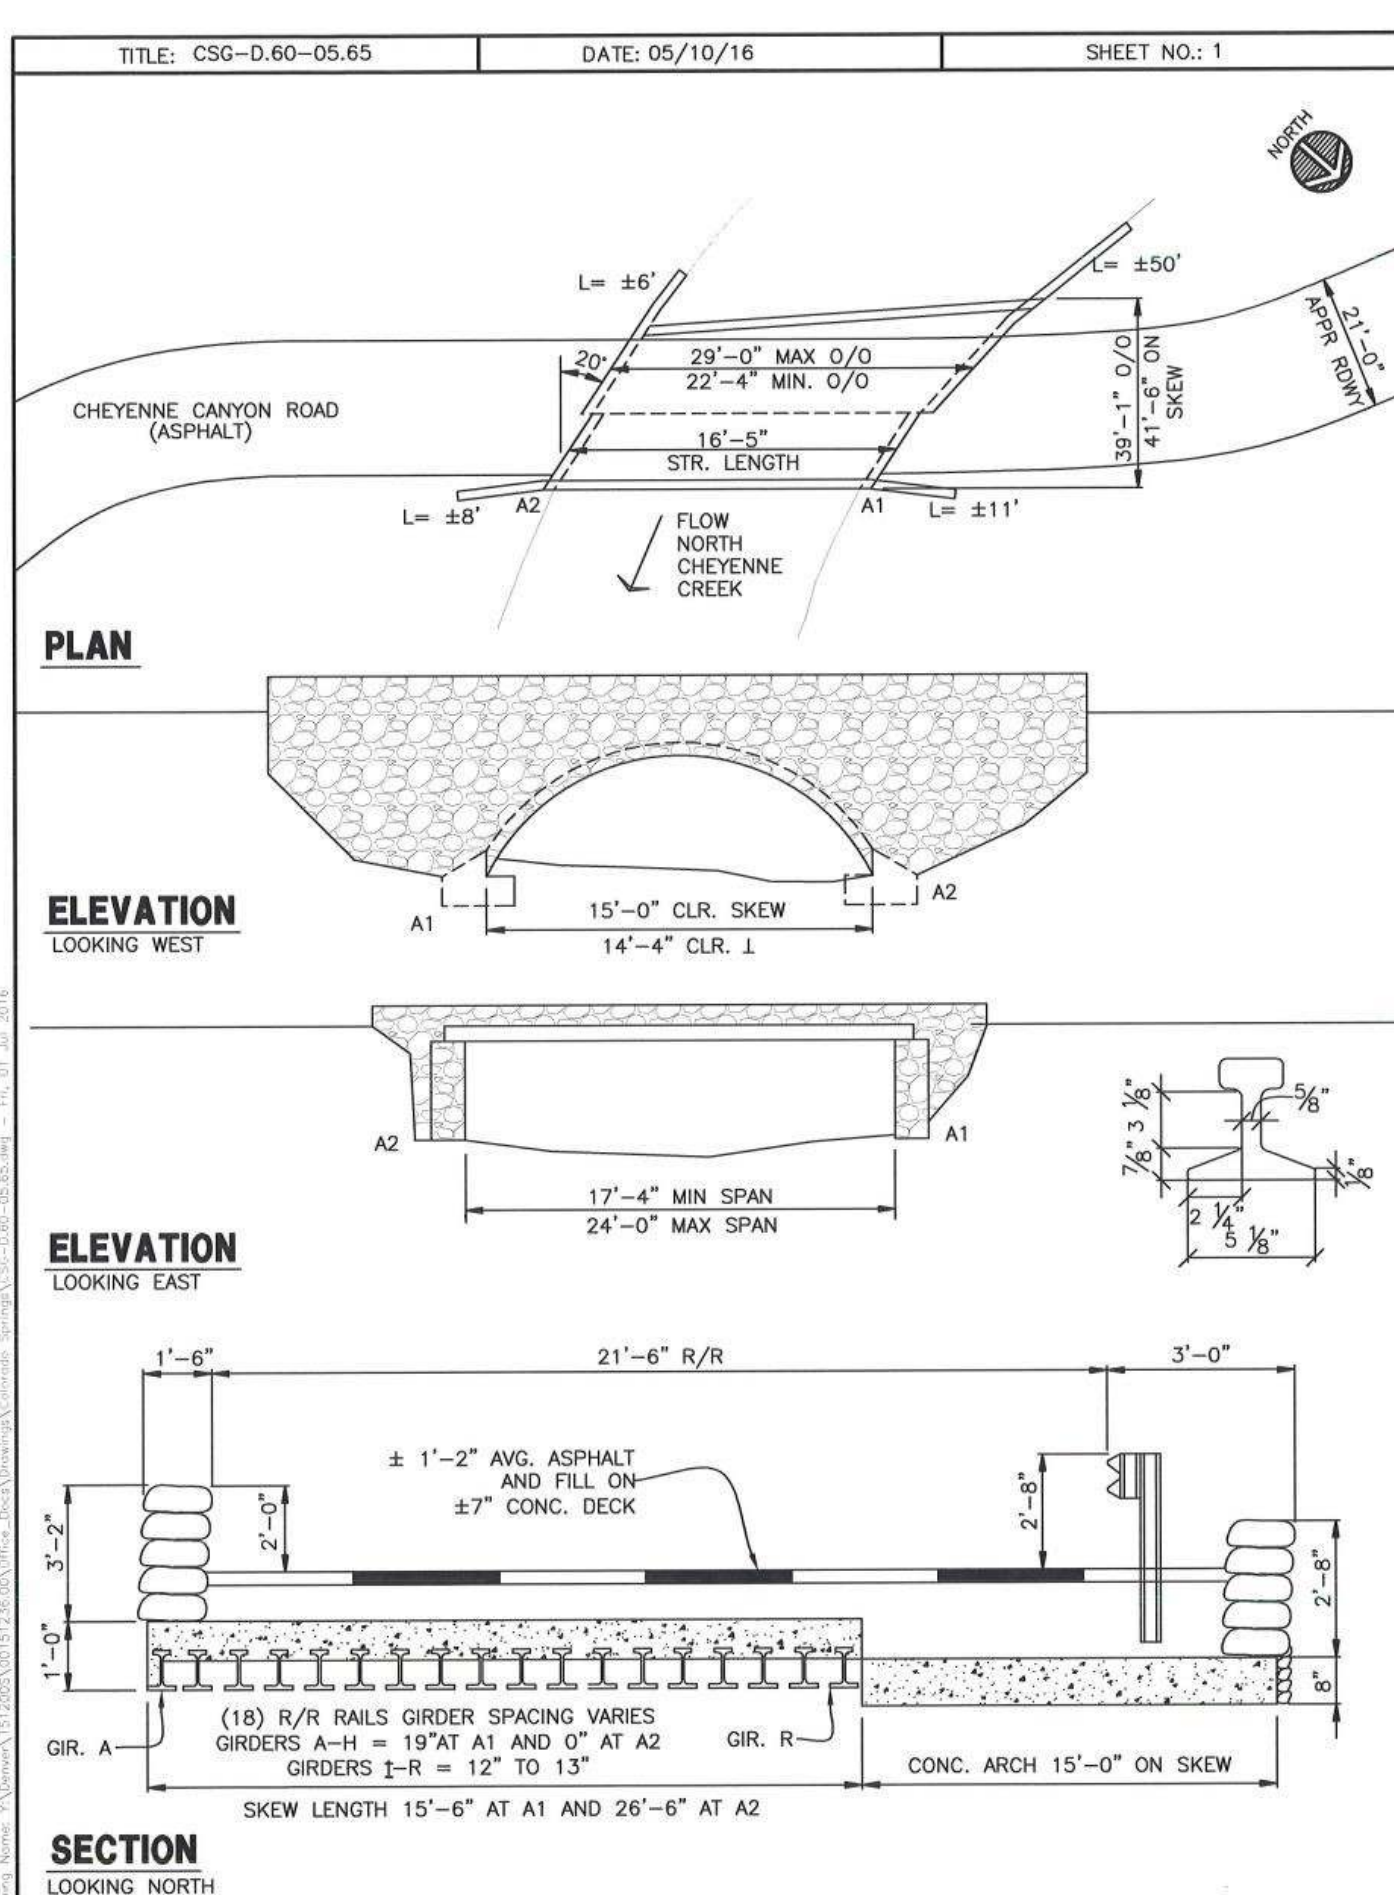
BRIDGE B (CSG-D.60-05.65)

Type of Bridge: Railroad rails with concrete deck & Concrete arch

Year Constructed: 1950/1922

Sufficiency Rating: 50 (Functionally Obsolete)

Load Posting: 20 Tons

Skew: 20 degrees (uphill abutment has a higher skew)

Superstructure Condition: Fair

Deck Condition: Fair

Abutment Condition: Fair

Deck Geometry: Critical

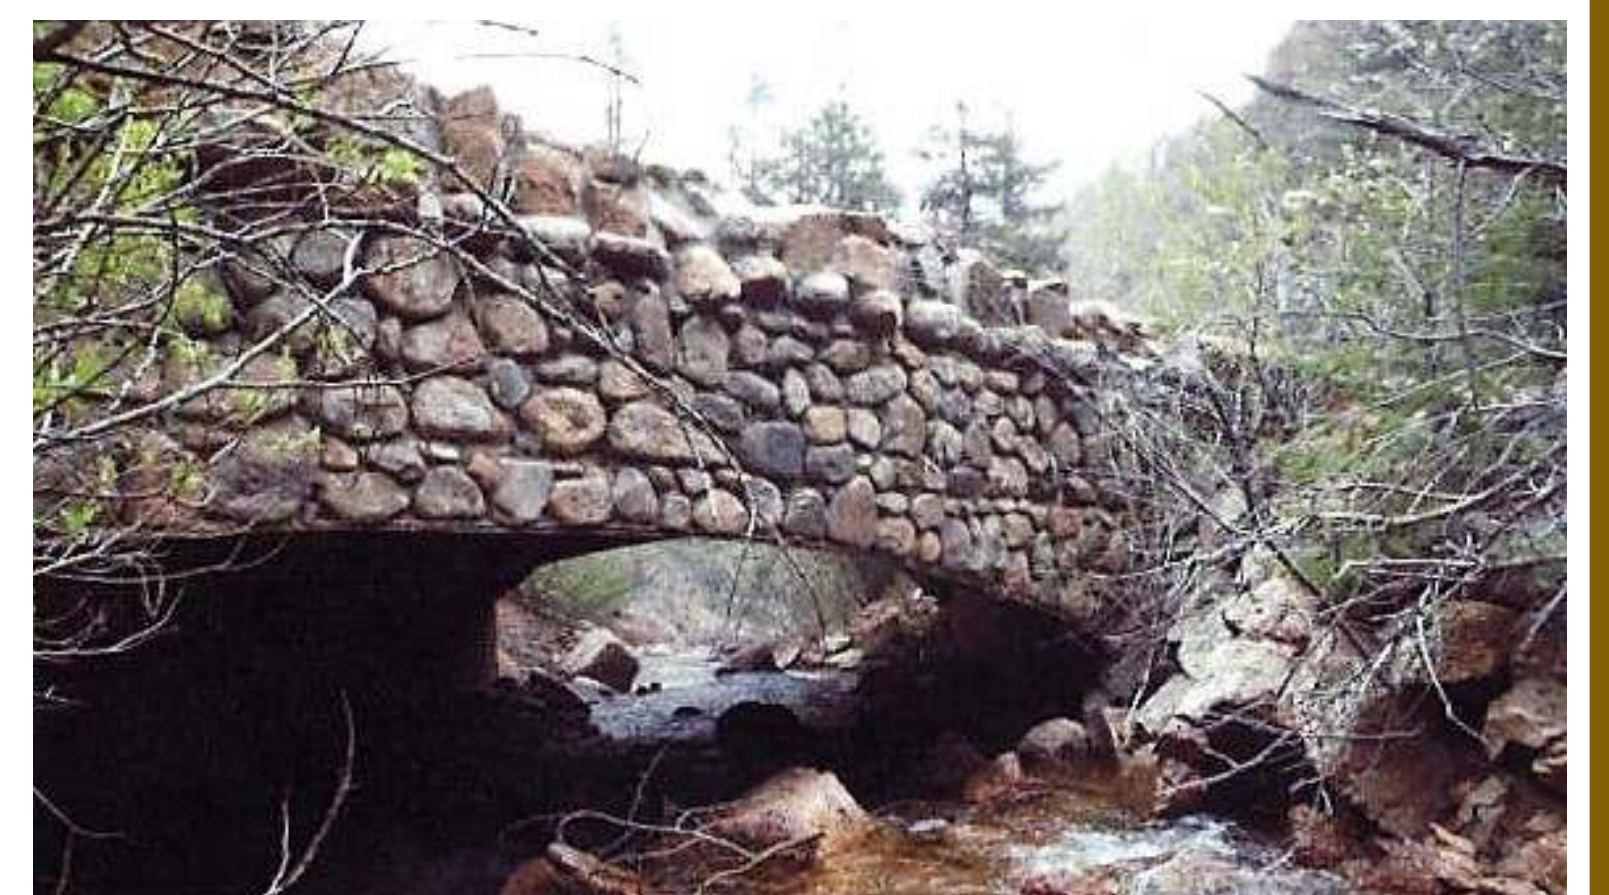
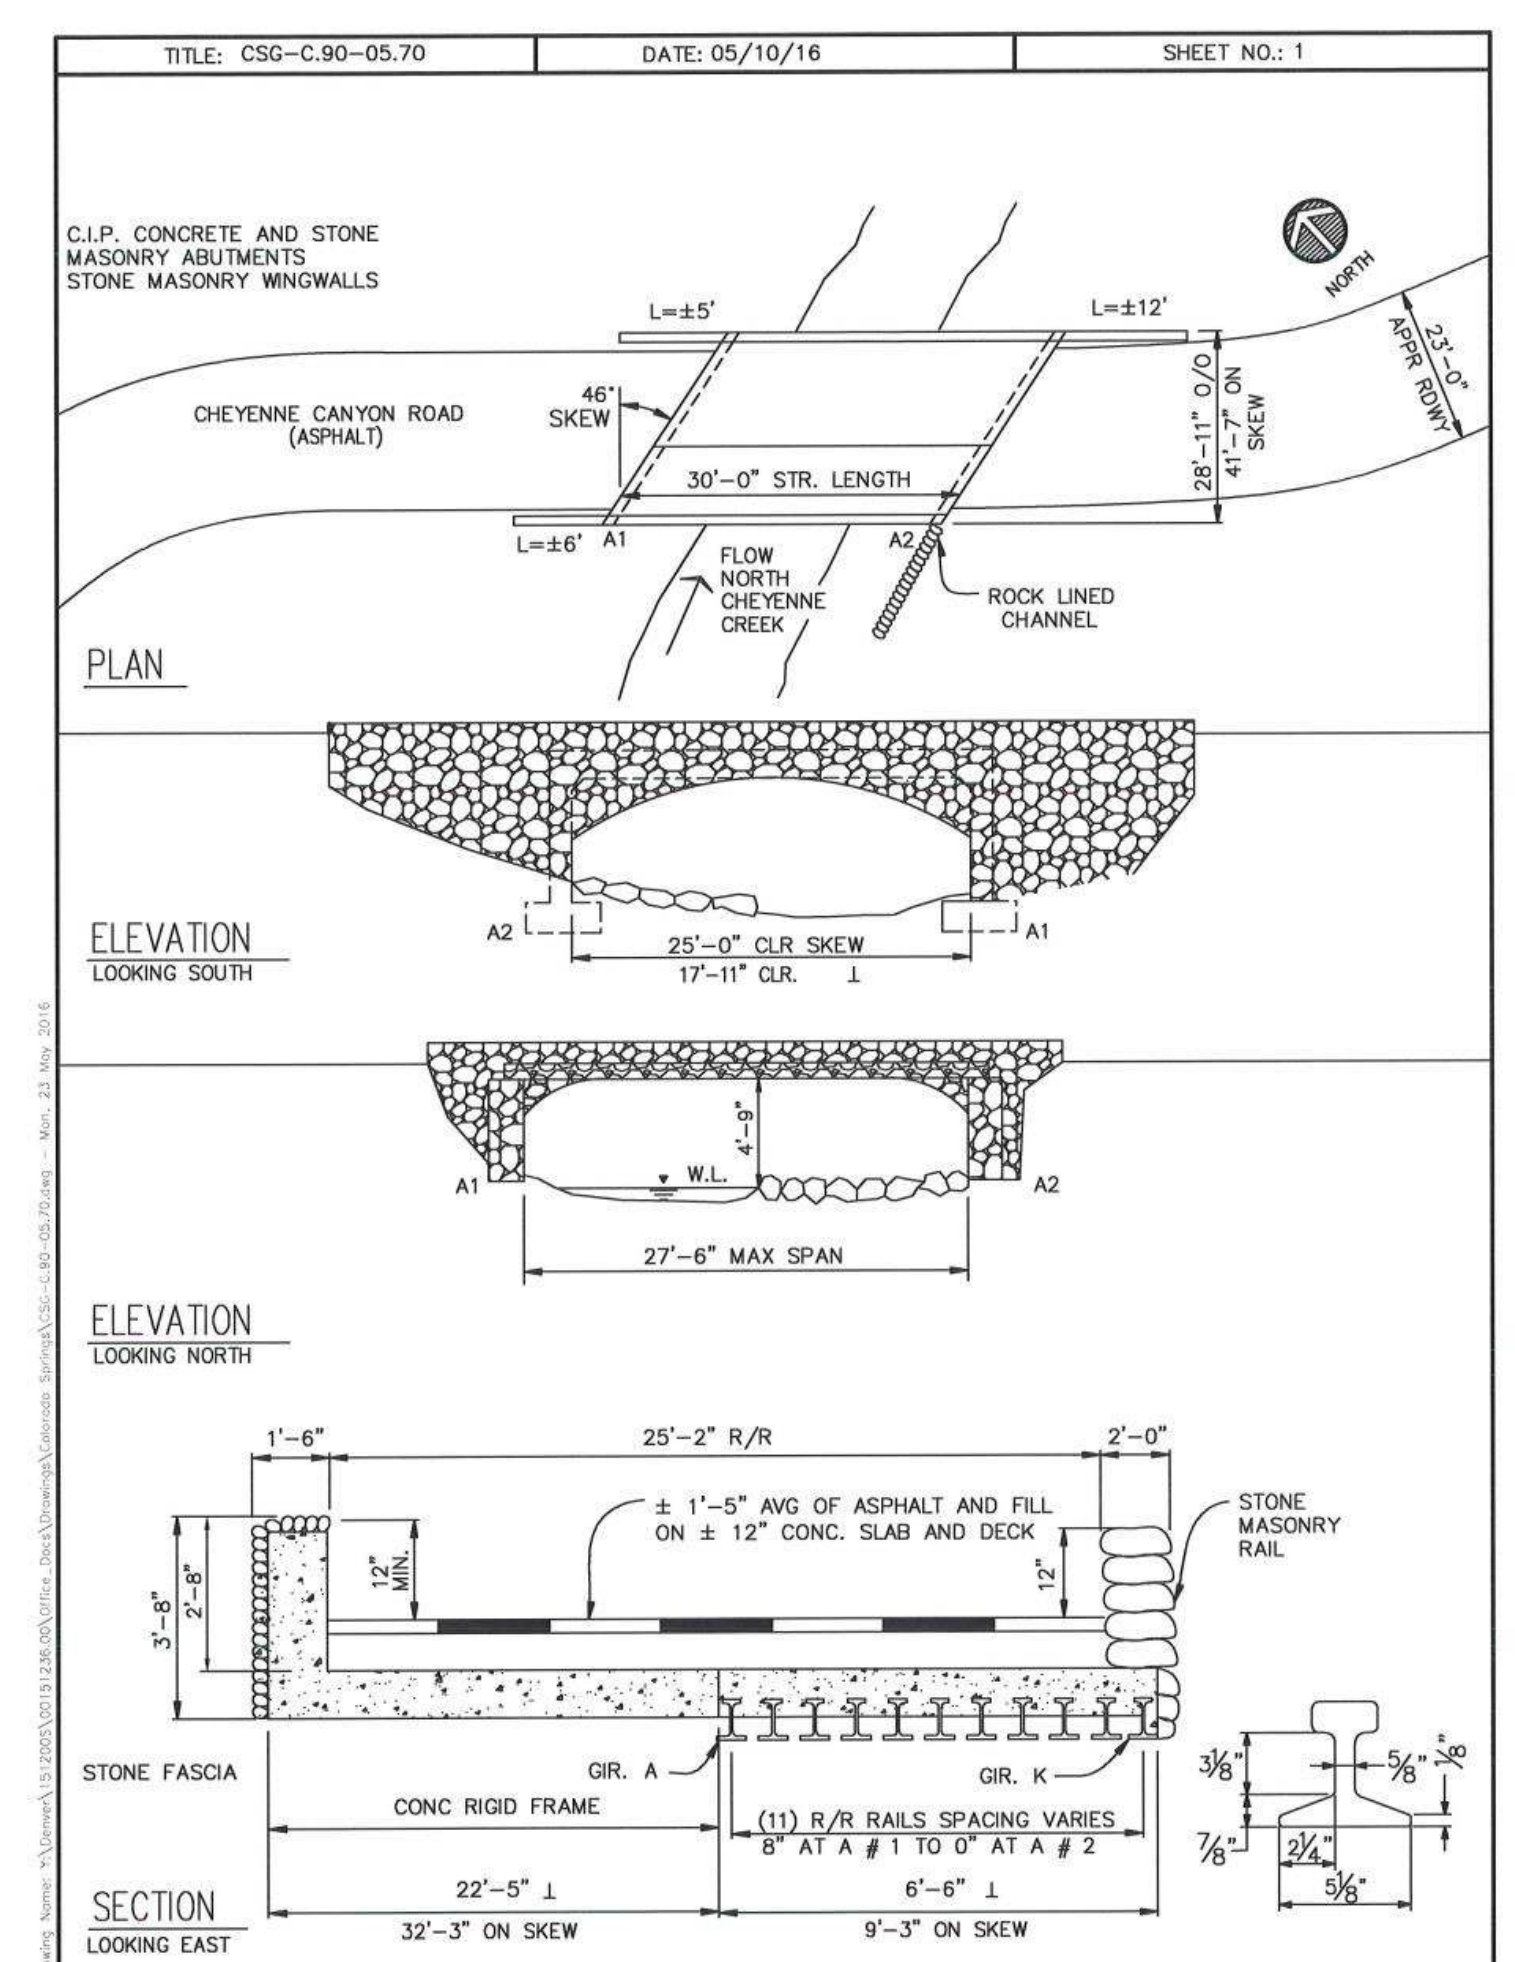
BRIDGE D (CSG-D.10-05.70)

Type of Bridge: Railroad rails with concrete deck/Concrete box culvert

Year Constructed: 1950/1922

Sufficiency Rating: 63

Load Posting: 20 Tons

Skew: 46 degrees

Superstructure Condition: Fair

Deck Condition: Fair

Abutment Condition: Fair

Deck Geometry: Poor
