Site Accessibility Evaluation

South Slope Recreation Area Open Space

Accessibility Evaluation

SUBJECT: South Slope Recreation Area Open Space Self-Evaluation

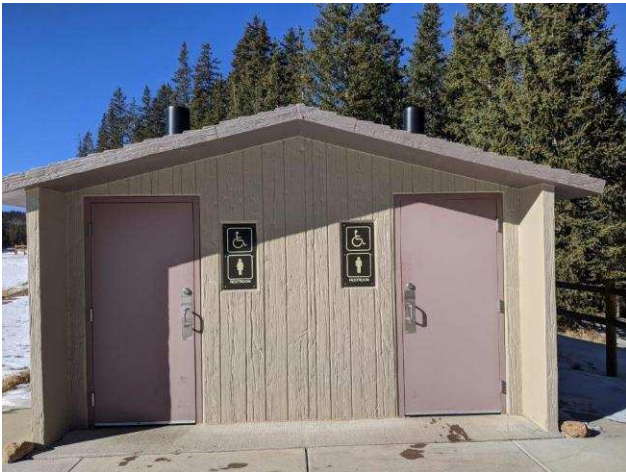
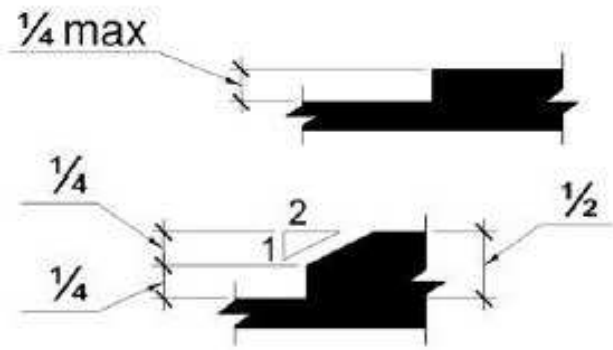
Finding #1 Continued

Finding: 1

The walkway contains abrupt vertical edges and/or variations over a 1/4 inch.

2010 ADAS Section: 303.3, 303.2

The entrance into the men's and women's restroom has greater than 1/4" vertical displacement within 5' of the door.

Reduce vertical displacement to at or under 1/4".

We need to lower the slope from the door as well. The cost is to cover this as well.

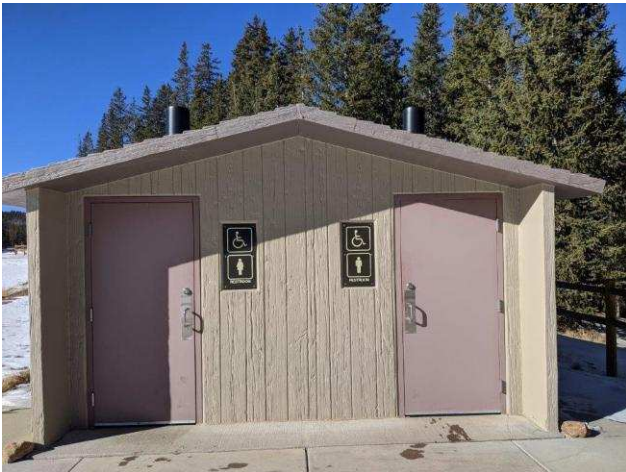
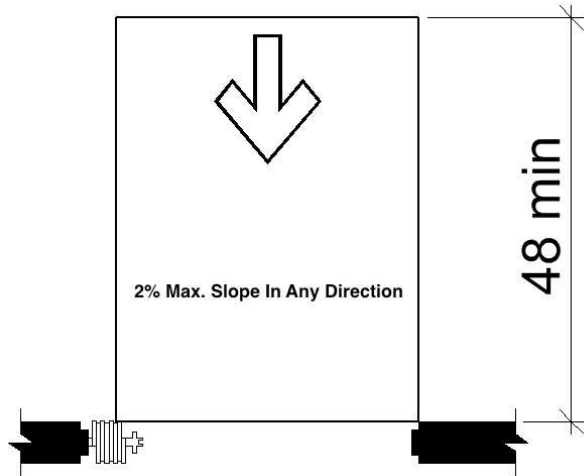
Finding #2 Continued

Finding: 2

The maneuvering clearance at the door exceeds a 2% slope.

2010 ADAS Section: 404.2.4.4

The slope from the vertical displacement to the door exceeds 2%.

Reduce to at or under 2% slope.
