# Site Accessibility Evaluation

**Tejon Park & Ride  
PU18-0085**

**1305 S Tejon St  
Colorado Springs, CO  
80905**

SUBJECT: Tejon St. Park & Ride Self-Evaluation

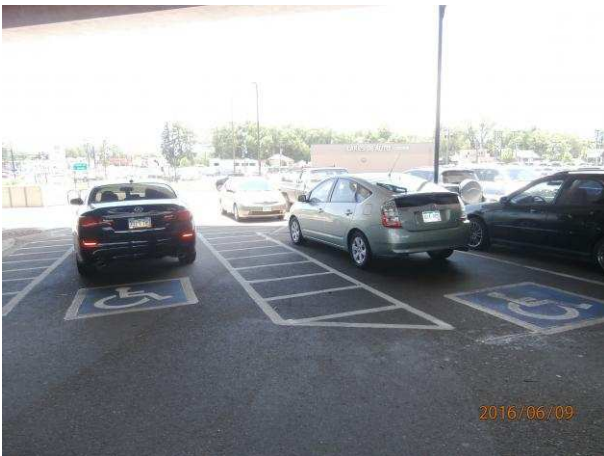
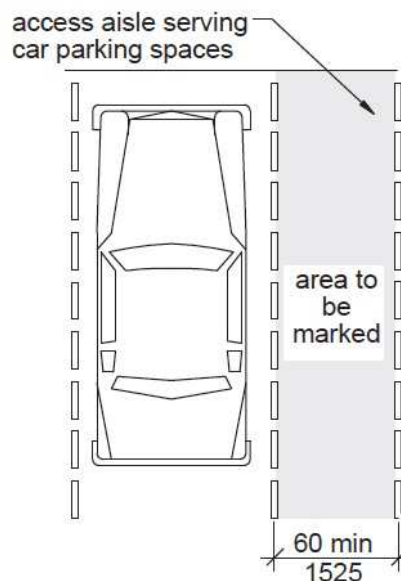
### Finding: 1

On the south side there are two access aisles approximately 4'-8" wide. On the north side the access aisles are 4'-9" and 6'-10" wide. However, the parking spaces range between 9'-0" and 9'-4" wide, wider than the 8'-0" minimum.

There are several access aisles narrower than 5'-0".

Image of narrow access aisles

Restripe the parking spaces to 8'-0" wide with 5'-0" wide access aisles.

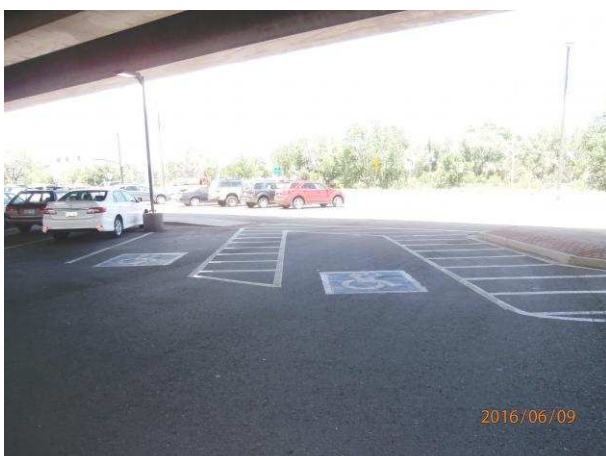
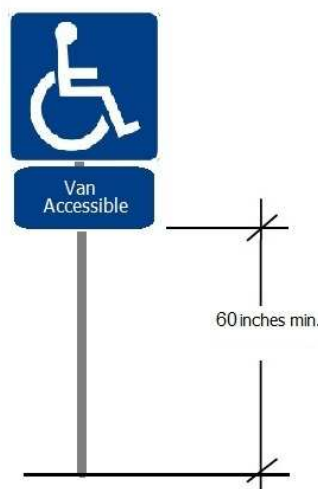
## Finding: 2

The required parking signage is missing.

None of the parking stalls have accessible parking signage.

Image of accessible parking without signage

Install signage. Flexible signs or some sort of barrier must be installed due to accessible parking location to the entrance/exit.

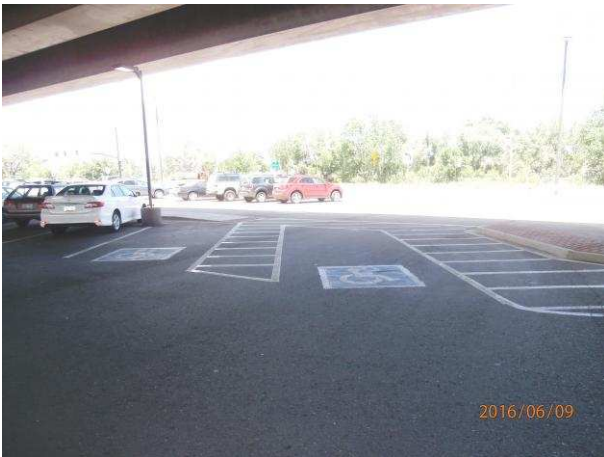
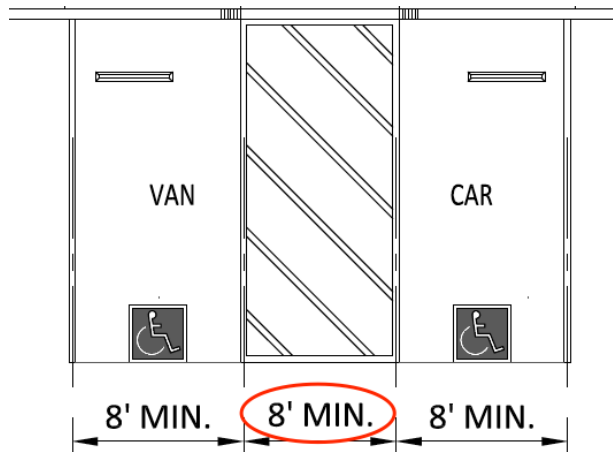
### Finding: 3

The access aisle is not a minimum 8 feet to the centerline of the stripe. There is a 9'-4" wide parking space with a 6'-10" access aisle. This space and access aisle together meet the 16'-0" required width, although they are not striped correctly as 8'-0" parking space with 8'-0" access aisle, or as 11'-0" parking space with 5'-0" wide access aisle.

There is not a van accessible parking space.

Image of lack of van accessible parking space

Restripe the parking and access aisle. In addition, add a van accessible parking sign.

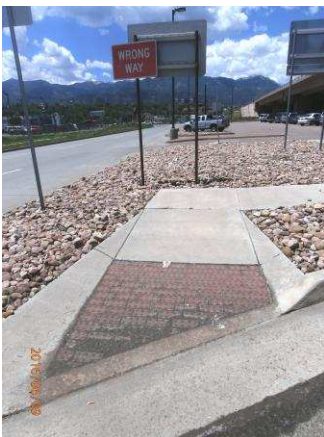
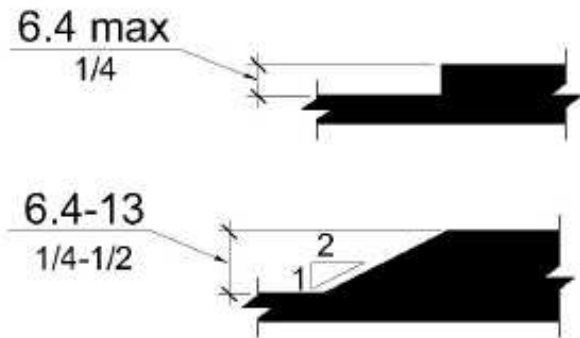
### Finding: 4

This ramp is on the west side of the southeast driveway into the park & ride lot.

There is 1/2" vertical displacement at the bottom of this curb ramp.

Image of vertical displacement at curb ramp

Grind to less than 1/2".

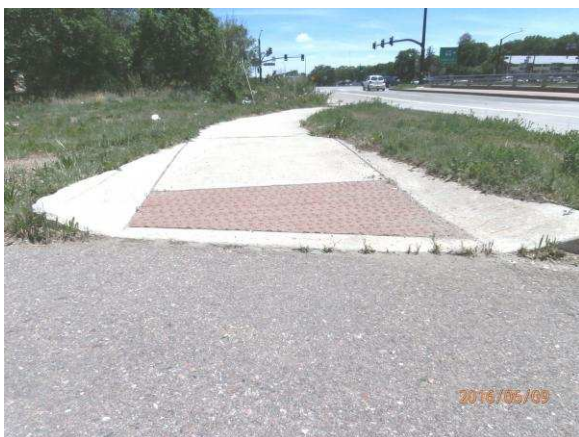
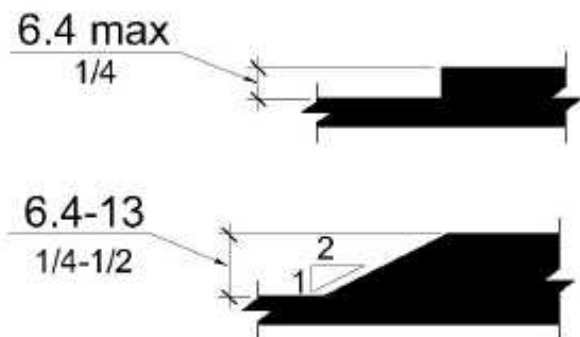
### Finding: 5

This curb ramp is at the east side of the southeast driveway into the park & ride lot.

There is 1/2" vertical displacement at the bottom of this curb ramp.

Image of vertical displacement at curb ramp

Grind to less than 1/2".

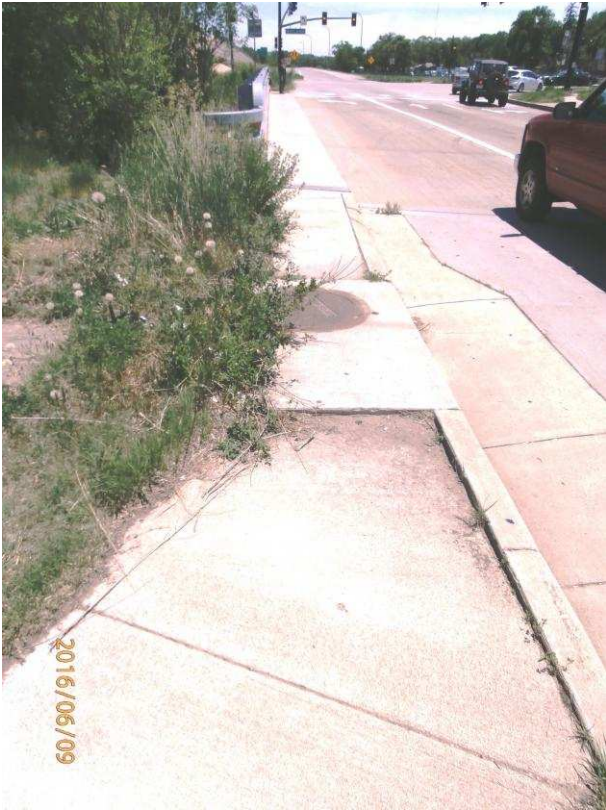
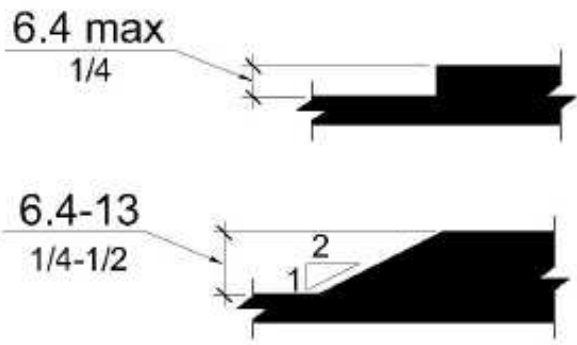
Finding #6 Continued

On one side of the storm drain there is 2" vertical displacement; on the other side is 1/2" vertical displacement.

There is vertical displacement at this storm drain on the access road between Nevada and Tejon.

Image of vertical displacement at storm inlet

Remove and replace the adjacent sidewalk.

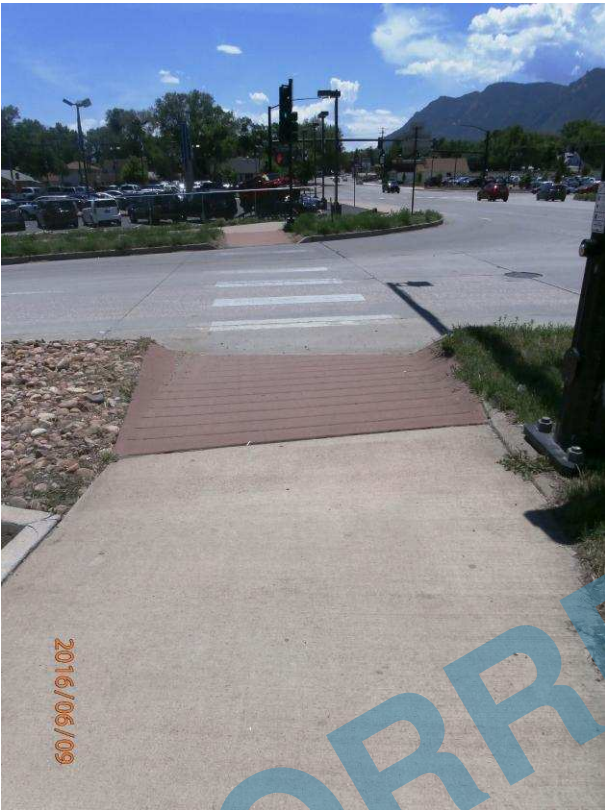
### Finding: 7

There are no detectable warnings on this curb ramp on the access road by Tejon on south side of facility.

Image of curb ramp without detectable warnings

CORRECTED

Install detectable warnings.

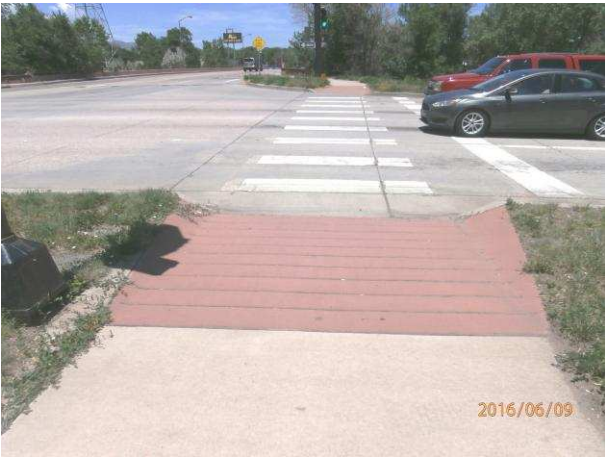
### Finding: 8

**There are no detectable warnings on this curb ramp on the access road by Tejon on north side of facility.**

Image of curb ramp without detectable warnings

CORRECTED

**Install detectable warnings.**

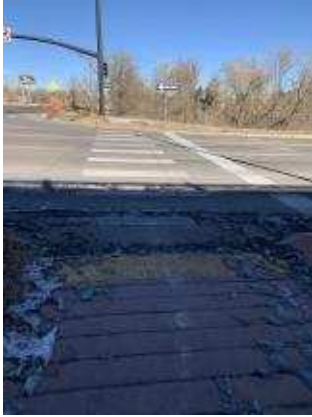
**Finding #8 Additional Finding Photos**

Finding 187211 Additional Photo

CORRECTED

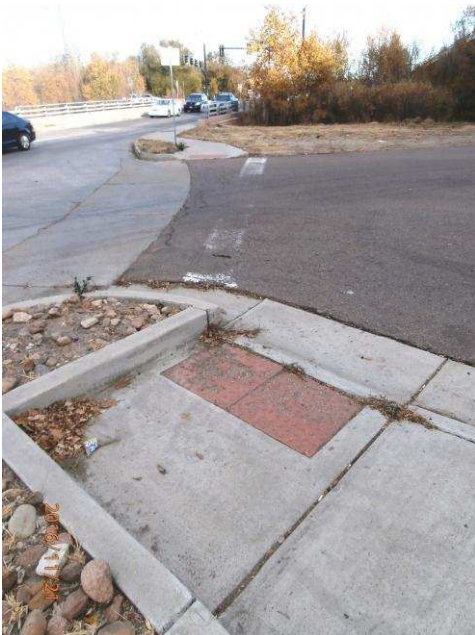
### Finding: 9

The detectable warning plates are deteriorating.

There is a 1" gap to the gutter that is up to 3/8" deep.

Image of noncompliant curb ramp

Replace the detectable warning panels. Clean out and fill the gap.

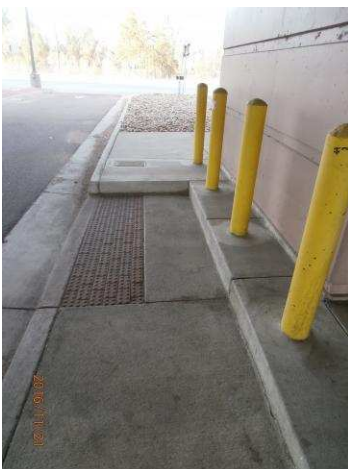
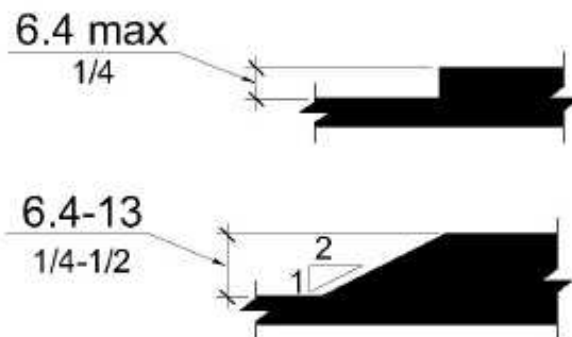
### Finding: 10

There is no fall protection at the end of the curb ramp.

There is a 6" drop at the edge of this curb ramp, which is accessible from the other side of the bridge pillar.

Image of curb ramp without fall protection

Install a guard to prevent pedestrians from tripping on the 6" curb.

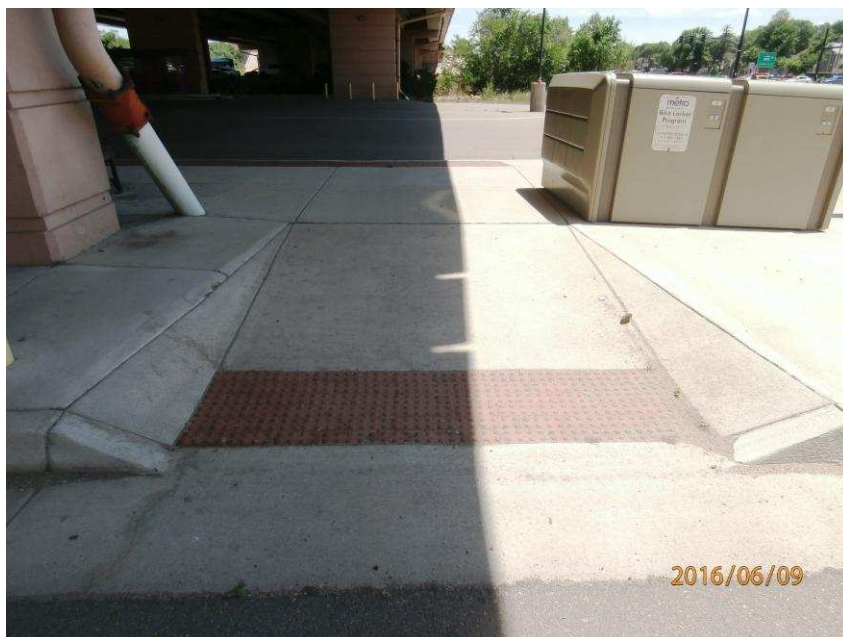
### Finding: 11

The side flares are 22%.

The drain pipe protrudes into the path of travel and is too tall (54") to be cane detectable.

The cross slope is 3.8%.

Image of noncompliant curb ramp

Replace the curb ramp and install a barrier at the drain.

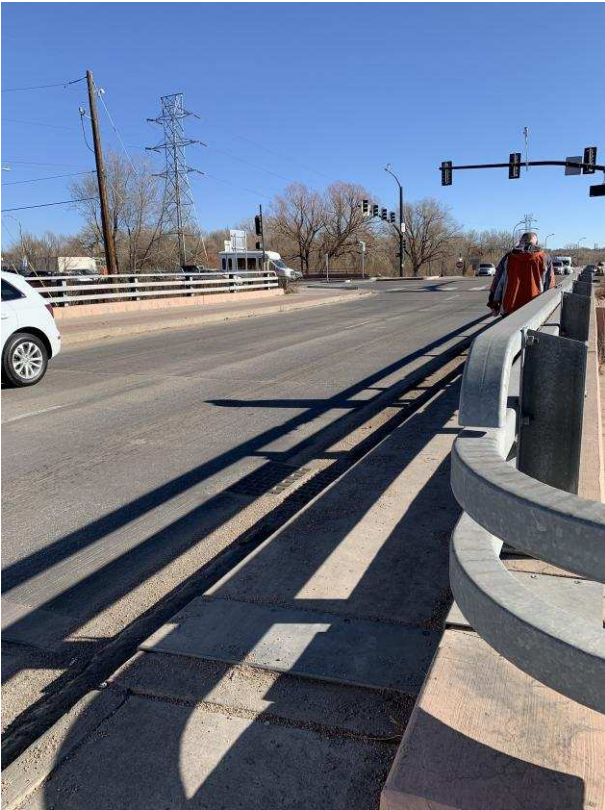
Finding #12 Continued

This is on the north access road, at the bridge between the parking lot for the park & ride and Nevada Ave. The metal plate in the sidewalk has 1/2" vertical displacement.

There is 1/2" vertical displacement in the sidewalk.

Determine if the concrete can be re-poured and raised to provide a flush edge between the metal plate and sidewalk.

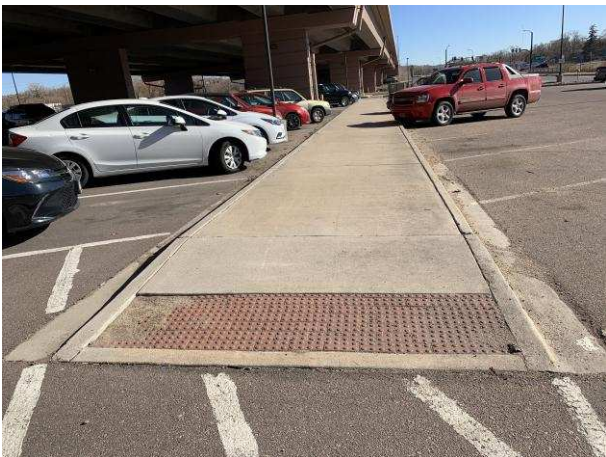
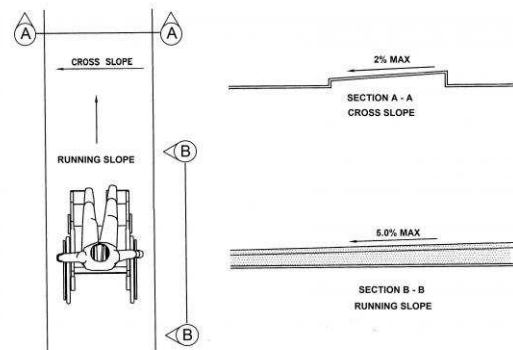
### Finding: 13

There is approximately 90' of sidewalk with cross slope between 3% and 6%. This is on the south side of the parking lot.

The cross slope of the sidewalk is excessive.

Remove and replace to provide maximum 2% cross slope.

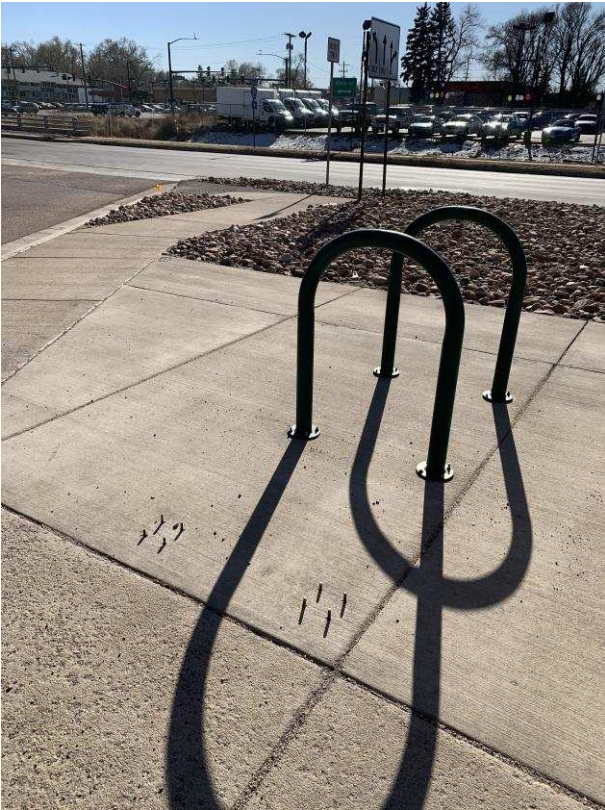
Finding #14 Continued

One of the bike racks is missing and the anchoring studs protrude above the sidewalk. The southernmost bike rack is only held on by one nut.

The studs from a previous bike rack protrude 1-1/2" above the sidewalk.

Replace the bike rack or grind the studs flush with the concrete. Re-anchor the southern bike rack.
