# Site Accessibility Evaluation

**Woodmen Park & Ride  
PU18-0089**

**6995 Mark Dabling Blvd  
Northeast Colorado  
Springs, CO 80919**

SUBJECT: Woodmen Park & Ride Self-Evaluation

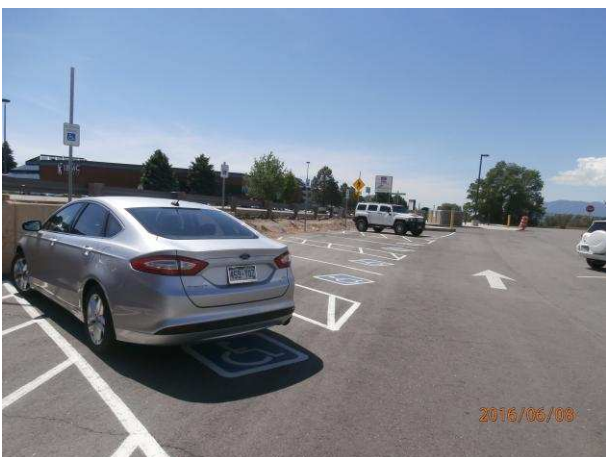
The access aisles are not a minimum 5 feet wide. One of the access aisles is 4'-6" wide, and one is 4'-3" wide. However, there is an extra access aisle at the end of the accessible parking.

There are two access aisles that are too narrow.

Image of narrow access aisles

Restripe the accessible parking and access aisles, reducing the width of the extra access aisle, and adding width to the two narrow access aisles.

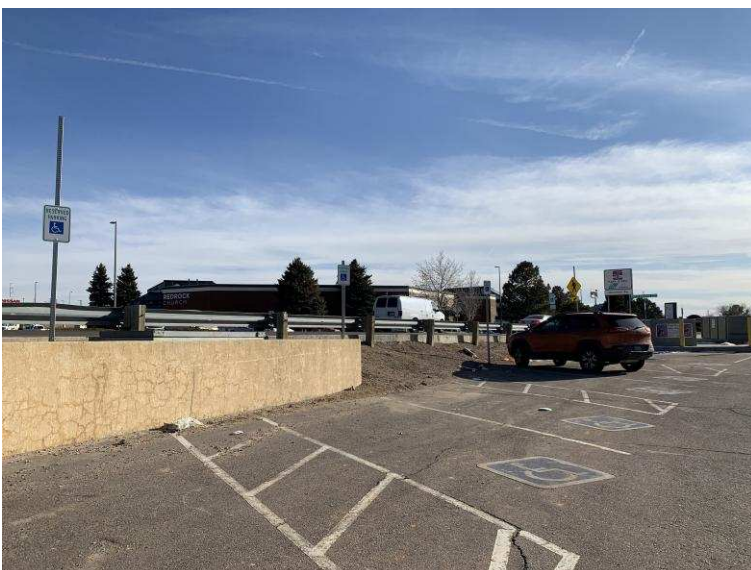
The accessible parking signage is mounted higher than 7'-0" to the bottom of the lowest sign.

The signage on the left parking space is mounted at 8'-2" to the bottom of the sign.

The signage on the 2nd from left parking space is mounted at 7'-8" to the bottom of the sign.

The signage on the 3rd from left parking space is mounted at 7'-6" to the bottom of the sign.

The accessible parking signage is mounted too high.

Lower the signage to between 5'-0" and 7'-0" to the bottom of the lowest sign.

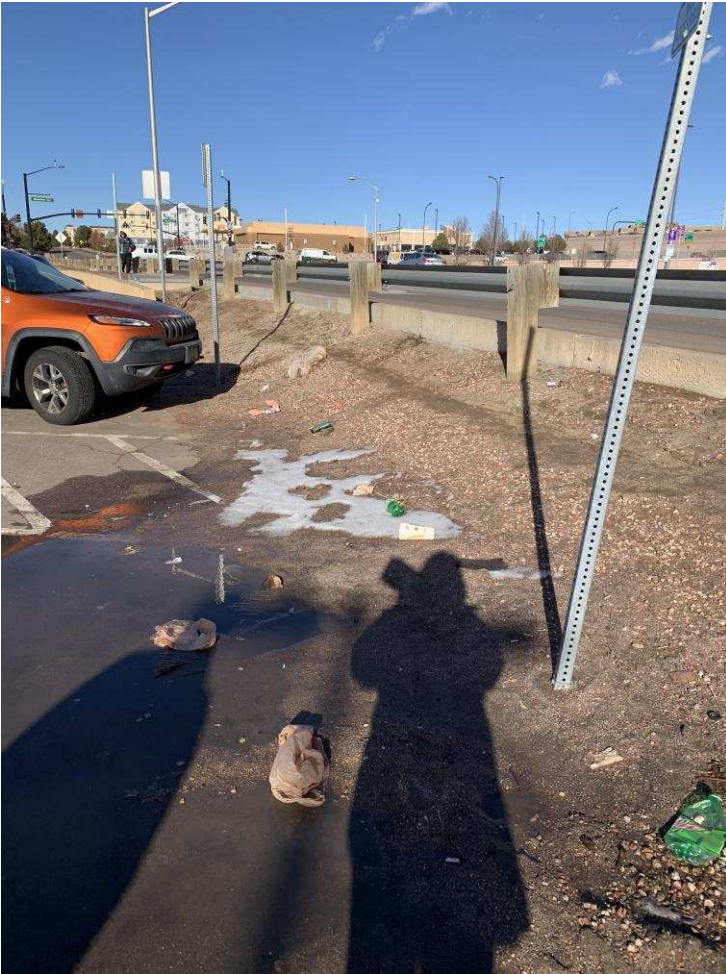
**Finding #3 Continued**

The surfaces of the accessible parking spaces and access aisles are not firm, stable, and slip resistant.

**There is considerable debris and dirt build up at the head of the parking spaces and access aisles.**

**Install a curb at the head of the accessible parking spaces and access aisles to reduce debris and dirt.**

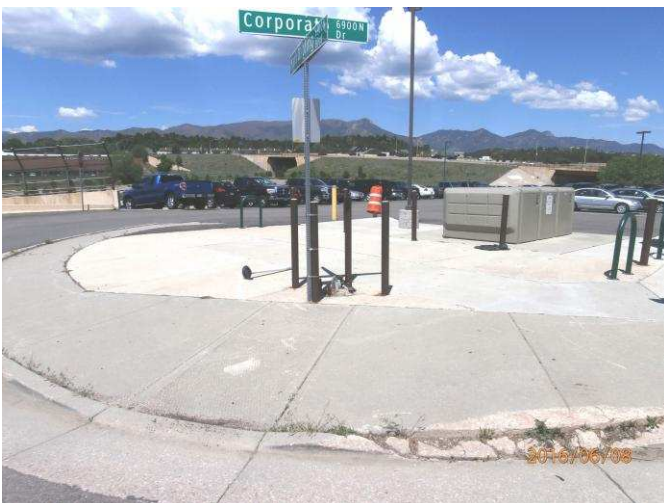
There are multiple issues with this curb ramp including:

There is 14% running slope at the gutter.

There is a 3/4" lip between the curb ramp and gutter.

There is no level landing, as the upper landing is 4%.

There are no detectable warnings.

Image of noncompliant curb ramp

Remove and replace the curb ramp.

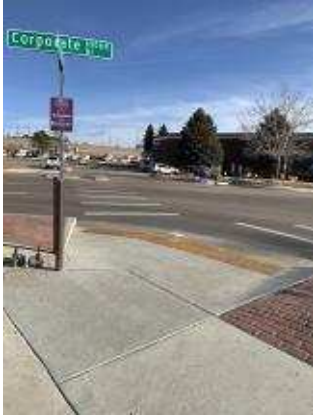
Finding 187196 Additional Photo

CORRECTED

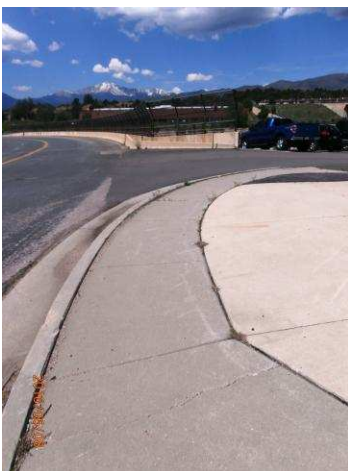
The sidewalk along Mark Dabling Blvd has a cross slope of 3%.

Image of sidewalk with excessive cross slopes

Remove and replace the sidewalk.

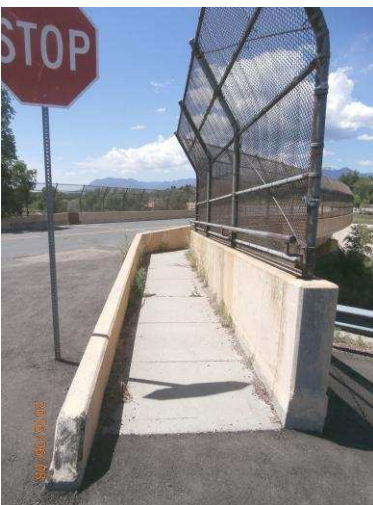
There are two areas of 1" vertical displacement on the bridge.

Image of sidewalk with vertical displacement

Grind to less than 1/2".

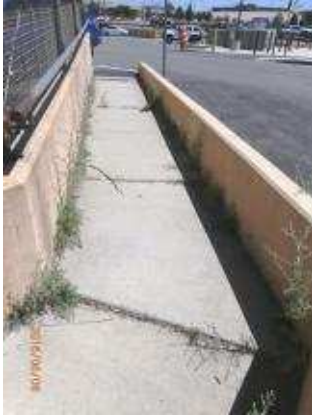
Additional image of vertical displacement
