# Site Accessibility Evaluation

**John "Prairie Dog"  
O'Byrne Park**

**Accessibility Evaluation**

***Inspection Date: 07/08/2021  
Inspector: Michael Killebrew/  
Jason Crowe***

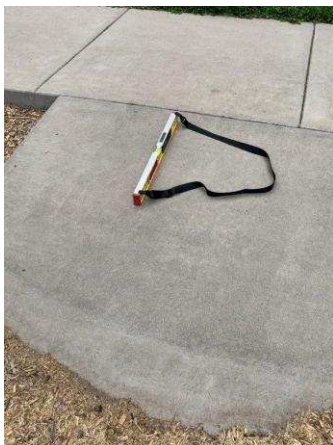
## Finding: 1

The running slope of the built ramp is as high as 9.1% and the side flares of the entry ramp into the play area exceed 10%.

*2010 ADAS Section 406.3*

*Where provided, curb ramp flares shall not be steeper than 1:10.*

The running slope is as high as 9.1% and the side flares are nearly non-existent.

1 (High): Should be completed immediately. (Includes findings that have little or no cost, were in violation of the codes at the time of construction, or pose an imminent safety threat)

Replace the ramp.

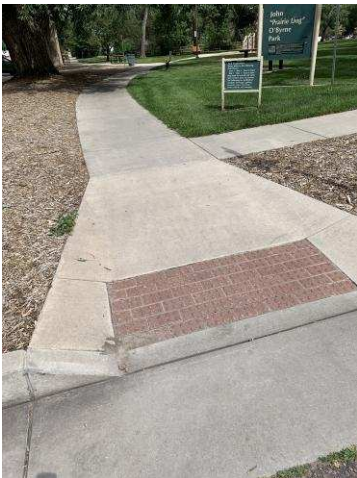
### Finding: 2

There are multiple issues with this curb ramp including: a running slope as high as 9.3%, brick truncated dome detectable warning starting to sink, non-delineated wings which can cause high cross slopes.

2010 ADAS Section 406  
Curb Ramps

The ramp at the corner of Bijou and Corona has several issues.

1 (High): Should be completed immediately. (Includes findings that have little or no cost, were in violation of the codes at the time of construction, or pose an imminent safety threat)

Remove and replace the curb ramp.

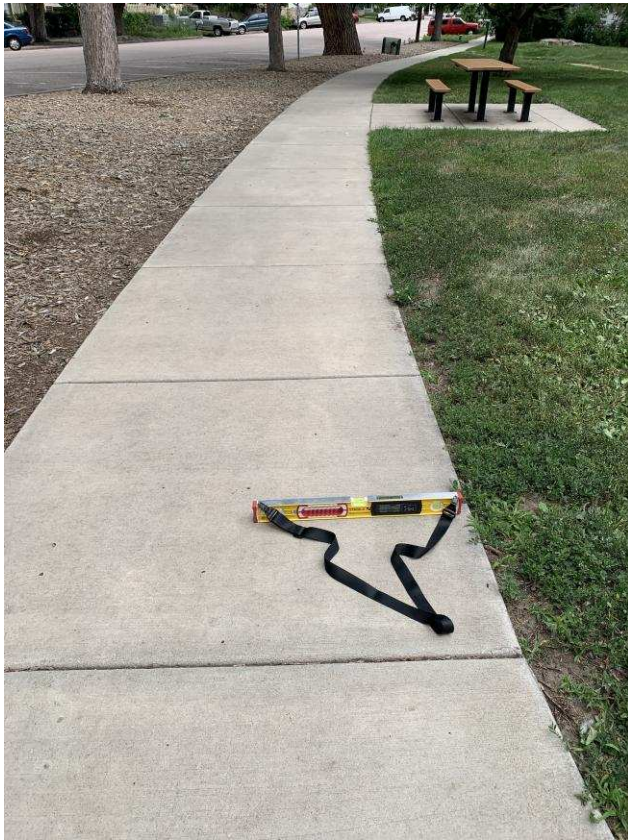
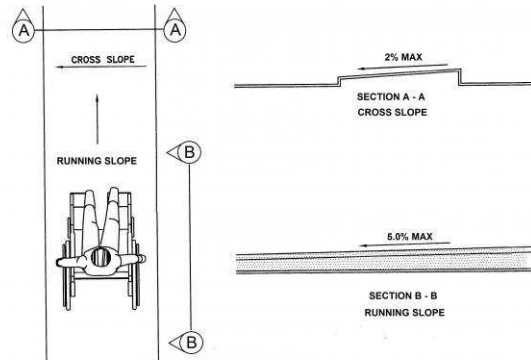
Finding #3 Continued

The accessible path of travel has cross slopes greater than 2%.

Surface cross slopes shall not exceed one unit vertical in 48 units horizontal (2-percent slope). When the slope in the direction of travel of any walk exceeds 1 unit vertical in 20 units horizontal (5-percent slope), it must be constructed as a ramp.

*2010 ADAS Section 403.3*

*The running slope of walking surfaces shall not be steeper than 1:20. The cross slope of walking surfaces shall not be steeper than 1:48.*

The stretch of accessible route that runs parallel to Bijou has four pads with cross slopes ranging from 2.5% to 2.8%.

1 (High): Should be completed immediately. (Includes findings that have little or no cost, were in violation of the codes at the time of construction, or pose an imminent safety threat)

Remove and replace pads.

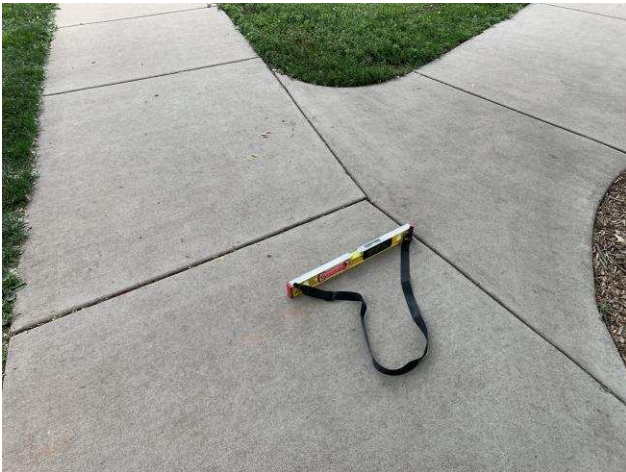
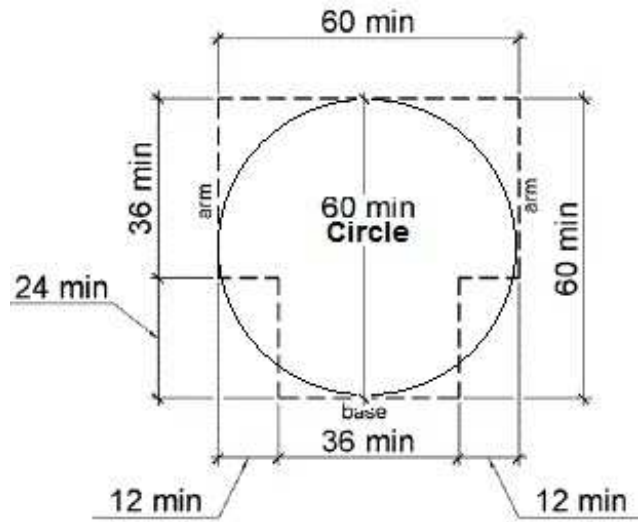
Finding #4 Continued

The T-shaped or circular turning space has excessive slopes.

Surface slopes greater than 1:48 (2.08%) are not permitted.

*2010 ADAS Section 304.2*

*Floor or ground surfaces of a turning space shall comply with 302. Changes in level are not permitted.*

The turn that branches toward the apartment complex has two pads with cross slopes as high as 3.3%.

1 (High): Should be completed immediately. (Includes findings that have little or no cost, were in violation of the codes at the time of construction, or pose an imminent safety threat)

Remove and replace pads.

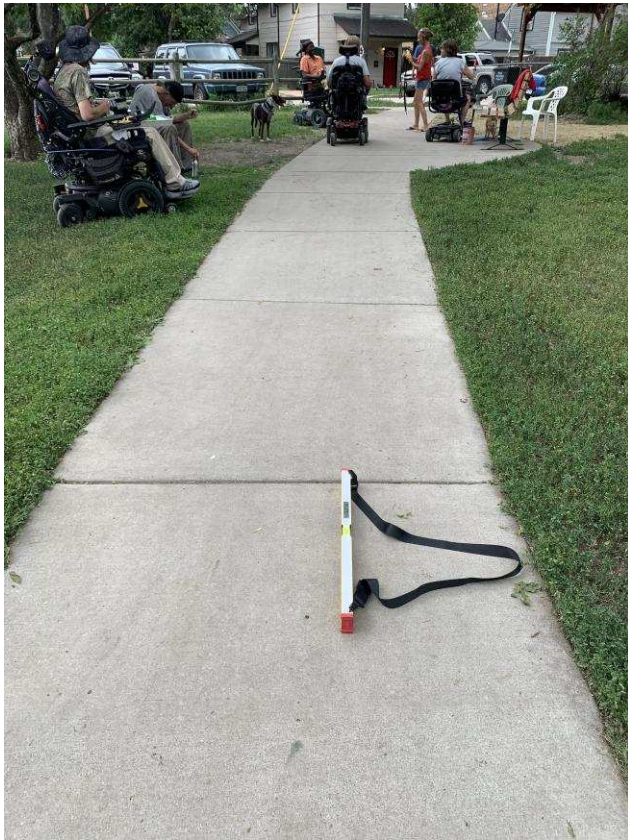
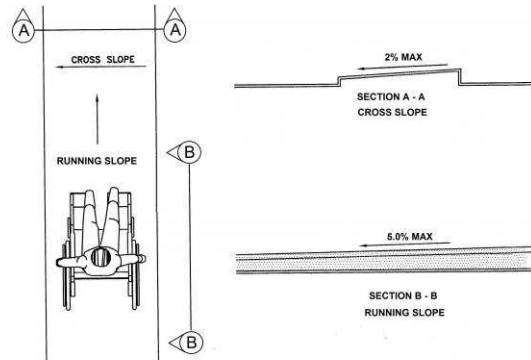
Finding #5 Continued

The accessible route on the site has running slopes greater than 5 percent and has not been constructed as a ramp (i.e. handrails, edge protection, etc.).

When the slope in the direction of travel of any walk exceeds 1 unit vertical in 20 units horizontal (5-percent slope), it must be constructed as a ramp. Surface cross slopes must not exceed one unit vertical in 48 units horizontal (2-percent slope).

*2010 ADAS Section 403.3*

*The running slope of walking surfaces shall not be steeper than 1:20. The cross slope of walking surfaces shall not be steeper than 1:48.*

There is one pad on the route that branches toward the apartment complex that has a running slope of 6.2%.

1 (High): Should be completed immediately. (Includes findings that have little or no cost, were in violation of the codes at the time of construction, or pose an imminent safety threat)

Remove pad and adjacent pads, grade, and re-pour the pads to achieve a running slope of less than 5%.

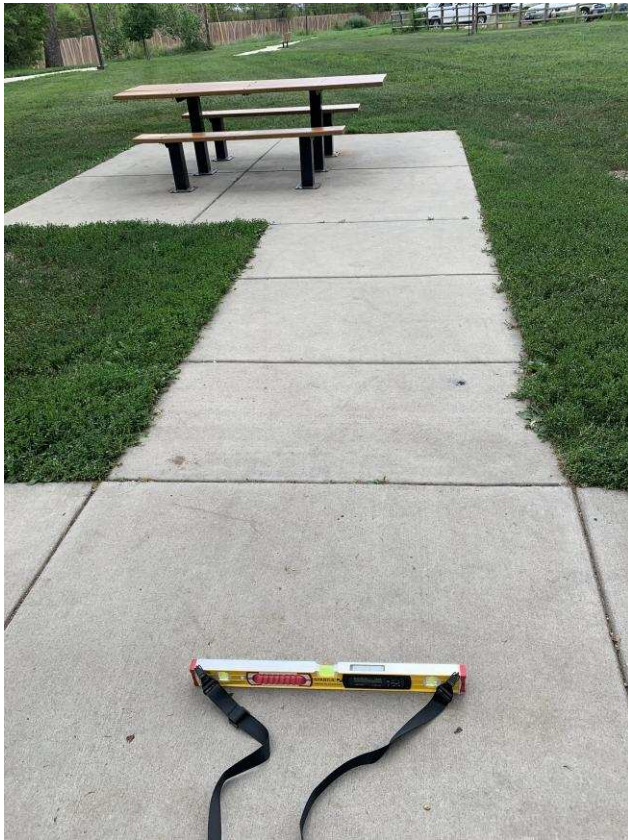
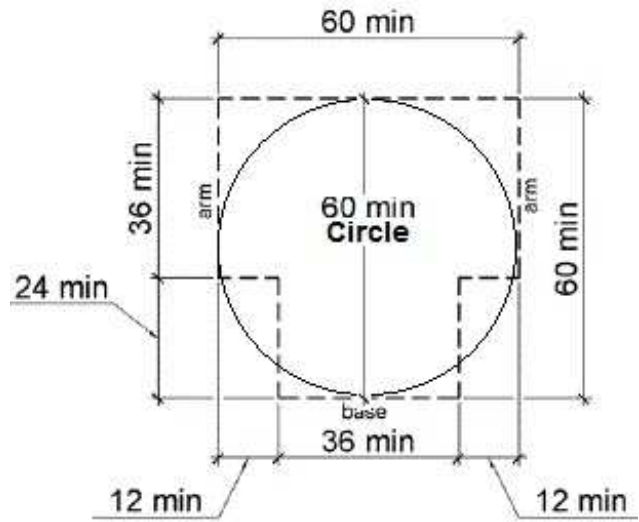
Finding #6 Continued

The T-shaped or circular turning space has excessive slopes.

Surface slopes greater than 1:48 (2.08%) are not permitted.

*2010 ADAS Section 304.2*

*Floor or ground surfaces of a turning space shall comply with 302. Changes in level are not permitted.*

There is one pad at the turn toward the accessible picnic area with a cross slope of 3.9%.

Remove and replace the pad in the turn area to 2% or less.
