Colorado
Environmental
Solutions

LIMITED ASBESTOS BUILDING INSPECTION

2422 N Franklin St
Colorado Springs, CO 80907

Asbestos Building Materials Inspection Date:

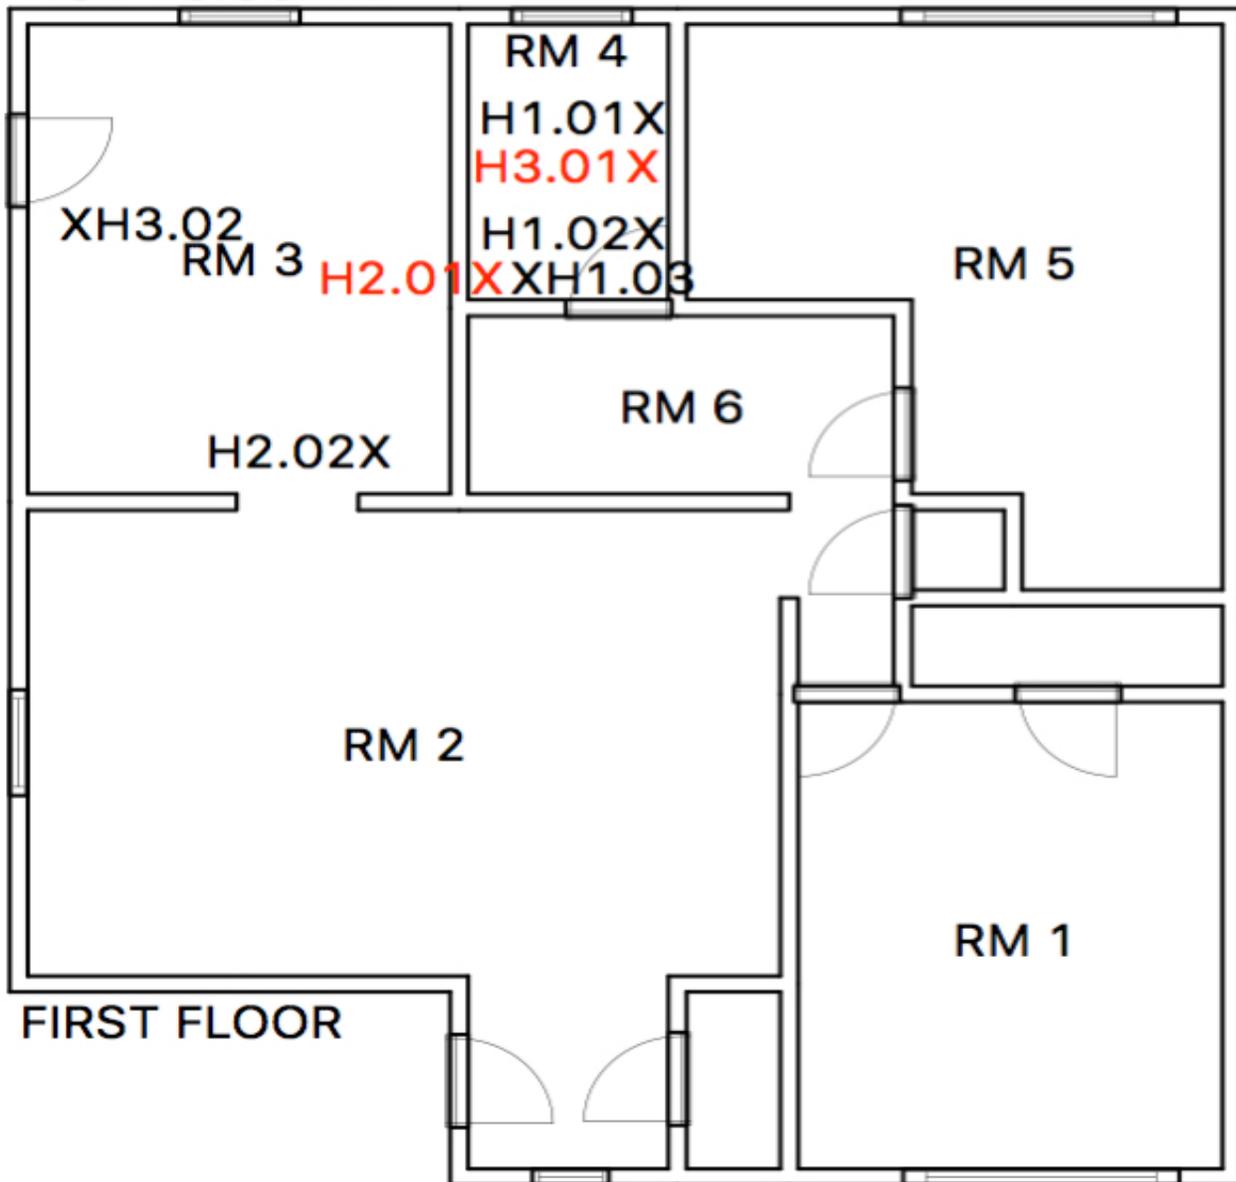
ATTACHMENT A
Building Floor Plan with ACM locations

Bulk sampling conducted during this inspection identified that the joint compound and drywall in the main floor bathroom of the property contains asbestos (2% Chrysotile).

Assessment: This inspection identified the material as undamaged and friable at the time of the inspection and had a hazard assessment of "Asbestos Containing Building Material (ACBM) with high potential for damage". This assessment was assigned to the material because of the planned renovation taking place and the close proximity to workers and or occupants. There is an unknown amount of joint compound and drywall in the main floor bathroom of the property. This material was composited and is below the EPA and State of Colorado regulated limit of 1%, however, OSHA guidelines and regulations still apply to this material.

Please Note: CES recommends all renovation work impacting ACM in the building be completed by an EPA certified and Colorado State licensed General Abatement Contractor (GAC).
