# Site Accessibility Evaluation

### **Madison Park**

**Accessibility Evaluation**

***Inspection Date: 08/30/2021  
Inspector: Michael Killebrew/  
Jason Crowe***

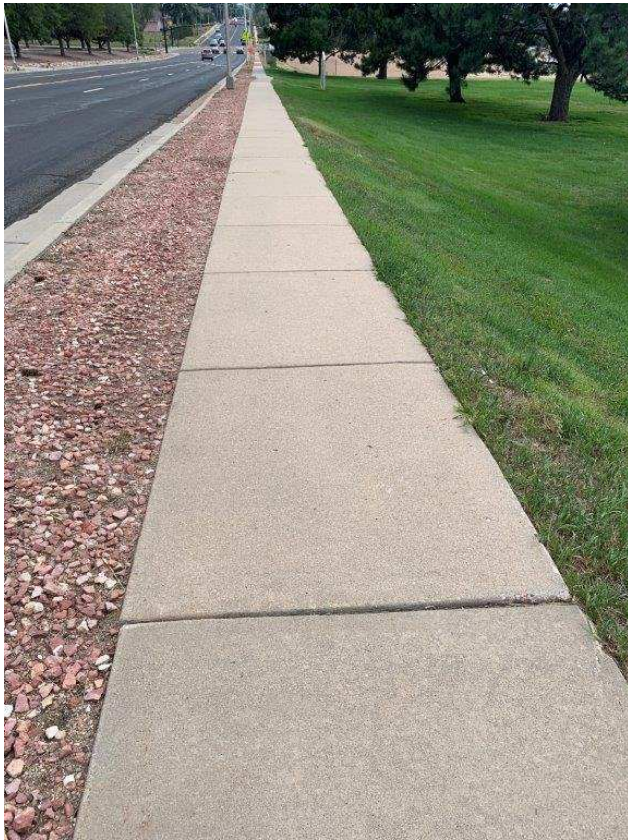
Finding #1 Continued

**The cross slope of the sidewalk that runs along Murray Blvd has eight pads of concrete with excessive cross slope as high as 6.5%.**

**Remove and replace the pads to compliance.**

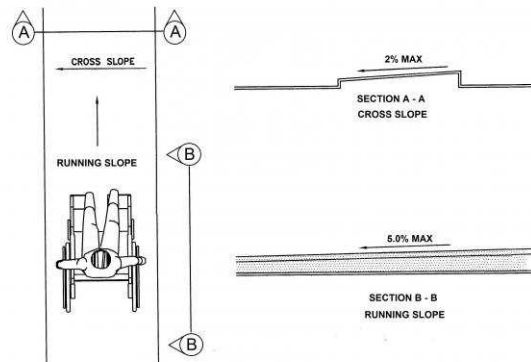
Finding 189108 Main Photo

**Sidewalk with excessive cross slope**

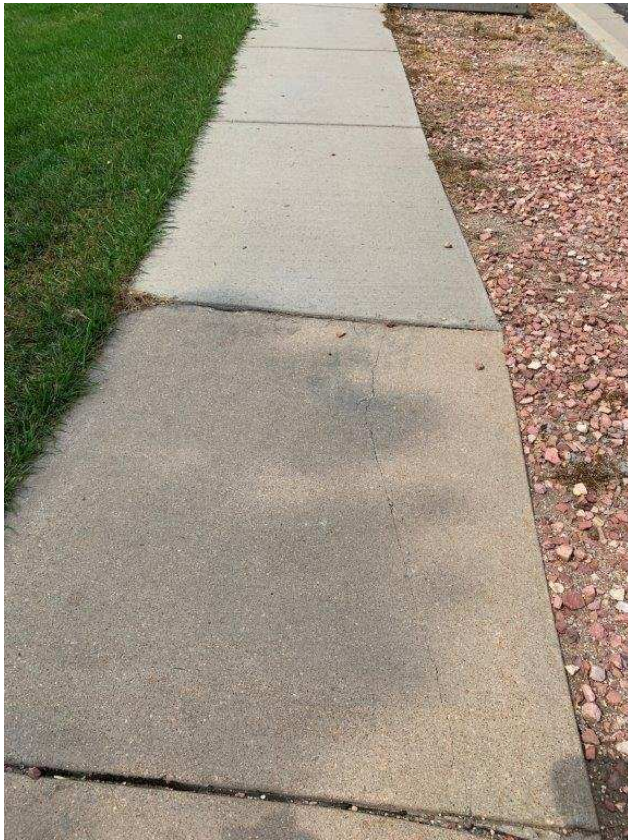
Finding #2 Continued

**There are four areas along Murray where pads have lifted/sunk causing vertical displacements ranging from 1/2" to 1".**

**Grind to less than 1/2" bevel where possible or replace pads.**

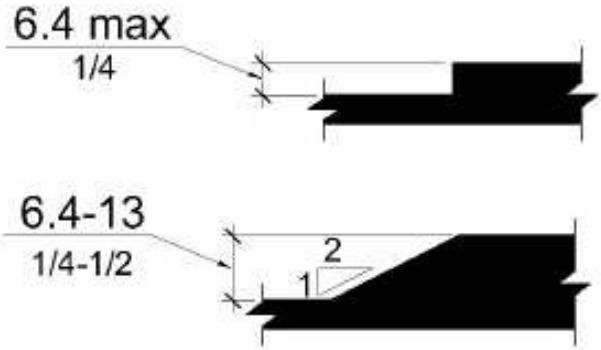
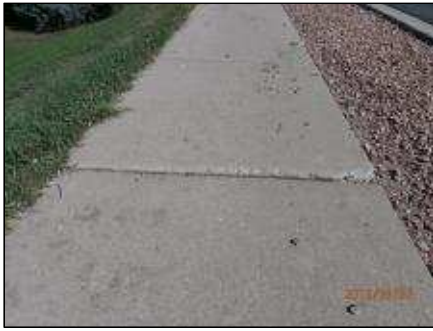
Finding 189110 Main Photo

**Vertical displacement in the sidewalk**

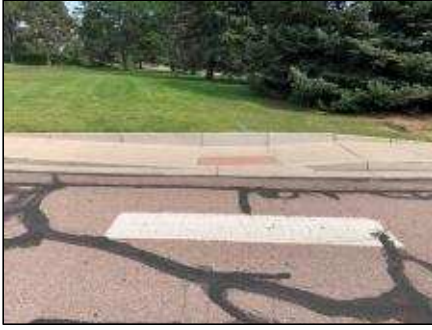
Finding 191706 Additional Photo

There are multiple issues with this curb ramp including:

A gutter pan running slope to the ramp face measuring 16.7%.

Brick detectable warnings that are deteriorating and shifting.

There are several issues with this curb ramp located along Northglenn.

Remove and replace the curb ramp.

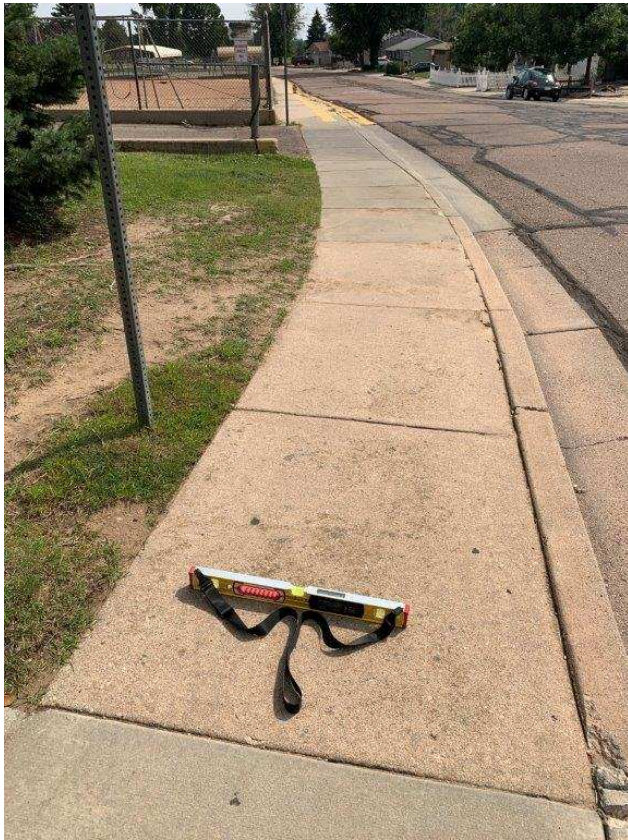
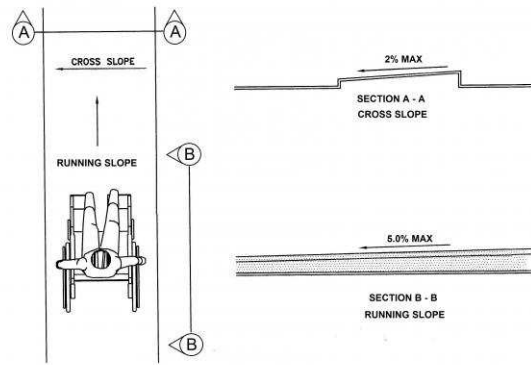
Finding #4 Continued

There are 75 pads of concrete on the route along Northglenn with excessive cross slope as high as 5.6%.

Remove and replace pads to compliance.

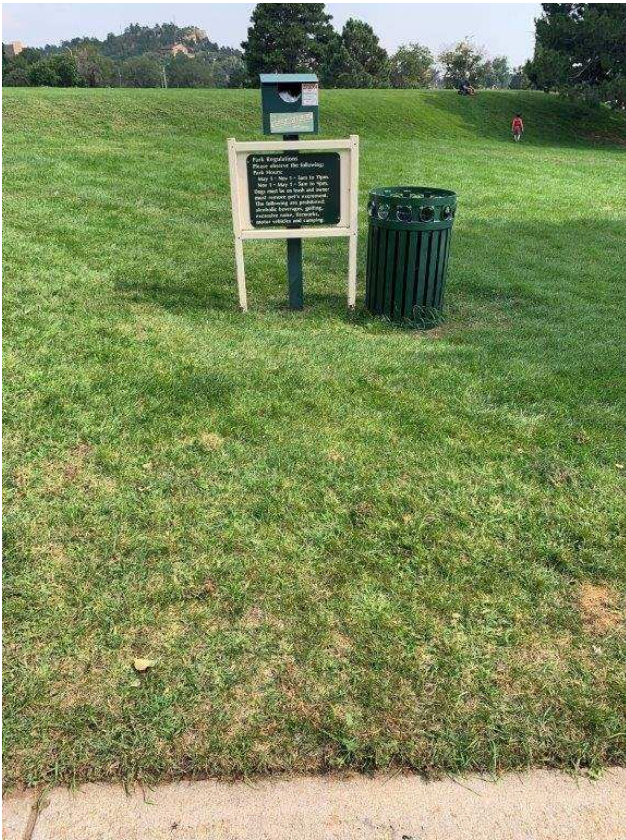
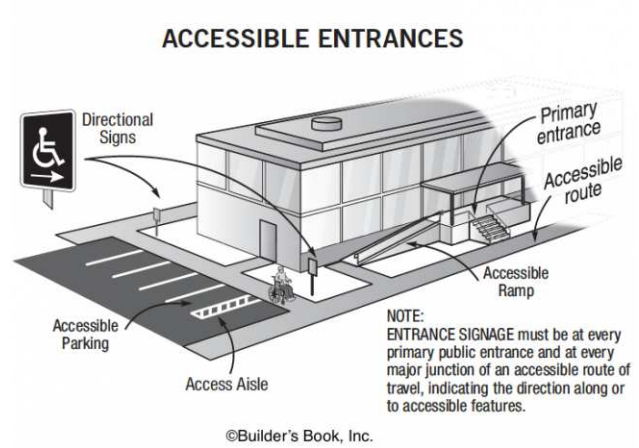
## Finding #5 Continued

**The trash can and dog waste bag dispenser are approximately 15 feet from the accessible route.**

**Re-locate the trash can and dispenser to compliance along the accessible route.**
