Site Accessibility Evaluation

Patty Jewett Junction Play Area

Accessibility Evaluation

***Inspection Date: 08/24/2021
Inspector: Michael Killebrew/
Jason Crowe***

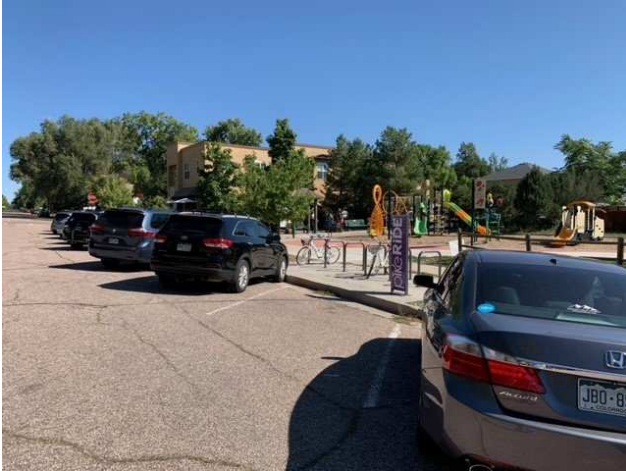
Finding #1 Continued

There are no on-street accessible parking stalls.

There are no accessible stalls along the angled parking in front of the playground on Corona St.

Add accessible parking, an access aisle, and curb ramp to the angled parking on Corona St.

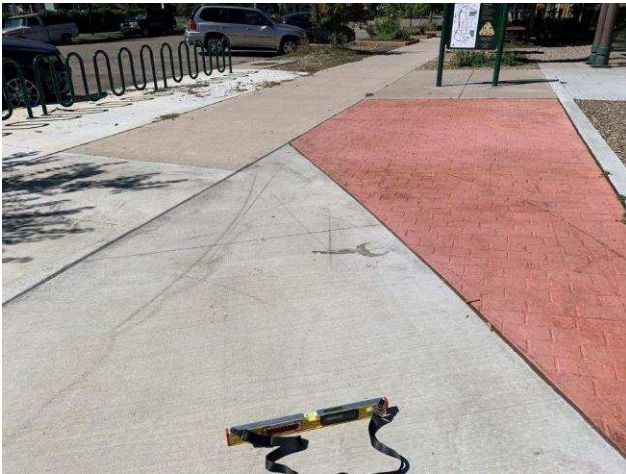
Finding #2 Continued

The accessible path of travel has cross slopes greater than 2%.

The sidewalk in front of the entrance to the playground has two pads with excessive cross-slope measuring 2.3% and 2.5%.

Remove and replace pads to compliance.

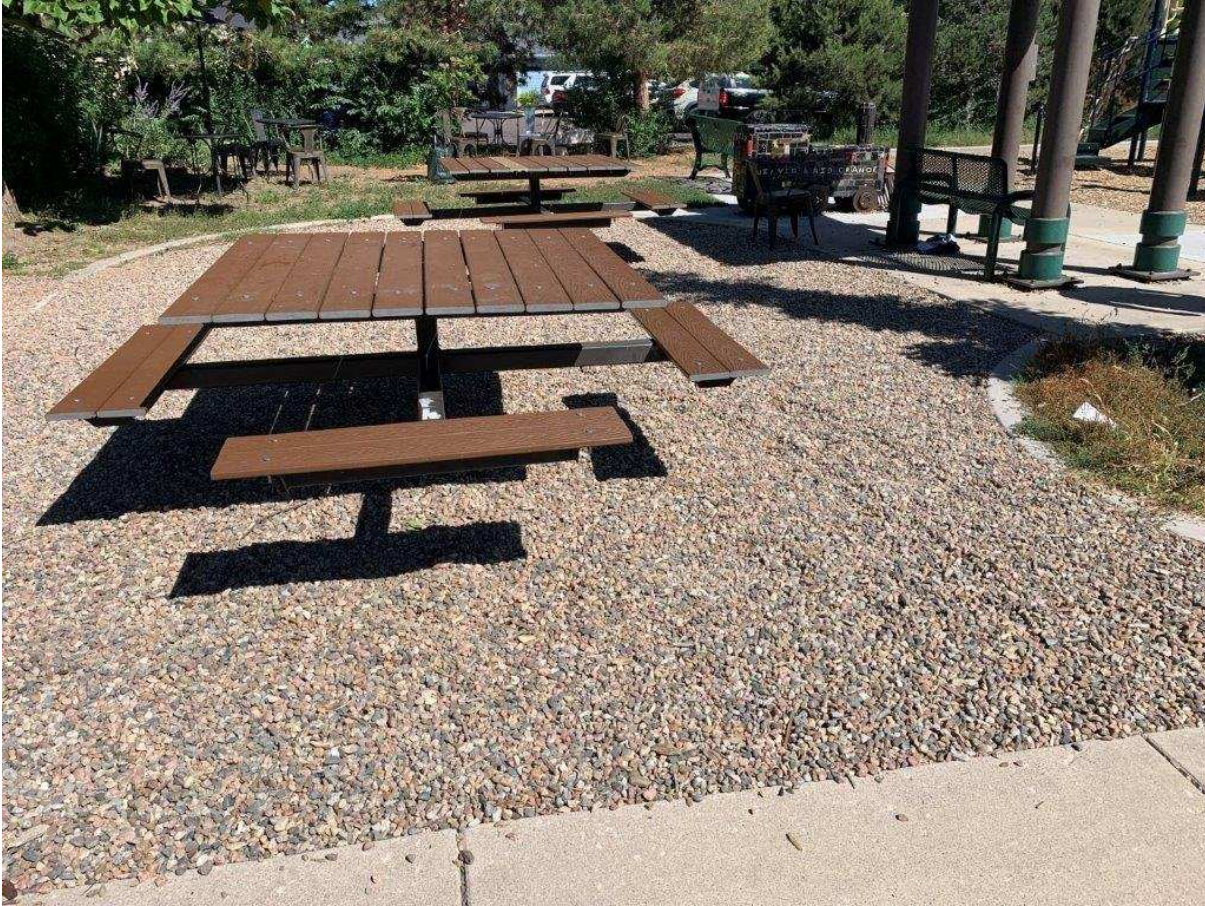
Finding #3 Continued

There is no accessible seating provided for this section of the outdoor dining area. Based on the number of outdoor seating provided (2), at least (1) wheelchair seating space/s is/are required.

There are two outdoor tables at the playground. Neither has accessible seating nor an accessible route.

Modify one table by removing one of four bench seats, add a concrete pad.

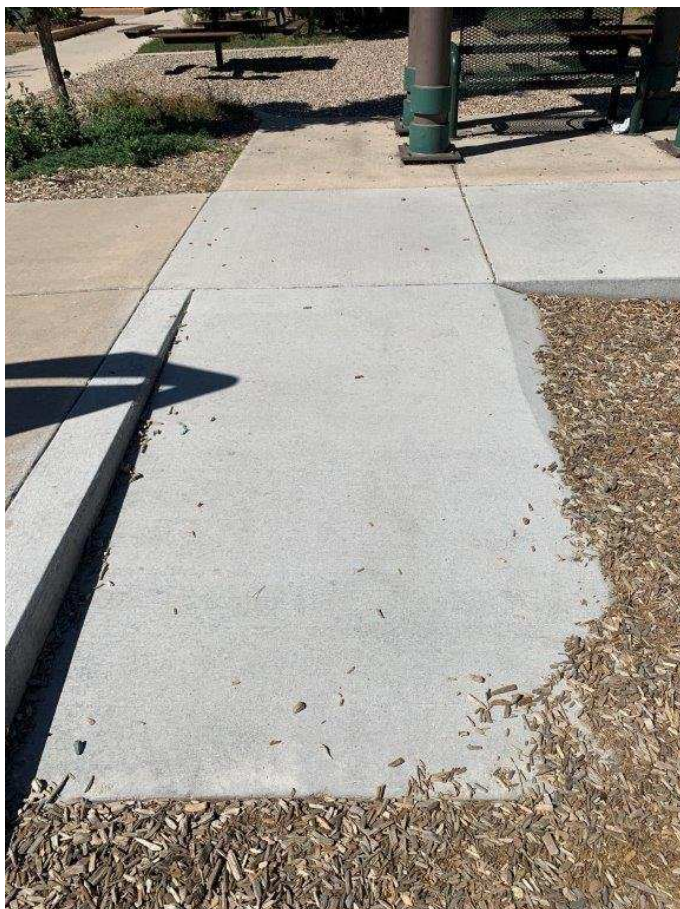
Finding #4 Continued

The side flares of the entry ramp into the play area exceed 10%.

The side flares of the ramp entering the playground are 31%.

Remove and replace ramp to compliance.
