Site Accessibility Evaluation

Rudy Park

**5360 Cracker Barrel Cir
Colorado Springs, CO
80917**

Accessibility Evaluation

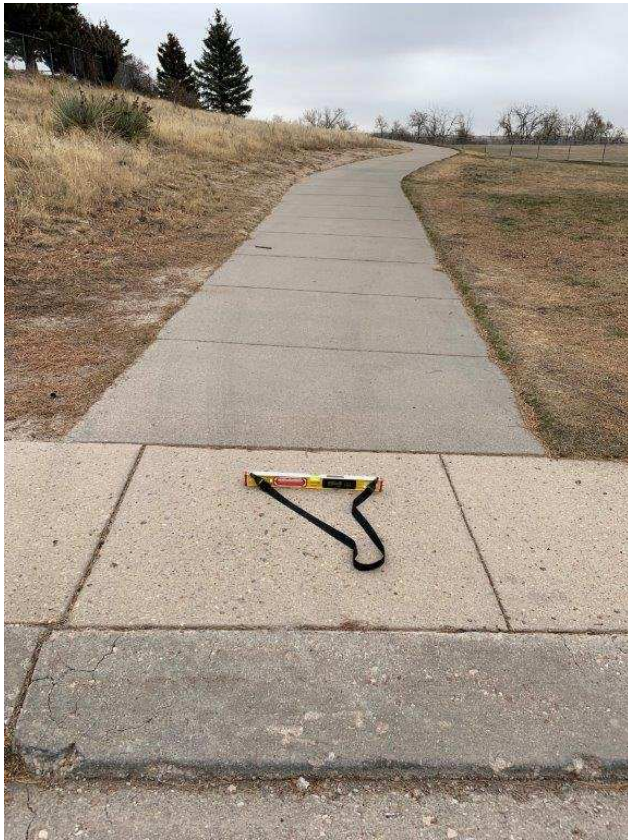
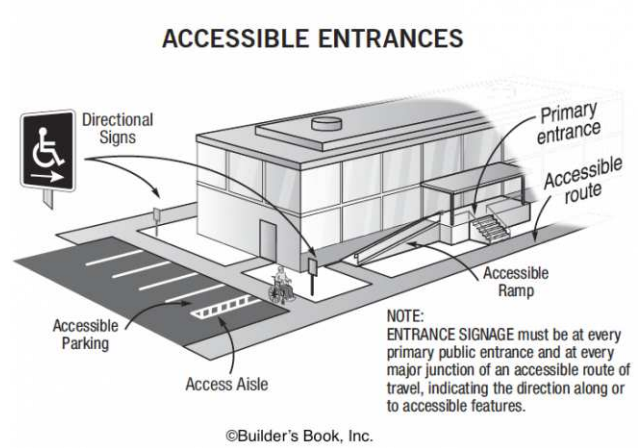
Finding #1 Continued

There is no accessible route of travel from the public way.

2015 IBC Section 1104.1

2010 ADAS Section 206.2.1

There is not a curb ramp from the street parking on Cracker Barrell Cir.

Install a curb ramp near the path into the park off of Cracker Barrell Cir.

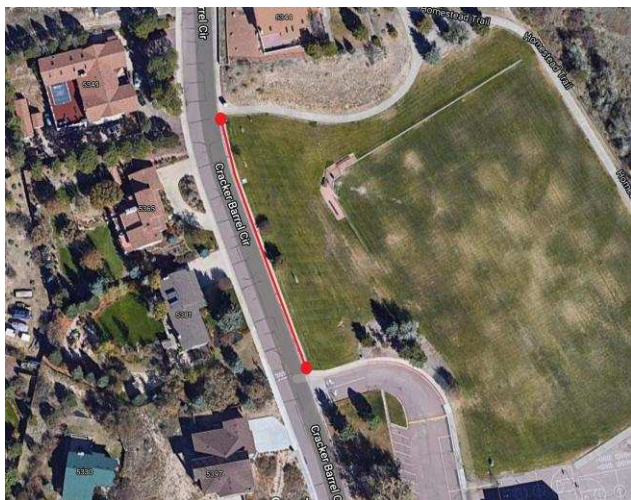
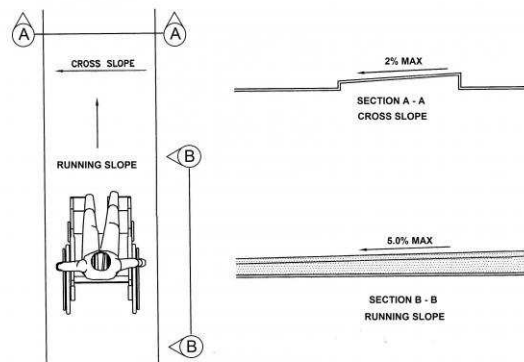
Finding #2 Continued

The accessible path of travel has cross slopes greater than 2%.

2010 ADAS Section 403.3

The sidewalk down Cracker Barrel Cir has 51 pads of concrete with excessive cross-slope measuring as high as 6%. This stretch of sidewalk also has a high running slope throughout, however, it follows street grade and therefore meets compliance. 29 pads are at or exceed 3% cross slope.

Remove and replace pads with high cross slope to compliance.

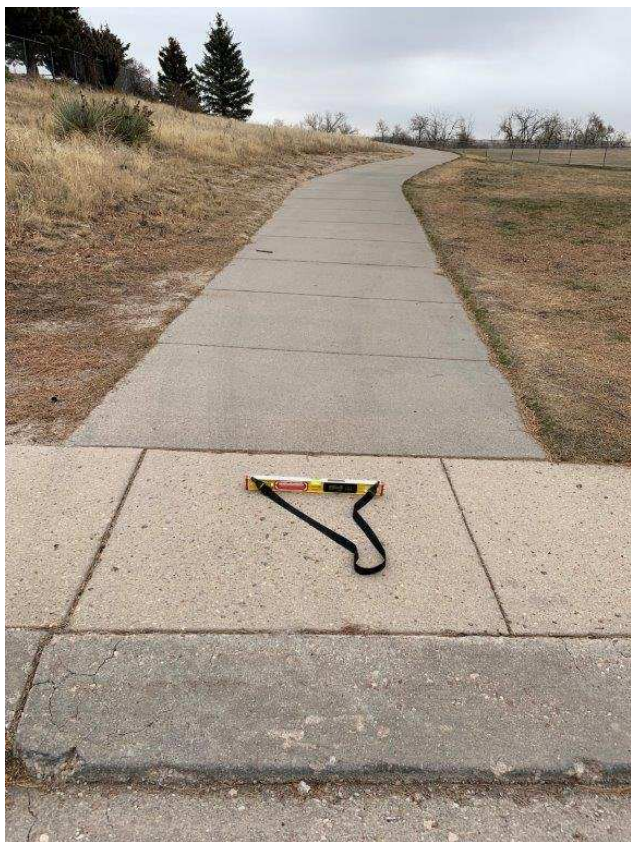
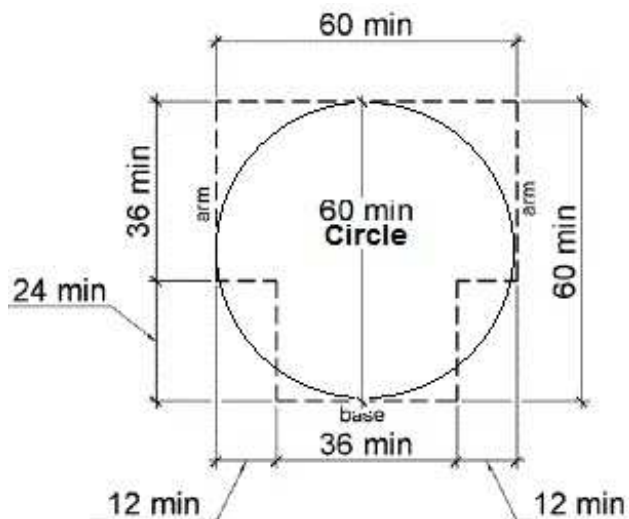
Finding #3 Continued

The T-shaped or circular turning space has excessive slopes.

2010 ADAS Section 304.2

This turn at the entrance to the park has a slope of 4.9%.

Remove and replace concrete at this turn to compliance.

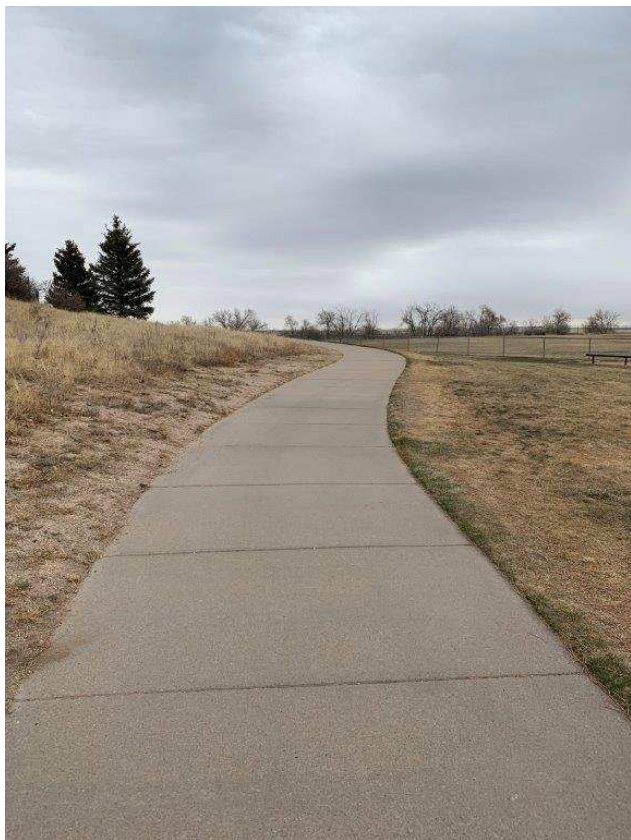
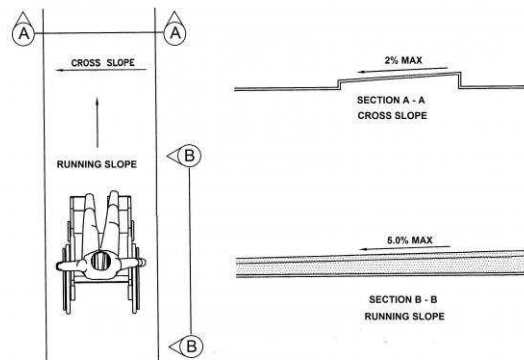
The accessible route has running slopes greater than 5% and has not been constructed as a ramp (i.e. handrails, edge protection, etc.). Cross slopes are greater than 2% across the width of the walk.

2010 ADAS Section 403.3

The path into the park, just north of the baseball field, that connects to the Homestead Trail in the northeast corner of the park, has 31 pads of concrete with excessive cross slope and/or running slope. There are 29 pads with a high cross slope measuring up to 5.2%. 14 of the pads are at or over 3% cross slope. There are 13 pads with a high running slope of up to 9%. 4 pads exceed 8.33%.

Remove and replace the pads with a high cross slope. The terrain is such that it may not be feasible to achieve a compliant running slope.

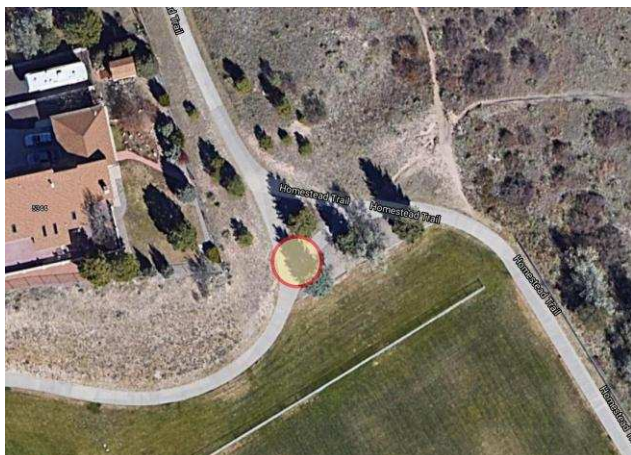
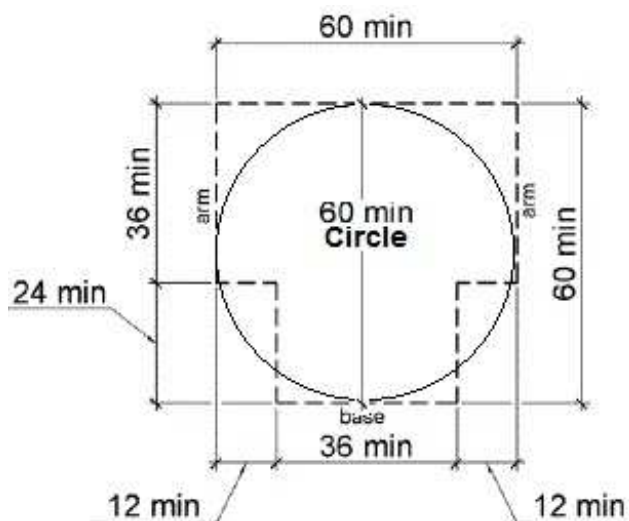
Finding #5 Continued

The T-shaped or circular turning space has excessive slopes.

2010 ADAS Section 304.2

This turn at the top of the path into the park, where it forks in two directions to the Homestead Trail, has a slope of 6.5%

Remove and replace concrete at this turn to compliance.

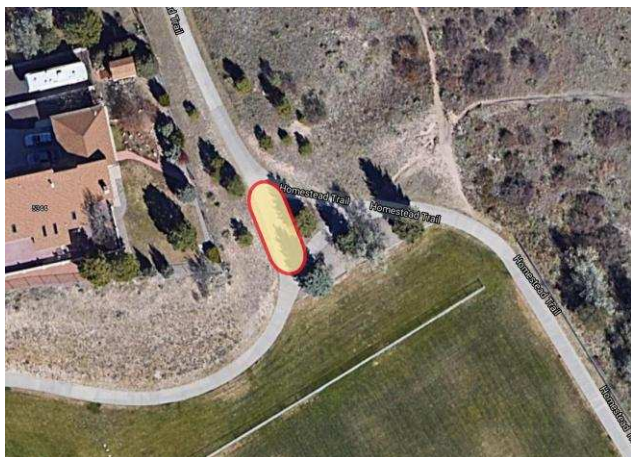
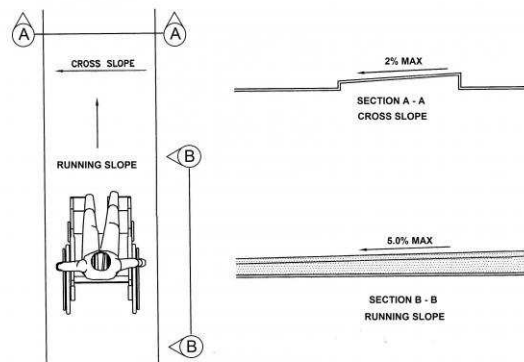
Finding #6 Continued

The accessible route on the site has running slopes greater than 5 percent and has not been constructed as a ramp (i.e. handrails, edge protection, etc.).

2010 ADAS Section 403.3

This stretch of the route that connects the route into the park to the Homestead Trail (the north route) has six pads of concrete with a high running slope measuring as high as 6.4%.

Do nothing as it is not feasible to achieve compliance running slope here given the terrain.

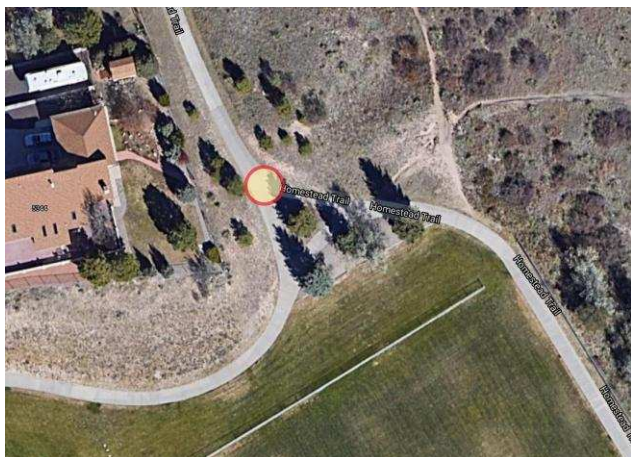
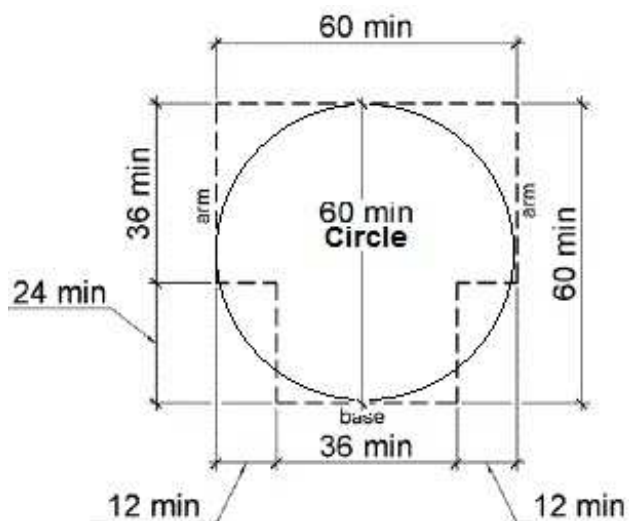
Finding #7 Continued

The T-shaped or circular turning space has excessive slopes.

2010 ADAS Section 304.2

This turn where the park route connects to Homestead Trail (the north connector) has a slope of 3.6%.

Remove and replace concrete at this turn to compliance.

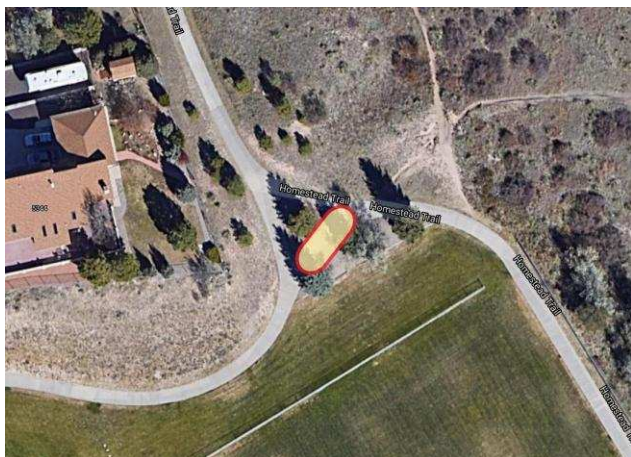
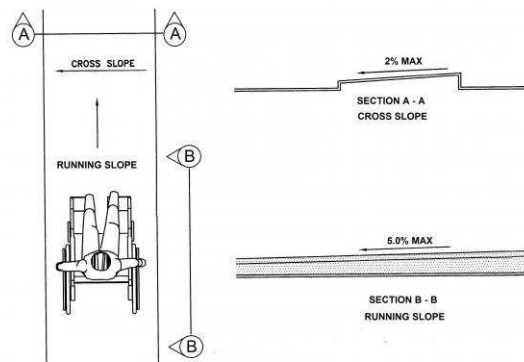
Finding #8 Continued

The accessible path of travel has cross slopes greater than 2%.

2010 ADAS Section 403.3

This stretch of path that connects the main route into the park to Homestead Trail has five pads of concrete with high cross slope ranging from 3.3% to 4.3%.

Remove and replace concrete to compliance.

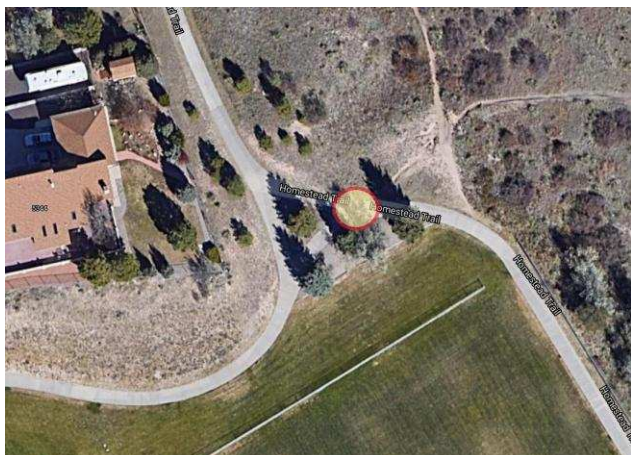
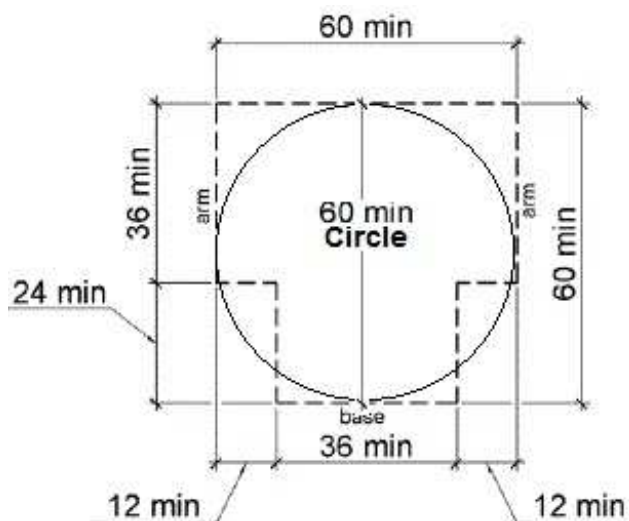
Finding #9 Continued

The T-shaped or circular turning space has excessive slopes.

2010 ADAS Section 304.2

This turn where the park route connects to Homestead Trail (the south connector) has a slope of 4.6%.

Remove and replace concrete at this turn to compliance.

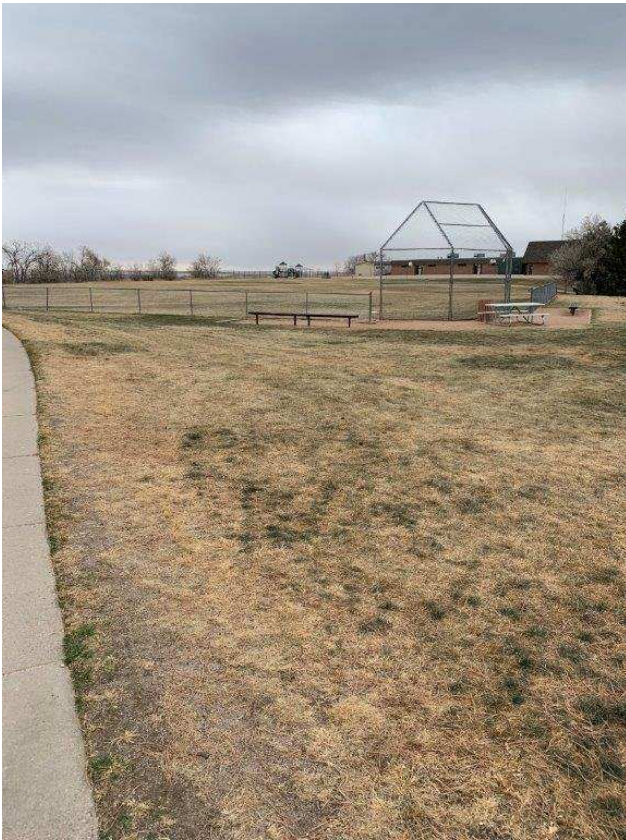
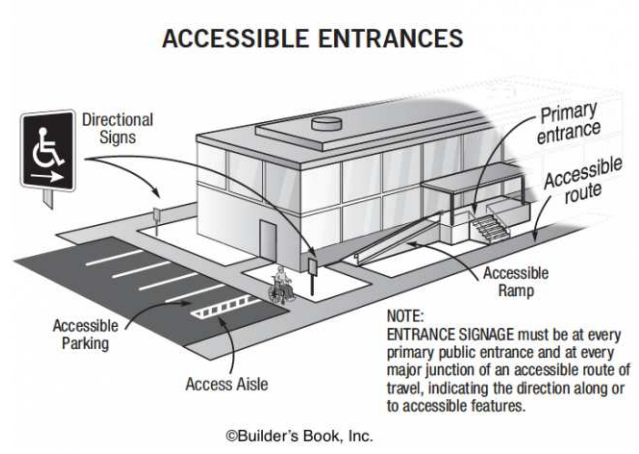
Finding #10 Continued

There is no accessible route to the element.

2015 IBC Section 1104.2

2010 ADAS Section 206.2.2

There is no accessible route to the baseball field.

Create an accessible route from the path into the park to the backstop seating area of the baseball field.

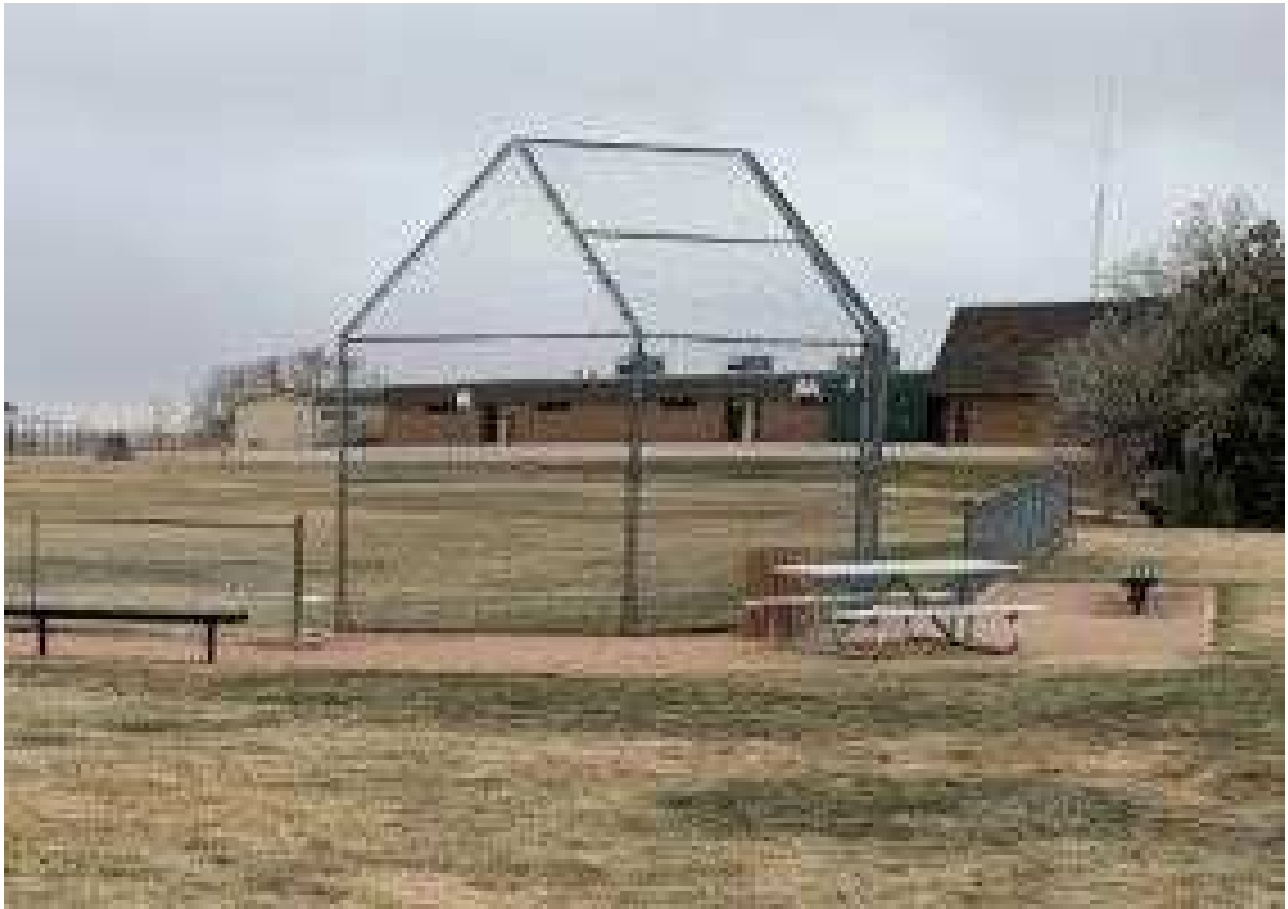
Finding #11 Continued

There are no accessible tables.

2010 ADAS Section 226.1

There is one picnic table in the park behind the baseball field backstop. It sits on gravel with no accessible route to it.

Pour a 15x10 concrete pad for the surface of the picnic table.
