**Appendix F  
Drainage  
Observations**

02 October 2023 - Wilson & Company

The drainage investigation performed for this master planning effort consisted of a brief site visit; locating, downloading, and a brief review of existing documentation; and providing professional engineering observations and ideas for potential actions for four areas of focus within the Blodgett Open Space.

**Appendix G  
Trail  
Standards**

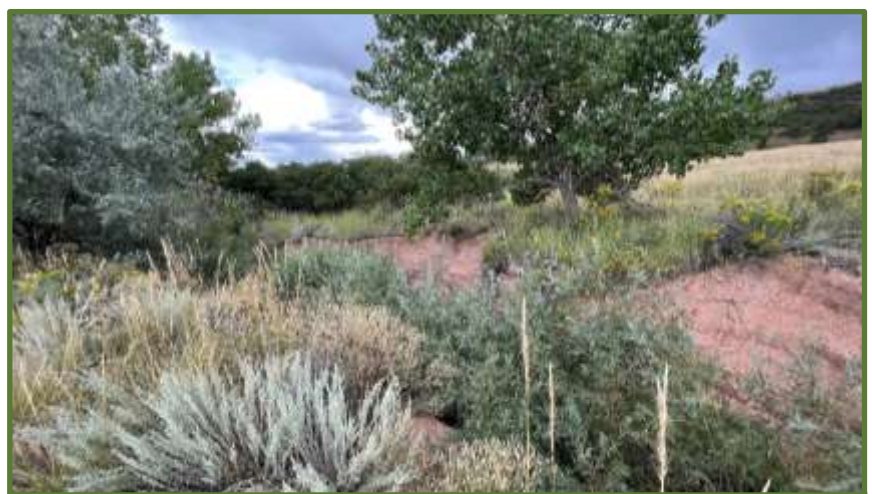
The primary, or northern, waterway conveys stormwater from nearly all of the disturbed quarry area. Various studies that were reviewed indicate the 100-year peak flow in the waterway is between 500 and 800 cubic feet per second. The waterway is routed through a sedimentation/detention pond, but no information was located that indicates how much peak rate mitigation the pond was designed for. The 1981 Douglas Creek Drainage Basin Planning Study recommended armoring the entire waterway with riprap due to its steepness. In its current configuration, the majority of the waterway is unlined and has incised to depths close to 9' deep with nearly vertical side slopes in some locations. Due to the

*Incised channel just south of the south pond to 10 depth*

presence of what appears to be a small perennial base flow, some trees and shrubs have established in the narrow invert of the waterway to help slow erosion, but over time the waterway will continue to incise. Stabilizing the waterway and raising its invert to better connect with its floodplain would be a significant improvement for the system.

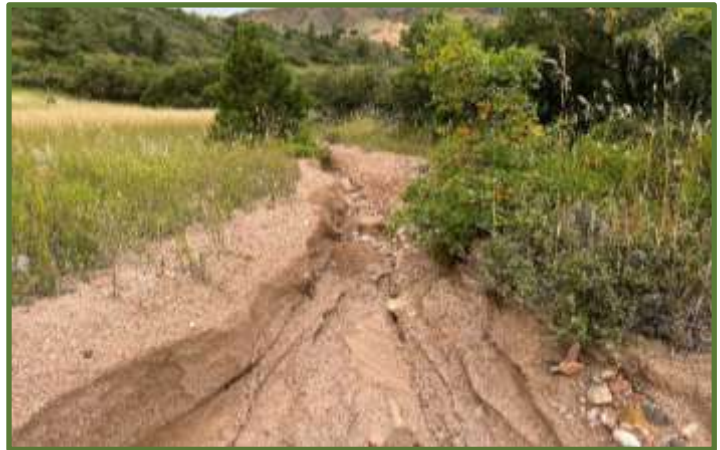
The secondary, or southern, waterway conveys water from a small watershed approximately 8 acres in size that includes a portion of the quarry access road as well as the lower quarry office building. Runoff concentrates in the roadway just north of curve near the entry point to the site. The runoff is routed over a steep slope that is poorly armored as it leaves the roadway and enters the waterway. A large gully has formed at this location. Downstream of this point the concentrated flow has formed a narrow-incised channel that is 2 to 4 feet deep. Unless measures are taken to stabilize this channel it will continue to erode and incise.

*Gully between Quarry Road and alluvial fan*

Upstream of the confluence with the primary channel, sediment from the eroding channel falls out of the flow and has created a small alluvial fan along the north side of Allegheny Drive. It appears that water and sediment are diverted into Allegheny Drive at this location due to the significant sediment deposits in the channel. Stabilization measures for the waterway are needed to mitigate this problem.

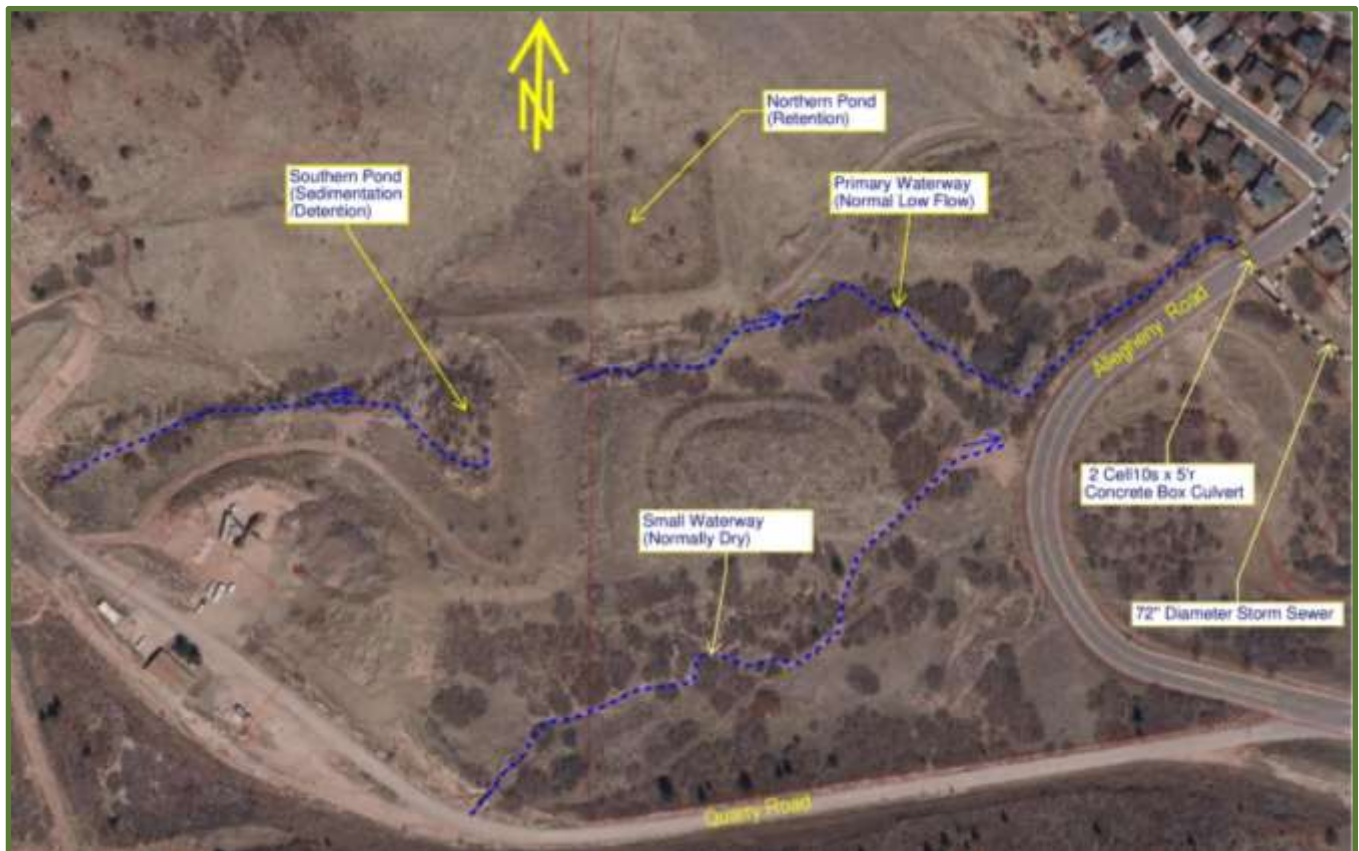
The southern pond includes 2 perforated corrugated metal pipe (CMP) standpipe risers with 42" CMP outlet pipes discharging through the dam to the downstream channel. The facility is nearly 30 years old, and the inside of the CMP risers are showing some surface rust. CMP is only expected to last 40 to 70 years so at some point in the future the outlet works will need to be replaced in order to maintain the function of the outlet and stability of the dam. The plans for the facility indicated a concrete lined stilling basin would be constructed at the pipe outlets but that is not evident. The downstream channel invert is over 3 feet below the outlet of the discharge pipes and the pipes are undercut a bit which is not desirable at the downstream toe of a dam. The southern pond is full of sediment to the top of the CMP risers. If the pond was built in accordance with the concept plans, the existing depth of sediment in the pond is approximately 10 feet. A visual inspection of the dam around the pond indicates that fill may have been added to the dam since its

*Perforated pipes at southern pond*

- Stabilize channels located upstream of the pond to reduce the sediment load contributed to the pond.
- Clean the dam and its spillway of loose materials and have an inspection and survey performed to establish its condition and configuration. Include inspection of the outlet pipes and risers.

- Repair or modify any deficiencies found in the inspections and analysis. Consider reconfiguring the pond to meet the criteria for non-jurisdictional dam status.

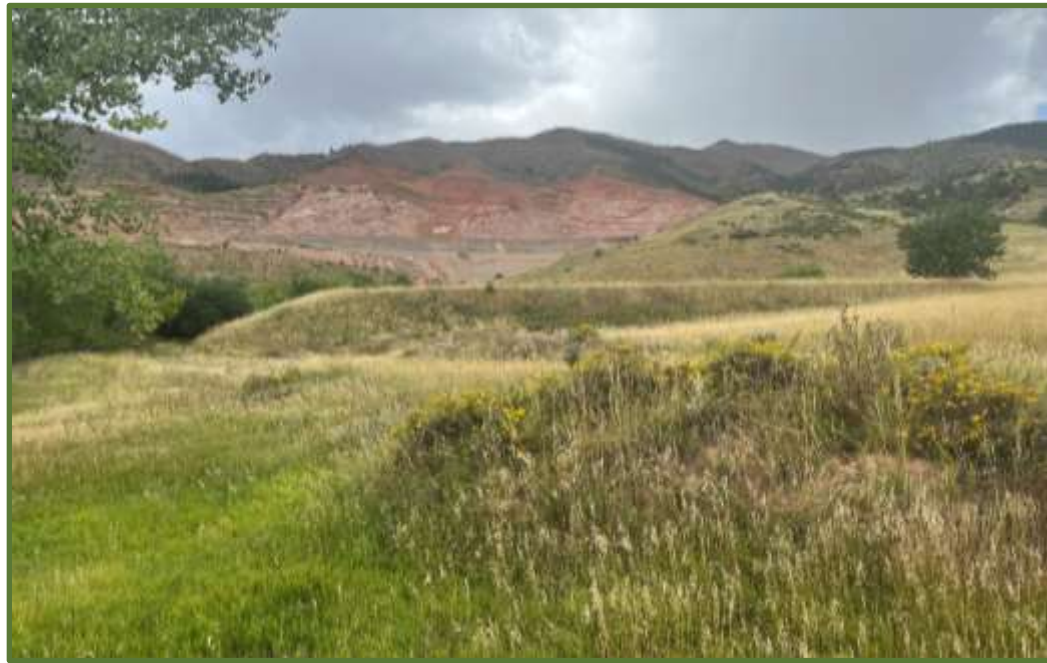
Much less documentation appears to exist for the northern pond. Based on review of USGS mapping, the pond was constructed prior to 1961. Quarry operations are also shown on the 1961 mapping, but it is unknown if the pond was related to the operation of the quarry. It may have been constructed as a stock pond. No outlet piping was apparent during a short site visit to view this pond; however, it is possible that the outlet piping is buried.

*Northern pond*

Without outlet piping, the pond will operate as a sedimentation/retention pond with stored water only leaving the pond through evaporation and infiltration. In the existing condition the pond appears to have a small watershed with nearly all runoff from the quarry site being routed to the southern pond. Based on comparison of existing pond bottom elevations to elevations of the surrounding ground, sediment has likely been deposited in the pond since it was constructed.

The northern pond dam appears to have a jurisdictional height (the vertical height between the emergency spillway level and historic ground at centerline of dam) that is in jurisdictional status. It is not obvious that the emergency spillway located at the northeast corner of the pond is armored. In the current condition the pond could potentially be considered as a non-jurisdictional erosion control pond except that its storage volume below an ungated outlet appears to exceed the State's maximum of 2-acre feet. The facility is not shown as a recognized jurisdictional facility on the State of Colorado Dam Safety web site map. It is unclear if this pond is needed during the quarry reclamation process or after. Preliminary recommendations for it include:

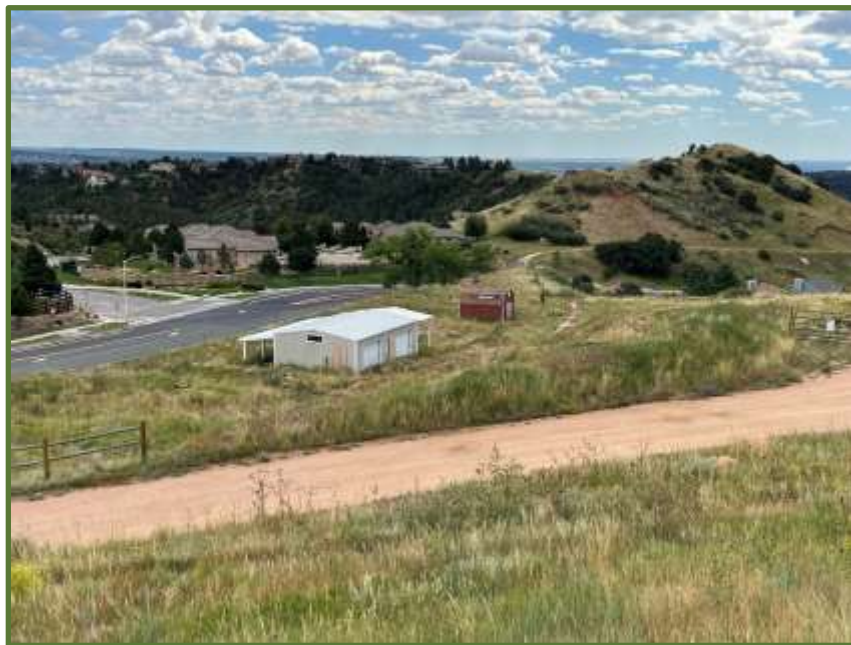
*Possible Future Orchard Valley trailhead site*

- The parking lot design should be done in a manner that considers keeping the redevelopment area to less than 1 acre in order to avoid triggering permanent water quality treatment and detention requirements for the project. Even so the new pavement area should be minimized to the extent practical and green infrastructure should be considered if it is practical to do so.

- Stormwater runoff from the new parking lot will need to discharge to adjacent Woodman Road. The capacity of the roadway and the downstream storm sewer system should be verified to be sufficient to handle any extra discharge rates from the parking area along with the design of the lot. A small extended detention pond at the south end of the lot may be required if sufficient capacity cannot be demonstrated.

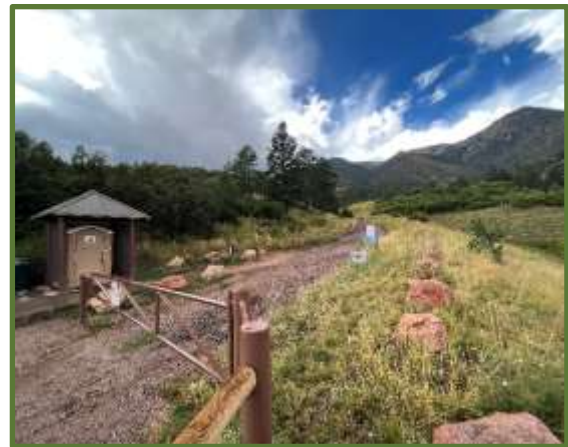
*Utilities access road looking west*

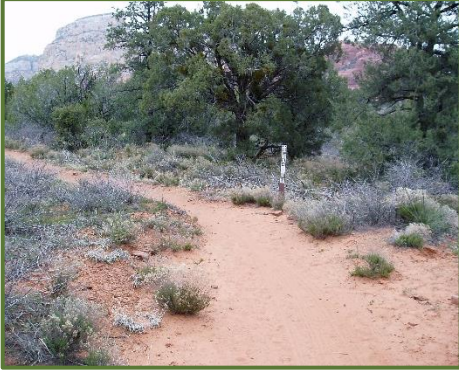
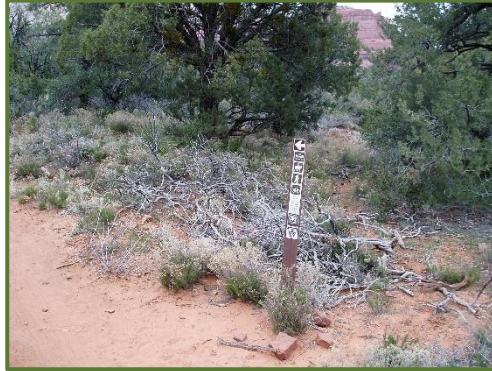
*active closure with smooth transition to reroute trail section, proper signage and intentional closure of illegal trail with obliterated trail, water diversions, and intentionally placed branches.*

- Obliterate the closed trail tread to soften the soil, discourage continued future use, and promote revegetation. Stabilize with constructed check dams (wood and/or rock) and drains to shed and slow water, reduce erosion, and accumulate topsoil.
- Seed the area with native grasses to promote revegetation.
- In appropriate locations, cover the obliterated tread with biodegradable erosion control matting and natural materials such as rocks/woody debris.
- Monitor the closed trails for erosion, vegetation establishment, and weeds.
- For popular user-created illegal trails, install temporary or permanent fencing to clearly direct users away from the closed trail. See fencing below.

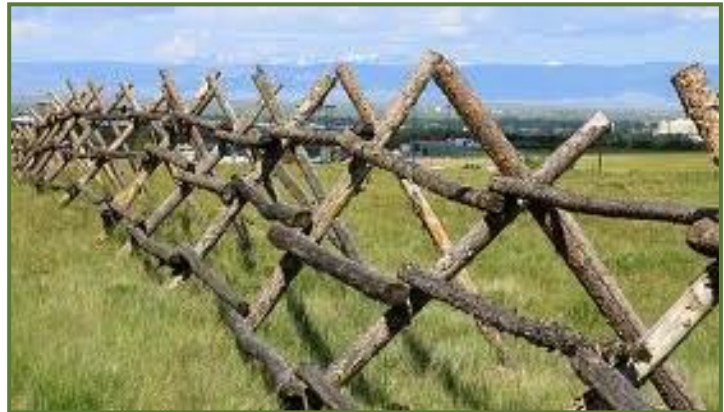
Install fencing to enforce the closure. Fencing must extend fully between two site obstacles such as a large rock outcrop or dense vegetation. When possible, buck and rail type fencing should be used as it creates a formidable obstacle that is difficult to climb over and is easy for volunteers to install as it does not require fence post holes. Split-rail and round-pole fencing is the Parks standard and will be the standard fencing in the open space.

*buck and rail fencing*

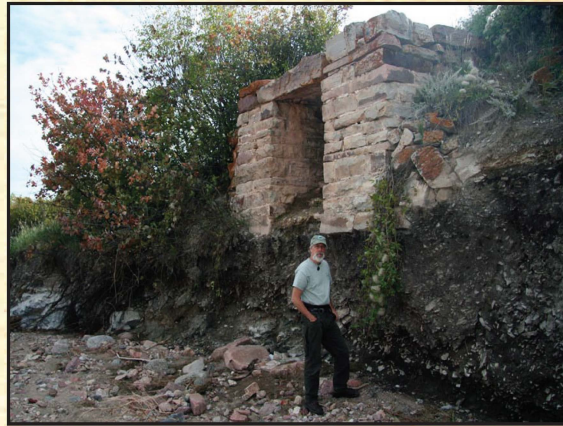
*The historic lime kiln was nearly destroyed in 2013 by the flooding creek when water undercut the bank beneath it. Fortunately it survived intact!*

This was an early Native American hunting area. The Lee Hill Lime Kiln is a historic structure from days gone by. Limestone from the local outcrop was burned to produce quicklime, an important component of cement. Lime produced here may have been used in construction of some of the University of Colorado's earliest buildings. The roughness of the kiln's construction created much waste due to over or under burned lime.

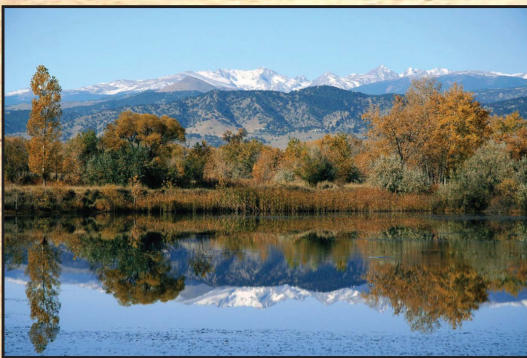
*This old gravel quarry has been converted to wetlands with a multitude of ponds.*

The 18 ponds at Sawhill are the result of a gravel mining operation and reclamation project. Boulder Creek, now at the northwestern boundary of the ponds, has traversed the entire area in the geologic past. This ancient floodplain laid down great quantities of sand and gravel, and these deposits were mined for several decades until the early 1970's. When mining ceased, groundwater filled in the pits, resulting in today's wetland.
