# Site Accessibility Evaluation

**Coleman Park**

**Accessibility Evaluation**

SUBJECT: Coleman Park Self-Evaluation

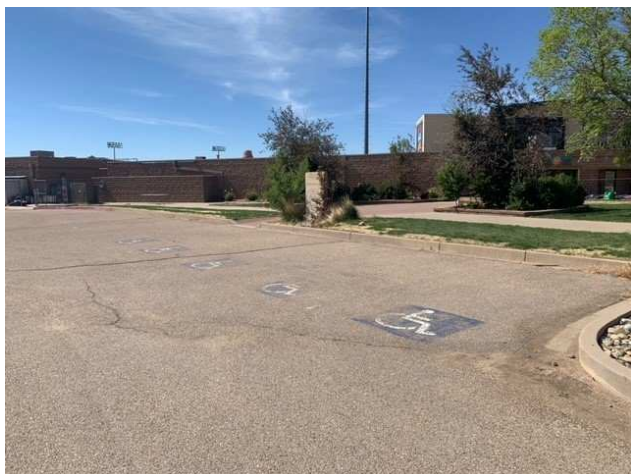
Finding 189476 Main Photo

The required parking signage is missing at all 11 accessible parking spaces.

There is no post-mounted signage at the accessible parking spaces.

As of June 2022, this park is undergoing a redesign master plan. The relevance of these findings is pending the results of that redesign.

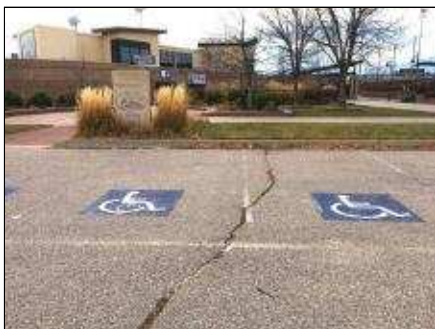
**Accessible parking spaces are not compliant**

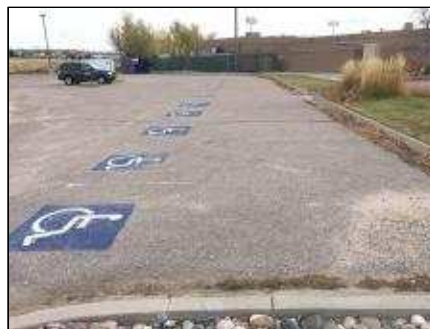
**Accessible parking is not compliant**

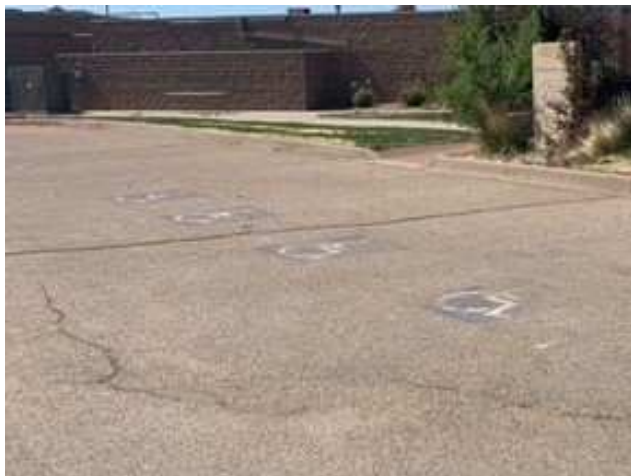
Finding 189478 Main Photo

The asphalt parking surface is fractured, with a gap up to 1-1/2" wide and 1" deep.

There is a gap in the asphalt in the accessible parking.

As of June 2022, this park is undergoing a redesign master plan. The relevance of these findings is pending the results of that redesign.

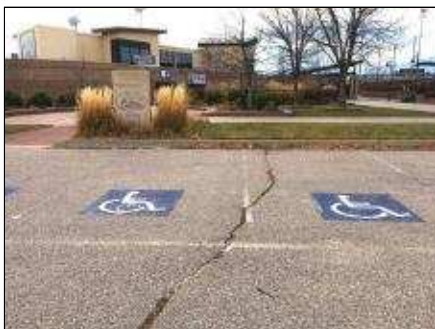
Gaps in the asphalt parking

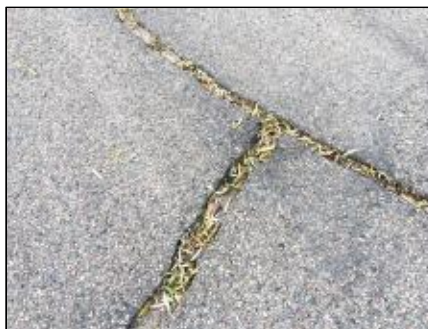
Gaps in the asphalt parking

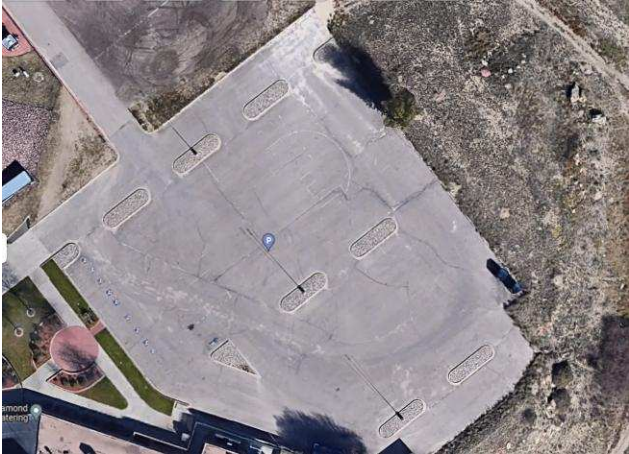
Finding 189479 Main Photo

Based on the total number of parking spaces provided at this facility, 5 are required to be accessible. One of the accessible parking spaces is required to be van accessible.

There are not enough access aisles provided.

As of June 2022, this park is undergoing a redesign master plan. The relevance of these findings is pending the results of that redesign.

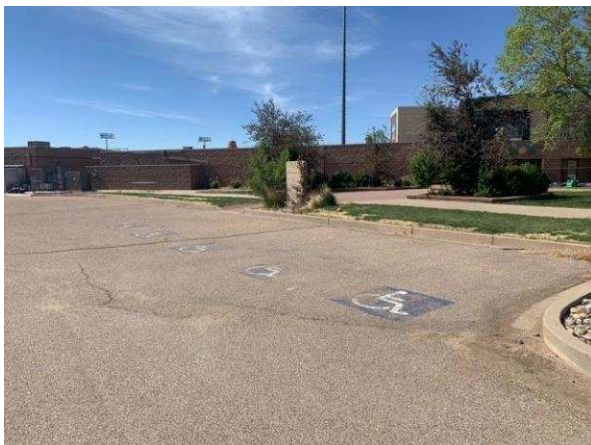
Finding 189480 Main Photo

The striping and markings for the accessible parking stall, loading/unloading access aisle are dilapidated and in need of repair and/or maintenance.

The striping on the accessible parking spaces is faded.

As of June 2022, this park is undergoing a redesign master plan. The relevance of these findings is pending the results of that redesign.

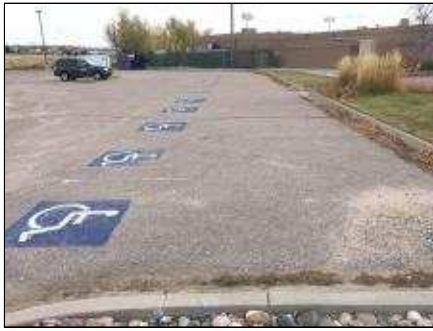
**Accessible parking striping is faded**

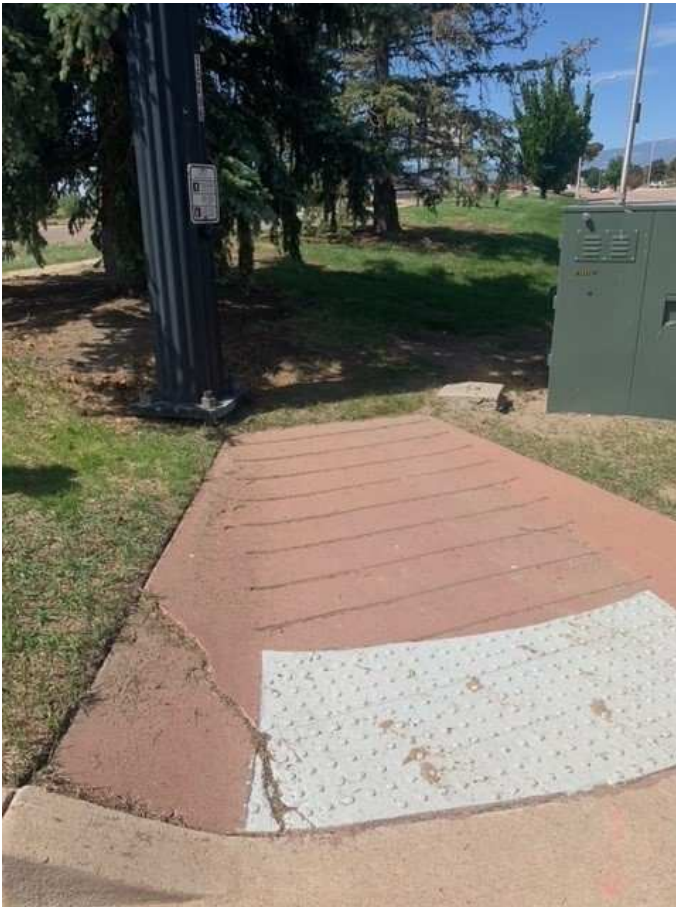
**Finding #6 Continued**

A clear floor space has not been provided at the APS.

This pedestrian signal, located at the corner of Barnes Rd at the far east stadium entrance, is not accessible. It does not have a level, clear space on which to stop and operate the signal.

As of June 2022, this park is undergoing a redesign master plan. The relevance of these findings is pending the results of that redesign.
