Features and Technical Issues Map

Camp Creek Project Reaches

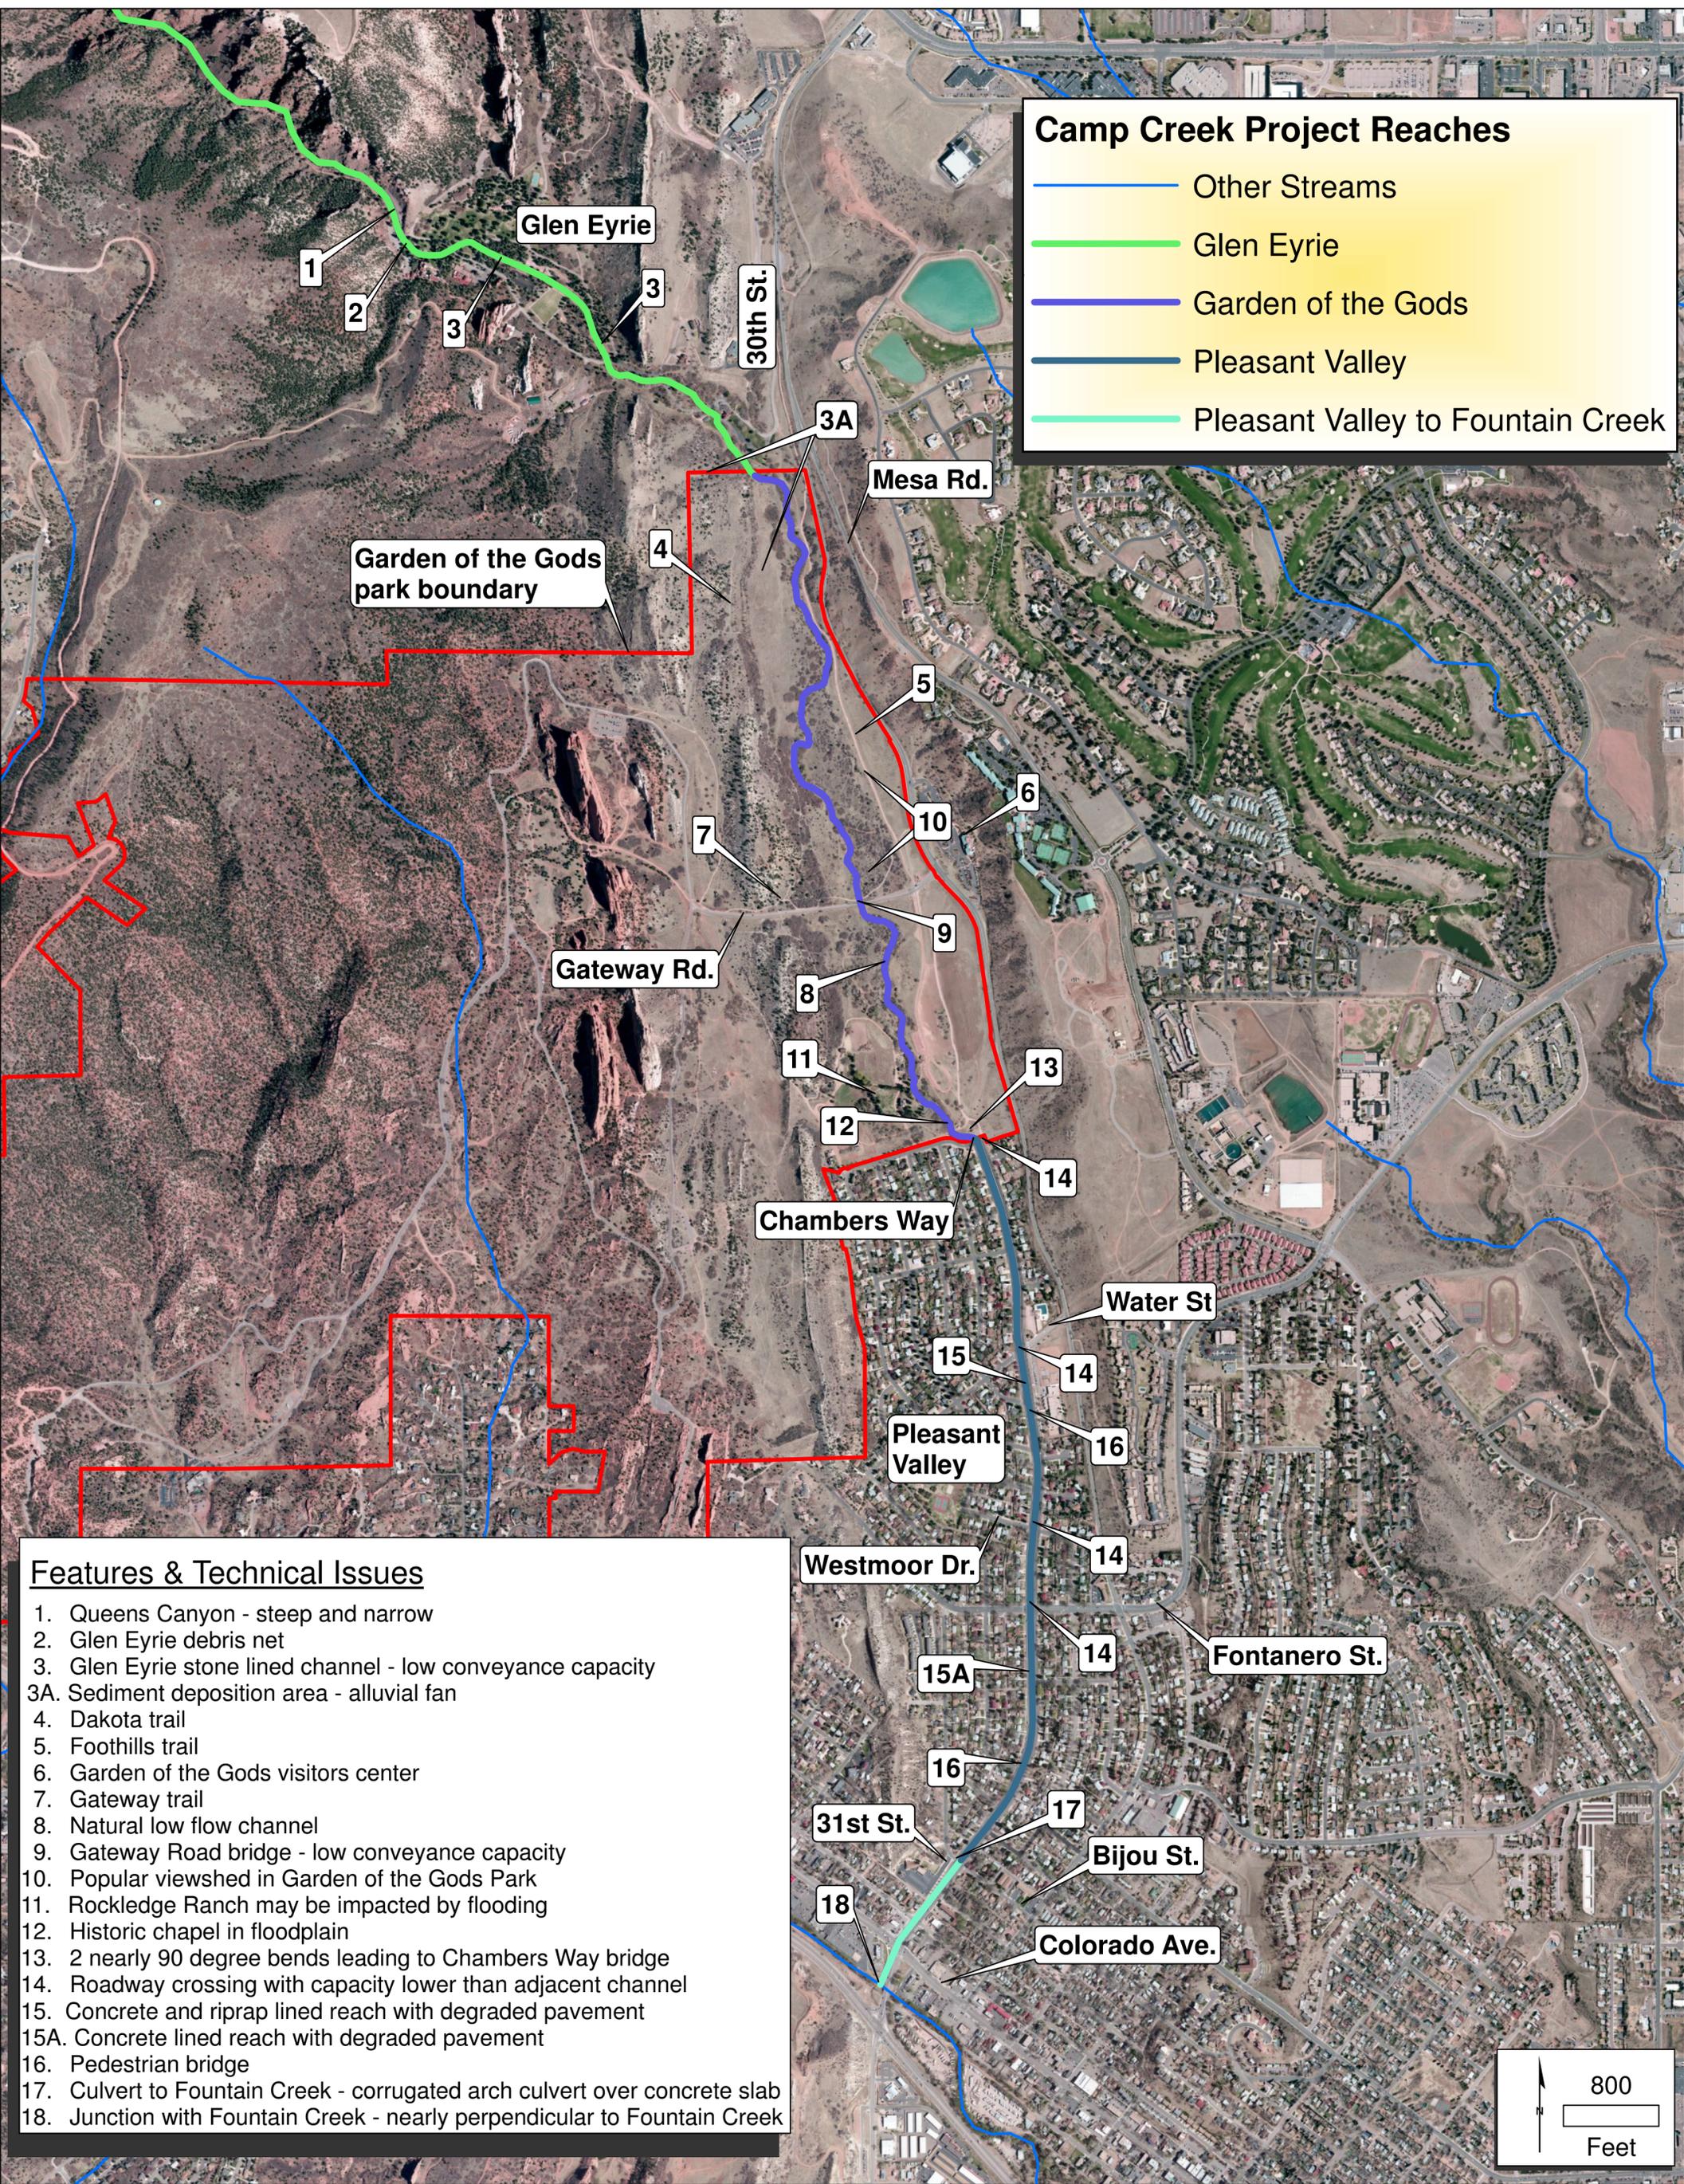
1. Queens Canyon - steep and narrow
2. Glen Eyrie debris net
3. Glen Eyrie stone lined channel - low conveyance capacity
- 3A. Sediment deposition area - alluvial fan
4. Dakota trail
5. Foothills trail
6. Garden of the Gods visitors center
7. Gateway trail
8. Natural low flow channel
9. Gateway Road bridge - low conveyance capacity
10. Popular viewshed in Garden of the Gods Park
11. Rockledge Ranch may be impacted by flooding
12. Historic chapel in floodplain
13. 2 nearly 90 degree bends leading to Chambers Way bridge
14. Roadway crossing with capacity lower than adjacent channel
15. Concrete and riprap lined reach with degraded pavement
- 15A. Concrete lined reach with degraded pavement
16. Pedestrian bridge
17. Culvert to Fountain Creek - corrugated arch culvert over concrete slab
18. Junction with Fountain Creek - nearly perpendicular to Fountain Creek
